# FINAL PRELIMINARY ASSESSMENT AND SITE INSPECTION OF PER- AND POLYFLUOROALKYL SUBSTANCES

**Fort Wainwright Sub-Installations, Alaska**

March 2023

Fort Wainwright Sub-Installations, Alaska

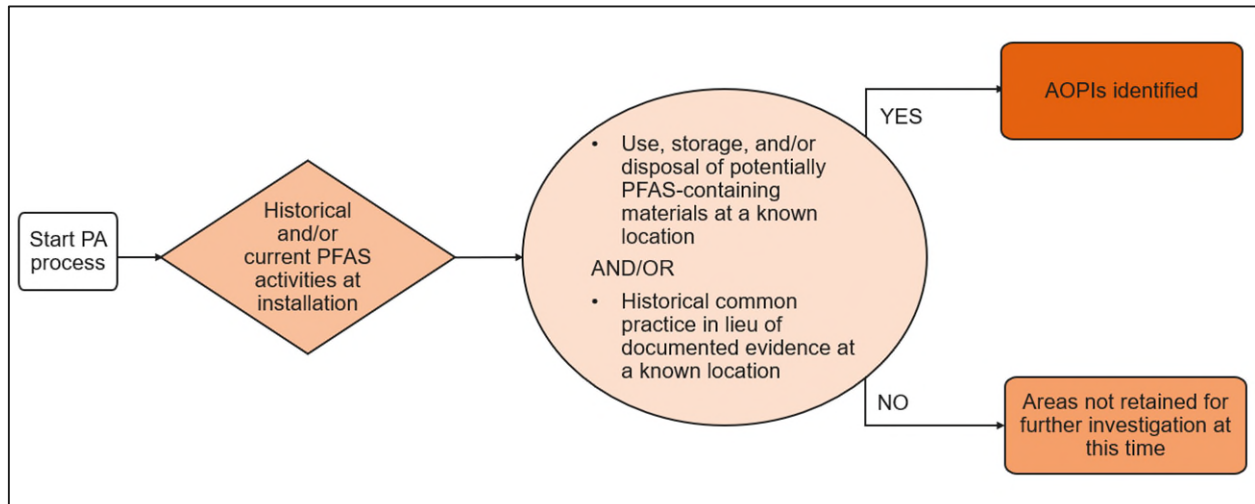
Figure 5-1: AOPI Decision Flowchart

The preliminary locations evaluated for potential use, storage, and/or disposal of PFAS-containing materials at the FTWW Sub-Installations, were further refined during the PA process and identified either as an area not retained for further investigation or as an AOPI. In accordance with the established process for the PA/SI, nine areas have been identified as AOPIs. The process used for refining these areas is presented on **Figure 5-1**, below.

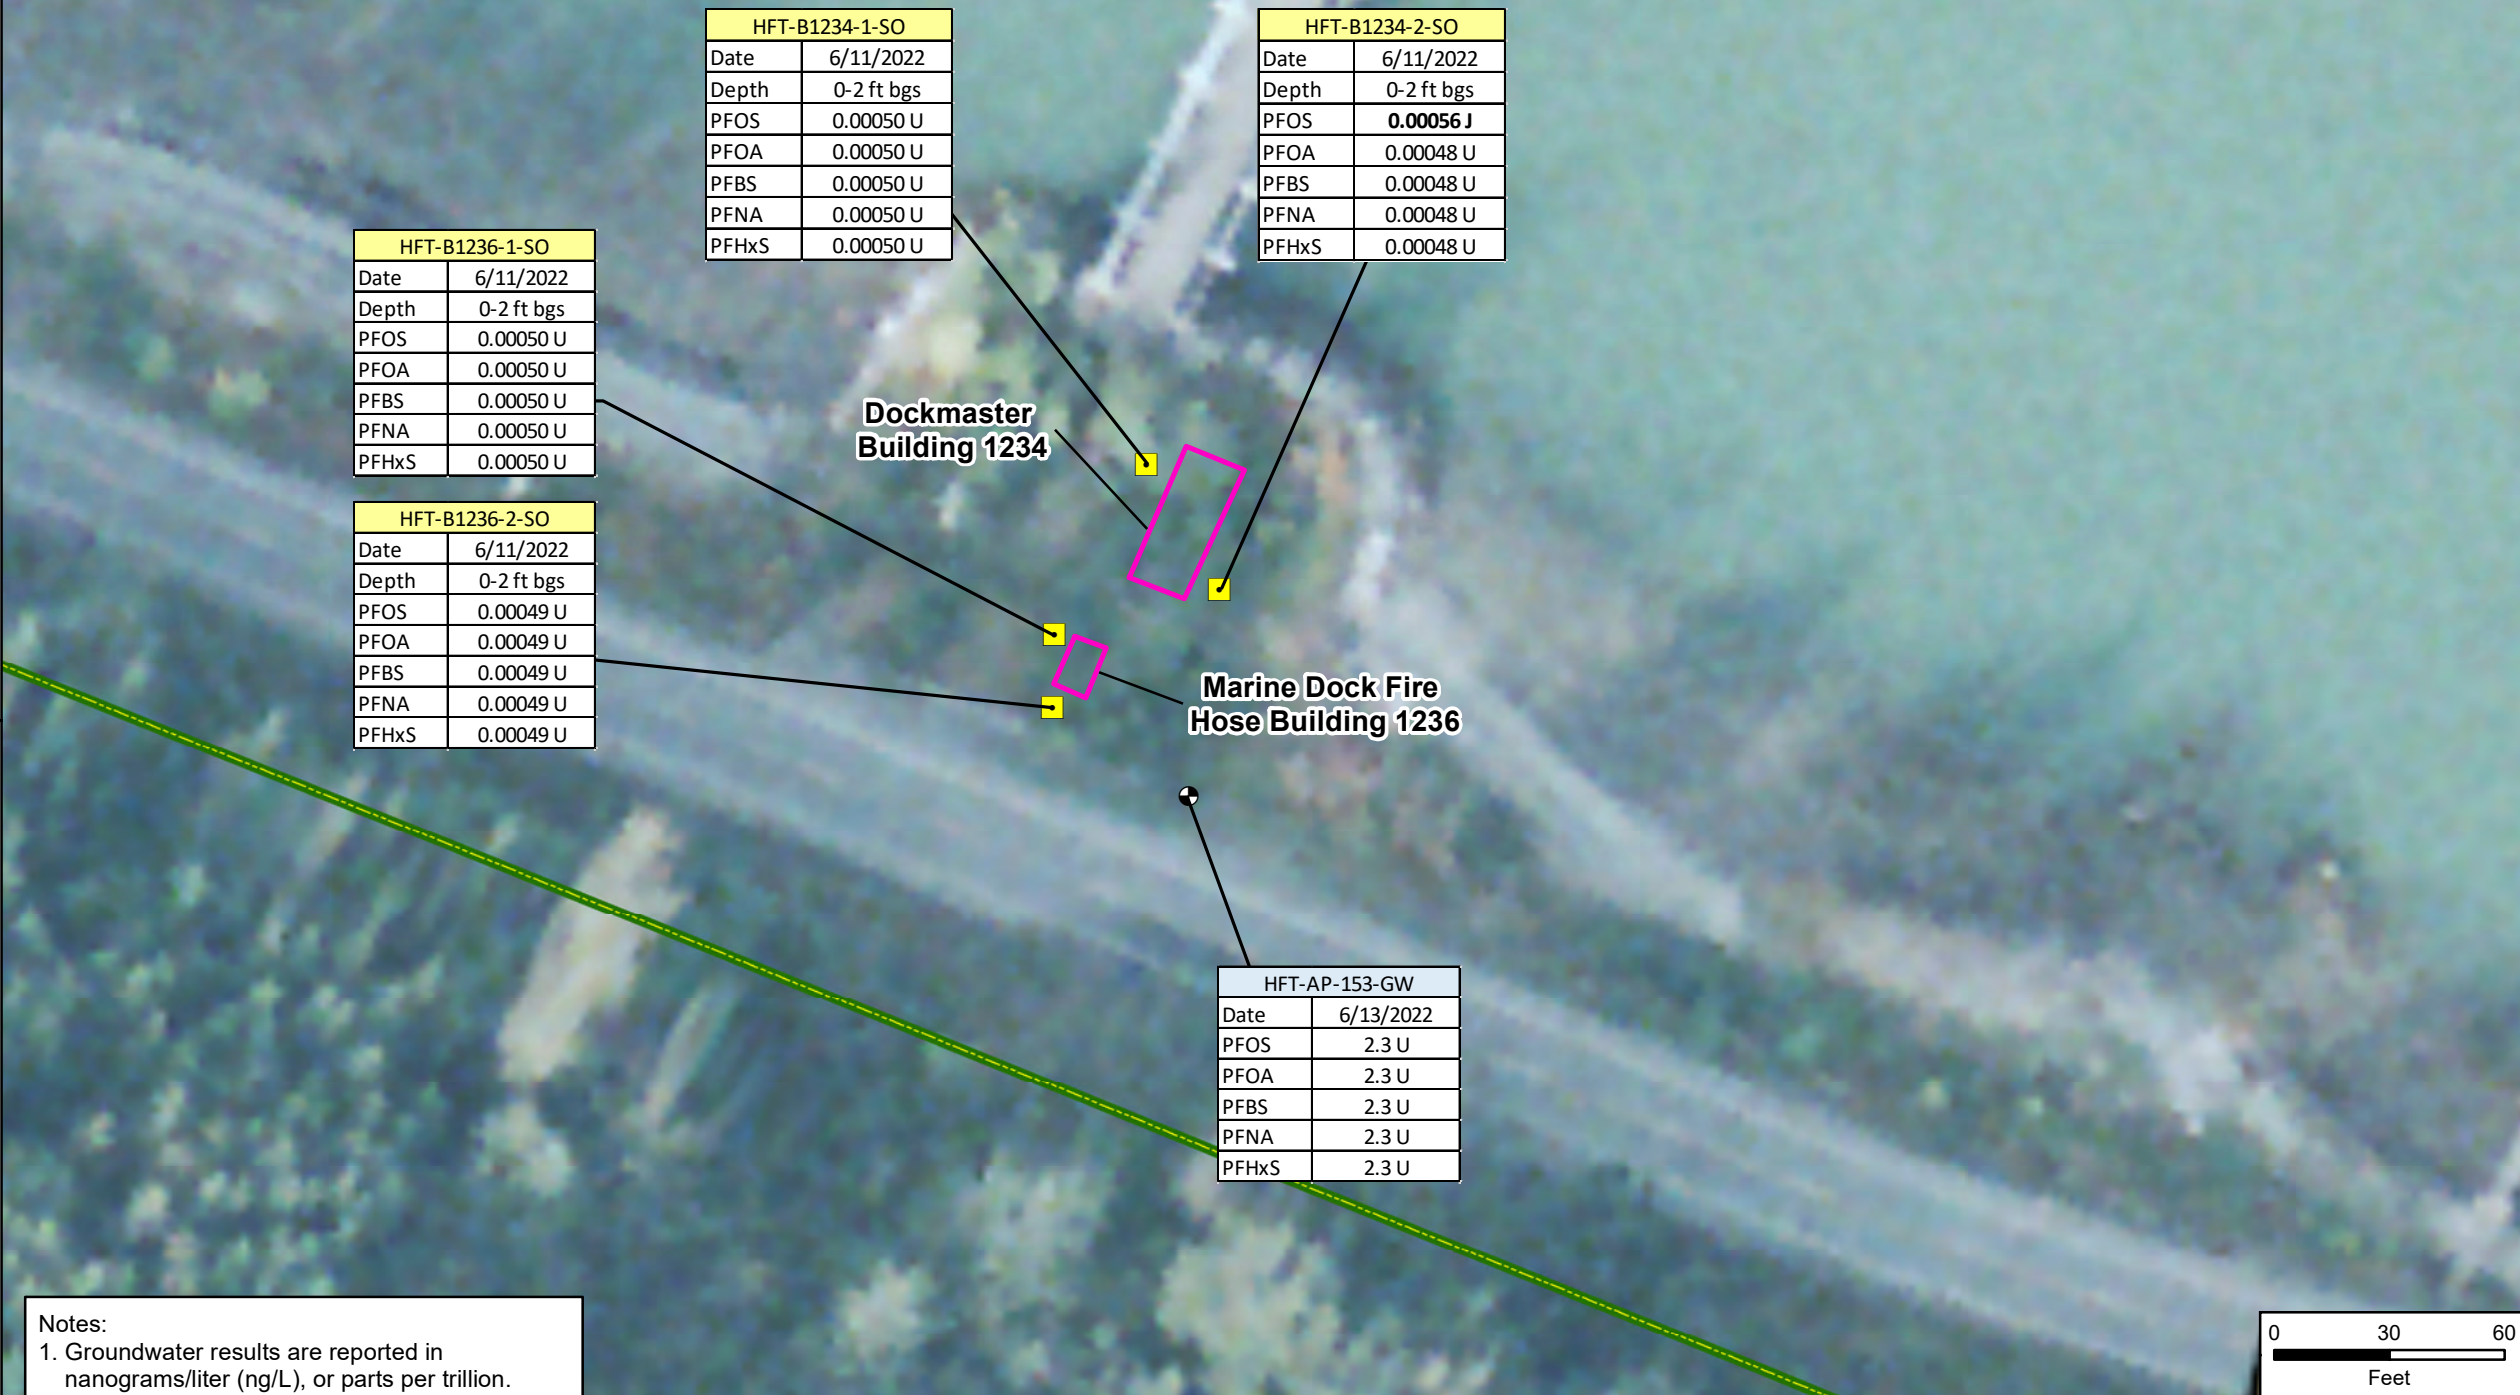
HFT-B1234-1-SO	
Date	6/11/2022
Depth	0-2 ft bgs
PFOS	0.00050 U
PFOA	0.00050 U
PFBS	0.00050 U
PFNA	0.00050 U
PFHxS	0.00050 U

HFT-B1234-2-SO	
Date	6/11/2022
Depth	0-2 ft bgs
PFOS	<b>0.00056 J</b>
PFOA	0.00048 U
PFBS	0.00048 U
PFNA	0.00048 U
PFHxS	0.00048 U

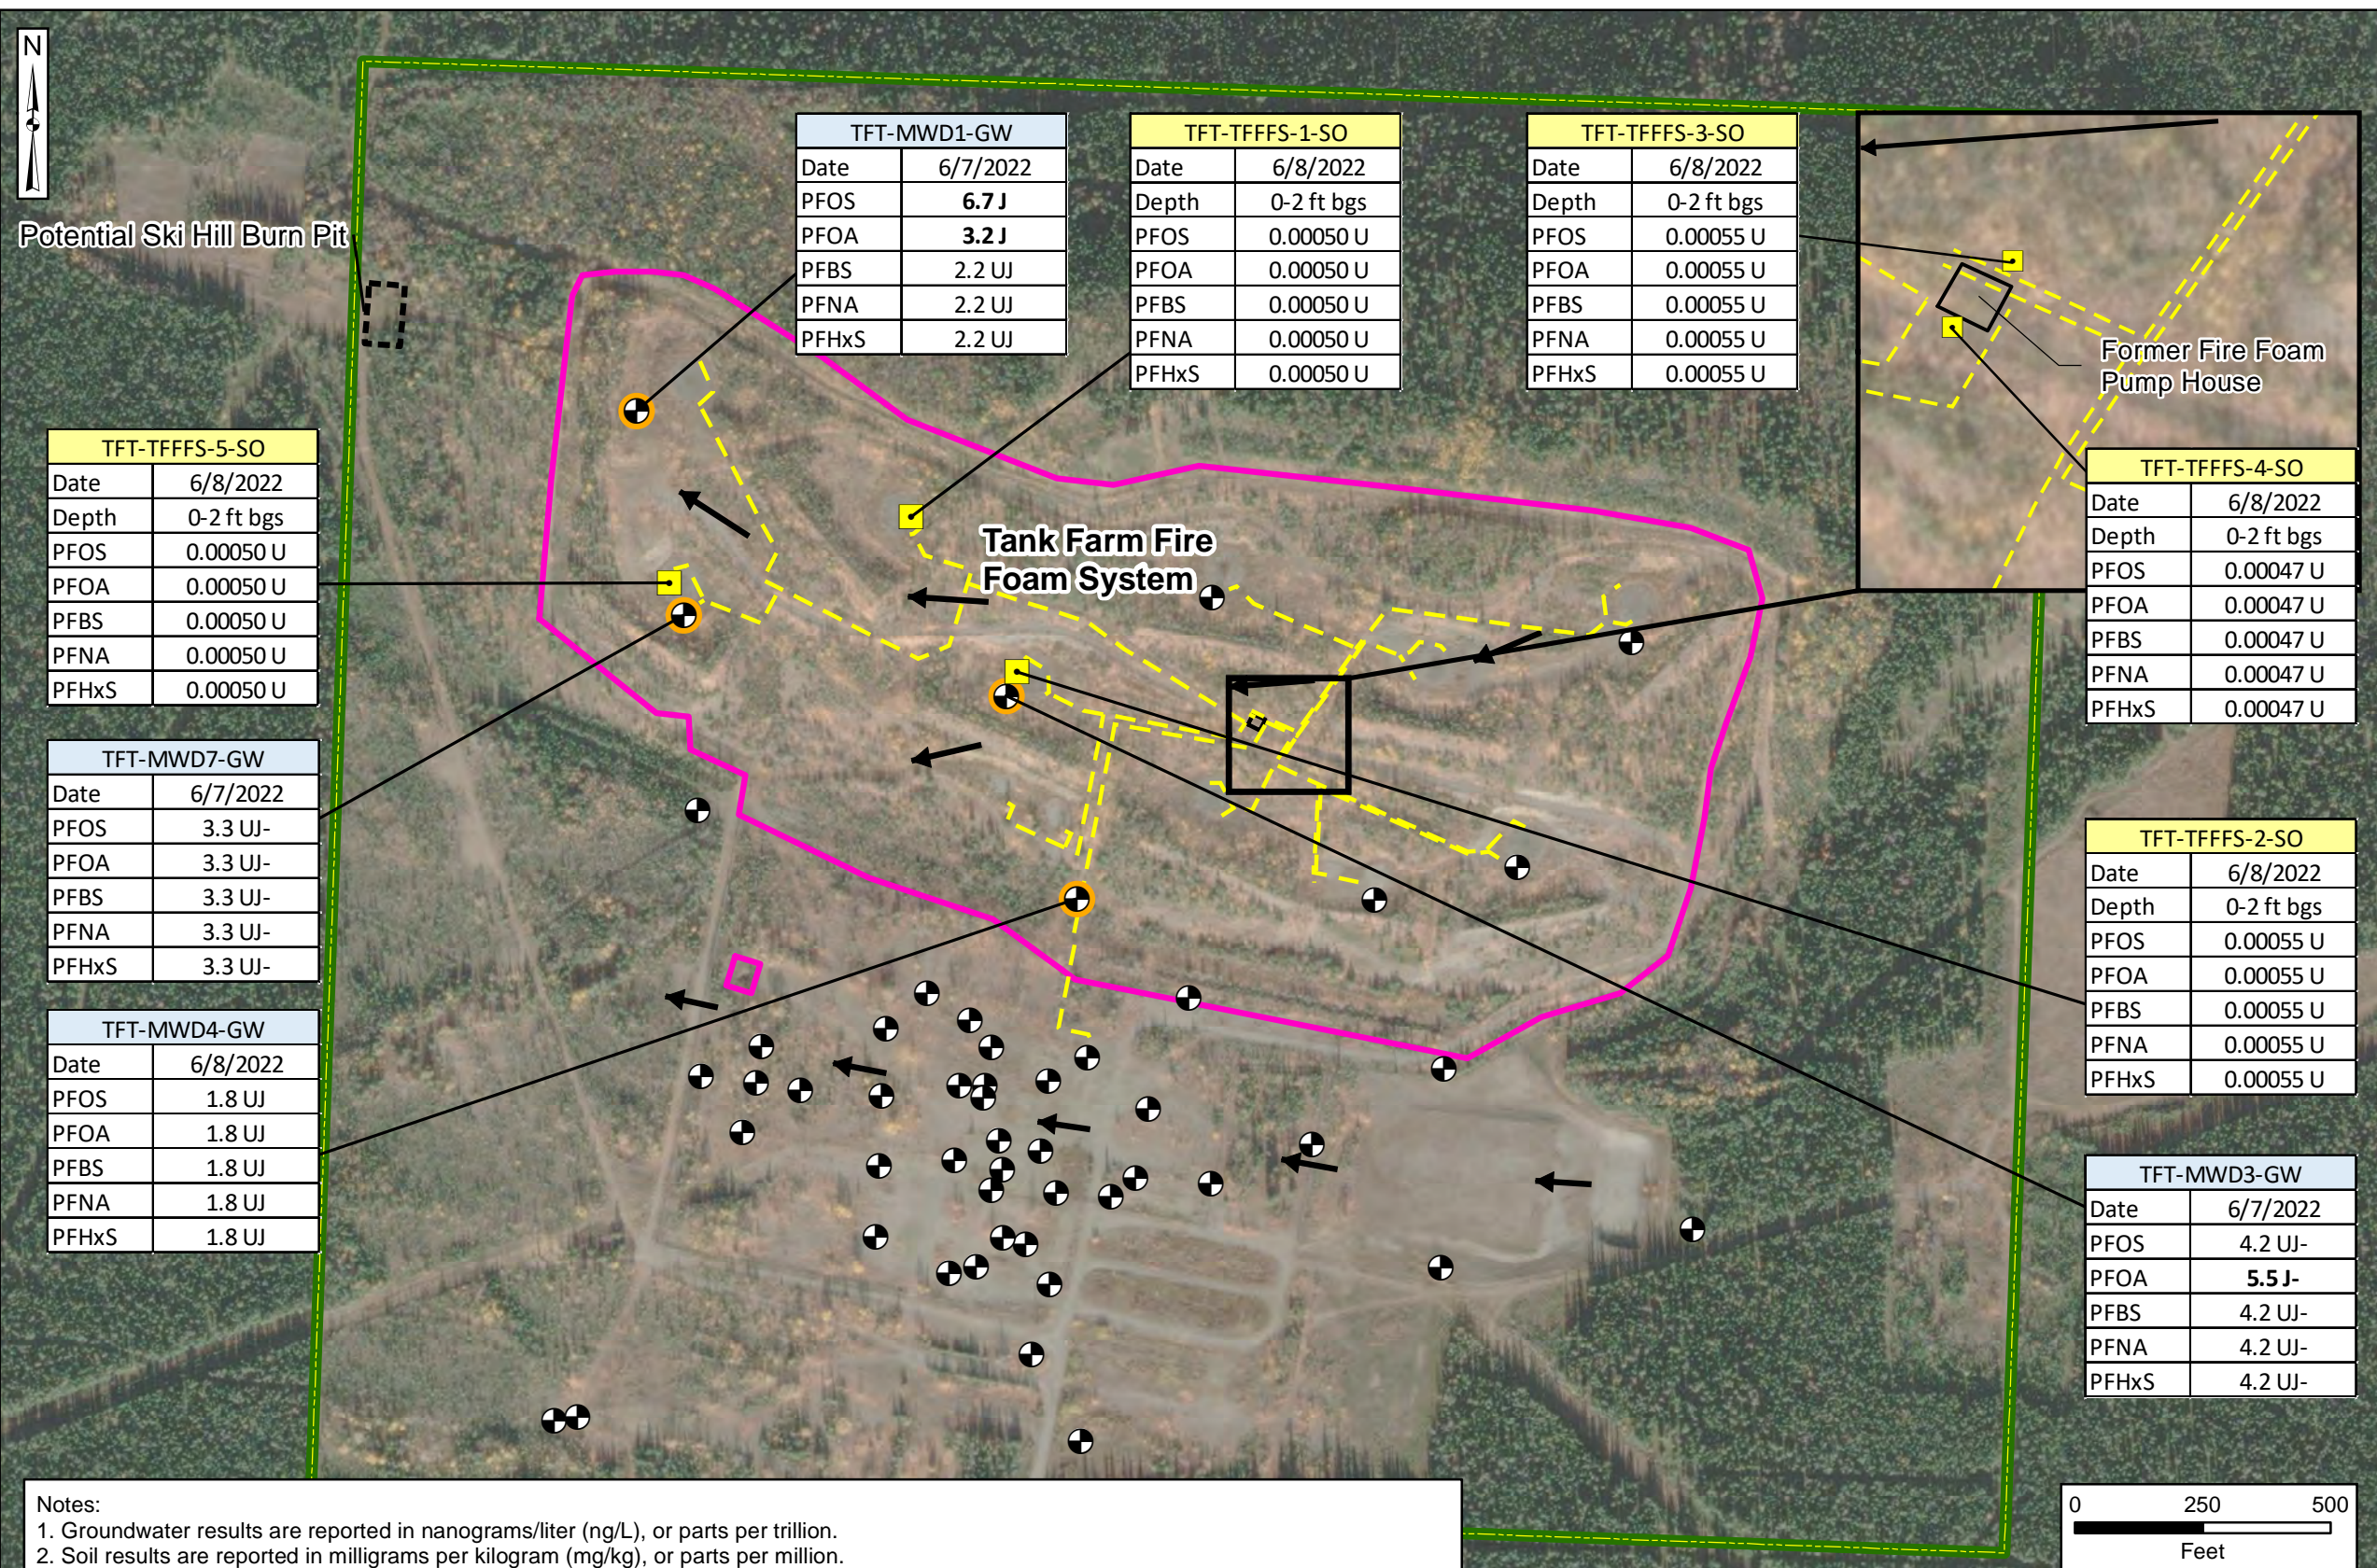
TFT-MWD1-GW	
Date	6/7/2022
PFOS	<b>6.7 J</b>
PFOA	<b>3.2 J</b>
PFBS	2.2 UJ
PFNA	2.2 UJ
PFHxS	2.2 UJ

TFT-TFFFS-1-SO	
Date	6/8/2022
Depth	0-2 ft bgs
PFOS	0.00050 U
PFOA	0.00050 U
PFBS	0.00050 U
PFNA	0.00050 U
PFHxS	0.00050 U

confirmation SI sampling is recommended to make a project decision for the AOPI/confirm concentrations in groundwater.
