AGRA EARTH & ENVIRONMENTAL, INC.
SUMMARY REPORT FOR TANK CLOSURE
Yutana Barge Lines
Former Service Station

AUGUST 1994

32-01104-00

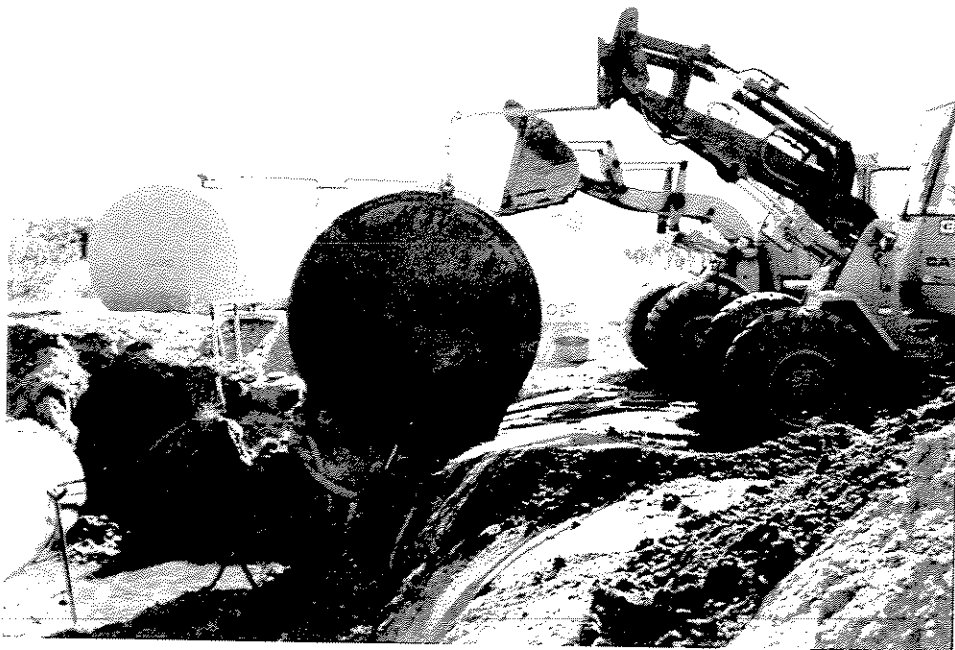
Photo 2: Tank No. 2 during removal.

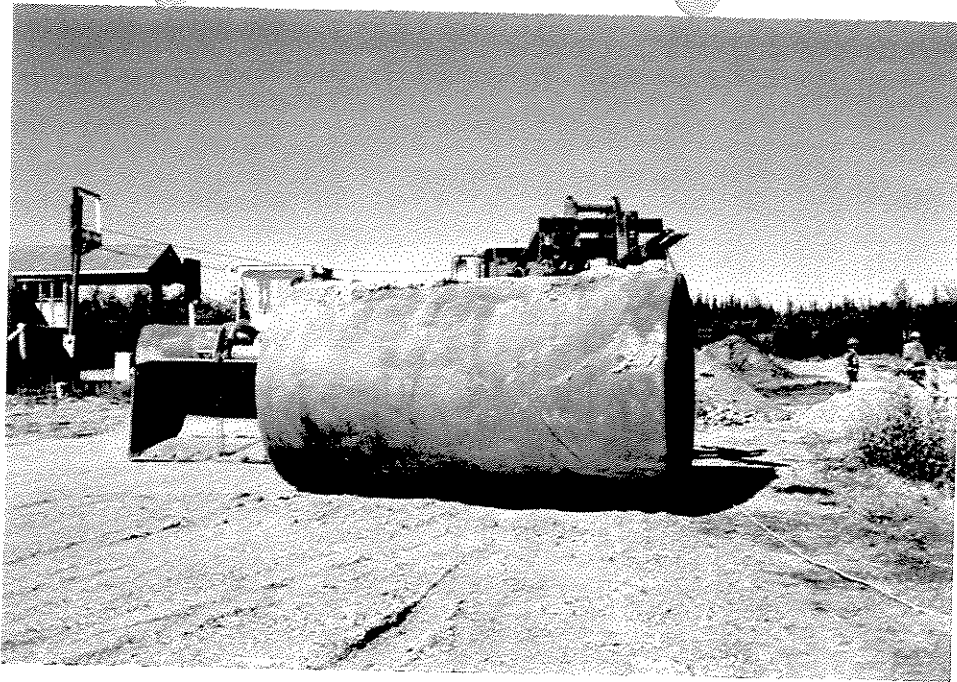
Upon removal of the remaining tanks, AGRA E&E personnel inspected the tank metal and associated piping. The tanks appeared to be in fair condition with moderate surface corrosion and no apparent holes or leaks. Associated piping showed appreciable surface rusting. It was not possible to determine the tightness of the pipe joints prior to removal, as some of the piping had been cut during past site work in the UST area. The excavation was terminated at approximately 7 feet below surface grade. (A leak detection system associated with the aboveground tanks was left in place for future removal.)

Photo 3: General condition of Tank No. 2.

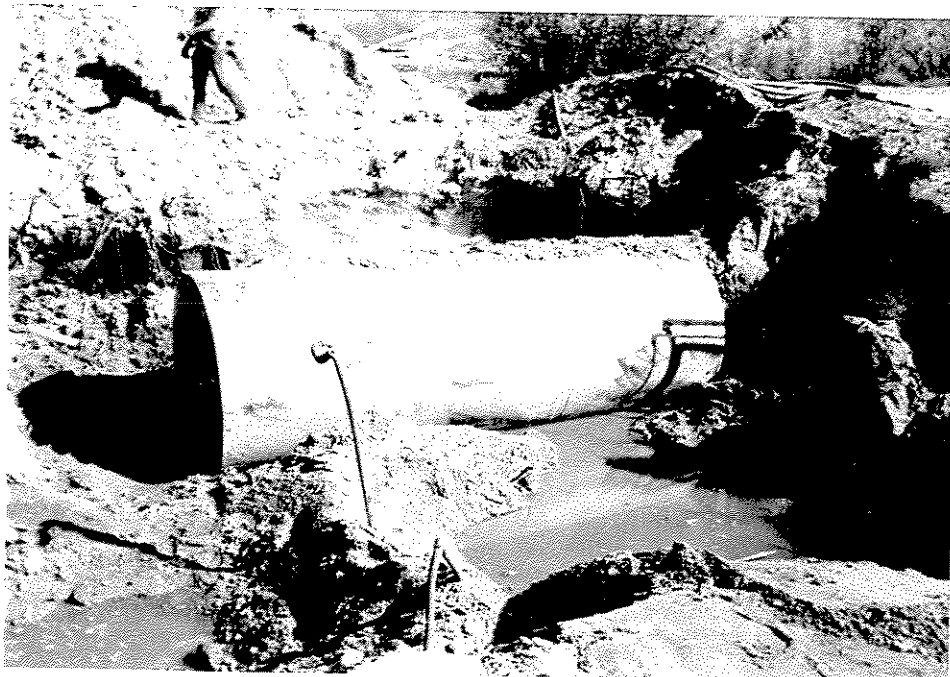
During a preliminary site assessment by Yutana personnel, it was found that the 4,000-gallon tanks was partially full of water. Yutana pumped the water into a water transportation vehicle prior to extracting the tank. During removal of the 4,000-gallon tank, approximately 3 to 5 gallons of water drained into the excavation pit from a short pipe located at the base of the tank. The pipe appeared to have been cut at a previous time. The top of the pipe was located below the groundwater interface, and apparently enabled groundwater to communicate with the tank interior. Photos 5 and 6 show the condition of the piping during the removal process.

Photo 4: Tank No. 3, a 4,000-gallon UST, in place in the excavation.
