Underground Storage Tanks

APPENDIX A

UST 1400 – Former Ammunition Storage (Site ID UST1400)

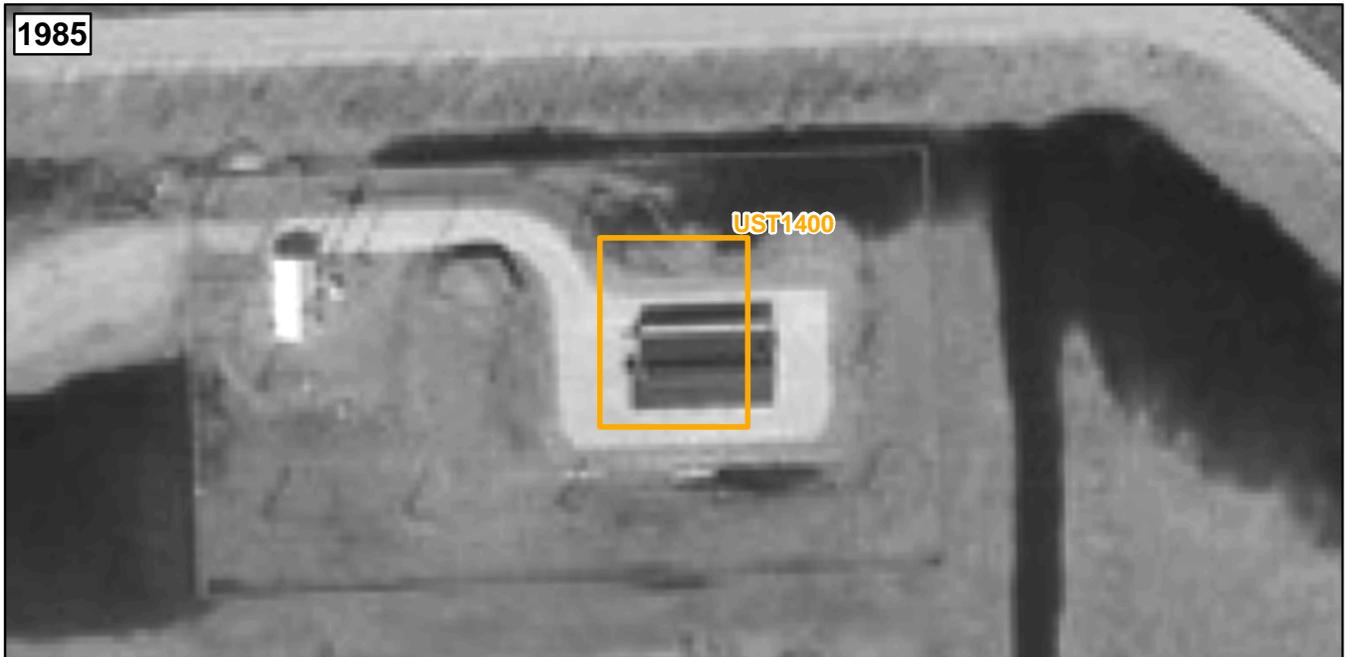
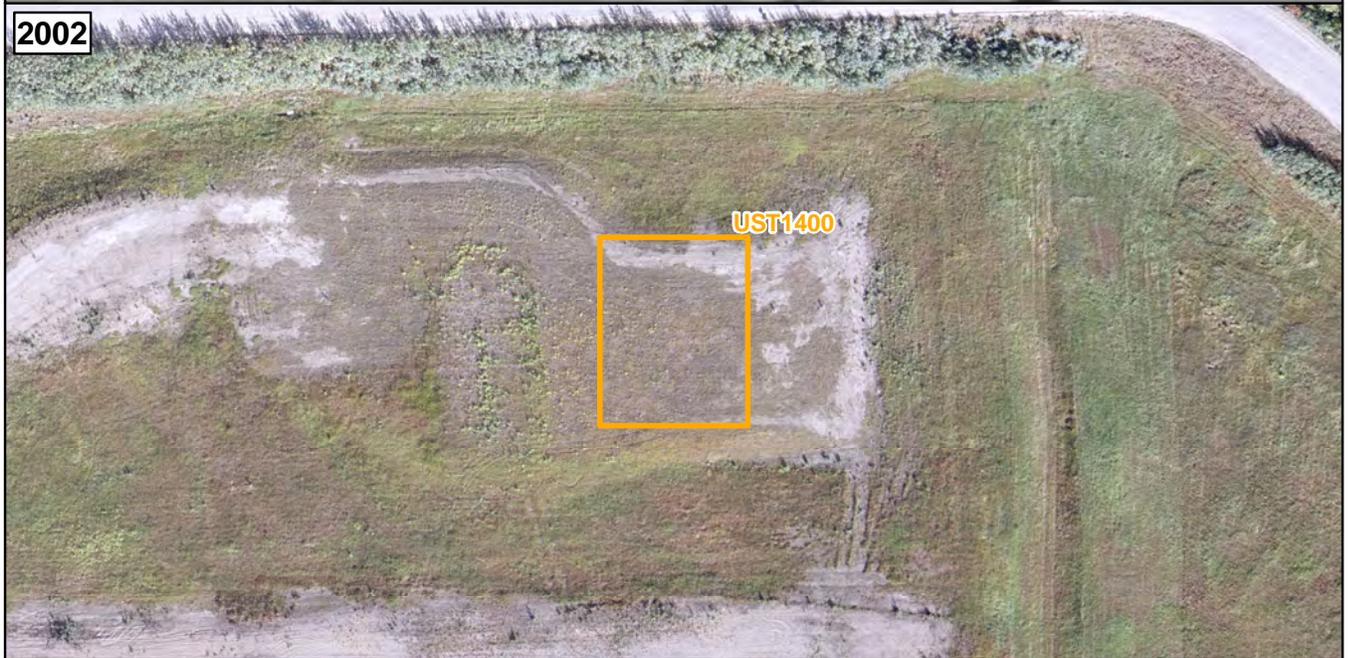
FIGURE A2-UST1400
Historical Aerial Photography
 Preliminary Assessment Report
 Former Galena Forward Operating Location, Alaska

Historical aerial photographs of Site UST1400, dated 1985 and 2002, are shown on Figure A2-UST1400.

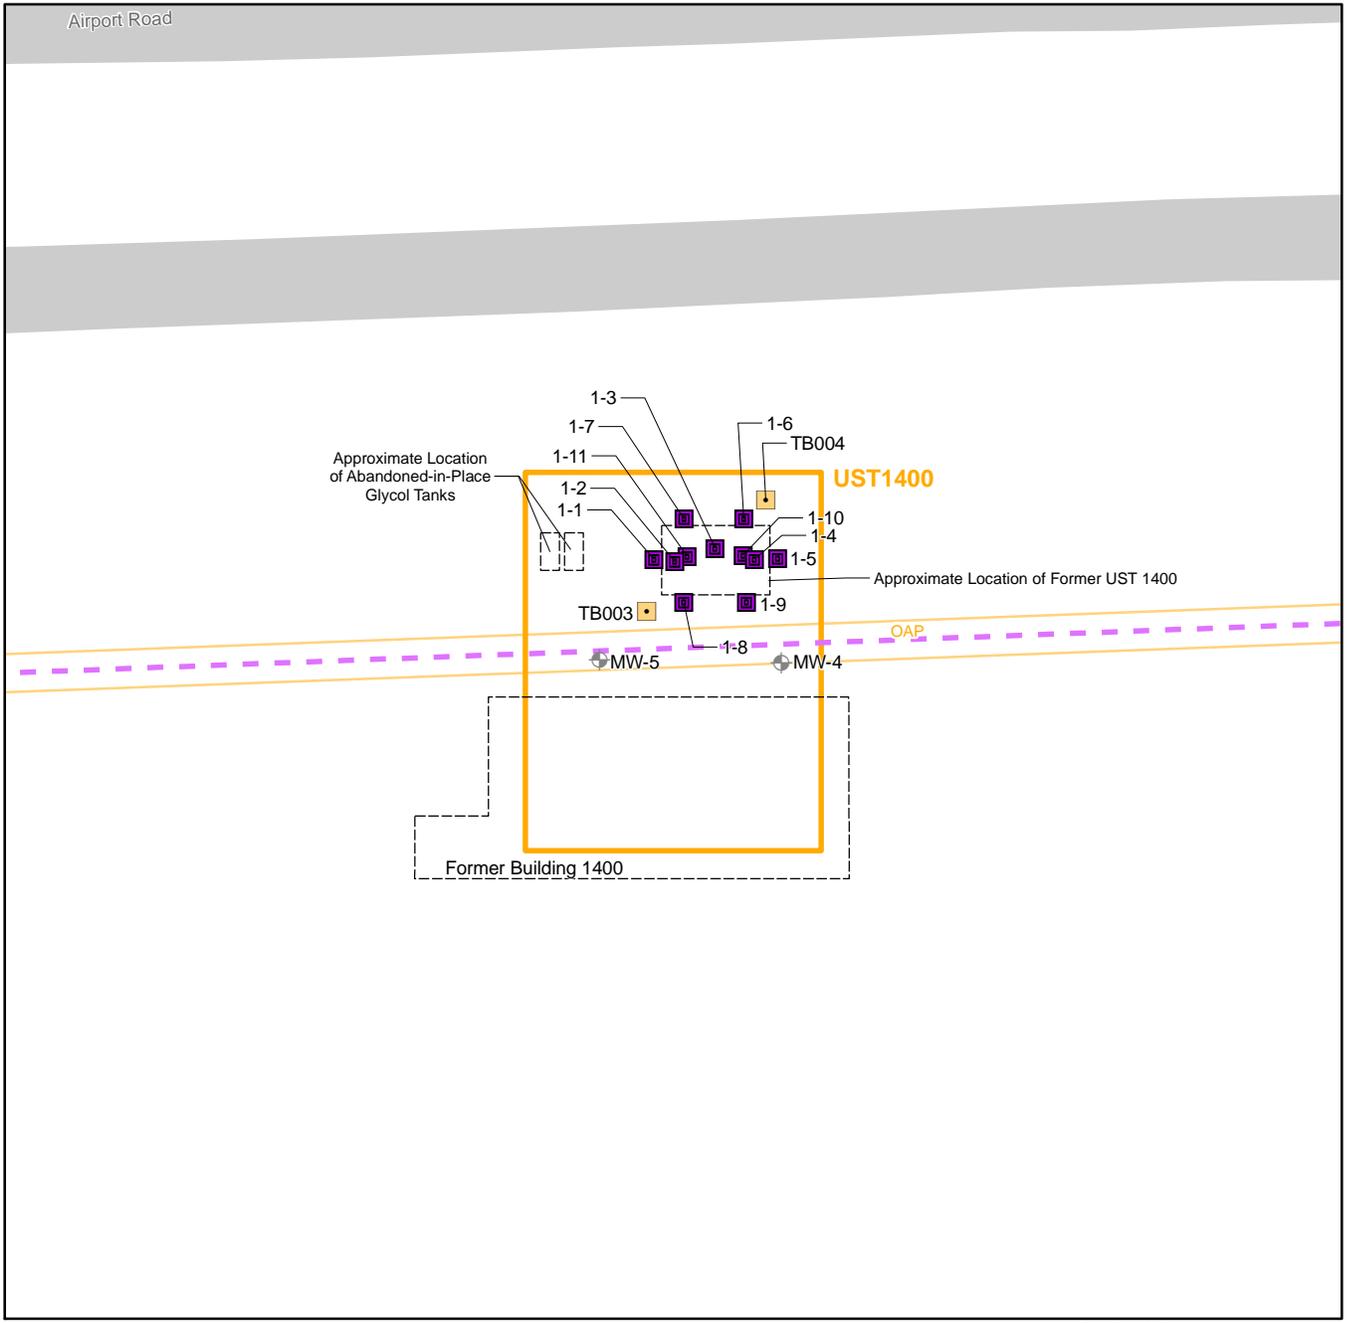
FIGURE A3-UST1400
Historical Sample Locations
 Preliminary Assessment Report
 Former Galena Forward Operating Location, Alaska

Historic sampling locations at Site UST1400 are shown on Figure A3-UST1400.

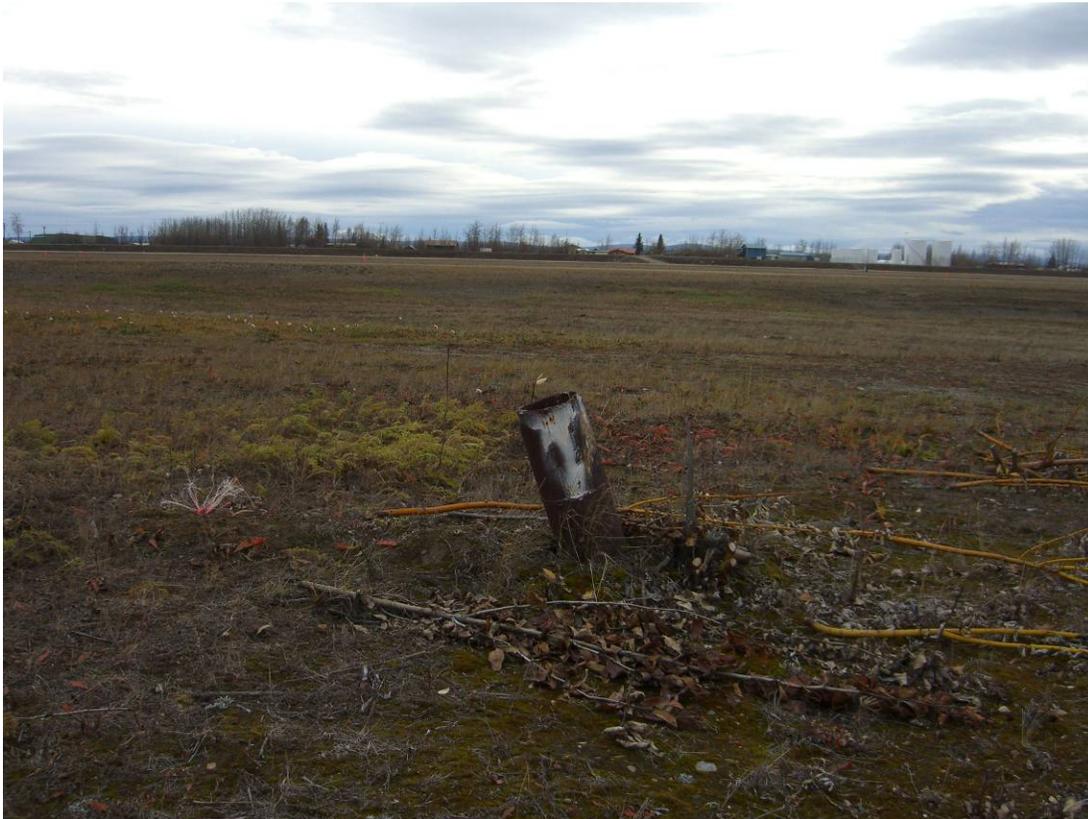
FIGURE A4-UST1400
Former Location of Building 1400, October 2009

An inspection of Site UST1400 was conducted in October 2009. The area is currently an unoccupied gravel pad. No visible stains or other evidence of contamination were noted. Figure A4-UST1400 shows the condition of Site UST1400 in 2009.

Site UST1400 is recommended for an ADEC site characterization. Additional investigation is recommended at Site UST1400 to further define the nature and extent of fuel related contamination. Limited site inspection sampling will also be conducted for the former radiator heating tanks and the septic system drain field.

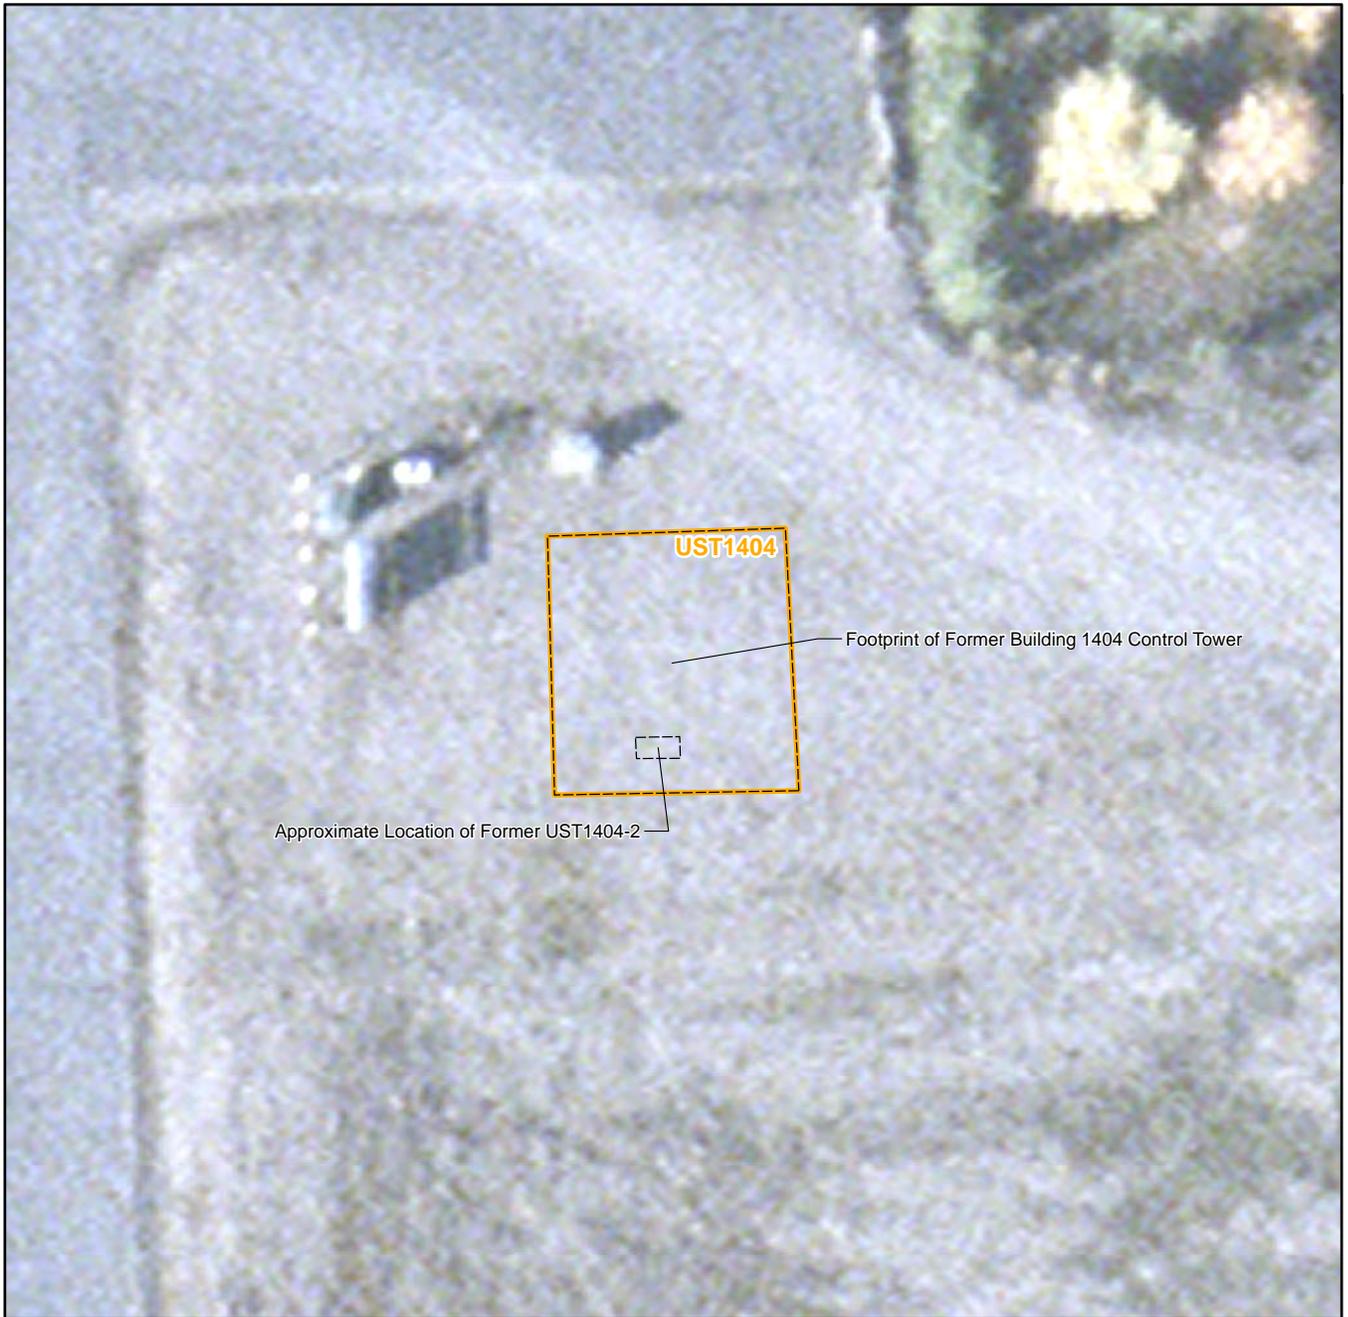
**FIGURE A1-UST1404
Site Layout**

Capacity:	500 gallons
Contents:	Diesel
Construction:	Welded steel
Condition:	Good
Use:	Fuel oil for control tower
Installation Date:	1986
Location:	Within Building 1404 footprint
Status:	Removed in 1990
ADEC Tank ID:	24
ADEC Status:	Permanently out of use

Recommendation: Site Inspection Sampling

Limited site inspection sampling is recommended to confirm the absence of contamination and complete closure of the UST in accordance with 18 AAC 78.

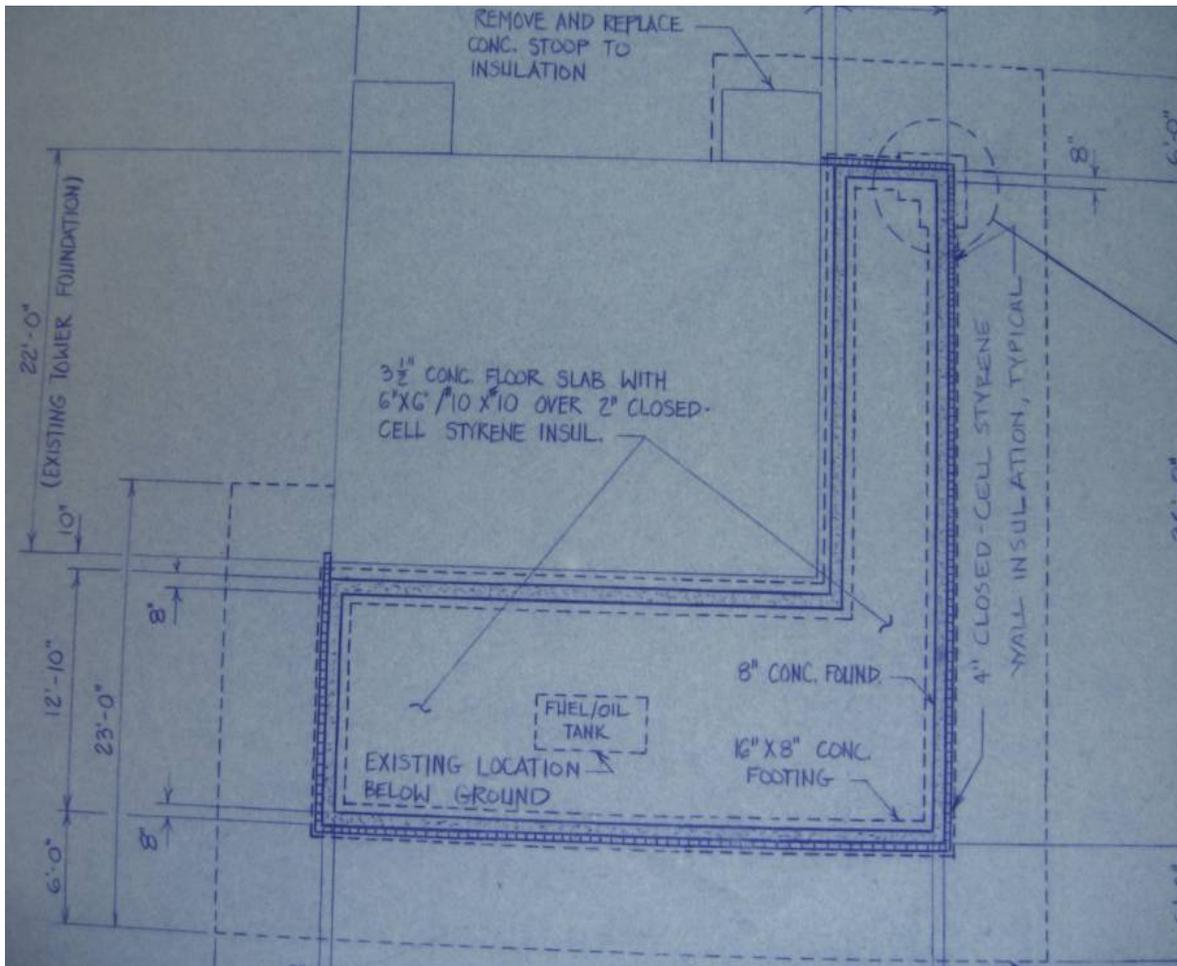
FIGURE A5-UST1404
Construction Drawing, Construct Galena Weather Facility, 1989

UST 1404-2, a 500-gallon diesel UST, was originally installed as a UST to provide fuel storage for the control tower when it was constructed in 1986. In 1990, when the weather facility was added to the control tower, the new footprint covered the location of the original UST. Because the UST was only 4 years old, the tank was relocated inside the facility as an AST. The AST continued to provide fuel storage for the facility until approximately 2007. The reutilization of the UST as an AST inside the facility indicates that this UST was in good condition and likely did not leak during the 4 years it was in the ground. The location of the former 500-gallon UST can be approximated from the facility drawings (Figure A5-UST1404).

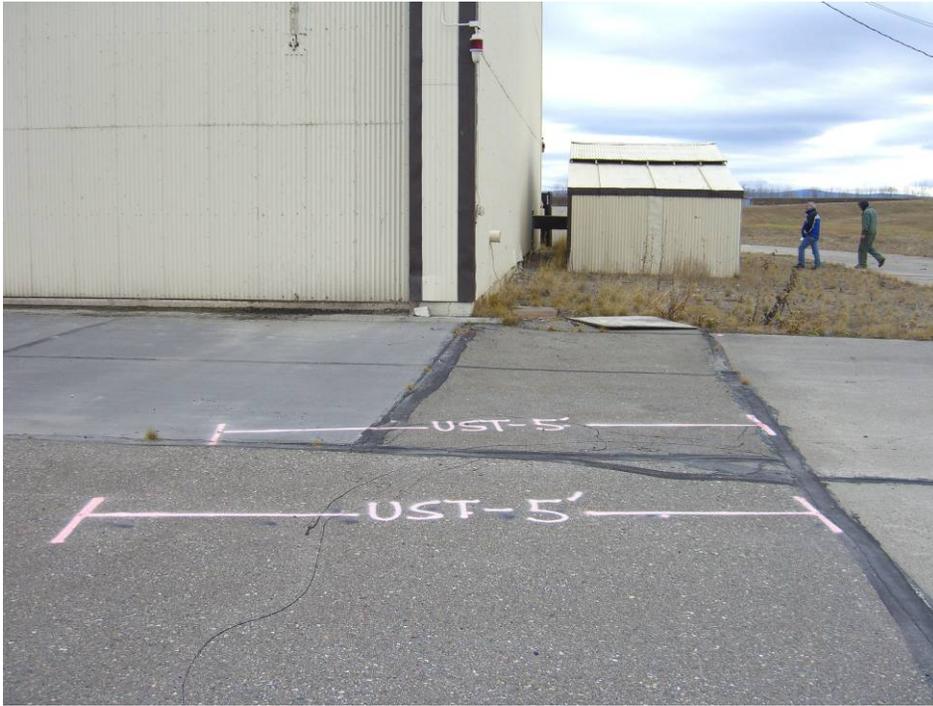
FIGURE A3-UST1428
Location of USTs at Northwestern Corner of Building 1428, October 2009

An inspection of Site UST1428 was conducted in October 2009. The site is covered with pavement. Figures A3-UST1428 and A4-UST1428 show site conditions and the determined locations of the USTs at Site UST1428 in October 2009.

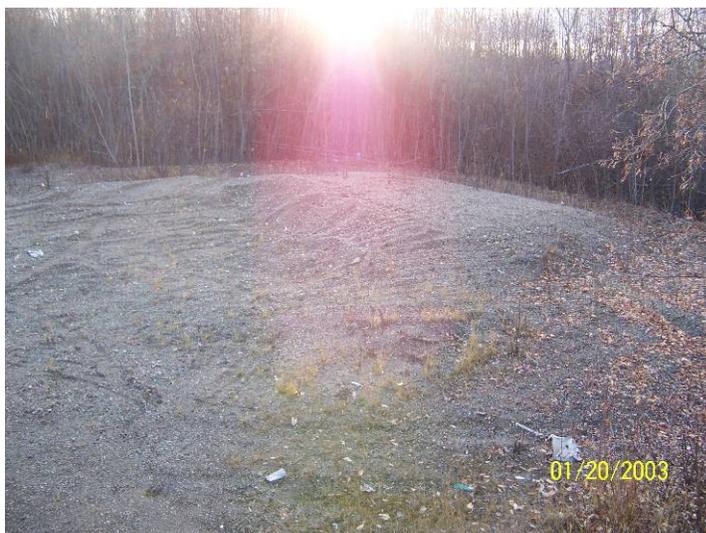
FIGURE A4-UST1770

Gravel Pad at Former Location of Building 1770, October 2009

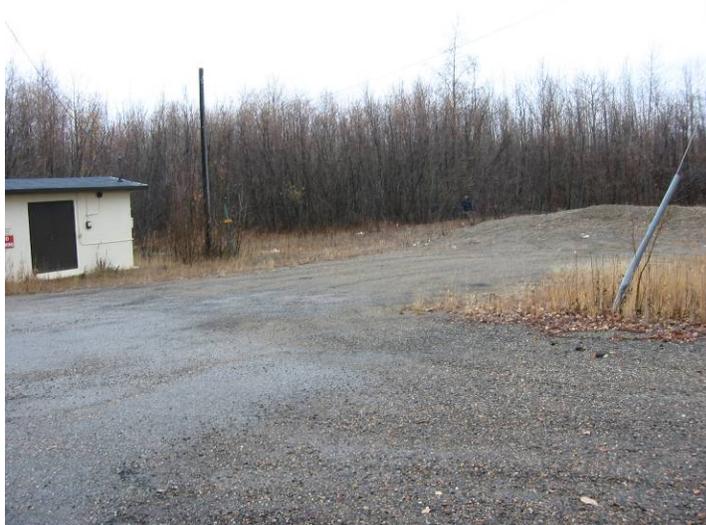
FIGURE A5-UST1770

Surrounding Area, October 2009

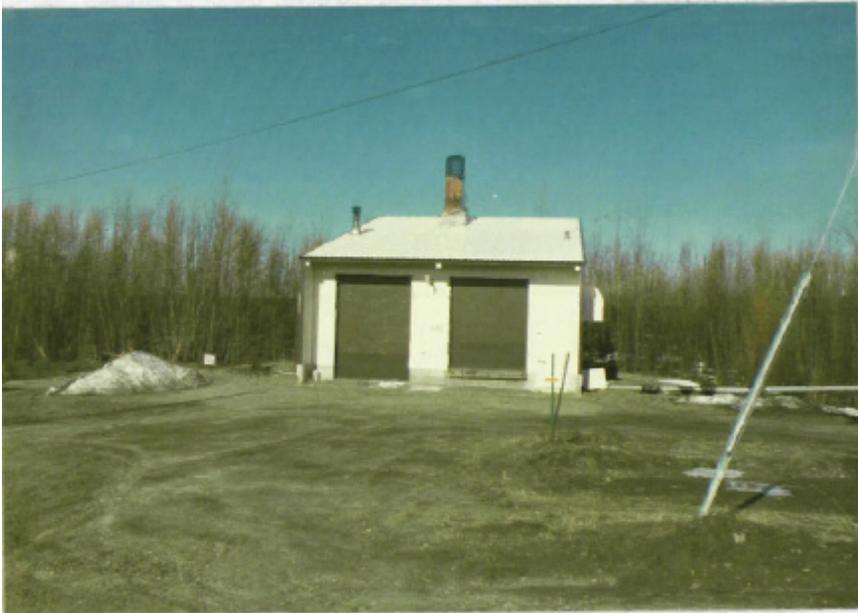
FIGURE A6-UST1770
Facility before Demolition, Undated Air Force Real Property Agency (AFRPA) document

Galena Airport
Air Force Building No. 1770, Solid Waste Disposal Facility
Constructed: 1974
Square feet: 1,440
Type construction: Concrete foundation and floor, corrugated
steel walls and roof.

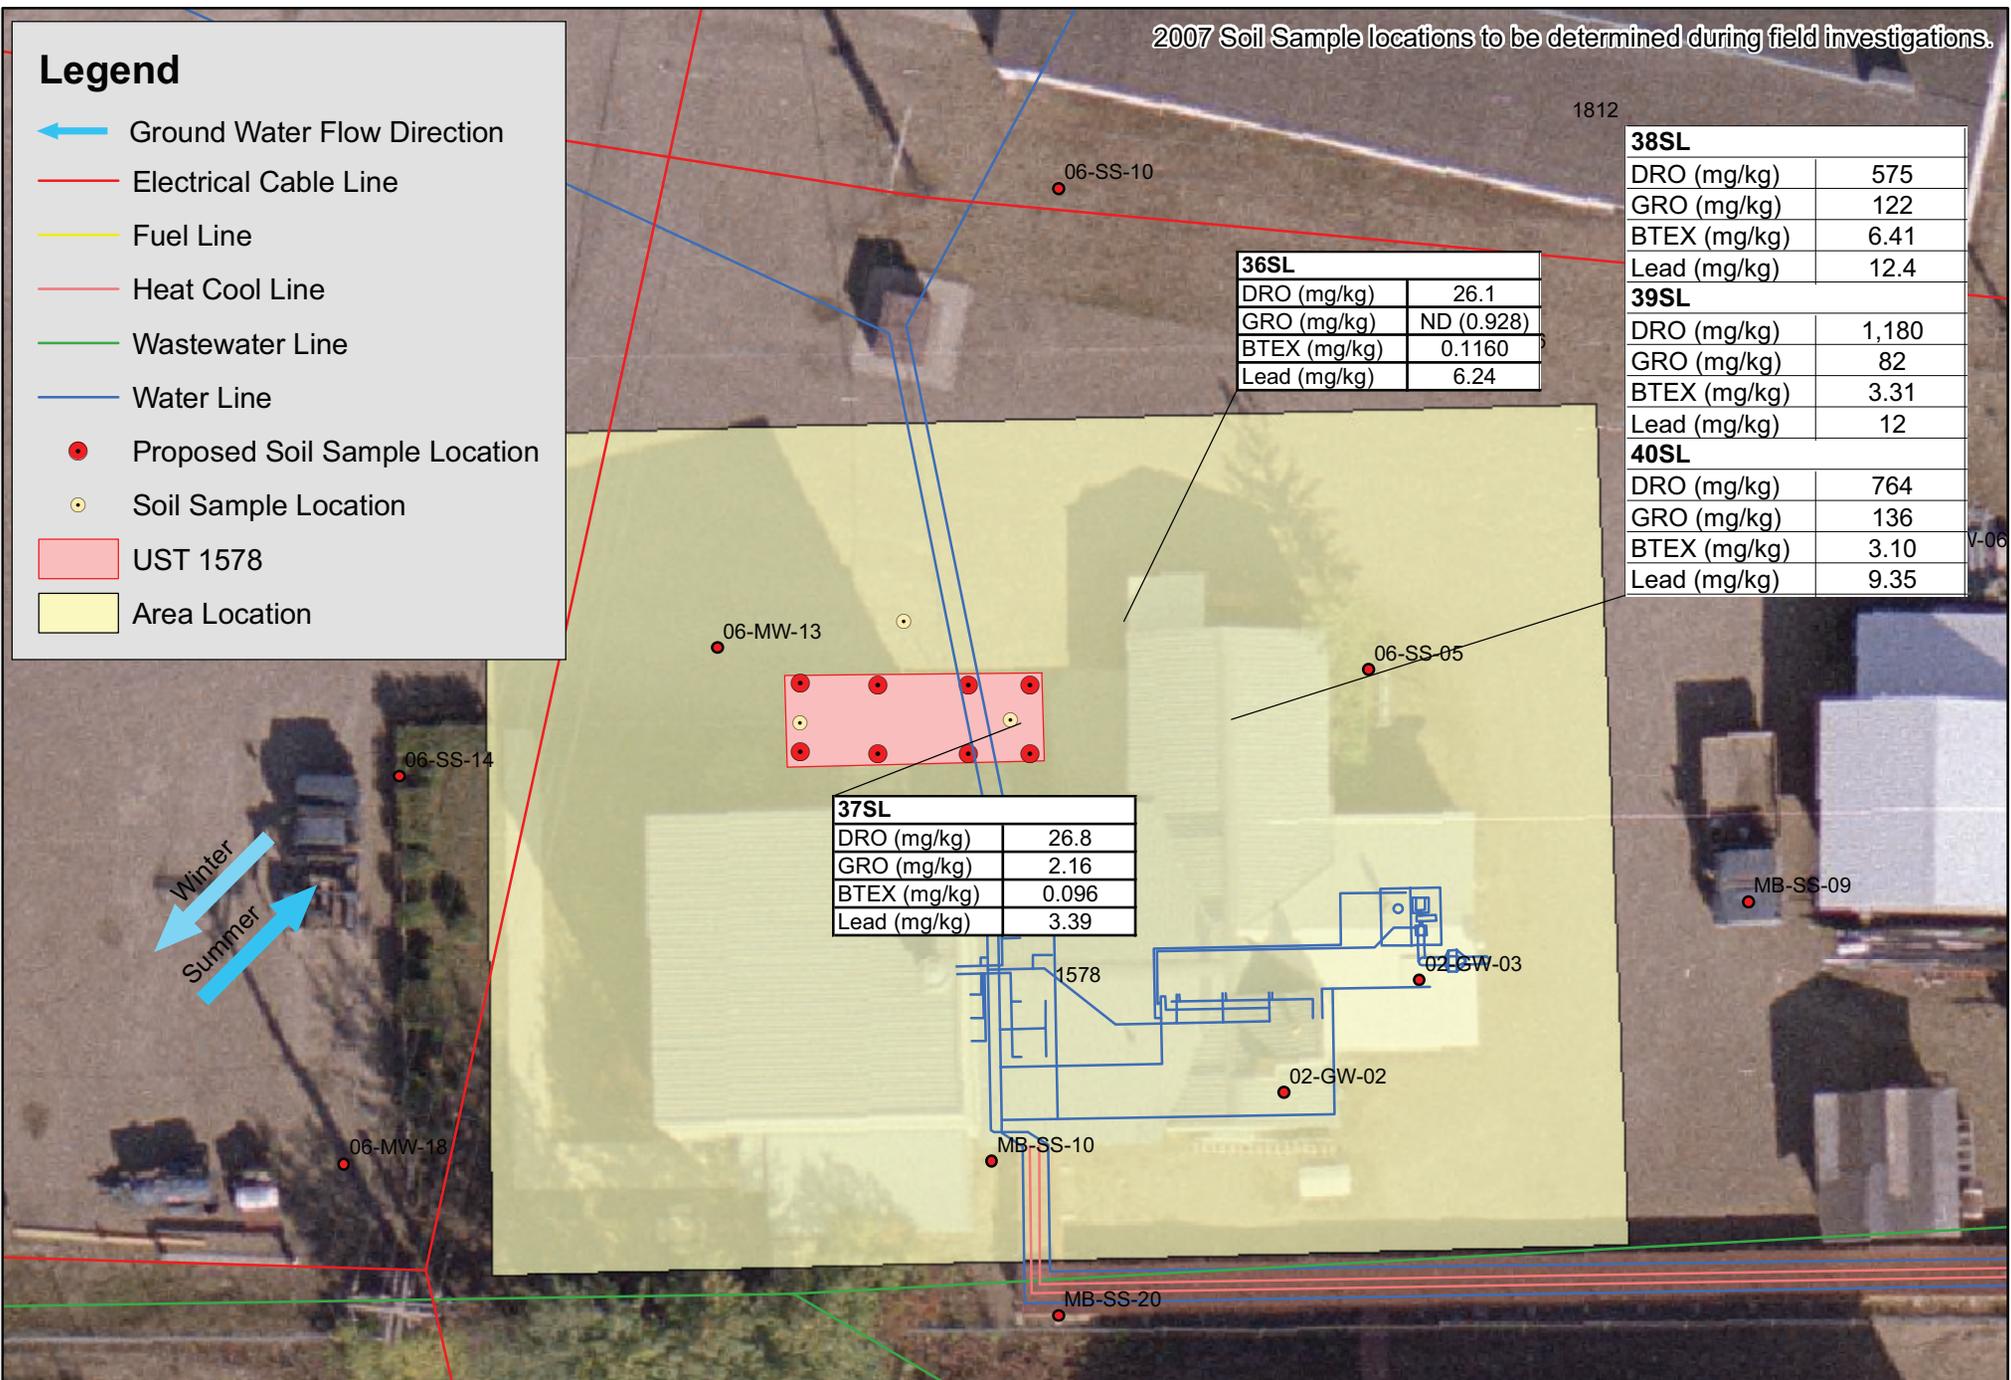
36SL	
DRO (mg/kg)	26.1
GRO (mg/kg)	ND (0.928)
BTEX (mg/kg)	0.1160
Lead (mg/kg)	6.24

38SL	
DRO (mg/kg)	575
GRO (mg/kg)	122
BTEX (mg/kg)	6.41
Lead (mg/kg)	12.4
