Oil-Water Separators

APPENDIX A

OWS1573 - Vehicle Maintenance Shop (SITE ID OWS1573)

Preliminary Assessment Report
Former Galena Forward Operating Location, Alaska

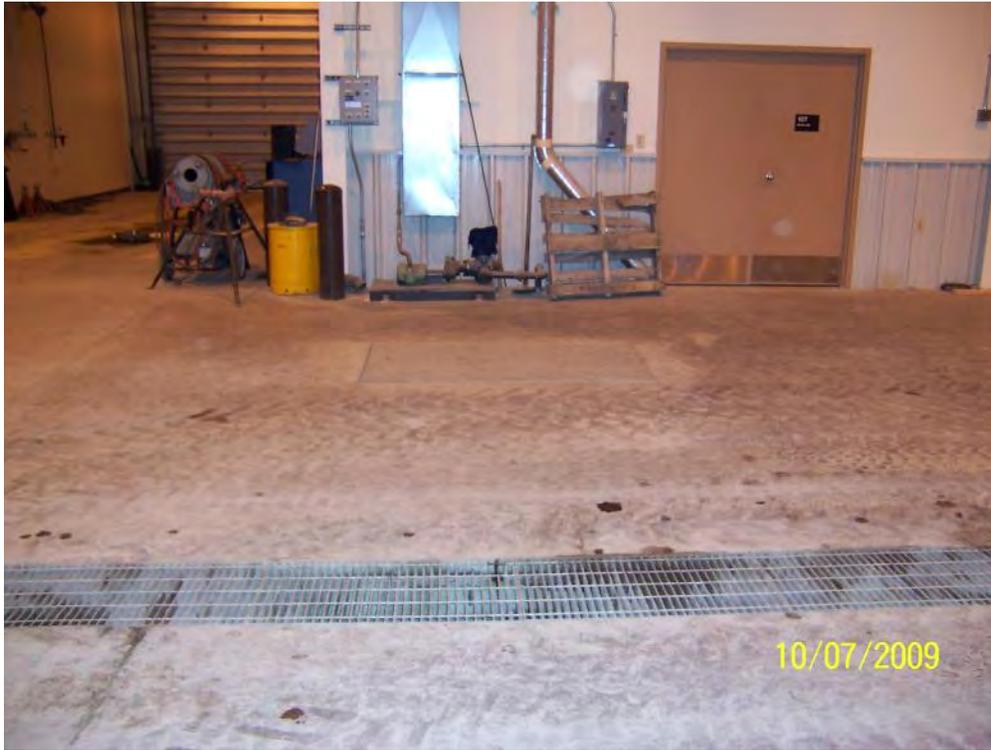
FIGURE A3-OWS1573
OWS, Floor Drain, and Pump in Building 1573, October 2009

A site visit of Site OWS1573 was conducted in October 2009. A photograph of the OWS, floor drain, and pump is provided in Figure A3-OWS1573. During the site visit, the OWS construction was confirmed to include cathodic protection and an electronic leak detection system. Building 1573 was observed to have a concrete slab. No evidence was found that would indicate a potential release from the OWS.

OWS 1573 was installed in Building 1573 in 1994. Based on the modern construction of the OWS, which includes cathodic protection and an electronic leak detection system, an undetected release from the OWS is unlikely. During the 2009 site visit, no visual evidence was found that would indicate a potential historical release from the OWS.

Because a release has not likely occurred at Site OWS1573, designation of Site OWS1573 as a "Non-Site" is recommended. Parcel Block 8, Lots 11 and 14 will continue to be investigated as ERP Site ST009, but it is recommended that Site OWS1573 be removed from consideration as a potential source area.

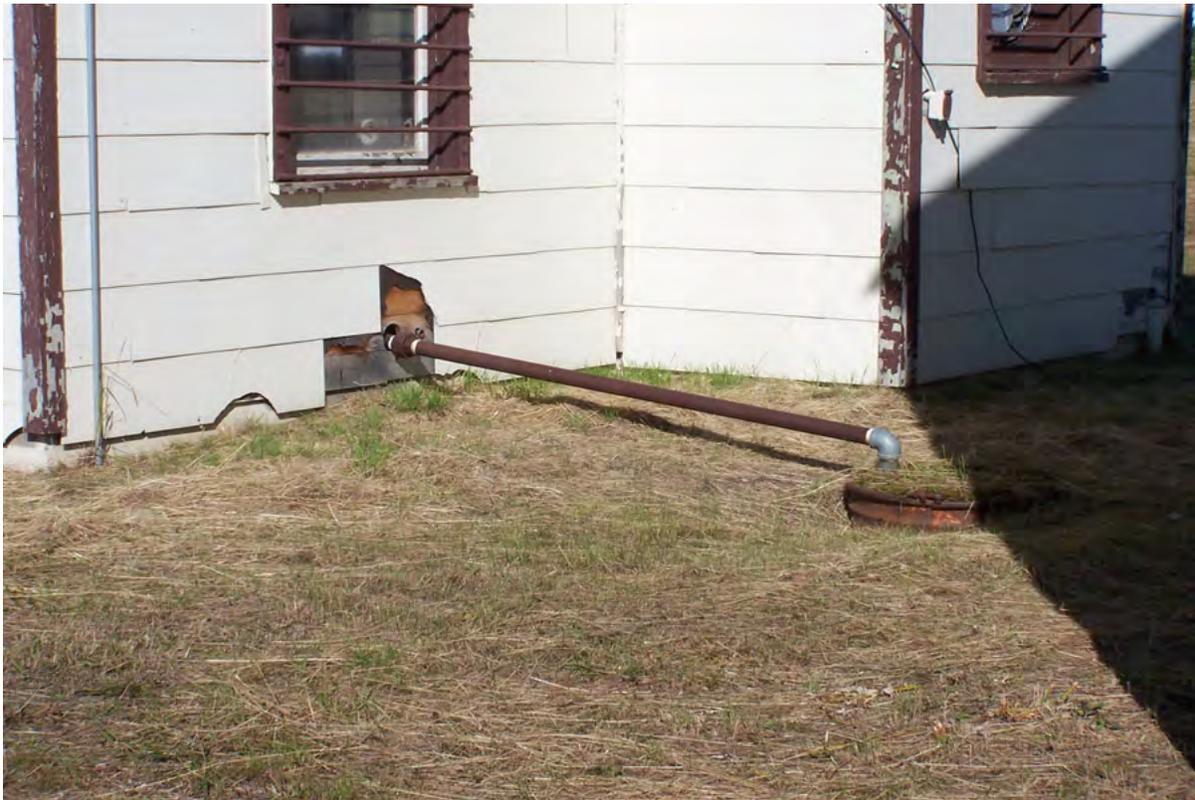
FIGURE A4-OWS1833
View of the Drum Partially Buried in the Ground and a Pipe Coming from Building 1833
Source: USAF, May 2008, Photo 39

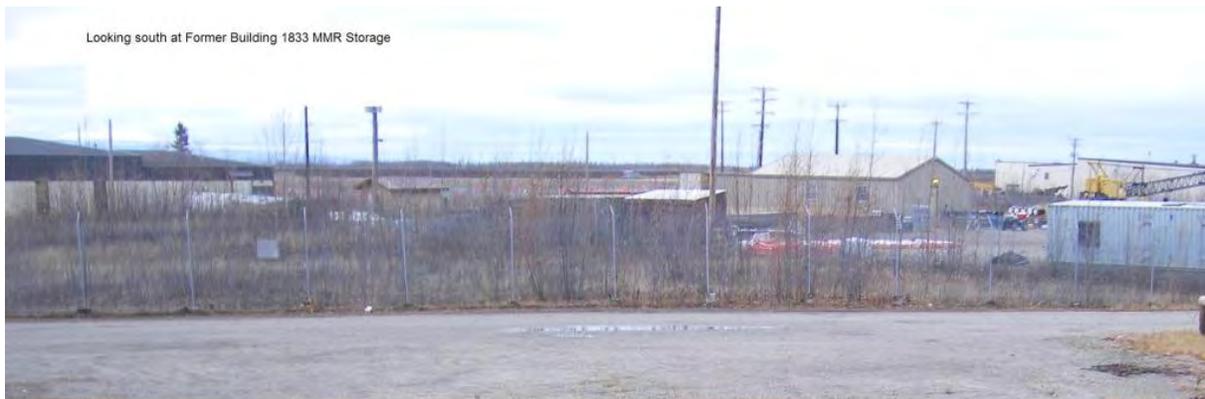
FIGURE A5-OWS1833
Looking South at former Building 1833, October, 2009

An inspection was conducted at Site OWS1833 in October 2009. The site was observed to be an empty lot covered in gravel and sparse grasses. Figure A5-OWS1833 shows the current condition of Site OWS1833.

Site inspection soil sampling for a subsurface multi-chemical release is recommended to confirm the presence or absence of impacts from historical activities at Site OWS 1833.

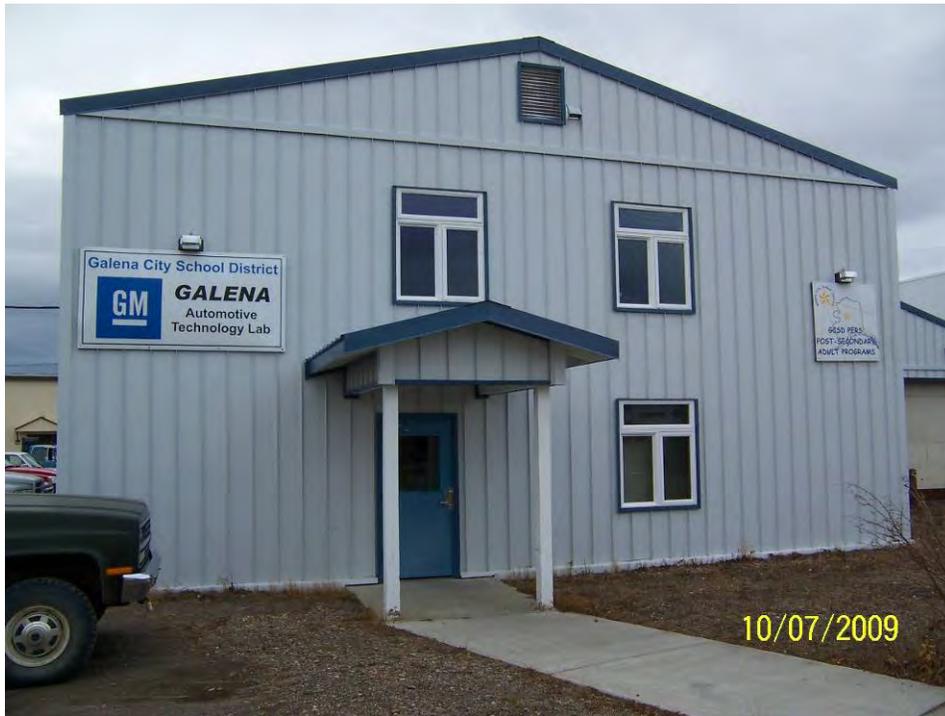
FIGURE A4-OWS1845
Outside of Building 1845, Vehicle Maintenance Shop, October 2009

A site visit of Site OWS1845 was conducted in October 2009. A small central floor sump that was no longer in use was observed. No signs of an OWS were observed. Figures A4-OWS1845 and A5-OWS1845 show the current condition of the outside and inside of the building, respectively.

Limited site inspection sampling is recommended to confirm the presence or absence of contamination from OWS 1845.

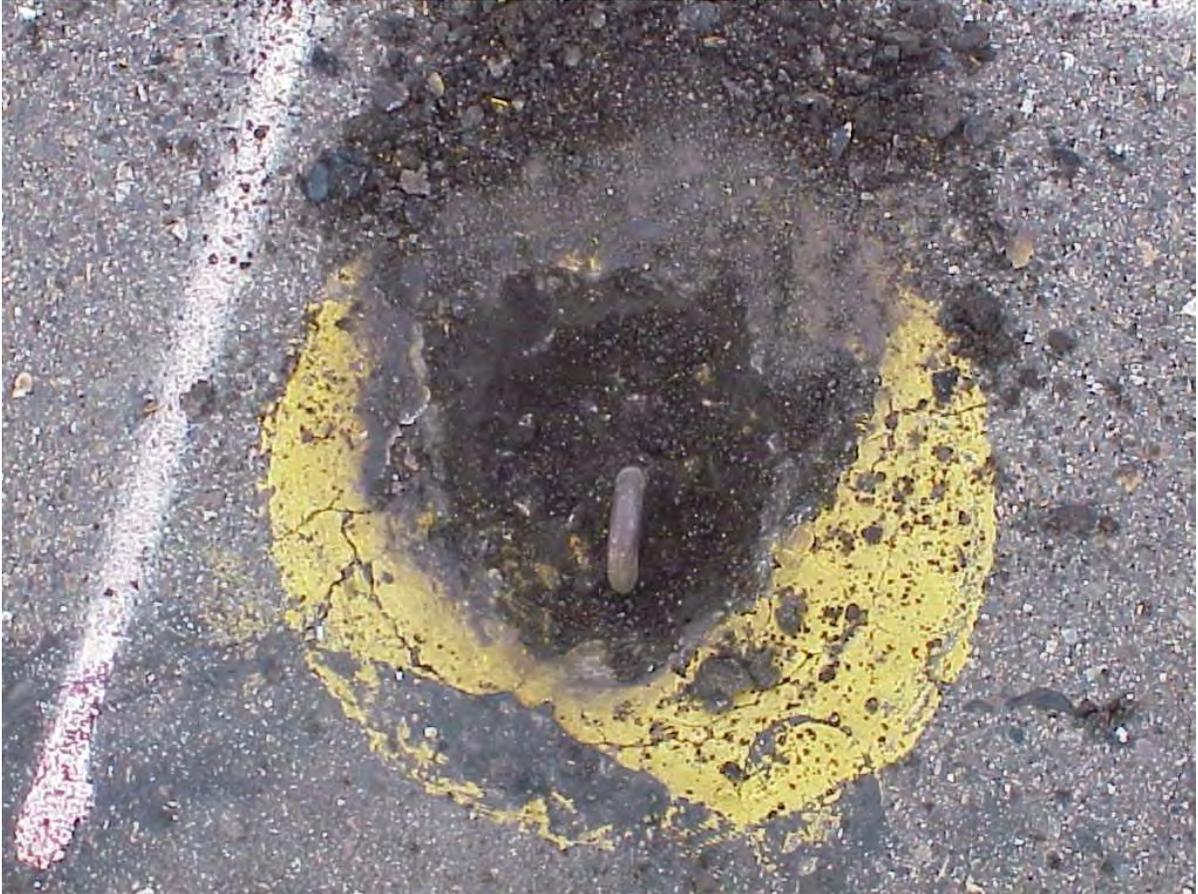
Figure A3-OAP/PADS/VP09
Photo of Tie-Back Loop within a Former Refueling Pad

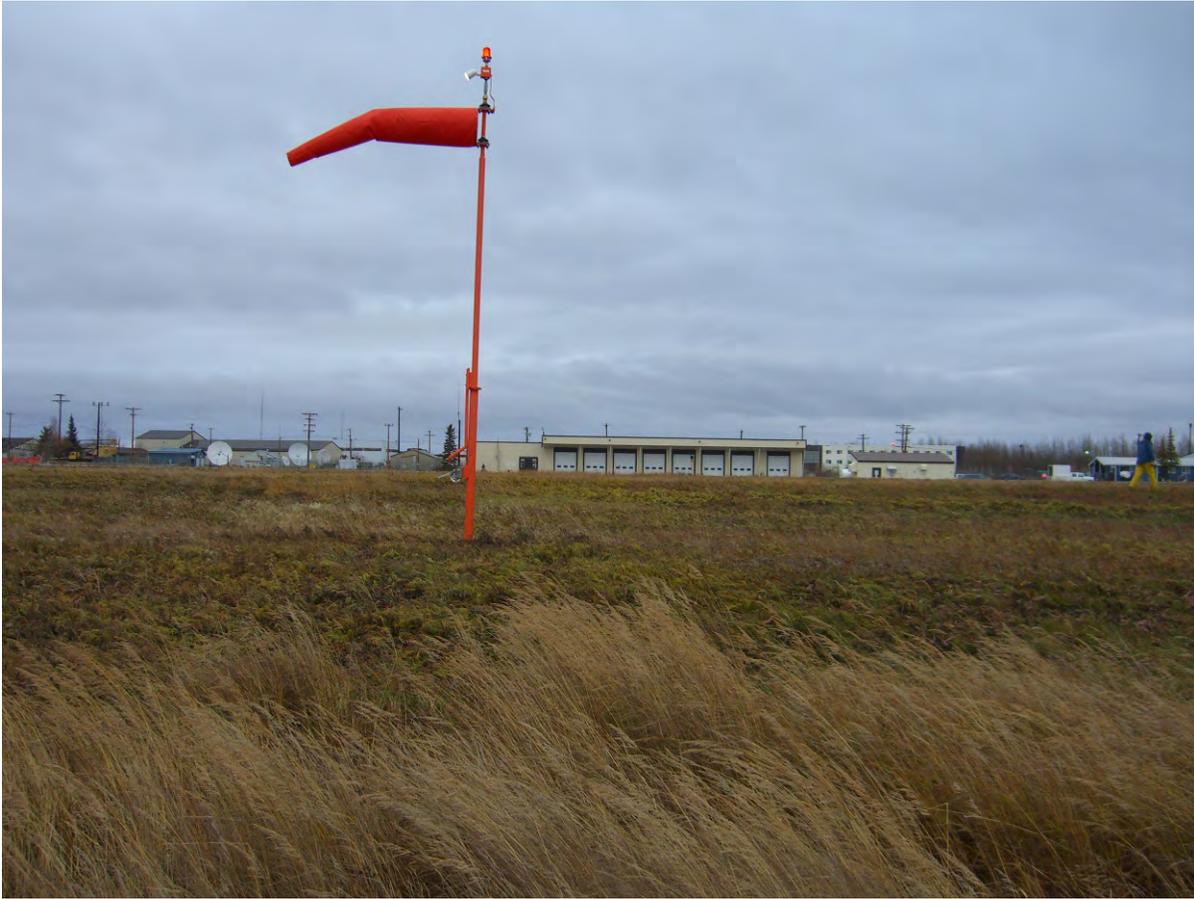
FIGURE A3-ILS8
Looking North

An inspection was conducted at Site ILS8 in October 2009. No visual signs of contamination were observed. The site was observed to be an open area vegetated with short grasses and forbs as shown in Figure A3-ILS8.

Because there is no evidence of historic or current sources of contamination at Site ILS8, designation of Site ILS8 as a "Non-Site" is recommended.

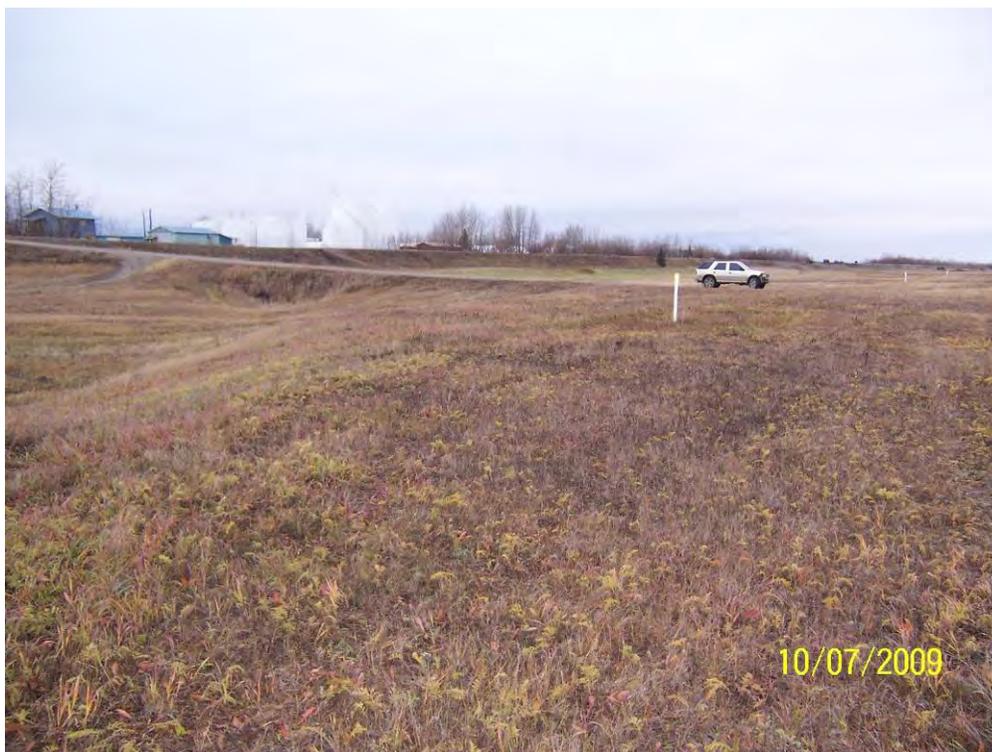
FIGURE A3-TACAN1
Looking West-southwest, October 2009

Site TACAN1 was observed to be covered with dry grass and forbs (dandelion and clover) and no surface staining or petroleum odors were noted. No evidence of a former structure was observed. Figure A3-TACAN1 shows current site conditions.

Limited site inspection sampling is recommended at Site TACAN1 to confirm the presence or absence of fuel-related contaminants in soil at the location of the former TACAN facility and at the location of the potential former “electric power station” package unit. The latter location will also be evaluated for possible PCB contamination.

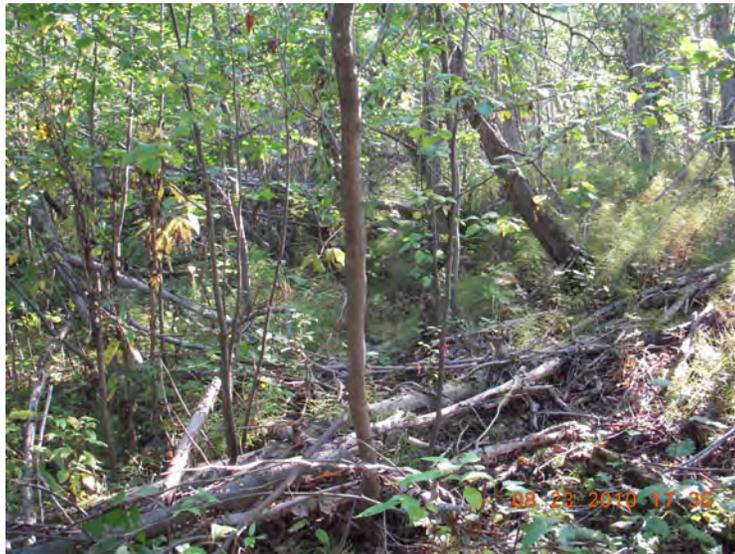
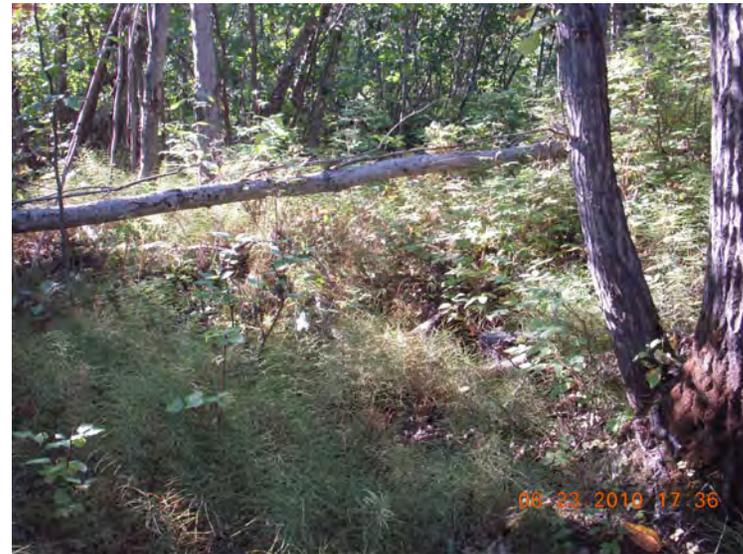
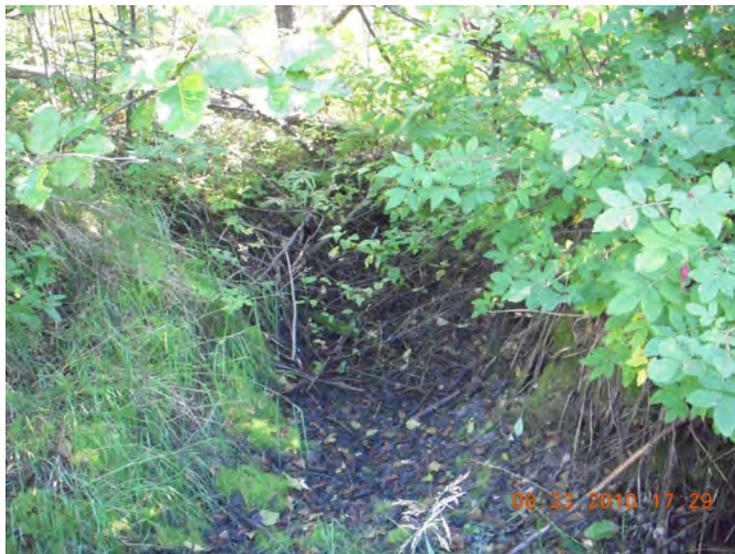
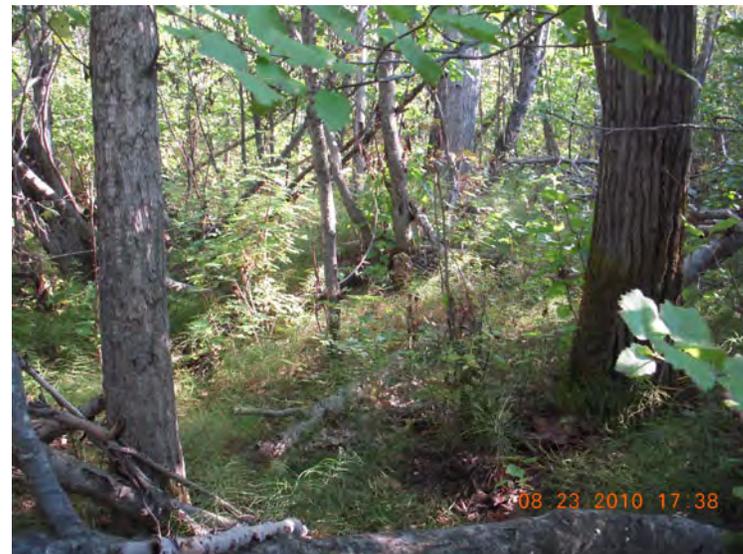
FIGURE A3-DSNW
August 2010
Disturbed Area Photographs
Preliminary Assessment Report
Former Galena Forward Operating Location, Alaska

During the October 2009 site visit, Site DSNW was identified as a new potential area of interest. An area of potentially disturbed terrain (that is, hummocky topography with mounds approximately 6 feet high and 30 feet long) was observed in this area, and is shown on Figure A3-DSNW. The site is heavily wooded.
