# Former Haines Fuel Terminal *Project Update*

**Restoration Advisory Board Meeting  
December 12, 2013**

# **Haines Fuel Terminal (HFT) Summary of 2009/2010 Activities**

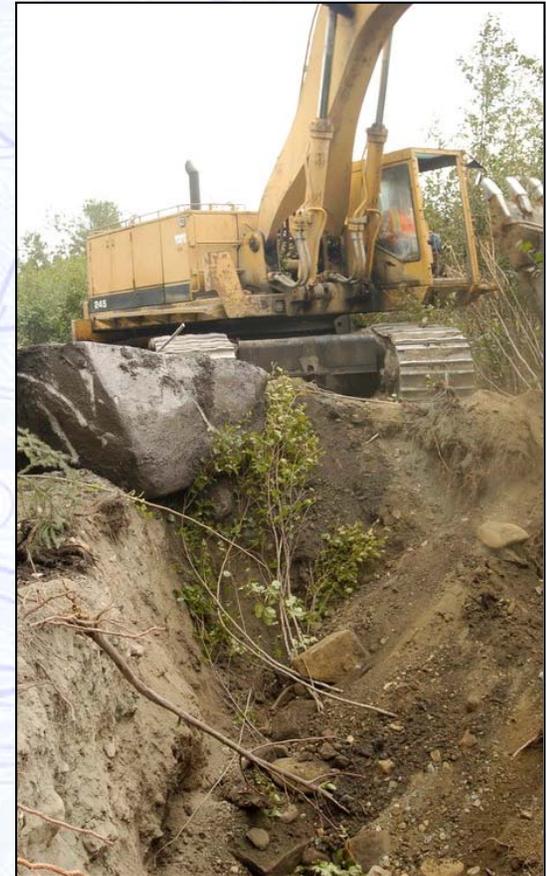
## Former Tank 100 Area

- Two treatment cells constructed
- 2,243 CY clean overburden removed
- 2,700 CY of contaminated soil removed and placed in stockpile and treated with ET-20 and microbes.
- Three groundwater monitoring wells were removed during excavation activities

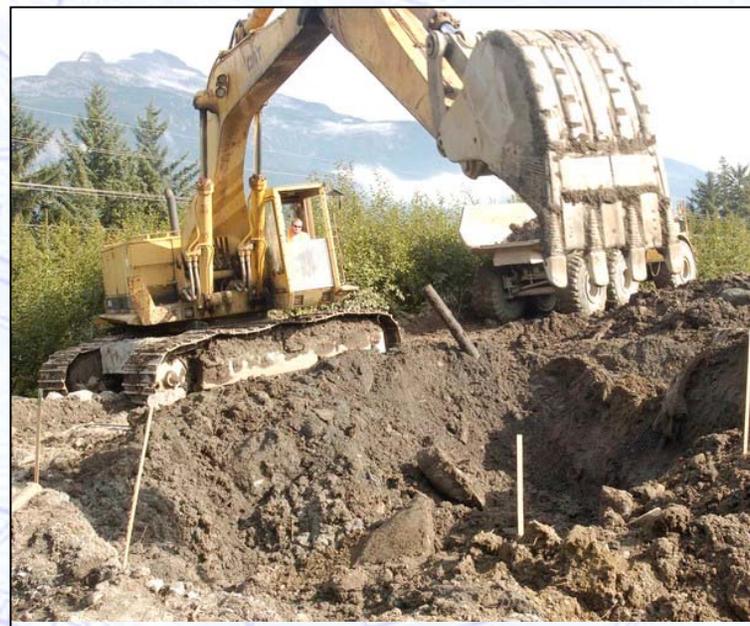
## Admin Area Utility Building

- Treatment cell constructed
- 250 CY of clean overburden removed and stockpiled
- 480 CY of contaminated soil removed and placed in stockpile cell for treatment

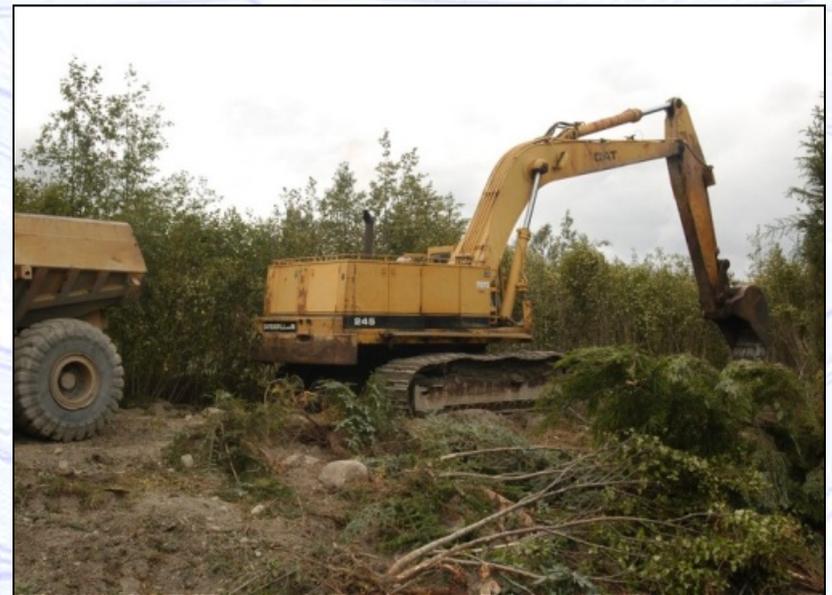
## AP-173 Area

- 200 CY of clean over burden removed
- 600 CY of contaminated soil removed and placed in stockpile cell for treatment
- One Groundwater monitoring well was removed during soil excavation activities

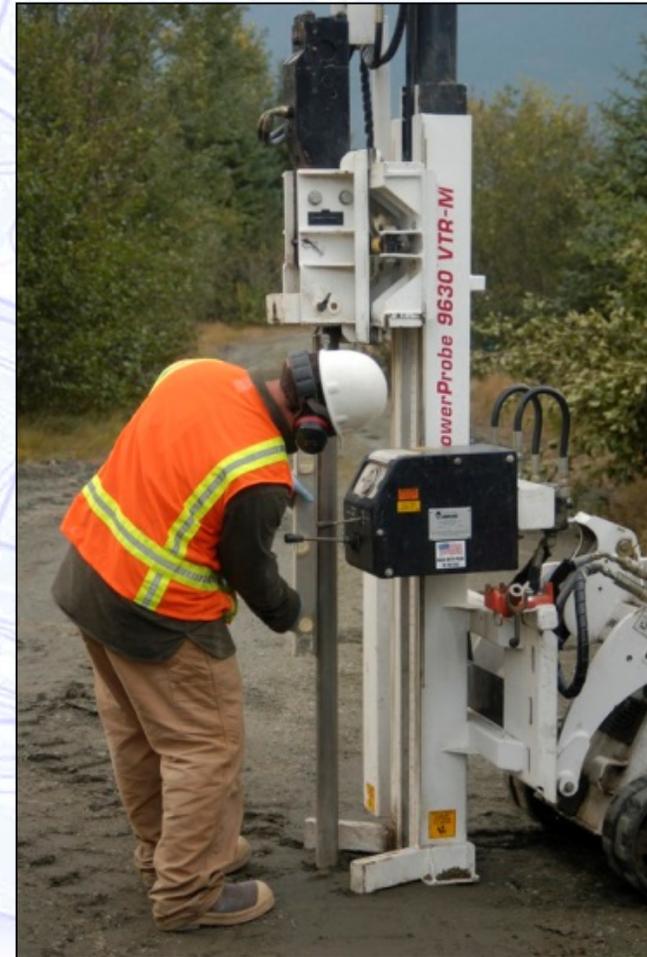
# HFT - Monitoring Well Reinstallation

- In 2010 the 4 wells removed during the source reduction activities were replaced
- Wells were placed at the original location and constructed to monitor the same depth interval
- Data from “before and after” will be used to determine effectiveness of source reduction

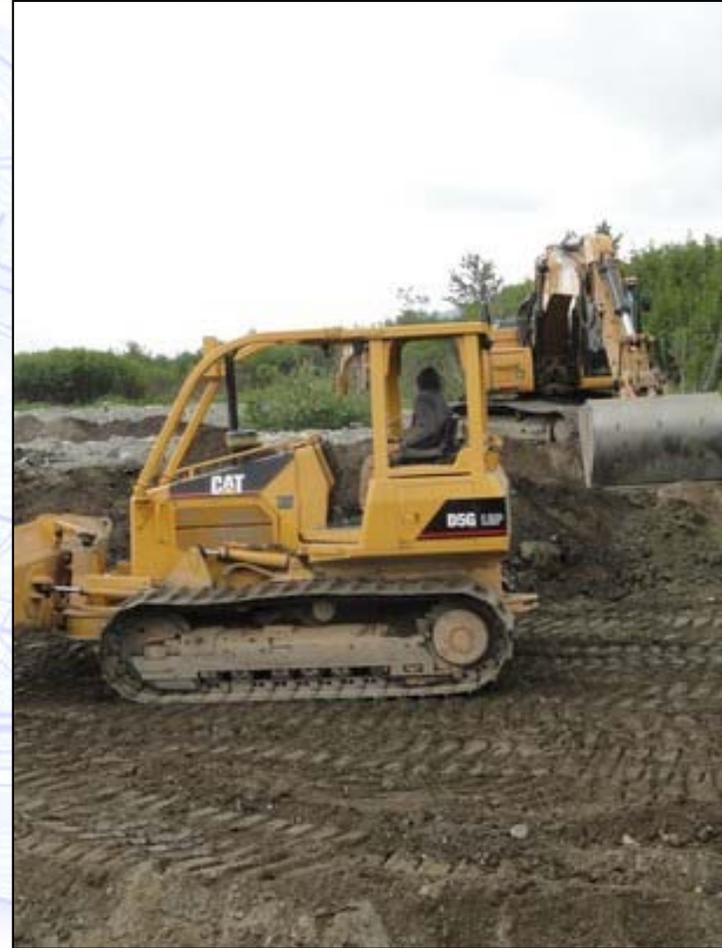
# HFT - 2011 Activities

- In June 2011, the treated soil stockpiles were spread and the liners were removed
- Excavation areas were recontoured and graded

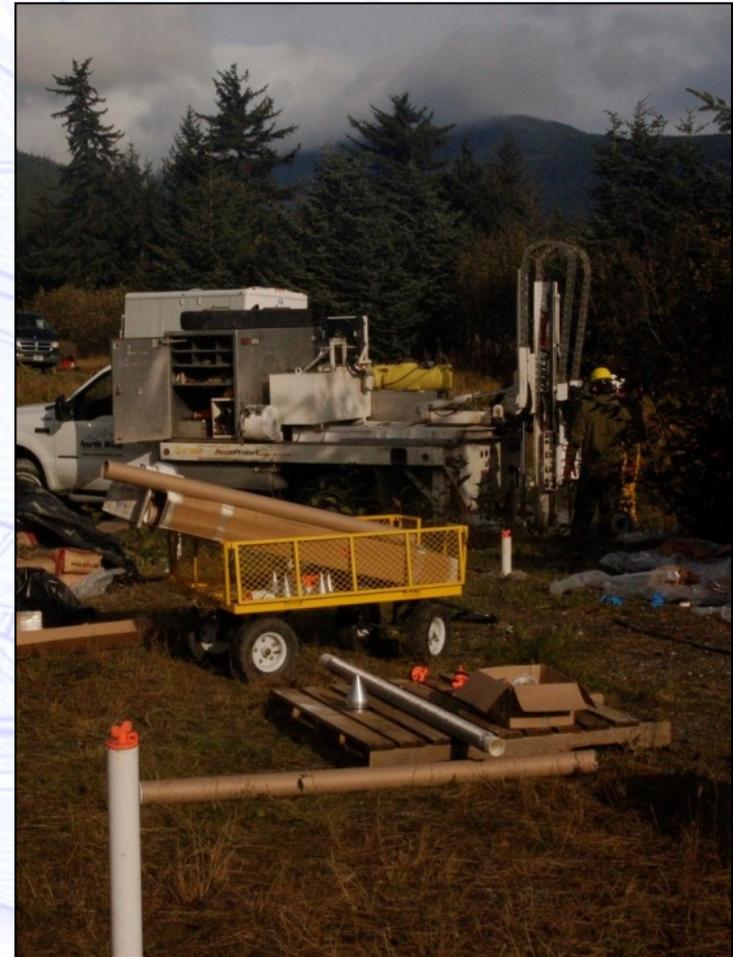
# HFT - 2013 Free Product Recovery

- In June of 2013, free product was found to be present in only 1 of the 24 recovery wells.
- Approximately 1 gallon of free product was recovered in 2013.

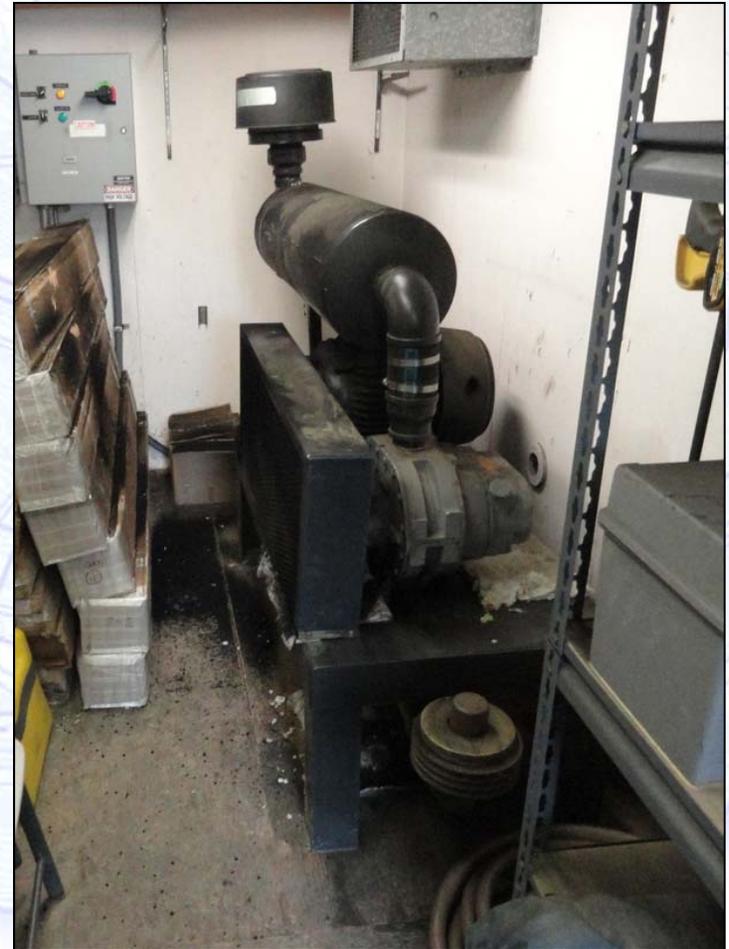
# HFT - AS System O&M

- In May 2011, the blower bearings seized
- Sparge system inoperable from May 2011 to June of 2013
- New blower and motor installed in June of 2013
- System restarted in July 2013 and continues to operate

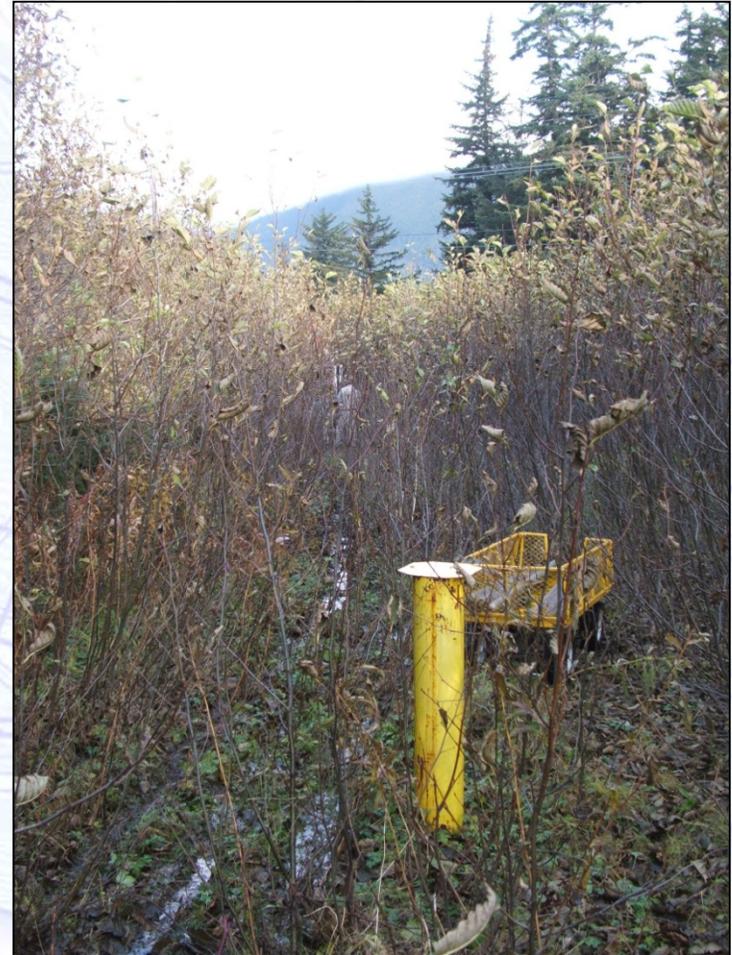
# HFT - Groundwater Monitoring

- 30 monitoring wells sampled in spring of 2013 for GRO/DRO, VOCs, Metals, and Natural Attenuation Parameters
- 11 monitoring wells sampled in fall of 2013 for the same COCs
