Alaska's 2008 Air Monitoring Network Plan

Chapter 3 - Anchorage

3 ANCHORAGE MONITORING SITE DESCRIPTION

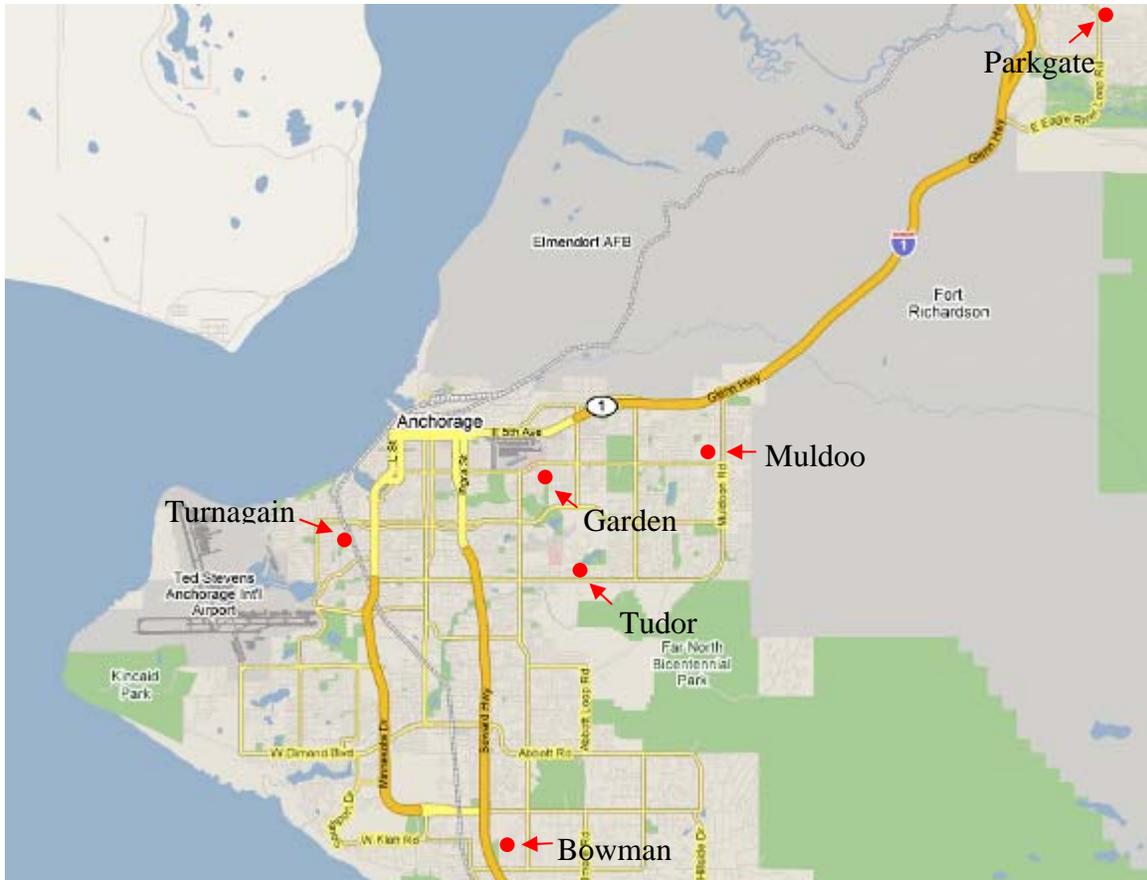
Figure 3.1:1: Map of Anchorage area. Red dots indicate monitoring sites.

The Municipality of Anchorage’s (MOA) air program currently operates four air monitoring stations in the municipality. Each station can be equipped to monitor for multiple pollutants. The network contains: one State and Local Air Monitoring Site (SLAMS) which monitors for PM₁₀, PM_{2.5}, and CO, three Special Purpose Monitoring Sites (SPM) for carbon monoxide and three SPM sites for PM₁₀. The municipality’s SLAMS and SPM sites are described below in Table 3-1. Figure 3.1:1 is a map showing the entire Anchorage monitoring network. Appendix B –lists siting criteria.

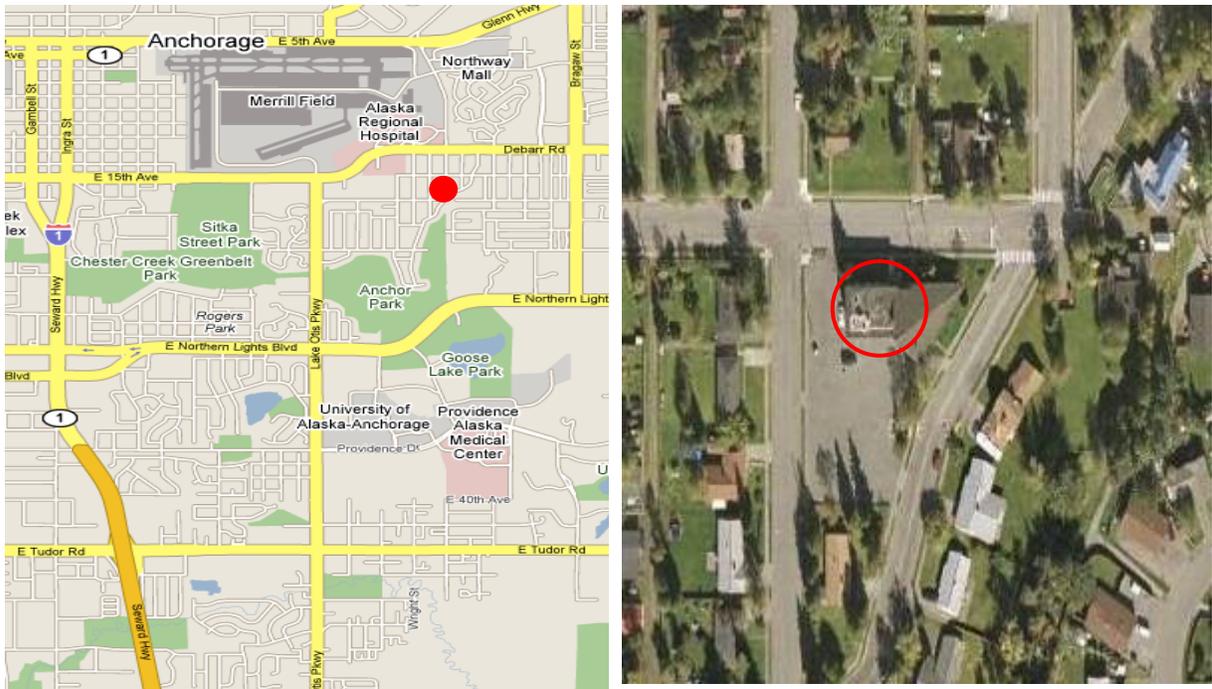
Figure 3.2:1: Street map and satellite image of the Garden monitoring site. The red circles indicate the sites location.

The Garden monitoring site is located at the Trinity Christian Reformed Church between 16th Avenue, Garden Street, and Sunrise Drive at latitude 61° 12' 25" ,longitude -149° 49' 15", and 128 feet (39 meters) above sea level. Figure 3.2:1 shows a street map of the central Anchorage area and a satellite image of the area. The site is located in a suburban, residential area. Garden is a neighborhood, population-oriented CO and PM site.

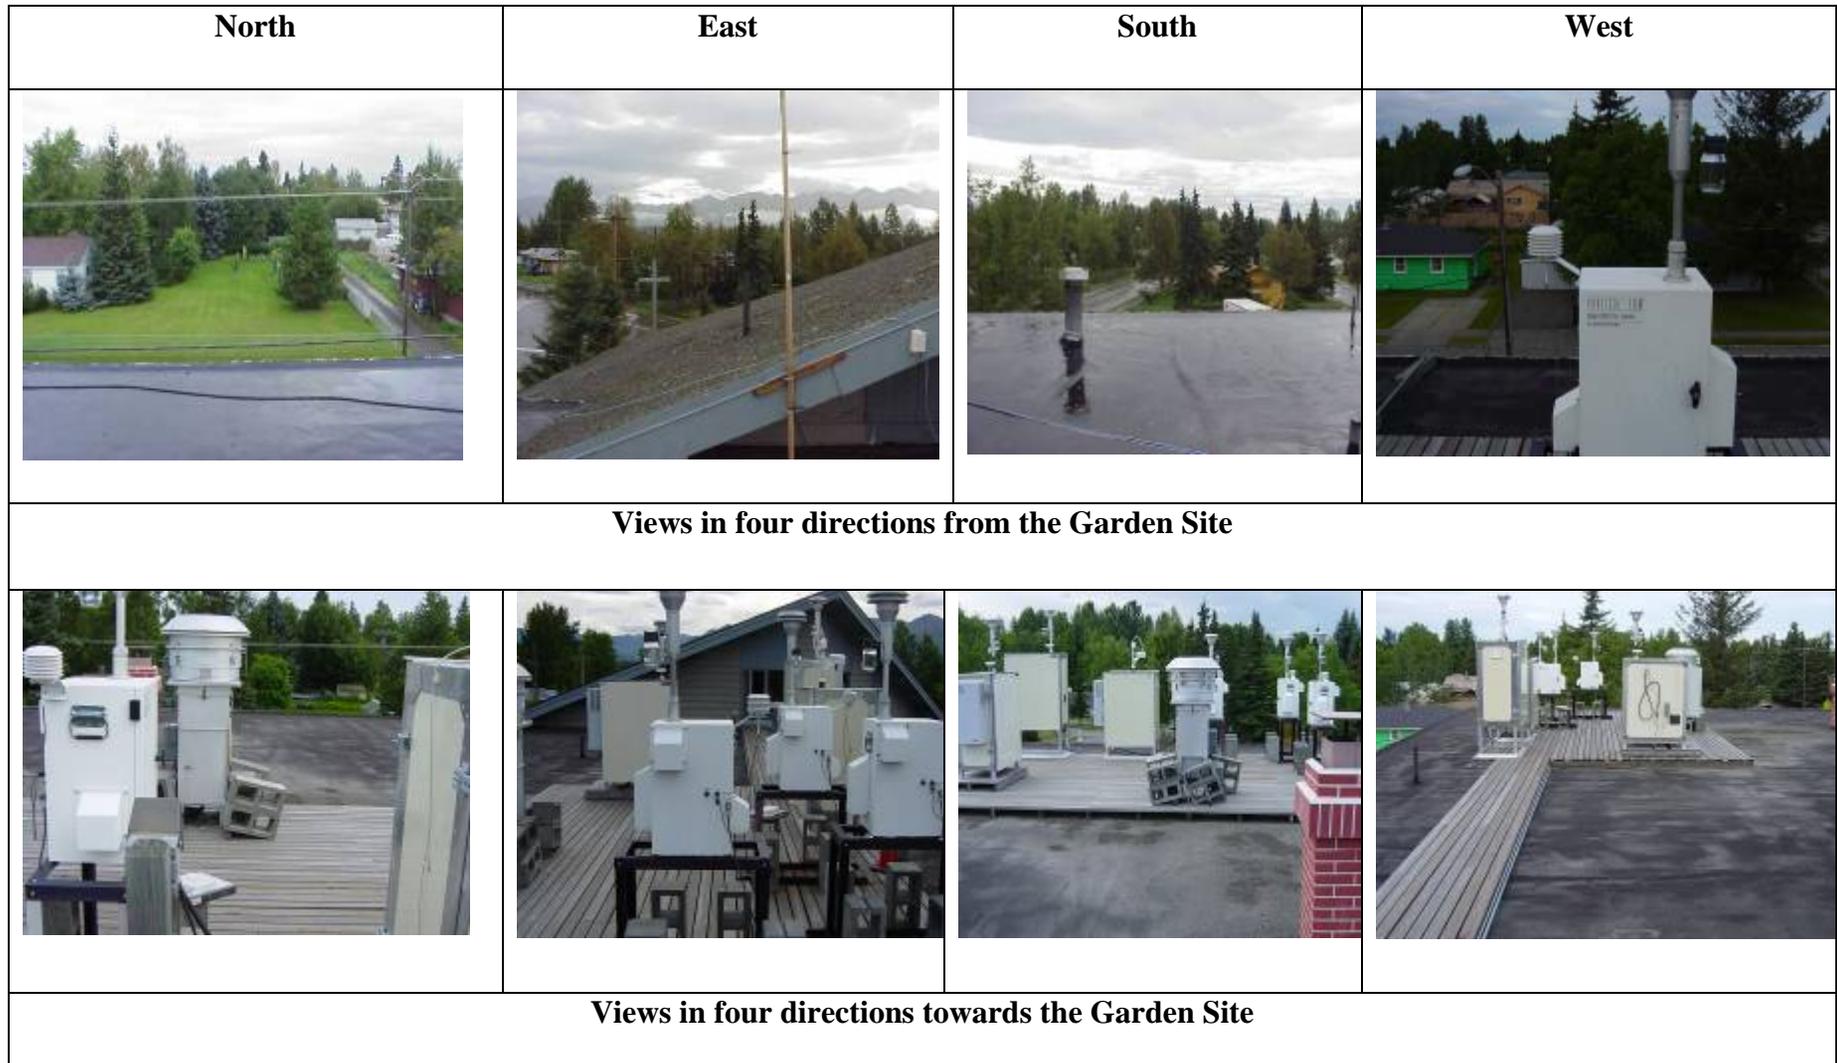
Figure 3.2:2: Pictures of the Garden Site

The particulate matter samplers are located on the roof at the south end of the Trinity Christian Reformed Church. Access to the site is from use of a window from a split level section of the church. This split level area is several meters from the monitoring site. The roof height is six meters (19 feet), and there are no trees in the vicinity that significantly exceed the height of the samplers. The airflow to these samplers is unobstructed. The samplers are approximately 10 meters (32 feet) south of the nearest traffic lane of 16th Avenue.

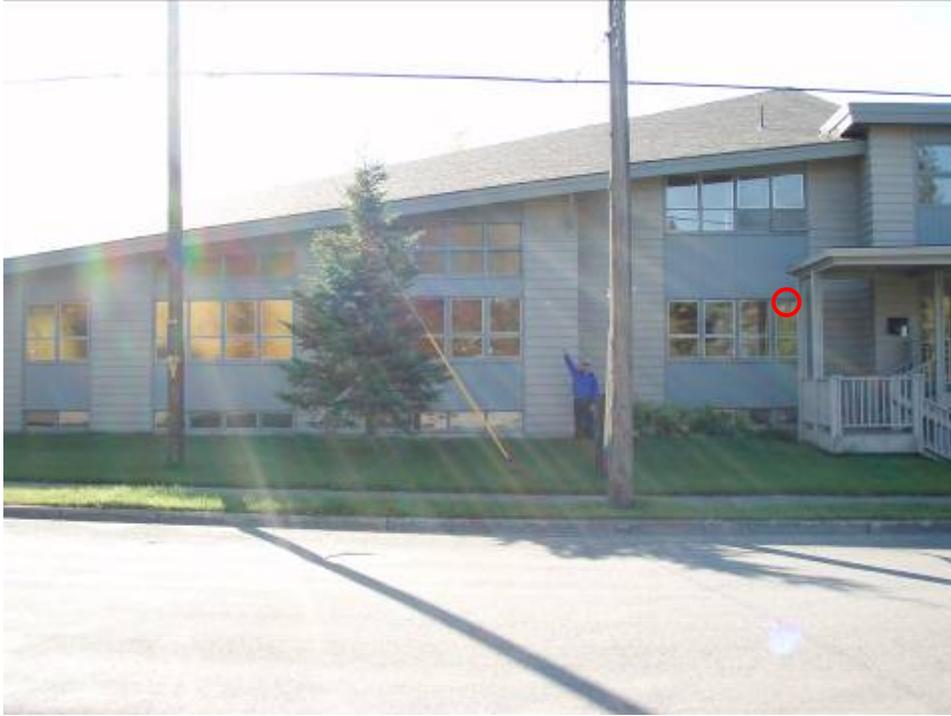
Figure 3.2:3: View of CO probe at Garden Site. The red circle indicates where the probe is located.

The CO monitor is installed in the church. The inlet probe is approximately three meters (9.5 feet) above the ground. The inlet probe is approximately 10 meters (32 feet) from the nearest traffic lane of 16th Avenue. Between the inlet and 16th Avenue is one tall spruce tree. The church itself obstructs air flow from the south.

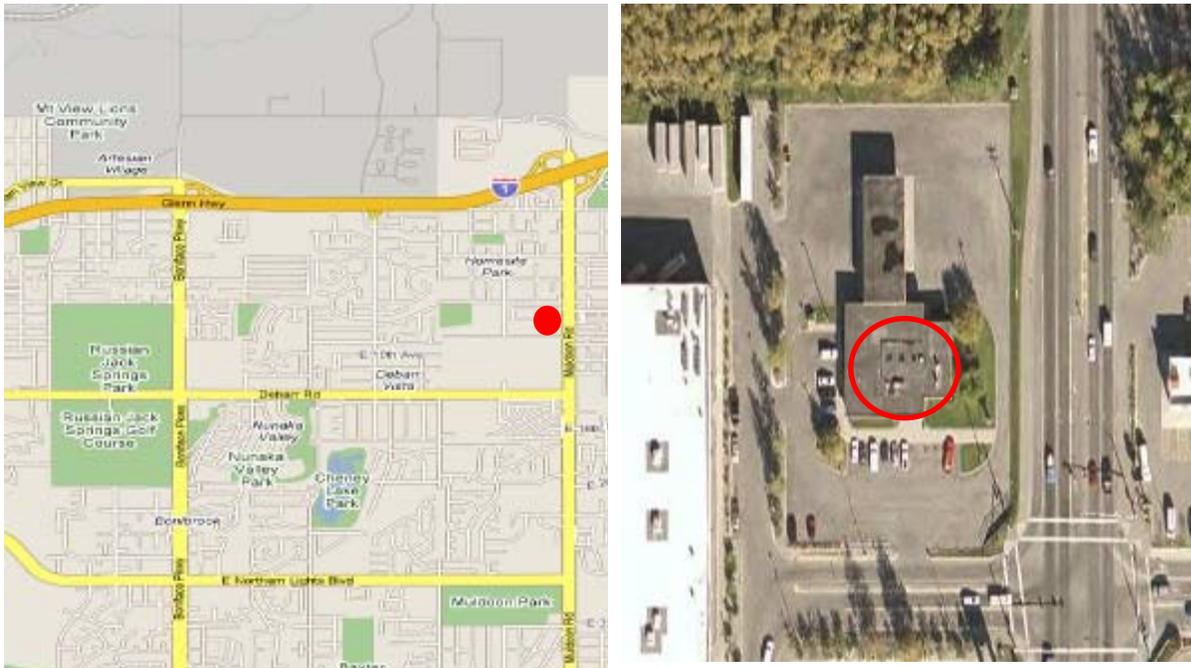
Figure 3.3:1: Street map and satellite image of the Muldoon monitoring site. The red circle indicates the sites location.

The Muldoon PM₁₀ monitoring site was located at the First National Bank of Anchorage building on Muldoon Road at latitude 61° 12' 42", longitude -149° 43' 53" and 262 feet (80 meters) above sea level. Figure 3.3:1 shows a street map of the east Anchorage Muldoon area and a satellite picture of the monitoring site. The site was located in a suburban, commercial location. Muldoon was a middle scale, population-oriented site. Because of the primary source of coarse particulate matter this site was only operated seasonally during the summer months.

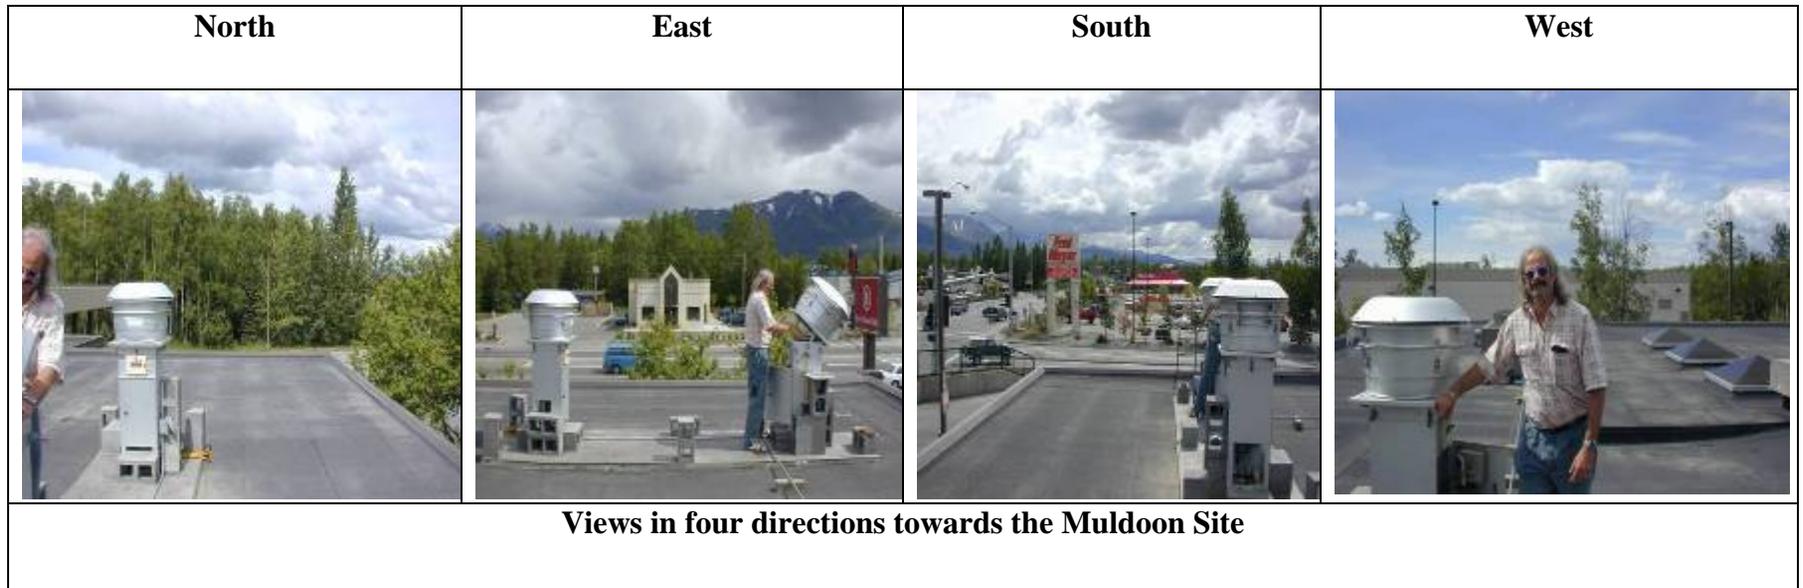
Figure 3.3:1: Pictures of the Muldoon Site

The particulate matter samplers were located on the roof at the east end of the bank. The roof height is 3.5 meters (11 feet), and there were no other structures. No trees in the vicinity significantly exceed the height of the samplers. The airflow to these samplers was unobstructed. The samplers were approximately 24 meters (76 feet) west of the nearest traffic lane of Muldoon Road.

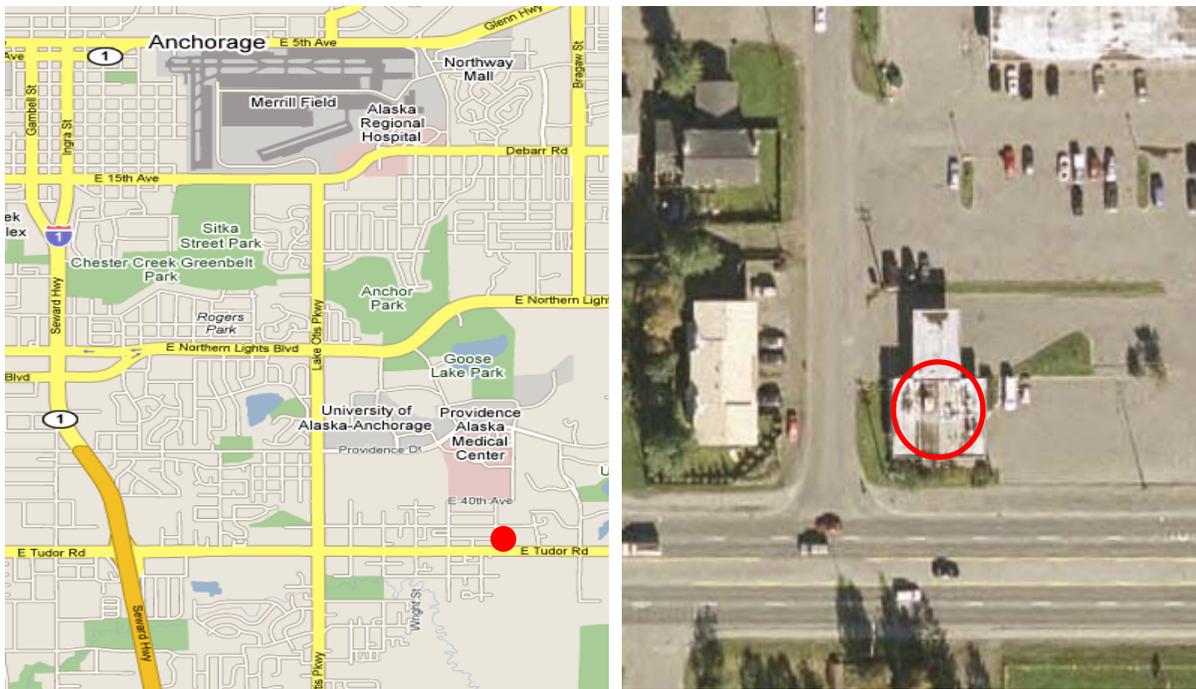
Figure 3.4:1: Street map and satellite image of the Tudor monitoring site. The red circle indicates the sites location.

The Tudor monitoring site is located at the Allstate Insurance Company building on Tudor Road at latitude 61° 10' 56", longitude -149° 48' 50", and 164 feet (50 meters) above sea level. Figure 3.4:1 shows a street map of the central Anchorage area and a satellite picture of the area immediately surrounding the Tudor site. The site is located in an urban, commercial location. Tudor is a microscale, population-oriented site.

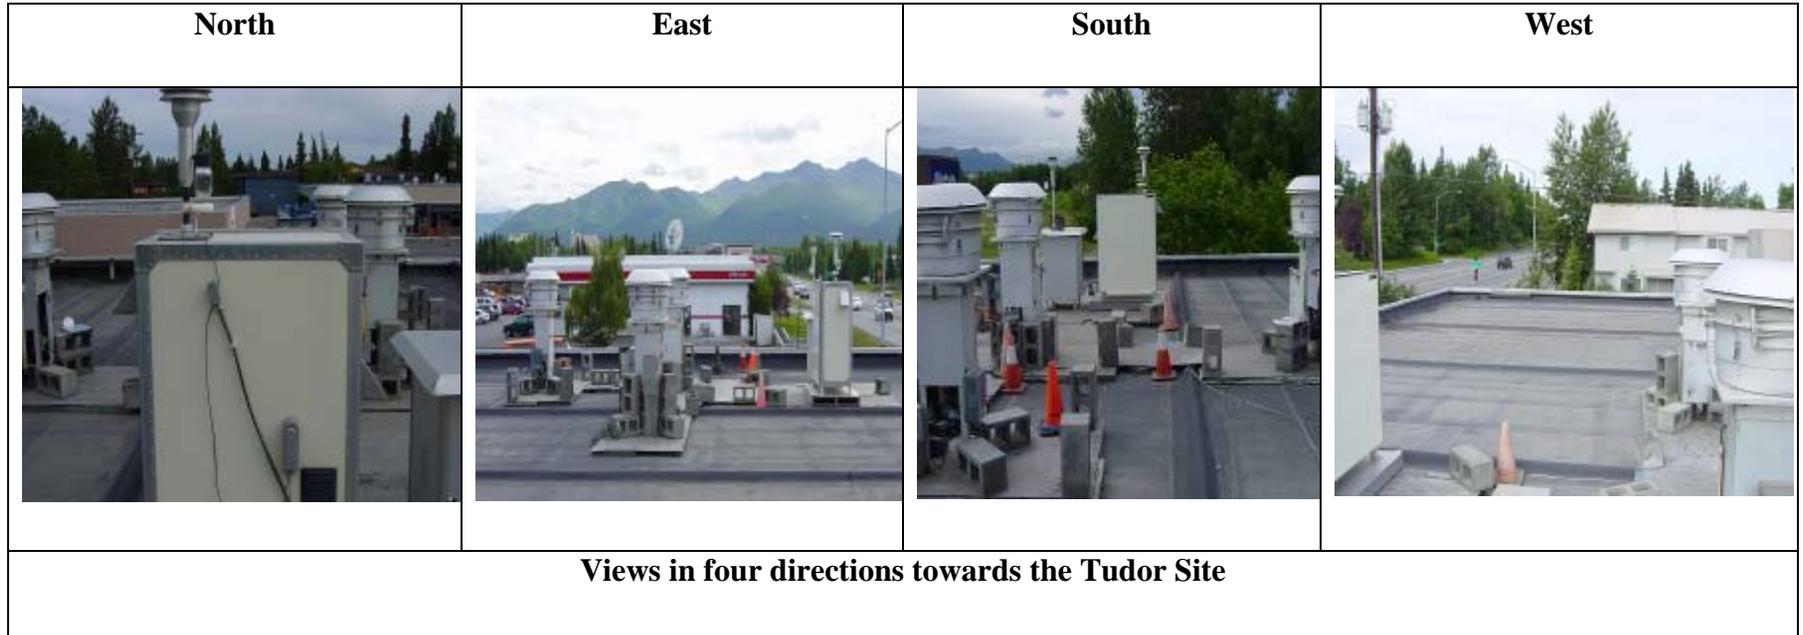
Figure 3.4:1: Pictures of the Tudor Site

The particulate matter samplers are located on the roof near the southeast edge. The roof height is 3.3 meters (10.5 feet), and there are no other structures. Twenty foot tall mountain ash trees between the samplers and the roadway do not significantly exceed the height of the samplers. The airflow to these samplers is unobstructed. The samplers are approximately seven meters north of the nearest traffic lane of Tudor Road.

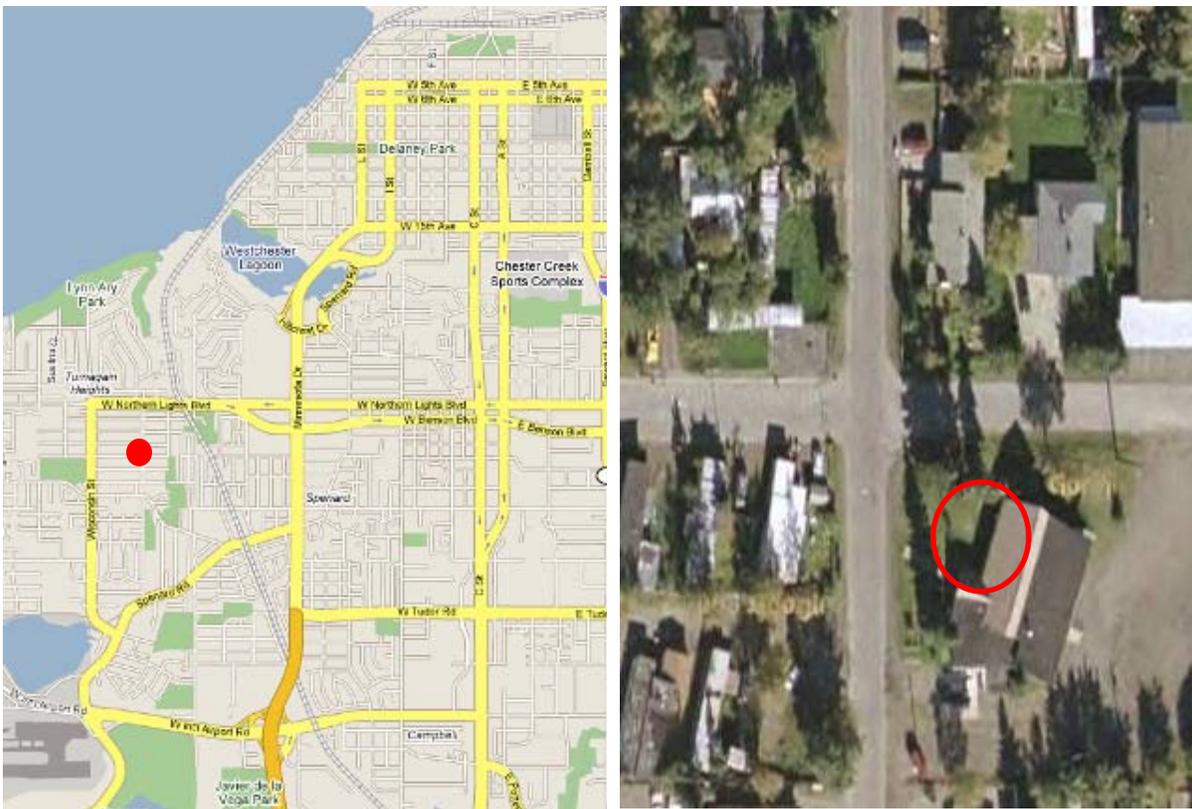
Figure 3.5:1: Street map and satellite image of the Turnagain monitoring site. The red circles indicate the sites location.

The Turnagain carbon monoxide monitoring site is located at the corner of Turnagain Street and 32nd Avenue at latitude $61^{\circ} 11' 32''$, longitude $-149^{\circ} 56' 9''$, and 69 feet (21 meters) above sea level. Figure 3.5:1 is street map of the western part of Anchorage and a satellite picture of the Turnagain site and surrounding area. The site is located in a suburban location. Turnagain is a neighborhood scale, population-oriented site.

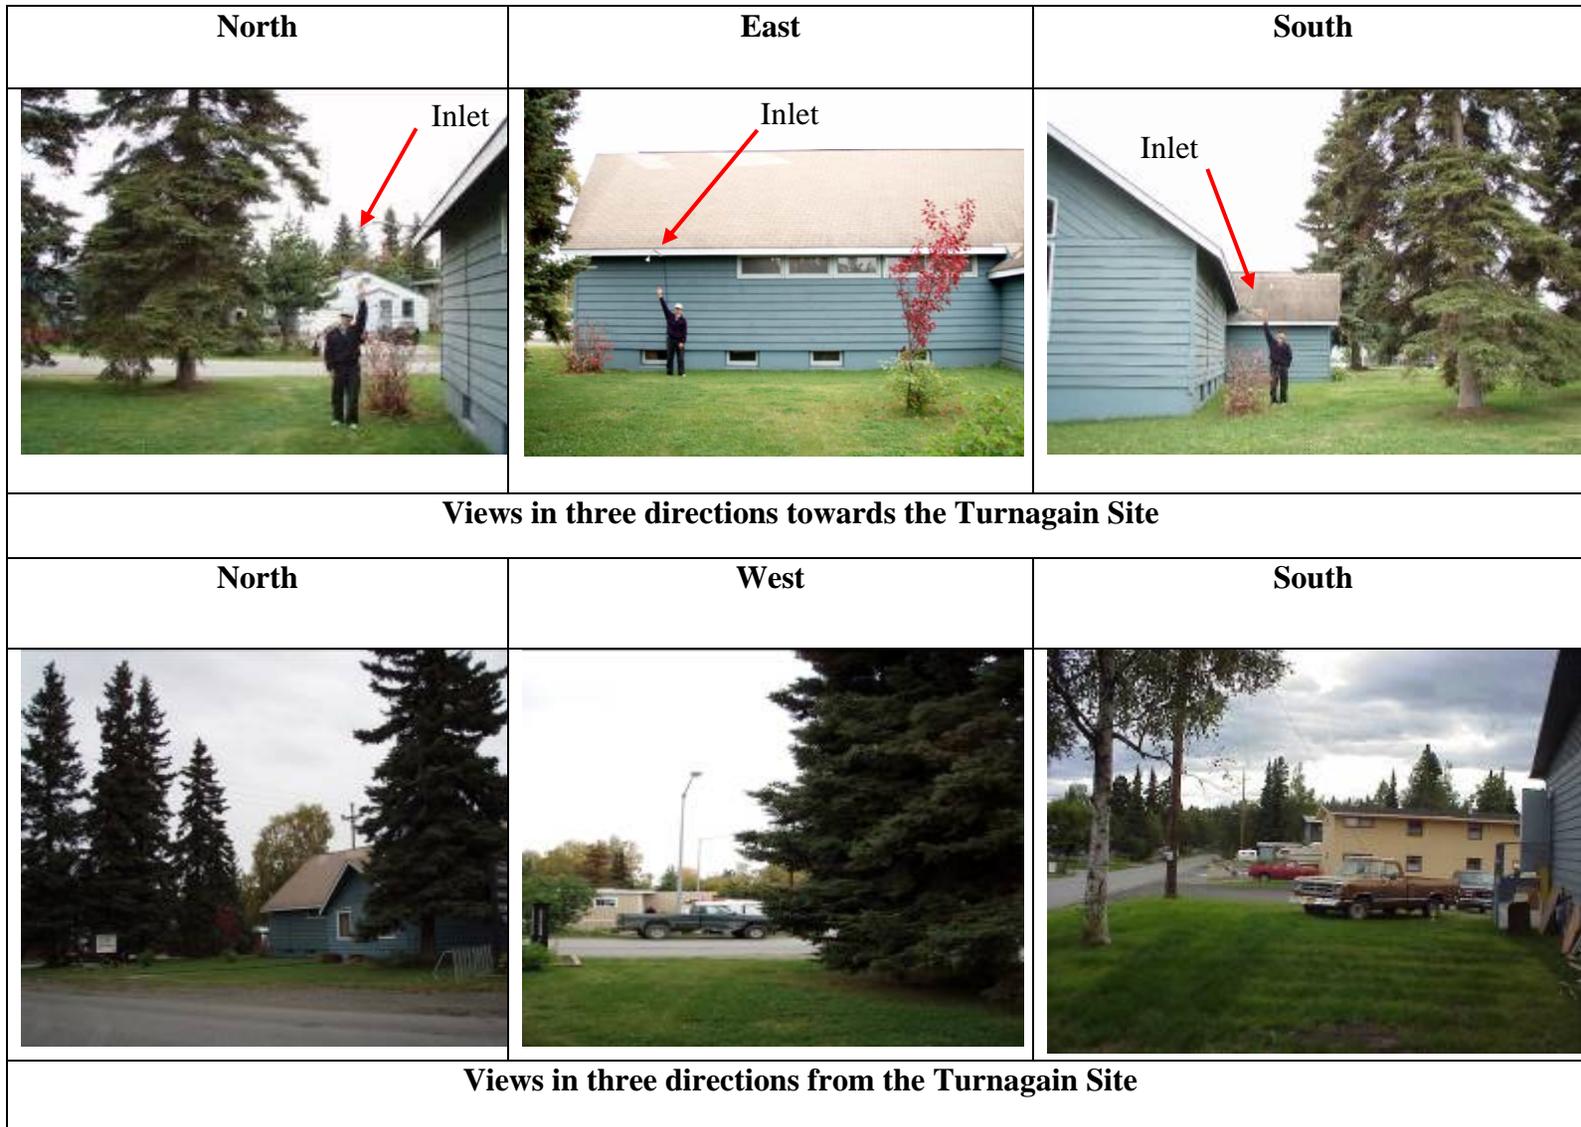
Figure 3.5:1: Pictures of the Turnagain Site

The monitor is installed in the Unitarian church. The inlet probe is approximately three meters (9.5 feet) above the ground. The inlet probe is approximately 18.5 meters (58 feet) from the nearest traffic lane of Turnagain Street. Between the inlet and Turnagain St are several tall white spruce trees. The church itself obstructs air flow from the south and east.

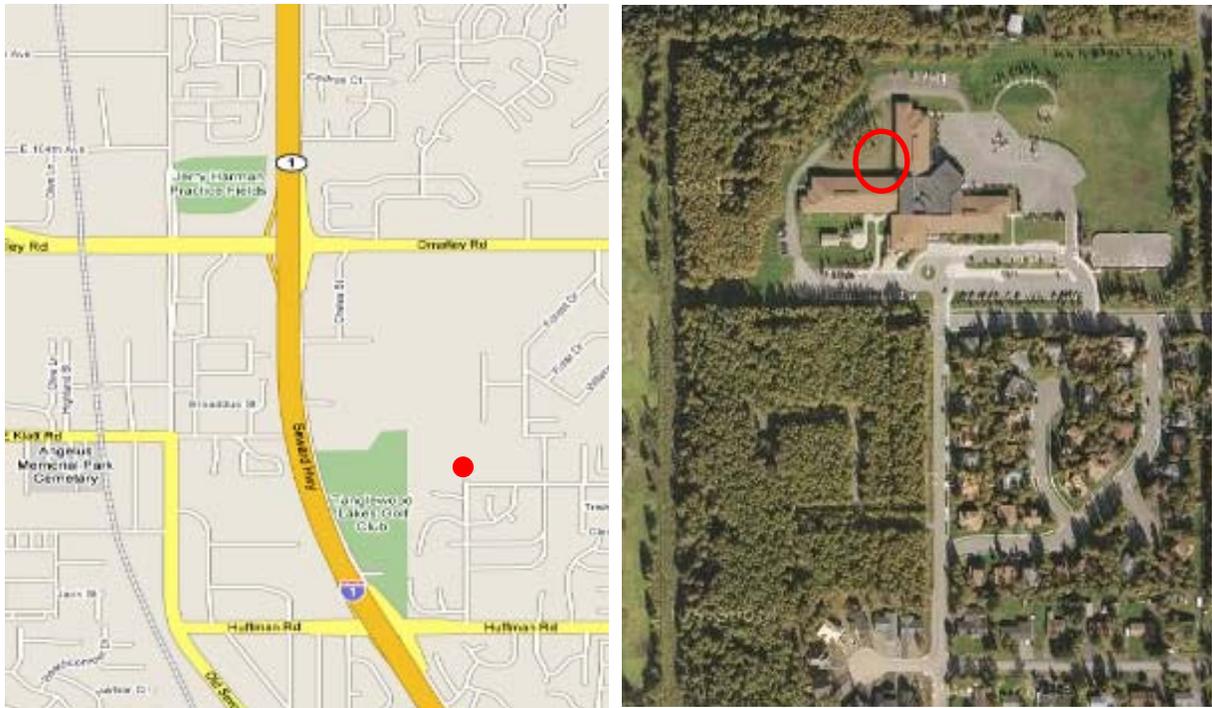
Figure 3.6:1: Street map and satellite image of the Bowman monitoring site. The red circles indicate the sites location.

The Bowman carbon monoxide monitoring site was located at the end of Gregory Rd. at latitude $61^{\circ} 6' 53.97''$, longitude $-149^{\circ} 50' 45.98''$, and 225 feet (69 meters) above sea level. Figure 3.6:1 shows a street map of the southern part of Anchorage and a satellite picture of the Bowman site and surrounding area. The site was located in a suburban location. Bowman was a neighborhood scale, population-oriented site.

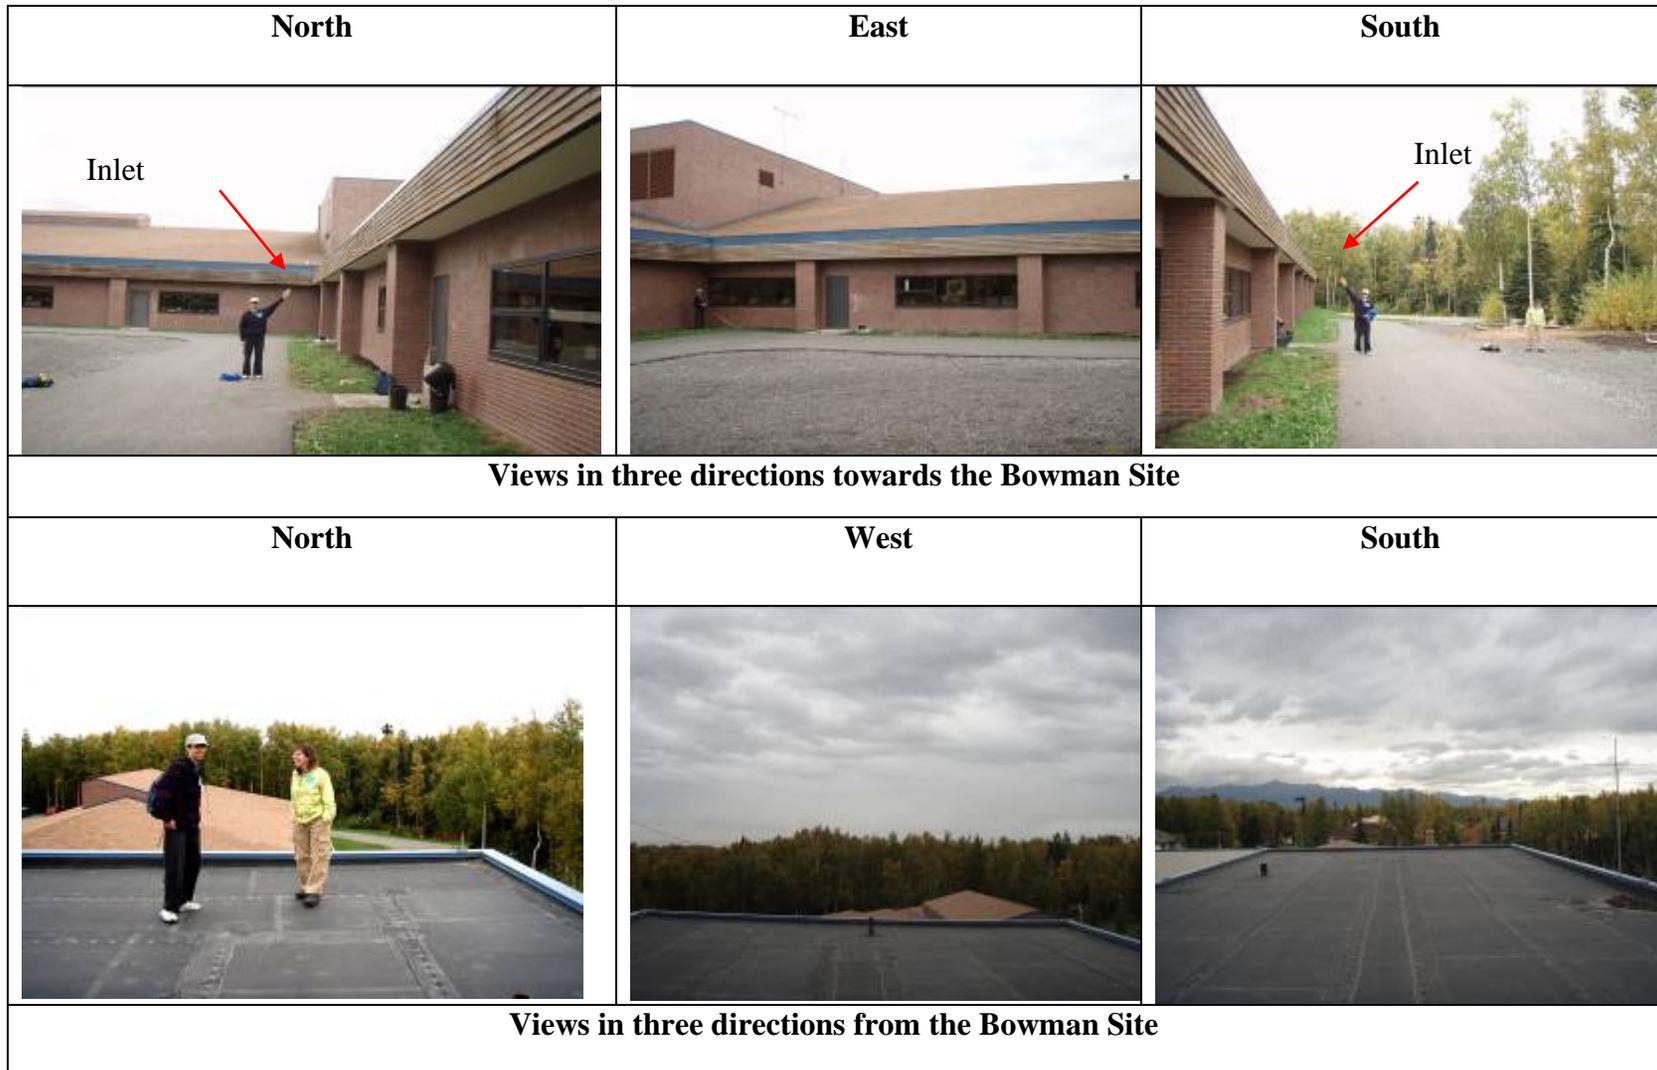
Figure 3.6:1: Pictures of the Bowman Site

The monitor was installed at the Bowman elementary school. The inlet probe was approximately three meters (9.5 feet) above the ground. There were taller trees between the samplers and the roadway but they were far enough away from the probe to not pose a problem. The probe was located along the east side of the school and airflow was generally unobstructed.

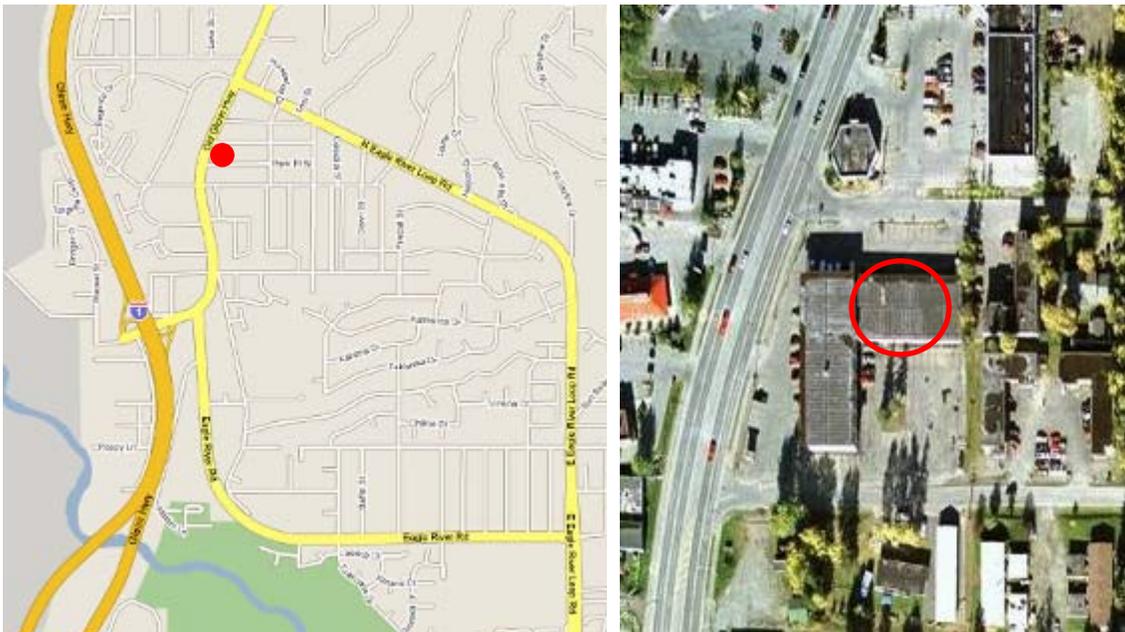
Figure 3.7:1: Street map and satellite image of the Eagle River monitoring site. The red circle indicates the sites location.

The Parkgate PM₁₀ monitoring site is located at the Parkgate Business Center building in Eagle River (a bedroom community of Anchorage that lies well within the Municipality) at latitude 61° 19' 27.5", longitude -149° 33' 15", and 328 feet (100 meters) above sea level. Figure 3.13 is a street map of the western Eagle River area and a satellite picture of the Parkgate site and surrounding area. The site is located in a suburban/commercial use area with monitoring site classified as neighborhood scale, population-oriented monitoring site.

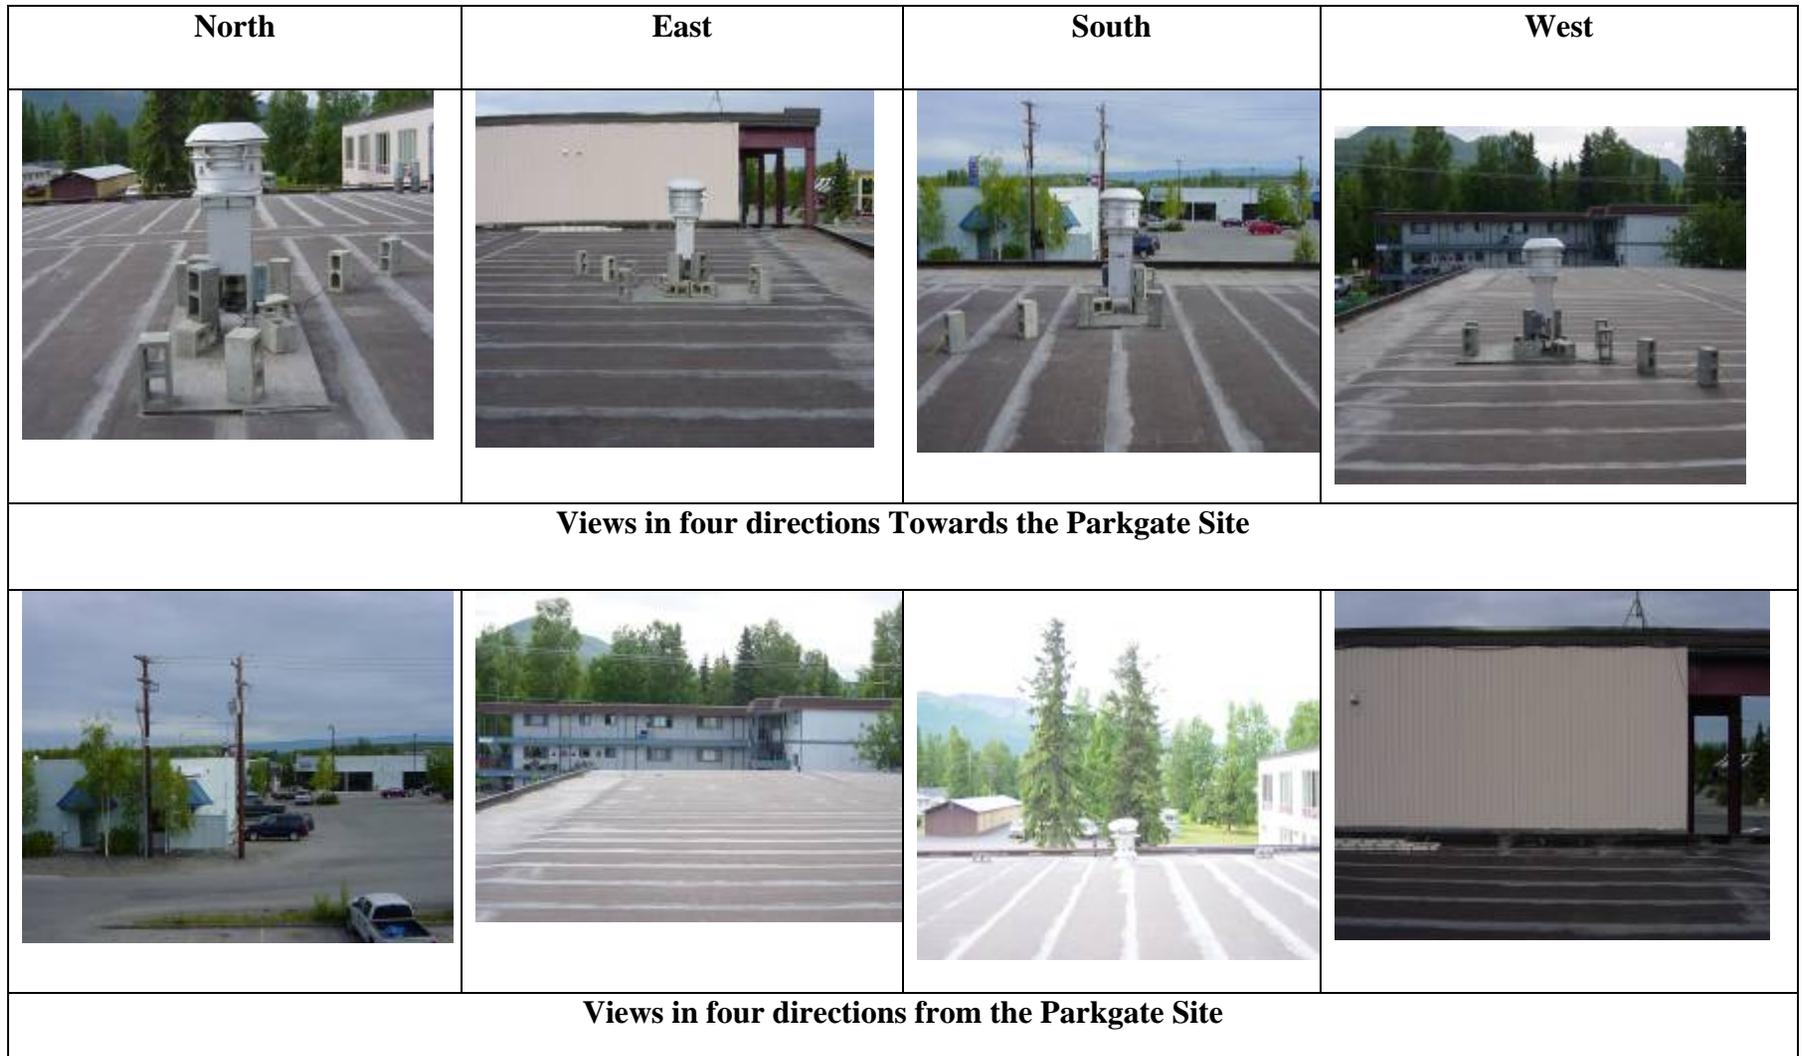
Figure 3.7:1: Pictures of the Parkgate Site

The particulate matter sampler is located on the roof of the first story of the Parkgate Business Center. The roof height is 5 meters (16 feet). There is another section of the building 13 meters (41 feet) to the west that is two stories tall (4 meters above the first story roof height). No trees in the vicinity significantly exceed the height of the samplers. The airflow to these samplers is unobstructed. The sampler is approximately 44 meters east of the nearest traffic lane of the Old Glenn Highway and 23 meters (73 feet) south of Easy Street.
