# Alaska's 2010 Air Monitoring Network Plan

## Chapter 3 - Anchorage

## 3 ANCHORAGE MONITORING SITE DESCRIPTION

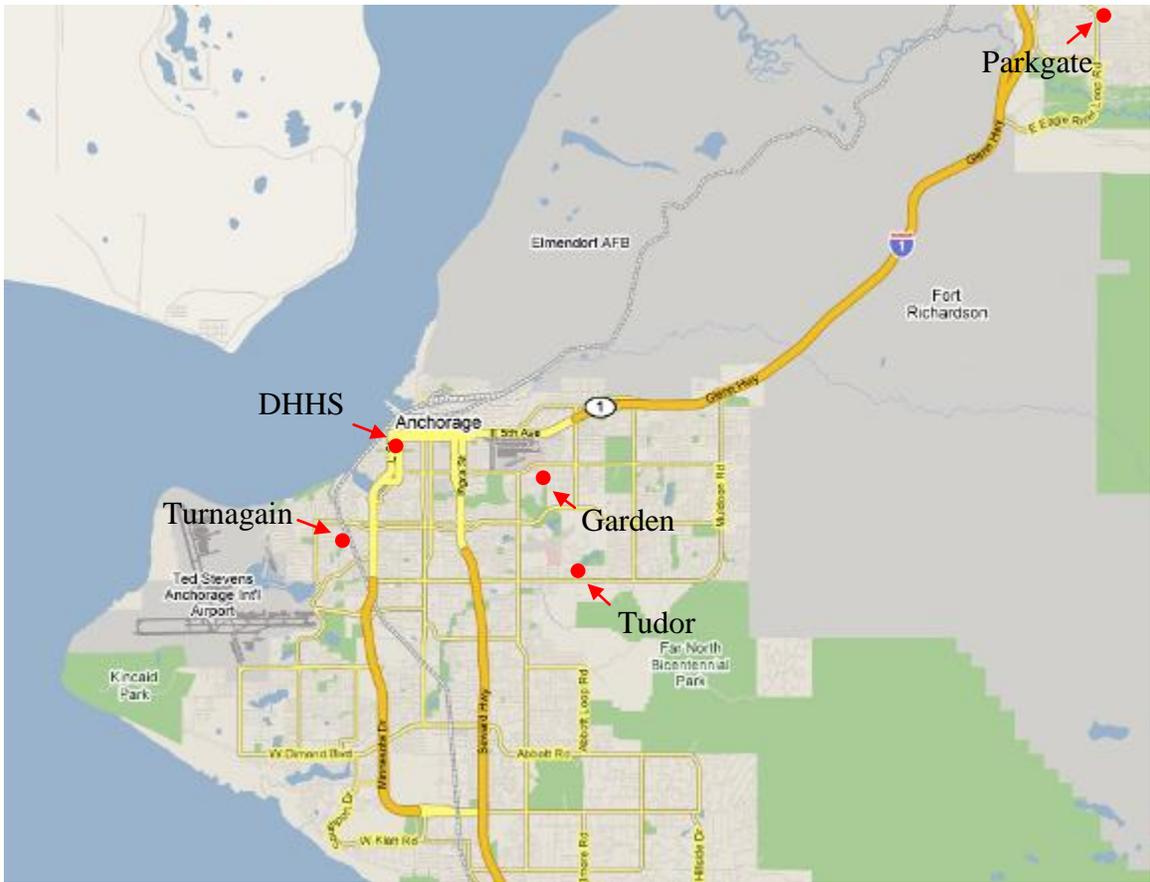
**Figure 3.1.1:** Map of Anchorage area. Red dots indicate monitoring sites.

The Municipality of Anchorage’s (MOA) air quality program currently operates five air monitoring stations in the municipality. Each station can be equipped to monitor for multiple pollutants. The network pollutant monitors have designations for both State and Local Air Monitoring Site (SLAMS) and Special Purpose Monitoring Sites (SPM). The municipality’s SLAMS and SPM sites are described below in Table 3-1. Figure 3.1:1 is a map showing the entire Anchorage monitoring network. Appendix B lists siting criteria.

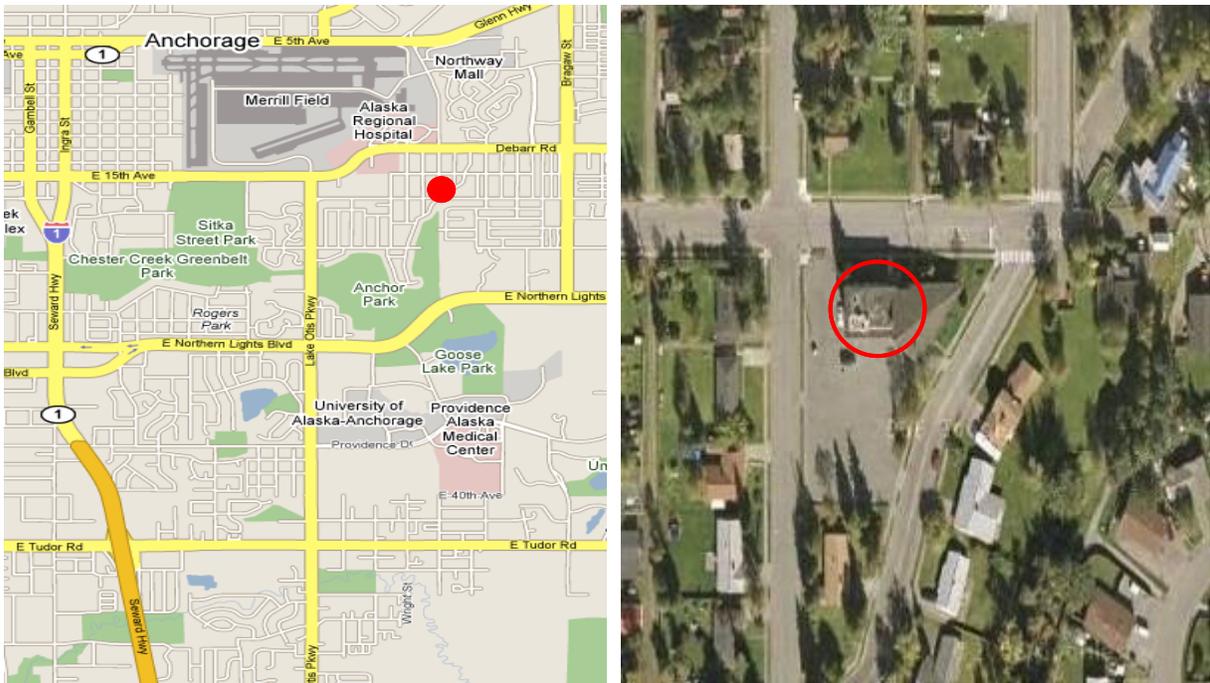
**Figure 3.2:1: Street map and satellite image of the Garden monitoring site. The red circles indicate the sites location.**

The Garden monitoring site is located at the Trinity Christian Reformed Church between 16<sup>th</sup> Avenue, Garden Street, and Sunrise Drive at latitude N 61° 12' 21.1", longitude – W149° 49' 29.0", and 128 feet (39 meters) above sea level. Figure 3.2:1 shows a street map of the central Anchorage area and a satellite image of the area. The site is located in a suburban, residential area. Garden is a neighborhood, population-oriented CO and PM site.

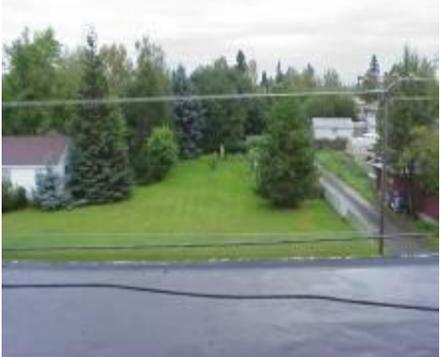
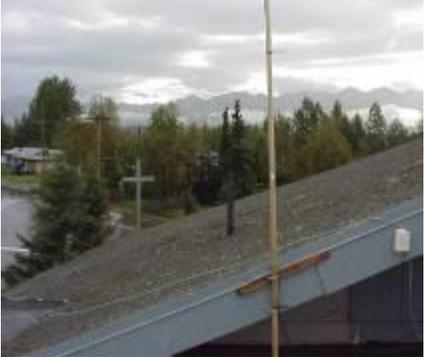
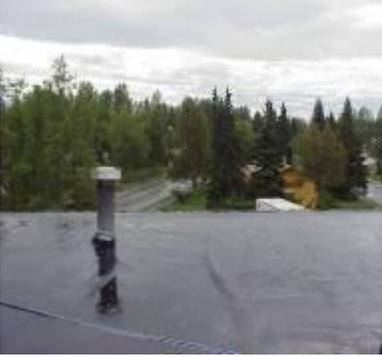
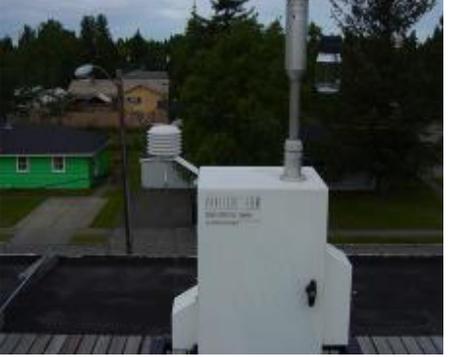
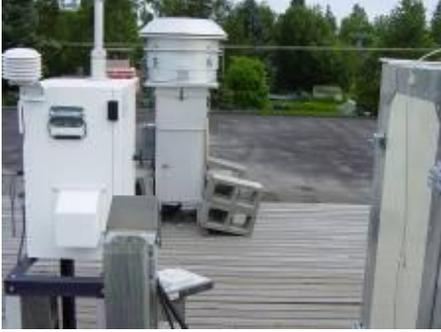
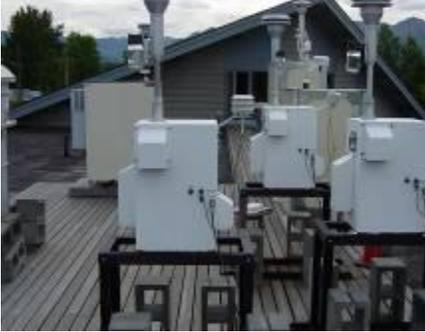
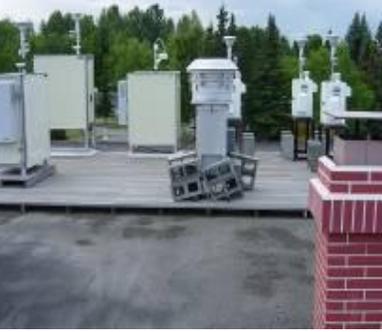
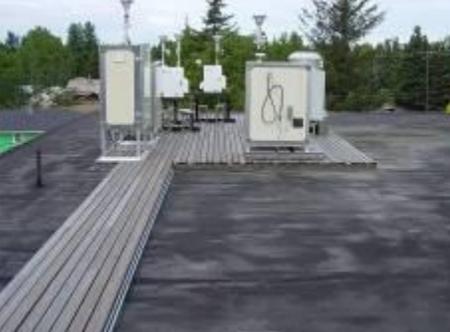
**Figure 3.2:2: Pictures of the Garden Site**

The particulate matter samplers are located on the roof at the south end of the Trinity Christian Reformed Church. Access to the site is from use of a window from a split level section of the church. This split level area is several meters from the monitoring site. The roof height is six meters (19 feet), and there are no trees in the vicinity that significantly exceed the height of the samplers. The airflow to these samplers is unobstructed. The samplers are approximately 14 meters (32 feet) south of the nearest traffic lane of 16<sup>th</sup> Avenue.

<p><b>Views in four directions from the Garden Site</b></p>

<p><b>Views in four directions towards the Garden Site</b></p>

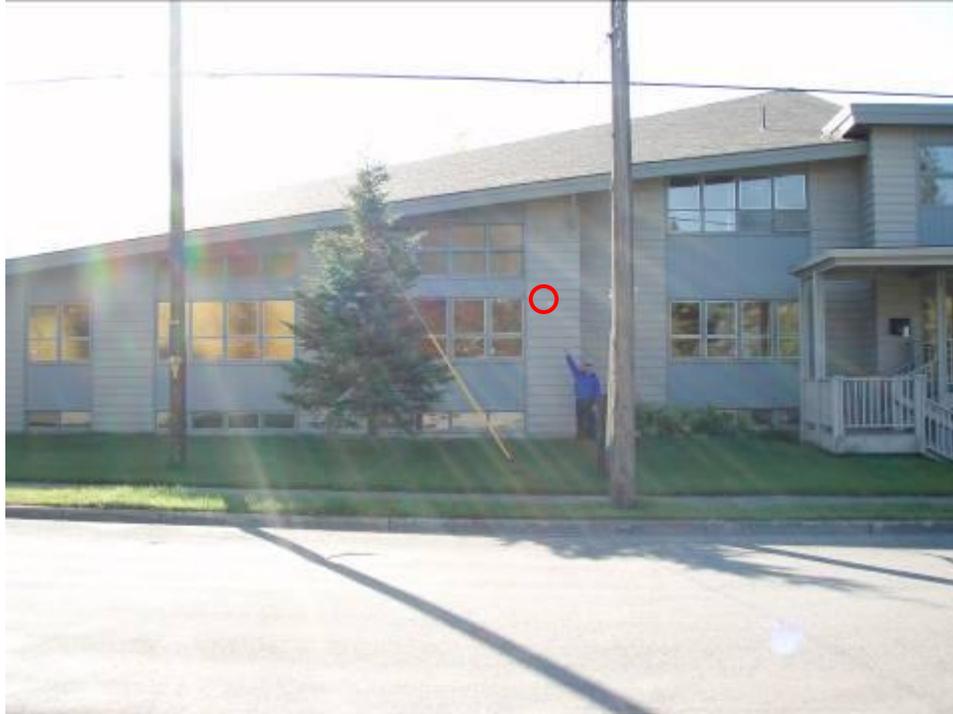
**Figure 3.2:3: View of CO probe at Garden Site. The red circle indicates where the probe is located.**

The CO monitor is installed in the church. The inlet probe is approximately three meters (9.5 feet) above the ground. The inlet probe is approximately 10 meters (32 feet) from

the nearest traffic lane of 16<sup>th</sup> Avenue. Between the inlet and 16<sup>th</sup> Avenue is one tall spruce tree. The church itself obstructs air flow from the south.

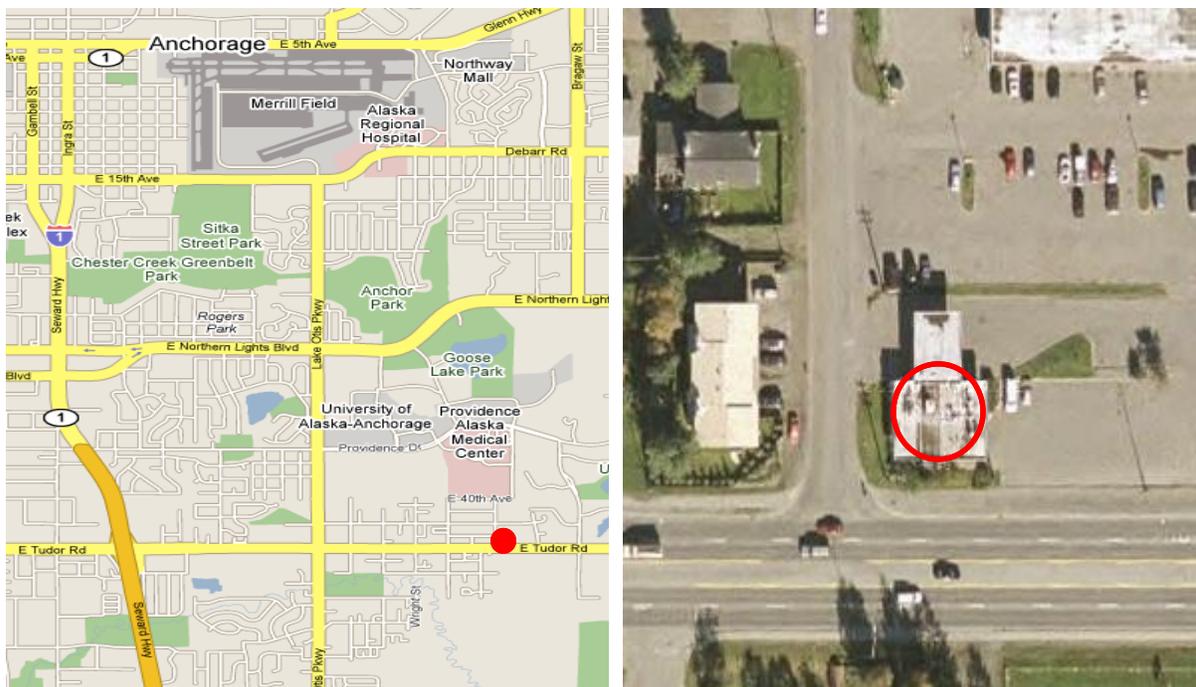
**Figure 3.3:1:** Street map and satellite image of the Tudor monitoring site. The red circle indicates the sites location.

The Tudor monitoring site is located at the Allstate Insurance Company building on Tudor Road at latitude N 61° 10' 51.9", longitude W 149° 49' 02.8", and 164 feet (50 meters) above sea level. Figure 3.3:1 shows a street map of the central Anchorage area and a satellite picture of the area immediately surrounding the Tudor site. The site is located in an urban, commercial location. Tudor is a microscale, population-oriented site.

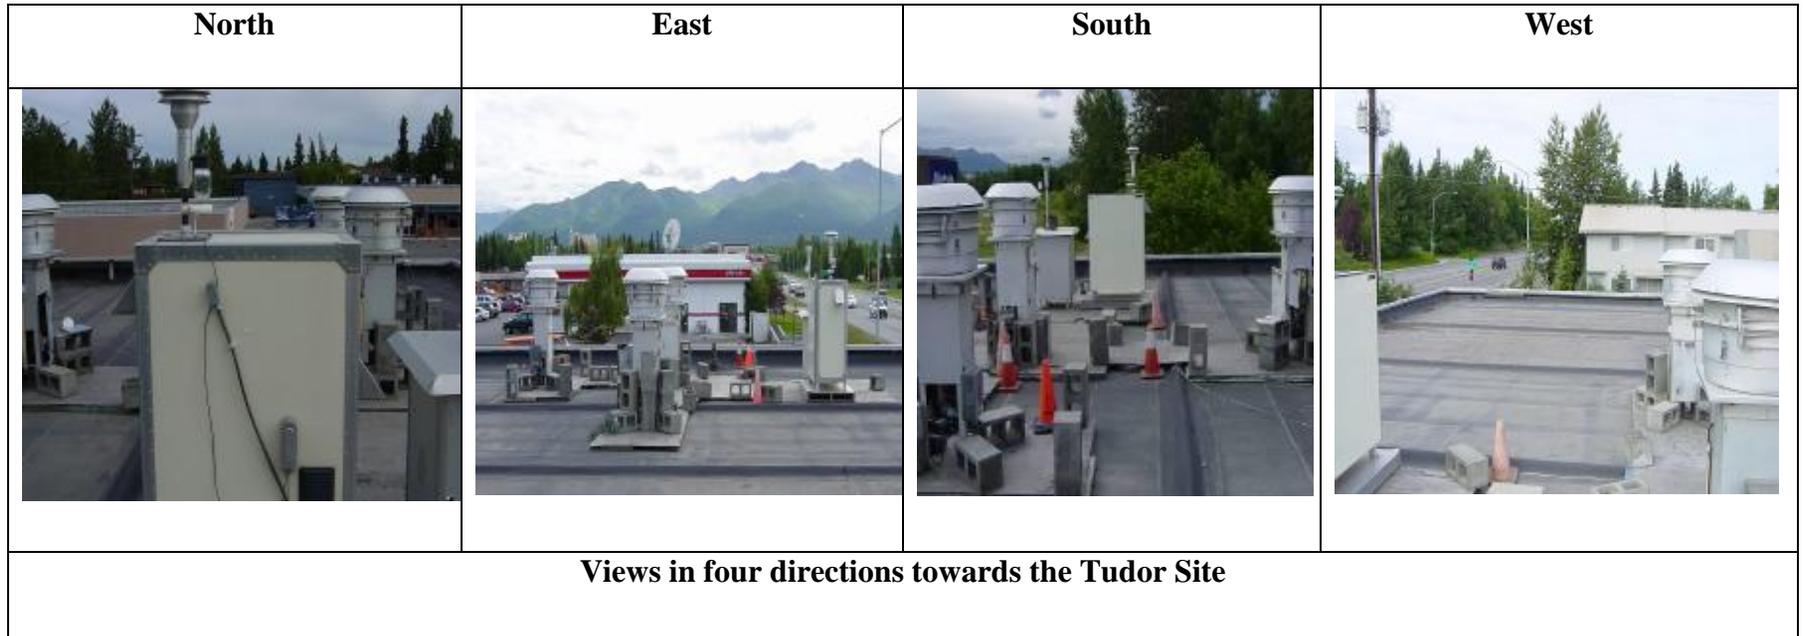
**Figure 3.3:2 : Pictures of the Tudor Site**

The particulate matter samplers are located on the roof near the southeast edge. The roof height is 3.3 meters (10.5 feet), and there are no other structures. Twenty foot tall mountain ash trees between the samplers and the roadway do not significantly exceed the height of the samplers. The airflow to these samplers is unobstructed. The samplers are approximately seven meters north of the nearest traffic lane of Tudor Road.

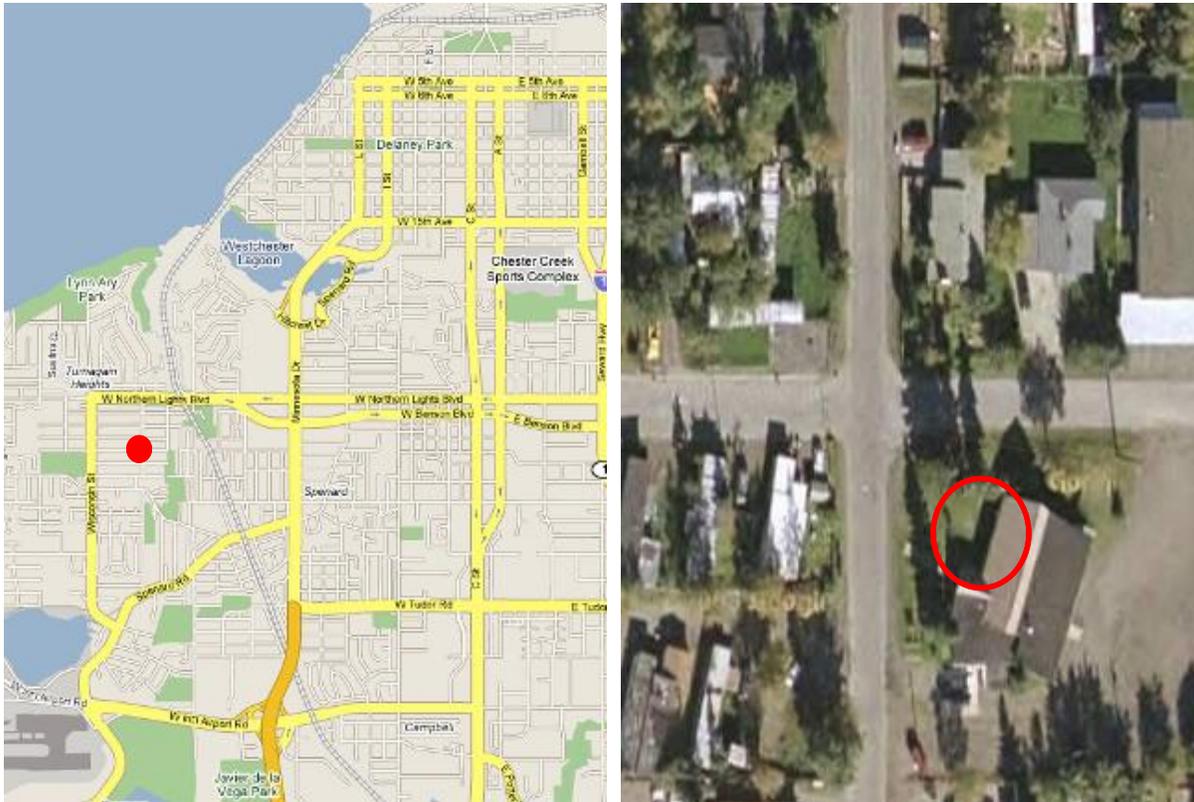
**Figure 3.4:1:** Street map and satellite image of the Turnagain monitoring site. The red circles indicate the sites location.

The Turnagain carbon monoxide monitoring site is located at the corner of Turnagain Street and 32<sup>nd</sup> Avenue at latitude N 61° 11' 29.4", longitude W 149° 56' 06.9", and 69 feet (21 meters) above sea level. Figure 3.4:1 is street map of the western part of Anchorage and a satellite picture of the Turnagain site and surrounding area. The site is located in a suburban location. Turnagain is a neighborhood scale, population-oriented site.

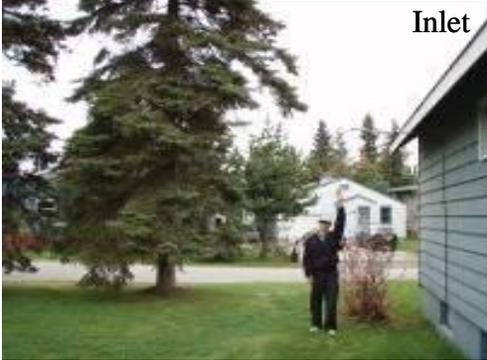
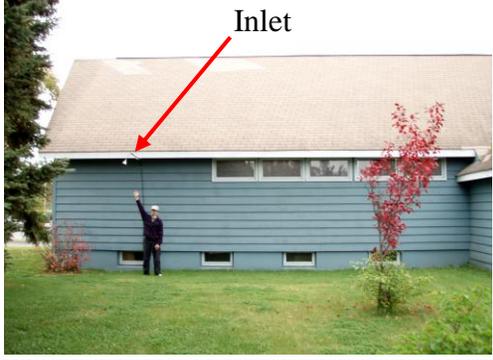
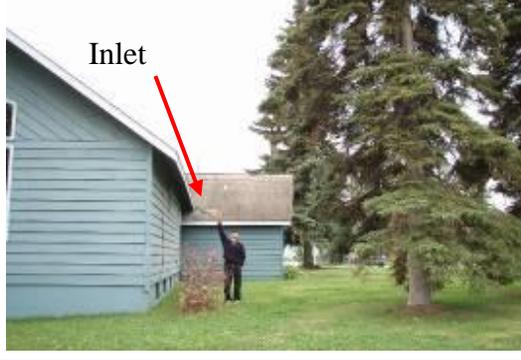
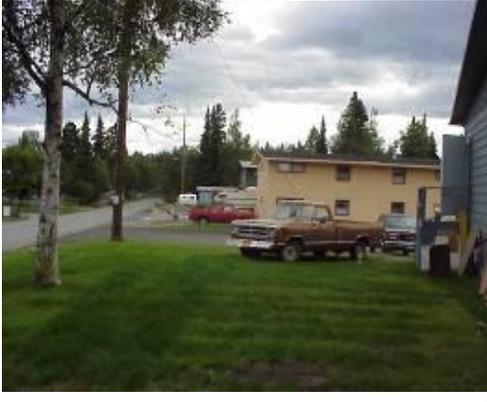
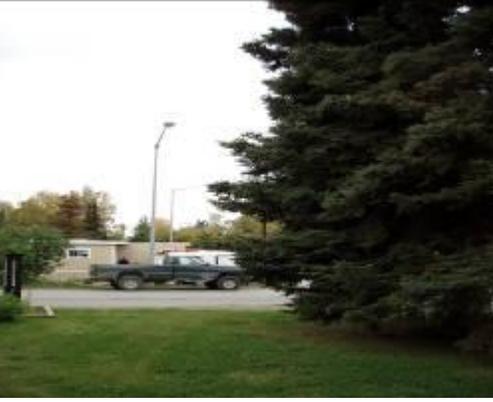
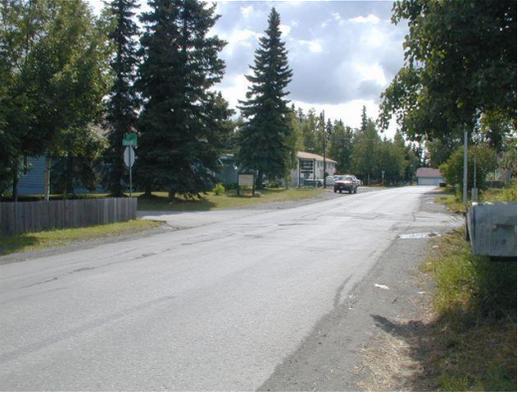
**Figure 3.4:2: Pictures of the Turnagain Site**

The monitor is installed in the Unitarian church. The inlet probe is approximately three meters (9.5 feet) above the ground. The inlet probe is approximately 18.5 meters (58 feet) from the nearest traffic lane of Turnagain Street. Between the inlet and Turnagain Street are several tall white spruce trees. The church itself obstructs air flow from the south and east.

A photograph showing a view from the north towards the Turnagain Site. A person is standing on a grassy area in the foreground, pointing towards a light blue building. The word "Inlet" is written in the top right corner of the image.

A photograph showing a view from the east towards the Turnagain Site. A person is standing on a grassy area, pointing towards the building. A red arrow points from the word "Inlet" to the roofline. The word "Inlet" is written in the top center of the image.

A photograph showing a view from the south towards the Turnagain Site. A person is standing on a grassy area, pointing towards the building. A red arrow points from the word "Inlet" to the roofline. The word "Inlet" is written in the top left corner of the image.
<p><b>Views in three directions towards the Turnagain Site</b></p>		
North	West	South

A photograph showing a view from the north looking away from the Turnagain Site. A yellow building and a brown pickup truck are visible in the background. The sky is overcast.

A photograph showing a view from the west looking away from the Turnagain Site. A dark green car is parked in a lot, and a large evergreen tree is in the foreground.

A photograph showing a view from the south looking away from the Turnagain Site. A paved road leads away from the site, lined with trees and a utility pole.

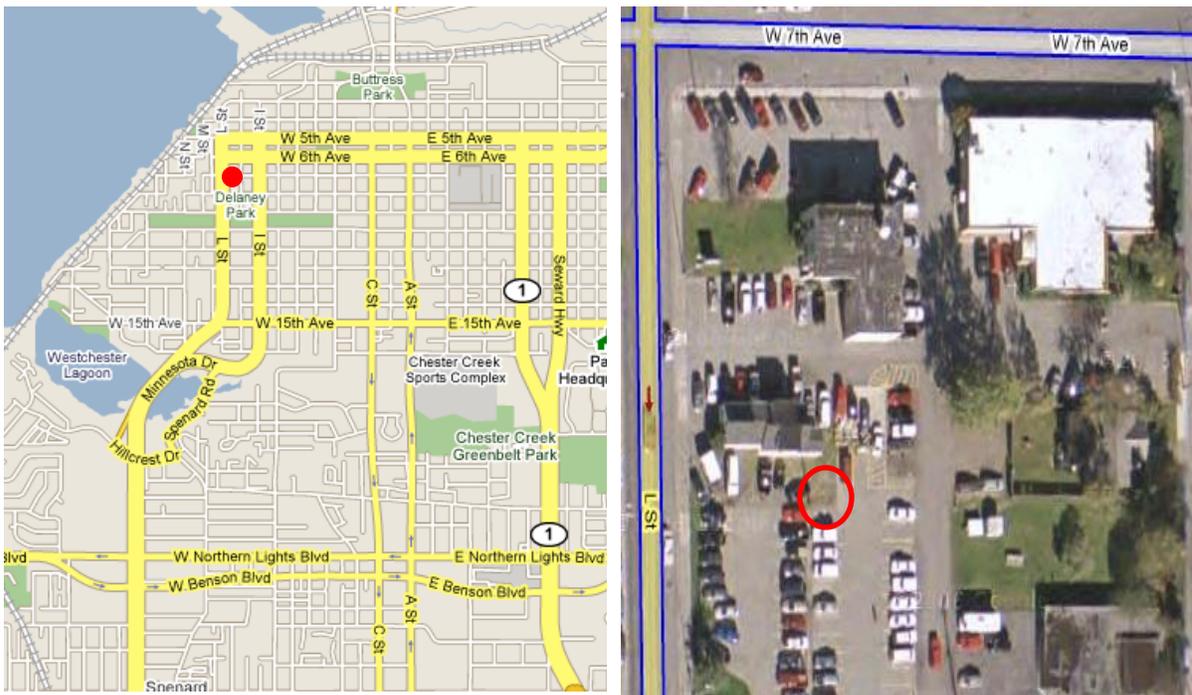
**Figure 3.5:1:** Street map and satellite image of the DHHS monitoring site. The red circles indicate the sites location.

The Department of Health and Human Services (DHHS) carbon monoxide monitoring site is located in the employee parking lot for DHHS at latitude N 61° 12' 54.1", longitude W 149° 54' 11.2", and 115 feet (35 meters) above sea level. Figure 3.5:1 shows a street map of the western part of Anchorage and a satellite picture of the DHHS site and surrounding area. The site is located downtown. The Municipality of Anchorage considers the DHHS site to be middle scale, representing a dimensional area up to 0.5 km.

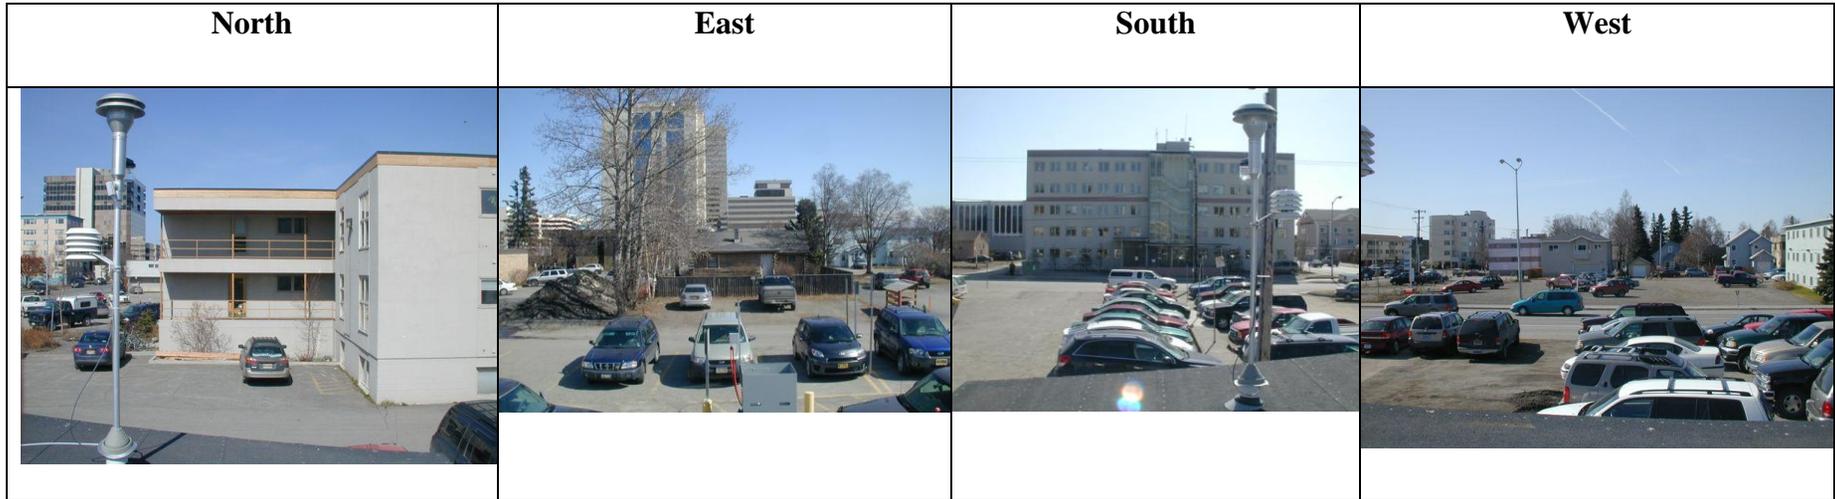
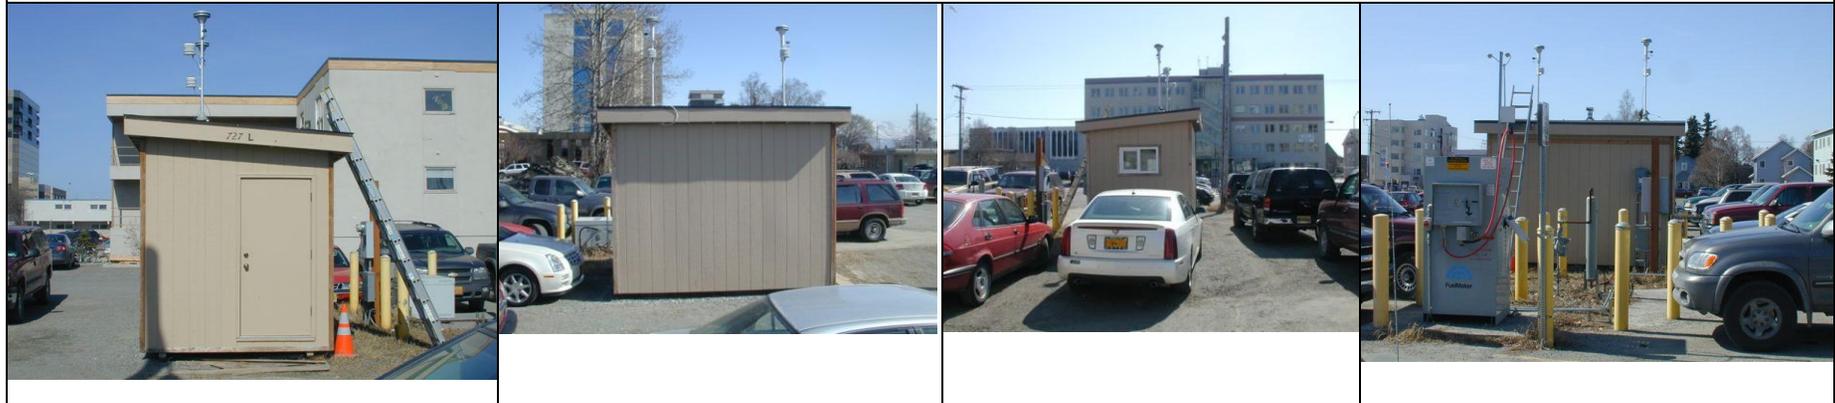
**Figure 3.5:2: Pictures of the DHHS Site**

The monitors are installed in a small shed building located at 727 L Street.. The CO inlet probe is approximately three meters (9.5 feet) above the ground. The inlet probe is approximately 28 meters (85 feet) from L Street, the nearest traffic lane. The probe extends off the northwest corner of the shed, and air flow to the probe is unobstructed for 270 degrees. The PM<sub>10</sub> and PM<sub>2.5</sub> inlets each extend one meter above the shed roof with two meters of separation between them. This site has sufficient separation distance from surrounding buildings to meet EPA siting criteria.

**Views in four directions from the DHHS Site**

**Views in four directions towards the DHHS Site**

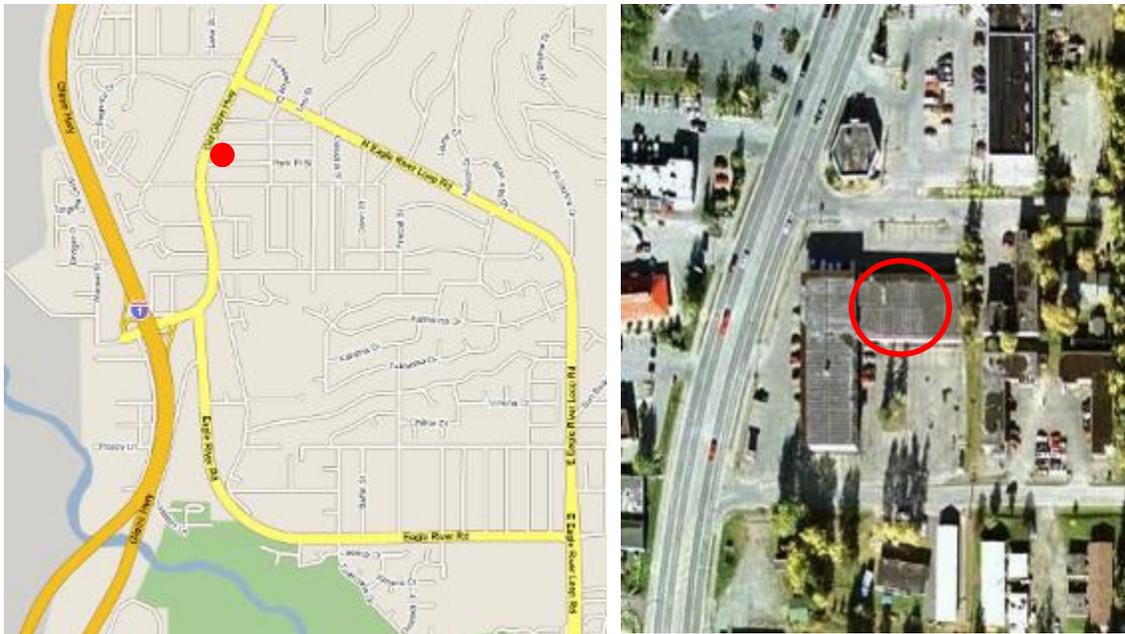
**Figure 3.6:1:** Street map and satellite image of the Eagle River monitoring site. The red circle indicates the sites location.

The Parkgate PM<sub>10</sub> monitoring site is located at the Parkgate Business Center building in Eagle River (a bedroom community of Anchorage that lies well within the Municipality) at latitude N 61° 19' 36.0", longitude W 149° 34' 10.8", and 328 feet (100 meters) above sea level. Figure 3.13 is a street map of the western Eagle River area and a satellite picture of the Parkgate site and surrounding area. The site is located in a suburban/commercial use area with monitoring site classified as neighborhood scale, population-oriented monitoring site.

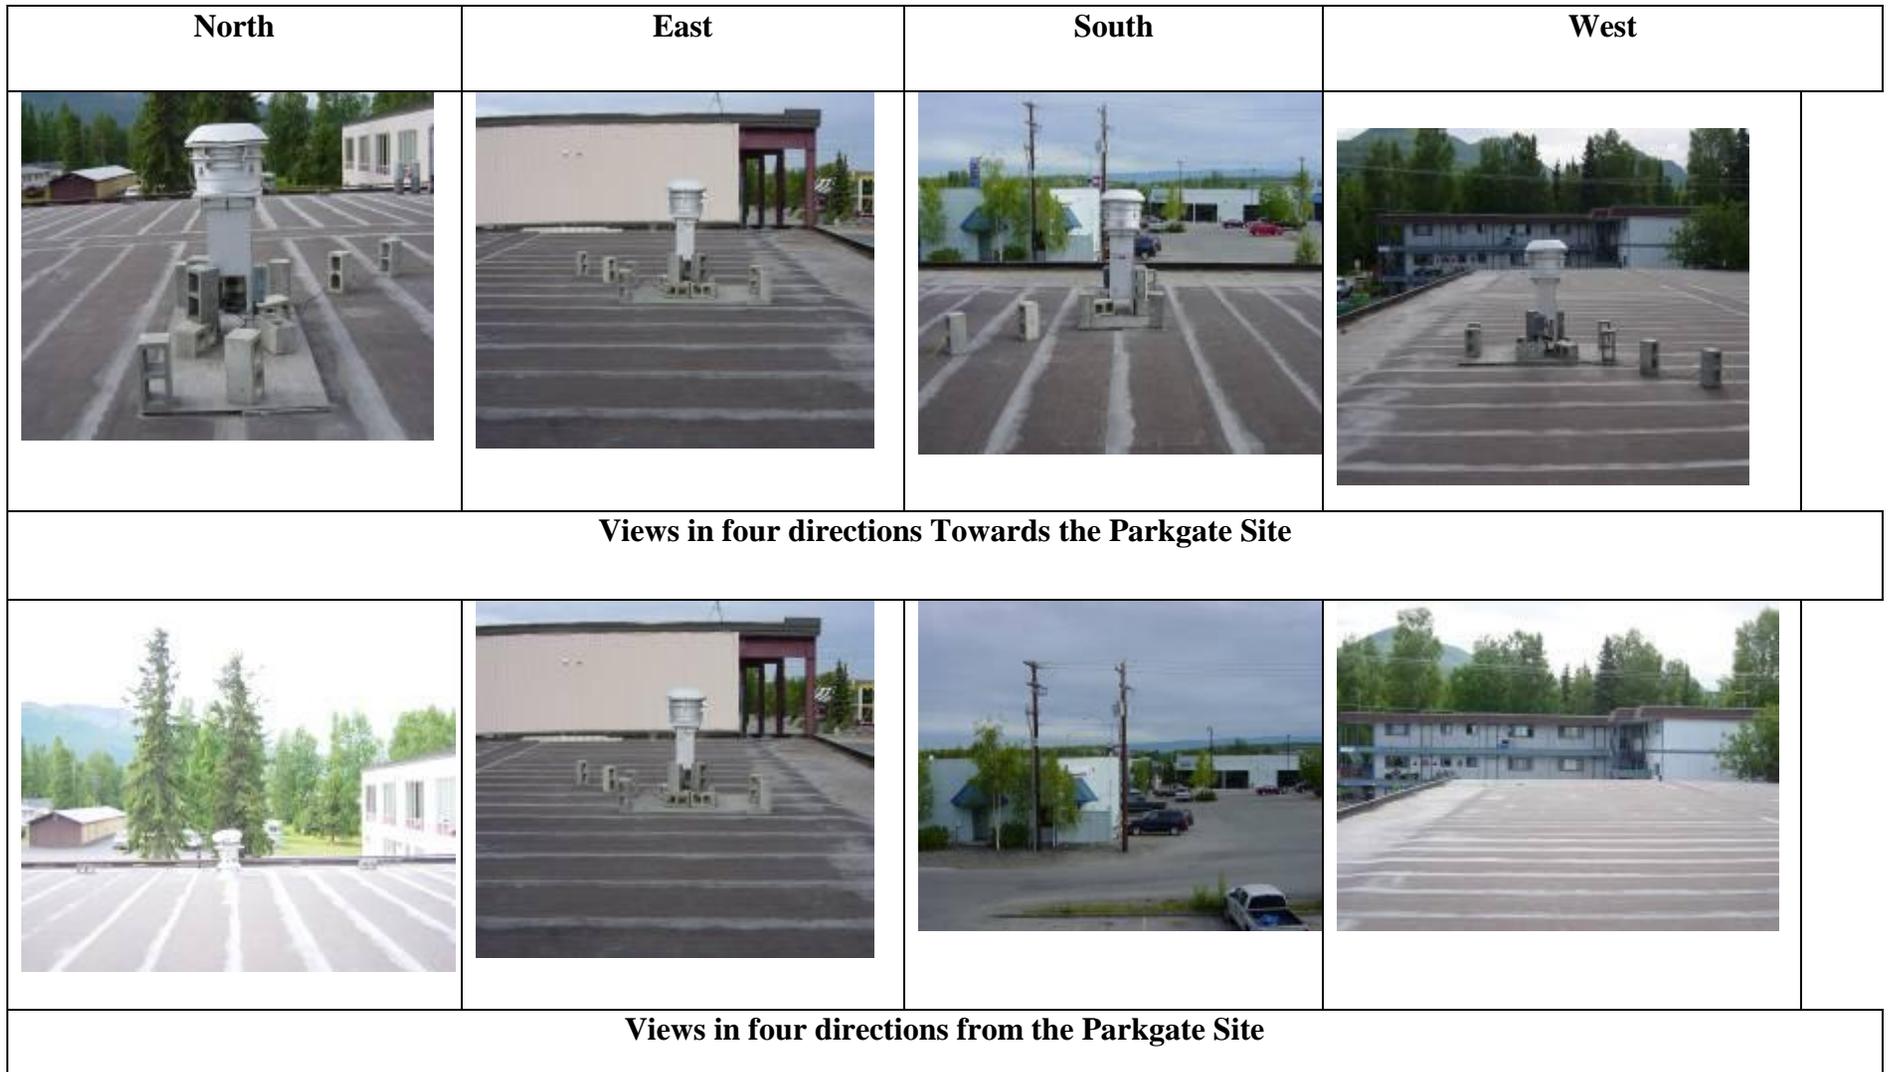
**Figure 3.6:2: Pictures of the Parkgate Site**

The particulate matter samplers are located on the roof of the first story of the Parkgate Business Center. The roof height is 5 meters (16 feet). There is another section of the building 13 meters (41 feet) to the west that is two stories tall (4 meters above the first story roof height). No trees in the vicinity significantly exceed the height of the samplers. The airflow to these samplers is unobstructed. The samplers are approximately 44 meters east of the nearest traffic lane of the Old Glenn Highway and 23 meters (73 feet) south of Easy Street.

The CO inlet probe is approximately three meters (9.5 feet) above the ground and is attached to the east side of the building. The CO probe inlet is approximately 42 meters east of the nearest traffic lane of the Old Glenn Highway and 23 meters (73 feet) south of Easy Street. Airflow to the probe inlet is unobstructed from the north, south, and east. The Parkgate building itself obstructs air flow to the CO probe inlet from the west.
