CIAP WEAR Trip Report
Council (seasonal summer population 15, winter population 0)
July 30, 2013

Alaska Department of Environmental Conservation (ADEC) Solid Waste Program (Trisha Bower and Kit Persson) conducted a Coastal Impact Assistance Program (CIAP), Waste Erosion Assessment and Review (WEAR) site visit for the Village of Council, July 30th, 2013. Michael Murphy, the local Bed & Breakfast owner helped coordinate our visit. The following narrative is a brief description of our findings during the July inspection.

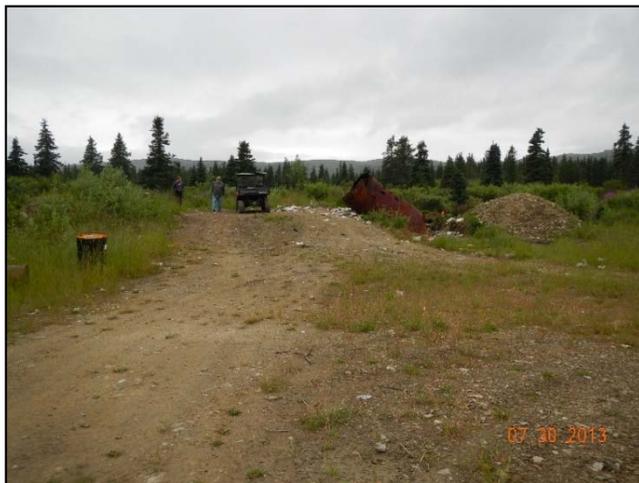
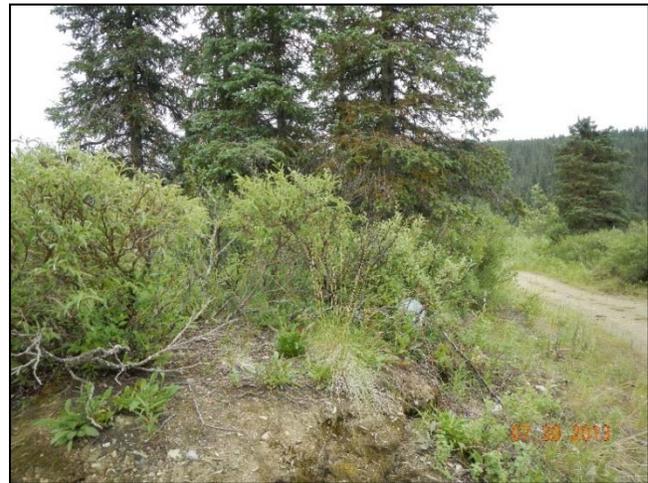
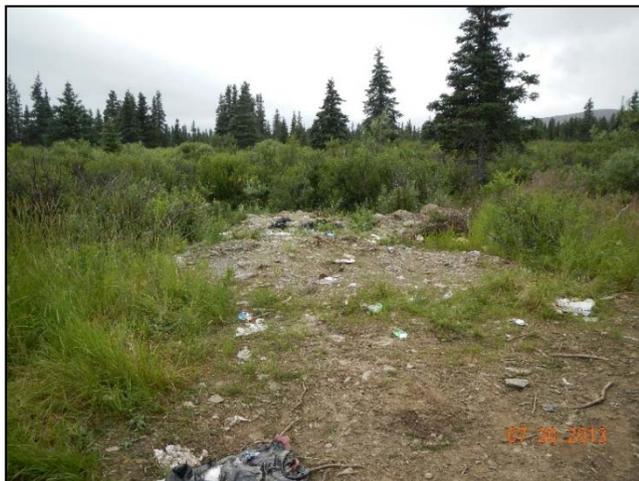
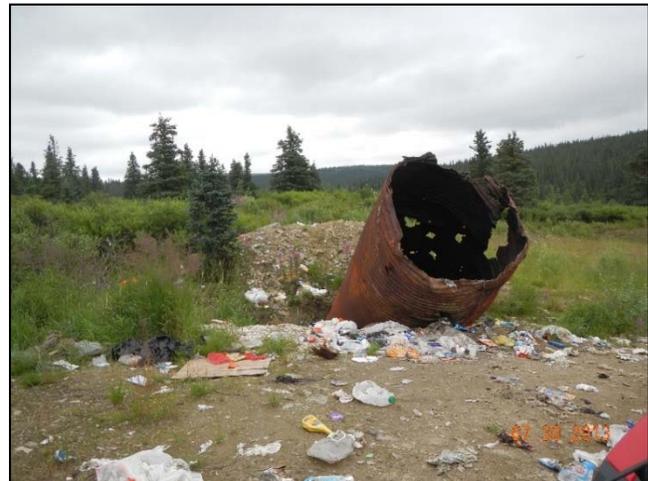
- **Landfill, 64.902185/-163.658057 (Active)** — The landfill is an unfenced area fill landfill. The landfill is currently managed by the seasonal residents of Council and is unpermitted. There is heavy equipment available, and the landfill is managed as needed. The landfill accepts municipal waste and has cover material stockpiled next to the site. Recyclable material is delivered to Nome by local residents. Council is only inhabited during the summer, so the landfill only receives waste during the summer months. The population in Council is variable, but there are usually 10 occupied households at any given time during the summer. The current landfill is located approximately 250 feet inland from the Melsing Creek and approximately 3860 feet from Niukluk River. The landfill is located in an elevated area.

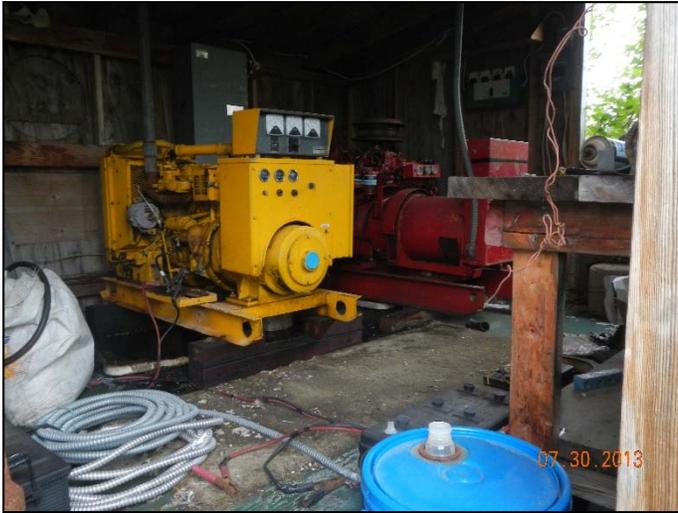
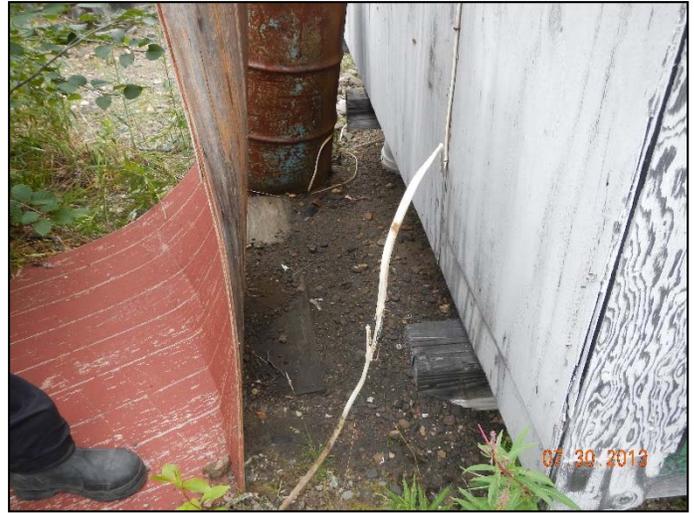
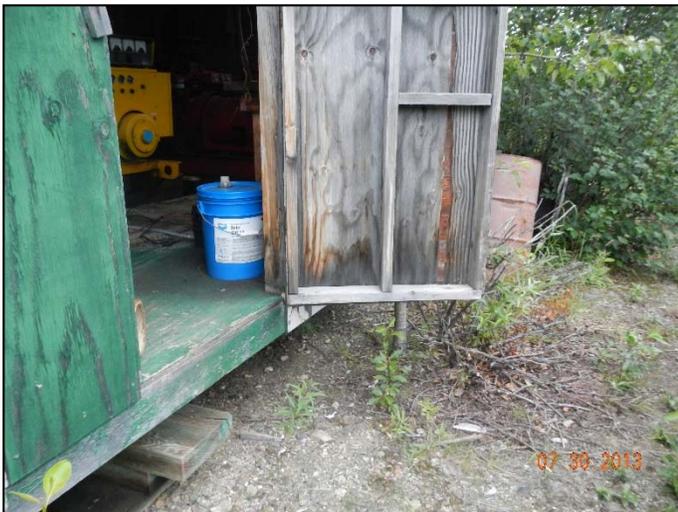
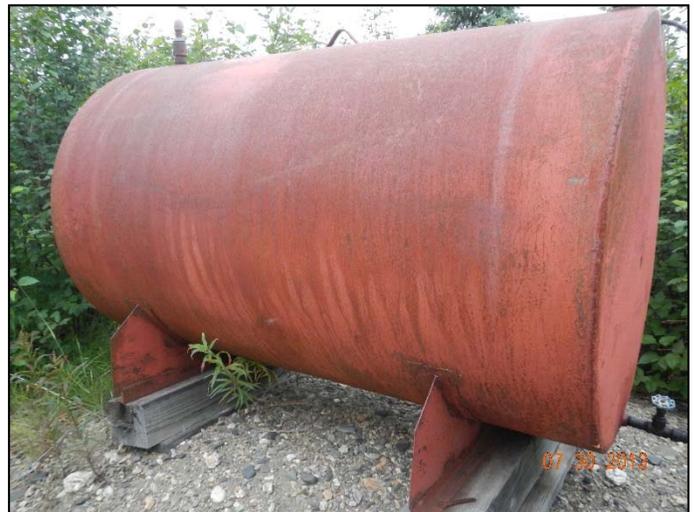
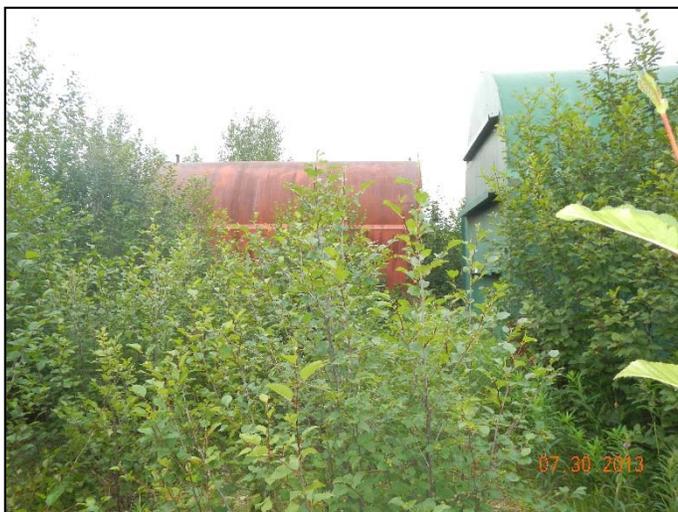
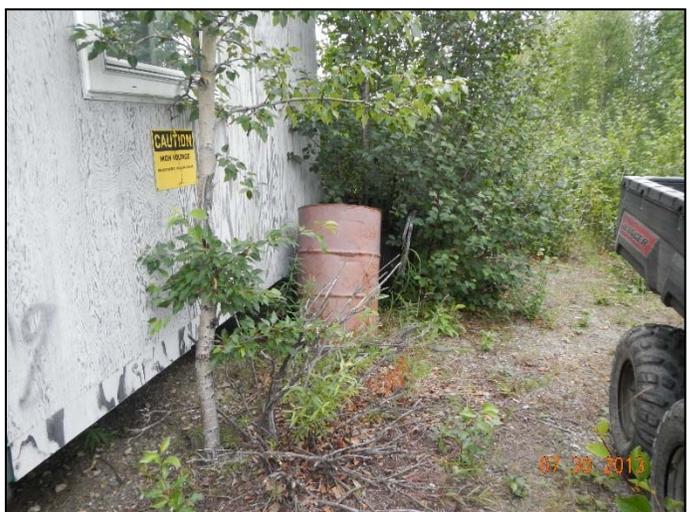
- **Generator Building, 64.89596/-163.68839 (Abandoned)** – This was the old generator building in Council; it is not used currently. The remaining residents in Council rely on personal generators or solar power. The building, equipment and fuel tanks remain abandoned on site, and there was evidence of stained soils. The site is approximately 1240 feet from Niukluk River.
