Alaska Department Environmental Conservation (ADEC) Solid Waste Program (Kit Perrson and Jacob Timmons) conducted a Coastal Impact Assistance Program (CIAP), Waste Erosion Assessment and Review (WEAR) site visit for Igiugig, May 28th, 2013. The following narrative is a brief description of findings during the May inspection.

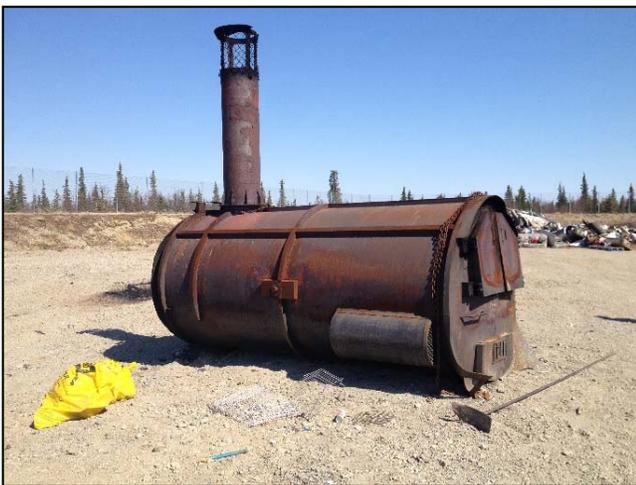
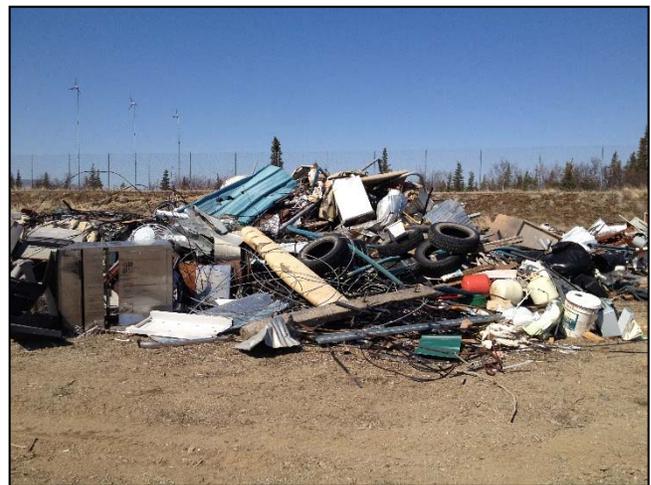
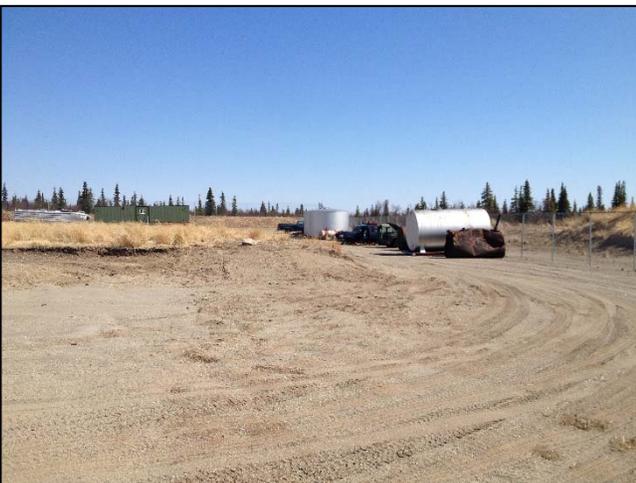
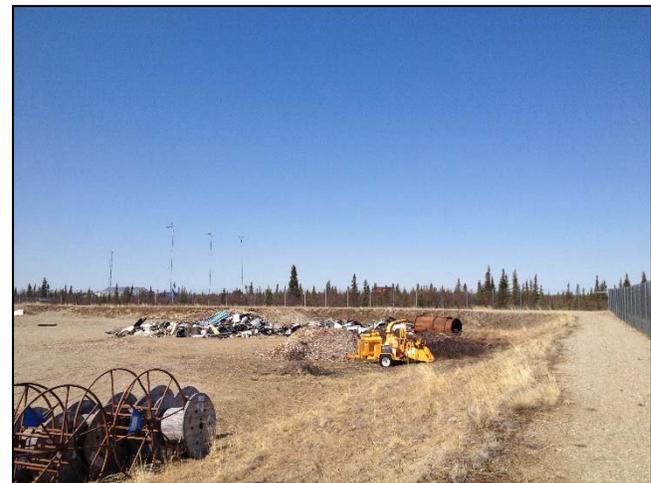
- **Landfill, 59.30807/-155.910792 (Active)** – The 5.4 acre landfill is located 1 mile south of the airstrip on the road. This permitted landfill was constructed around 2001. It is well run landfill that is fenced and separates and covers waste. It accepts municipal waste and construction and demolition debris. A Tok burn box is used to reduce waste volume. At least 75% of the waste is brought to the landfill by a collection program. The community is very active in its backhaul and recycling programs. It lies 3,300 feet away from the Kvichak River, the nearest source of erosion.

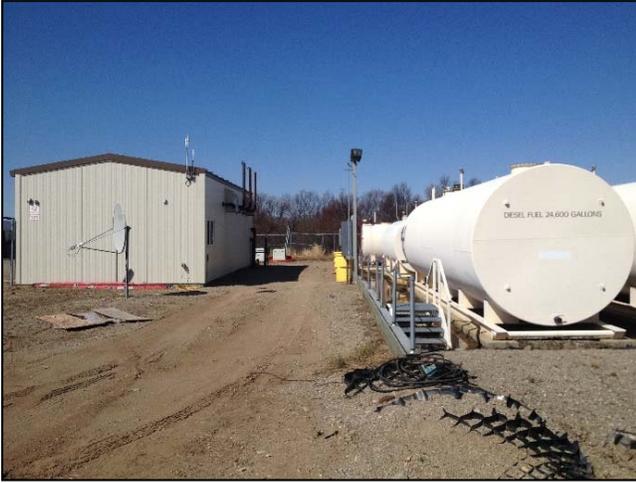
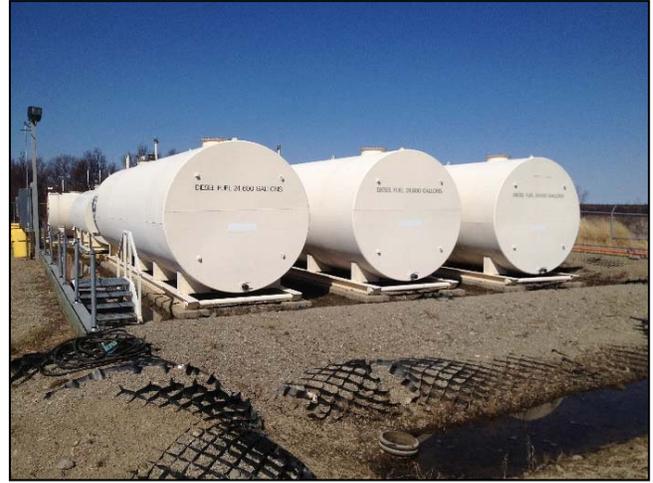
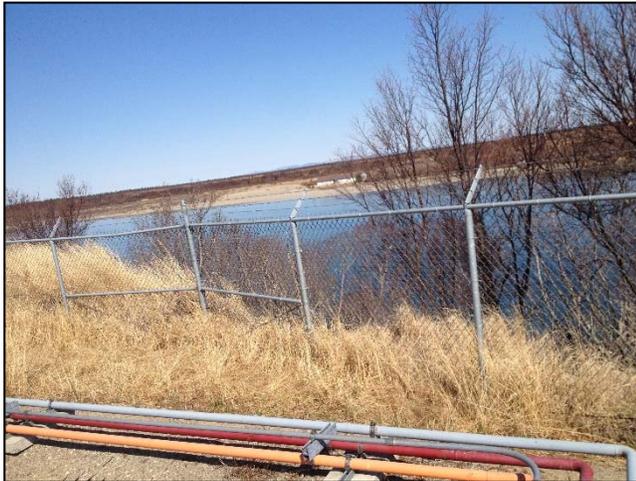
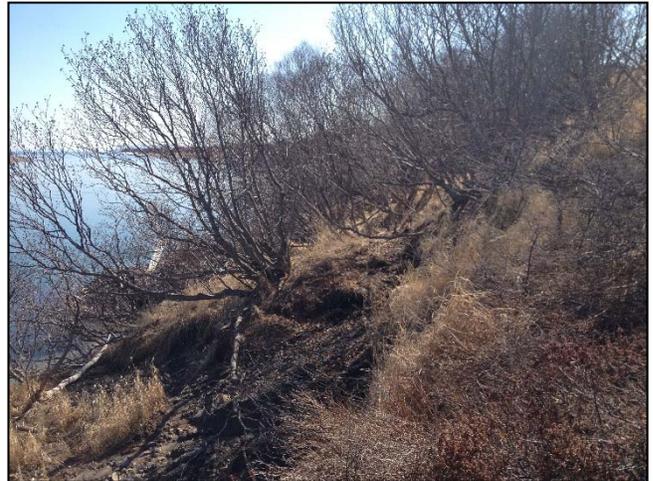
- **Tank Farm, 59.327258/-155.897948 (Active)** – This site is 400 feet northeast of the airstrip building. The site was constructed in 2004 for the Native Village of Igiugig and contains nine tanks with a total capacity of 111,000 gallons. The nearest source of erosion, the Kvichak River, is only 20 feet away. Erosion symptoms such as root exposure, undercutting, and slides were observed on the closest bank of the river.

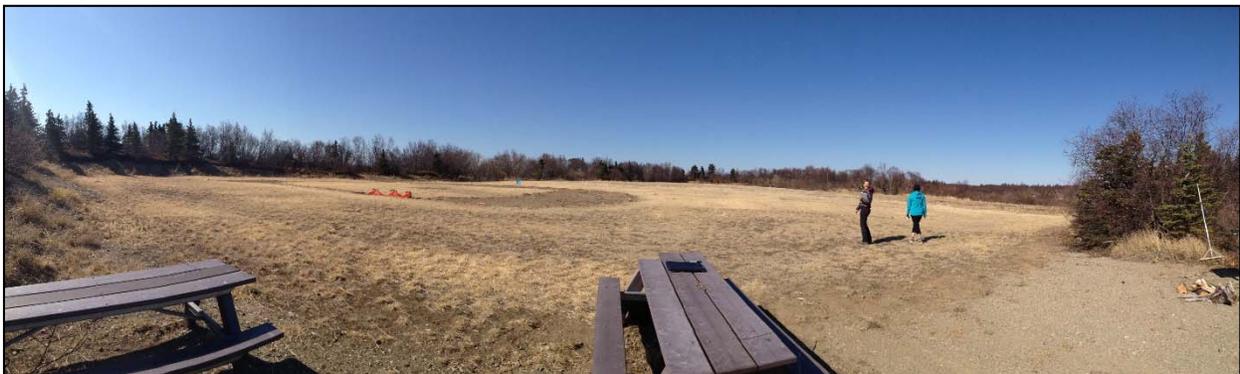
- **Community Landfill, 59.325198/-155.905045 (Retired)** – This is the location of a historical military landfill that was started in the 1950s. After the military left, the community used it as their landfill until 2001 when the new landfill was constructed. It has been transformed into a baseball field. There is no visible trash and the 2.5 acre site appears to be well closed and vegetated. It can be found 300 feet west of the school. The field is 500 feet from the closest source of erosion, the Kvichak River.

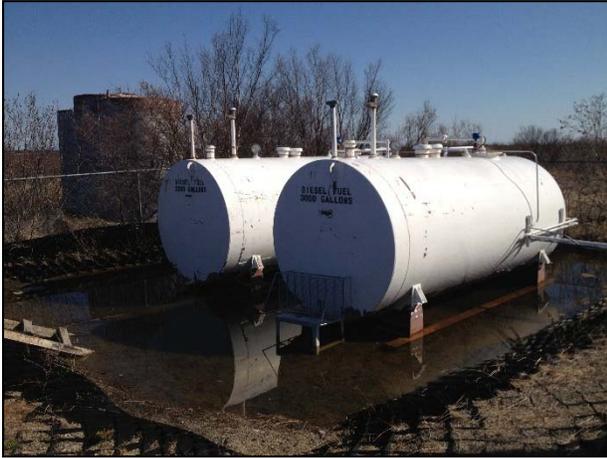
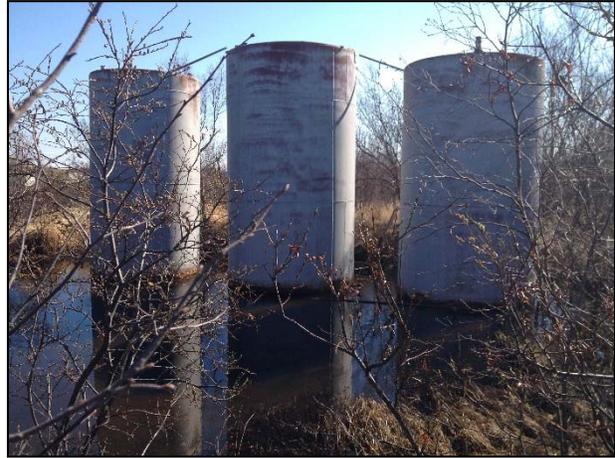
- **School Tanks, 59.325595/-155.903868 (Active)** – This site is 50 feet north of the school. It contains two 3,000 gallon horizontal diesel tanks owned by Lake and Peninsula School District. They are in a lined and fenced area. There are also three abandoned vertical tanks that are empty, disconnected and not in use 10 feet north of this tank farm. It lies 550 feet from the Kvichak River, the nearest source of erosion.
