Alaska Department of Environmental Conservation (ADEC) Solid Waste Program (Kym Bronson and Kit Persson) conducted a Coastal Impact Assistance Program (CIAP), Waste Erosion Assessment and Review (WEAR) site visit for Shageluk on September 11th, 2013. Robert Demientieff, maintenance for the city, and Anna Benjamin, Shageluk Tribal Council Administrative Assistant, participated on the site visit. The following narrative is a brief description of our findings during the September inspection.

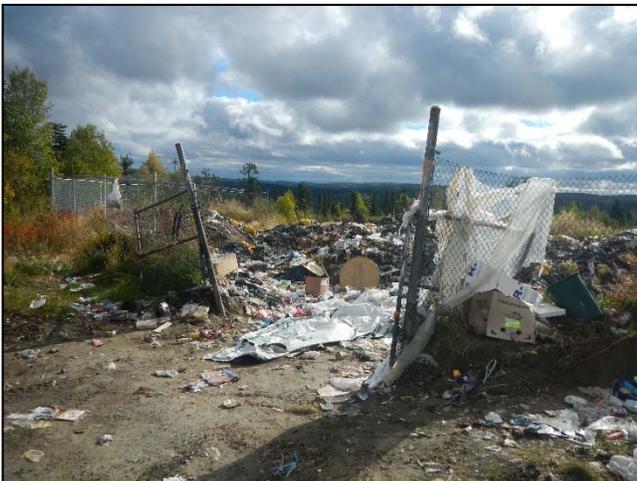
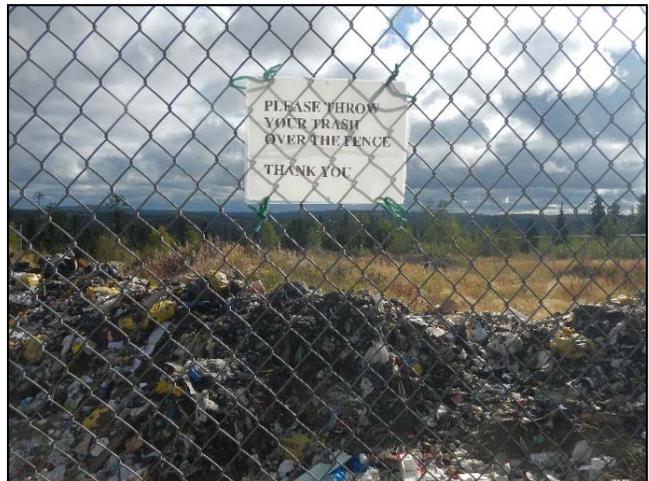
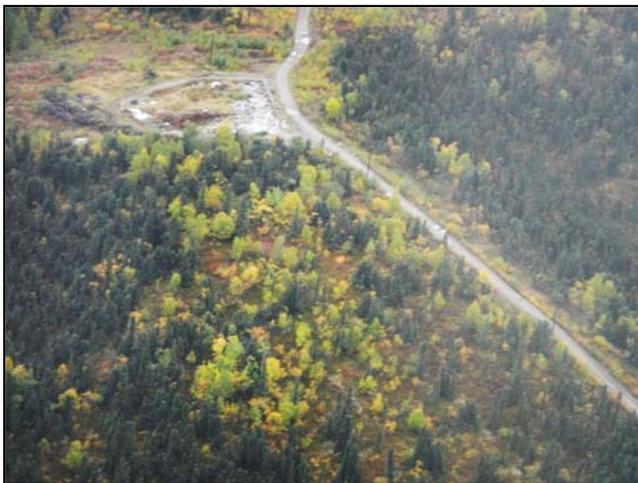
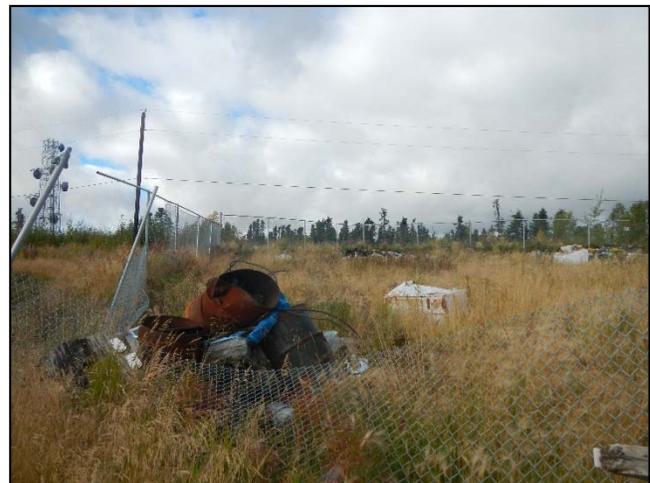
- **Landfill, 62.647314/-159.525761 (Active)** – This site is a self-haul landfill. The site is approximately 1.3 acres with waste primarily clustered near the entrance, located at the northwest corner of the site. The accumulated waste is cleared away from the entrance and consolidated periodically. Waste is open burned on the ground in the winter months only, due to wildfire risk in the summer. The fence around the site is in need of repair, with the gate left open for unrestricted access. It has been in operation since around 1985. This site is high on a hill outside the flood plain and is over 3,000 feet from the Innoko River.

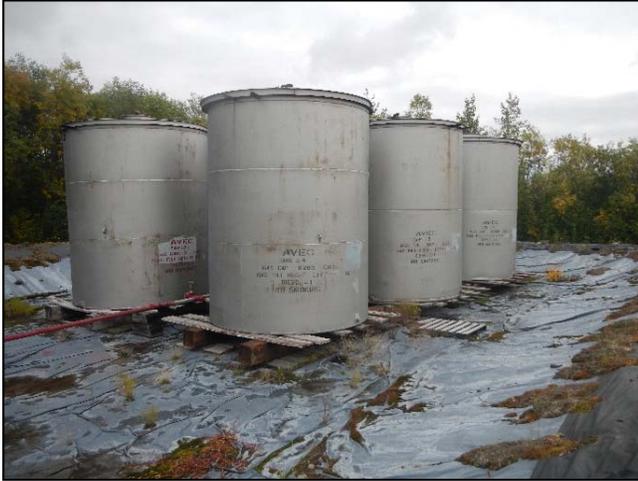
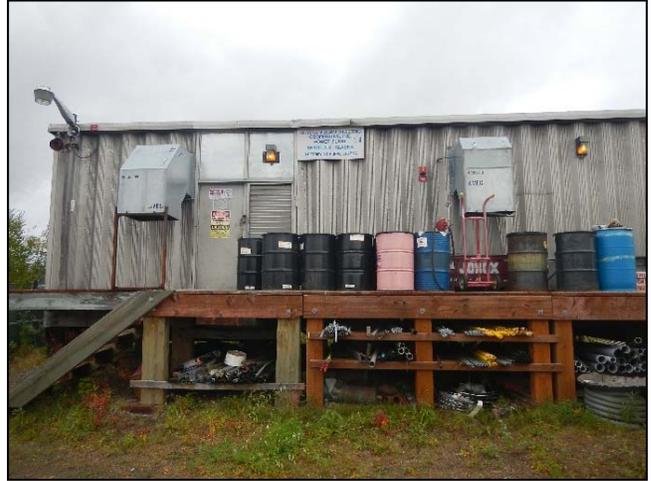
- **AVEC Tank Farm, 62.658069/-159.532737 (Active)** –This active tank farm contains 6 single wall diesel tanks with a total capacity of 57,066 gallons. They are located on pallets within a lined earthen berm, and the site is unfenced and accessible to the public. There are 6 used transformers and approximately 13 drums, contents unknown, located near the tanks. Site is located 85 feet from Hamilton Slough which flows into the Innoko River.

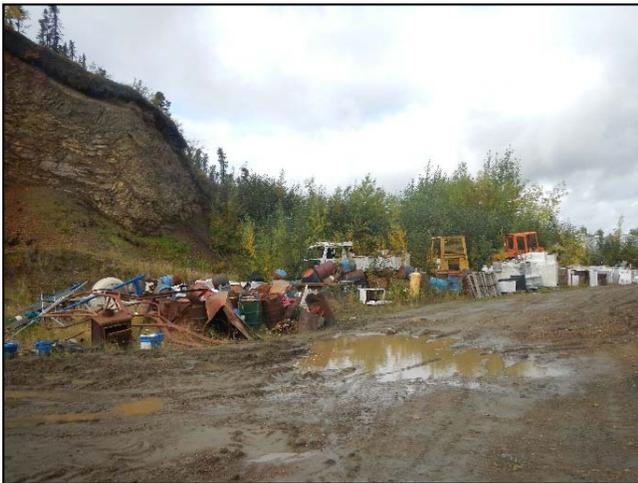
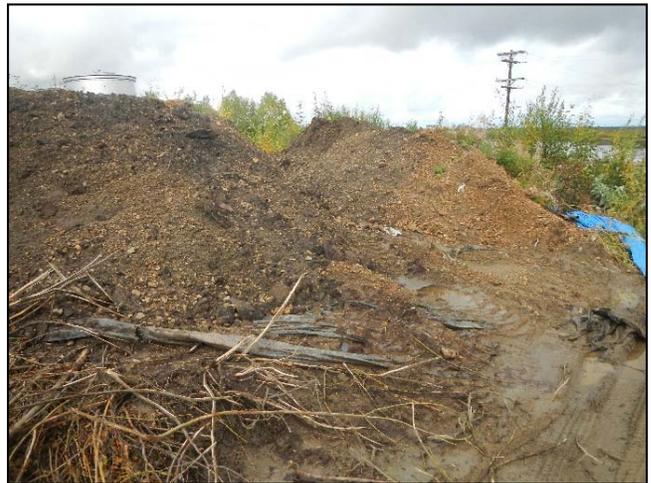
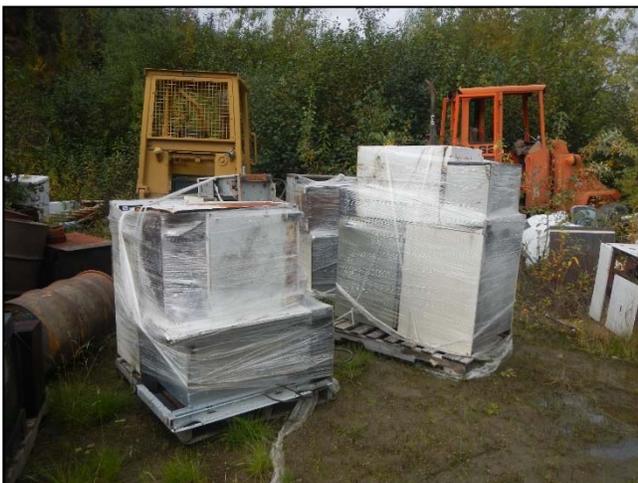
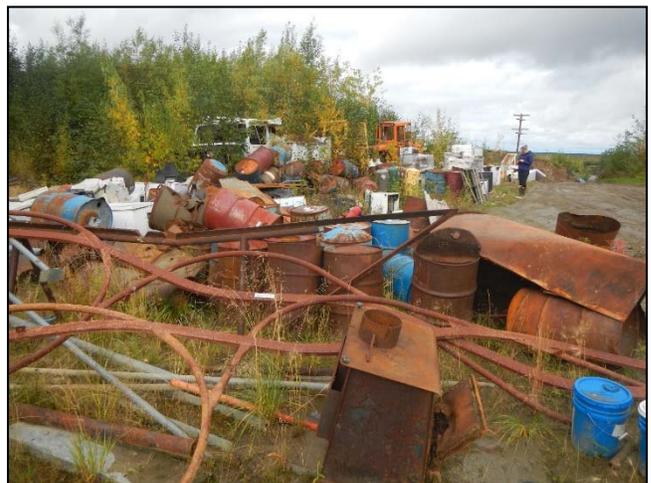
- **Boneyard, 62.654233/-159.533886 (Active)** – The gravel pit is the storage site for junk vehicles, white goods, various 55 gallon drums, old heavy equipment, and scrap metal. Some of the junked vehicles were submerged in mud. There is a pile of soil, possibly contaminated, on a liner near the entrance of the gravel pit. This site is located directly south of the school. It occupies 0.4 acres and is located 313 feet to the bank of the Innoko River.

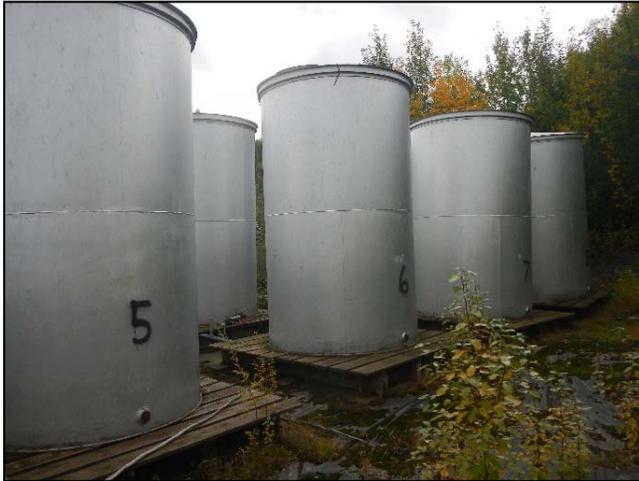
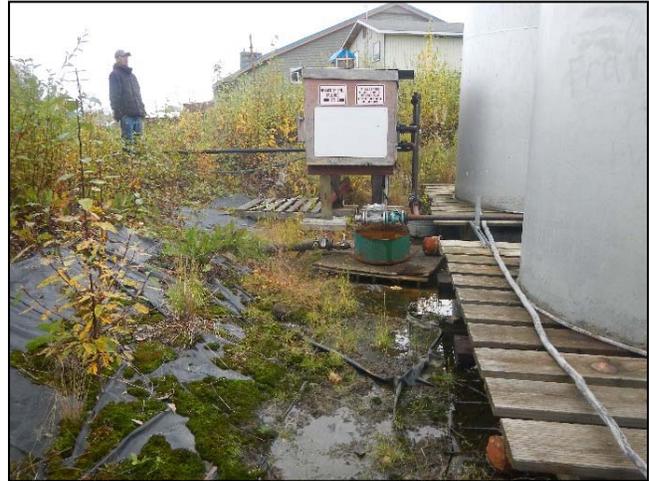
- **School Tank Farm, 62.654778/-159.534288 (Active)** – This tank farm supplies the nearby Innoko River School and is owned by the Iditarod Area School District. There are 8 fuel tanks on wooden pallets on a liner within an earthen containment berm. There was vegetation and moss on the liner, which was in poor condition. The tank farm is located approximately 100 feet from the Innoko River.

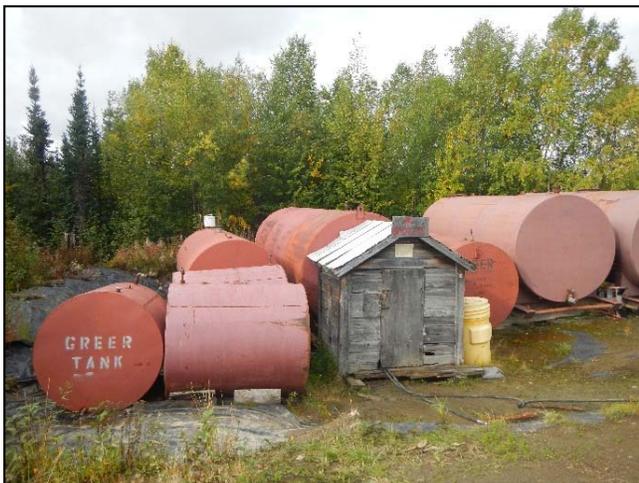
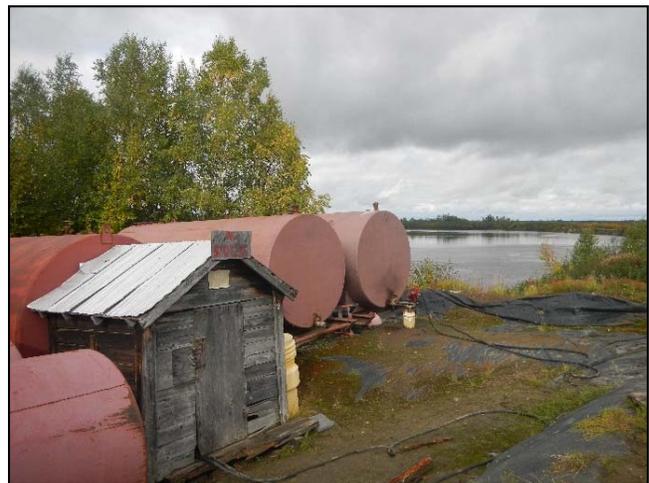
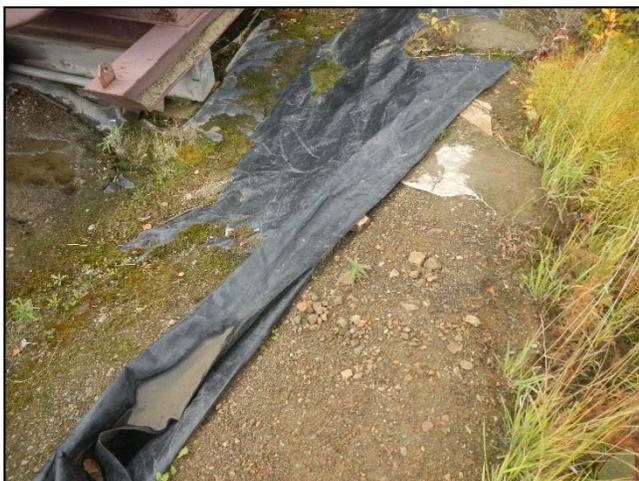
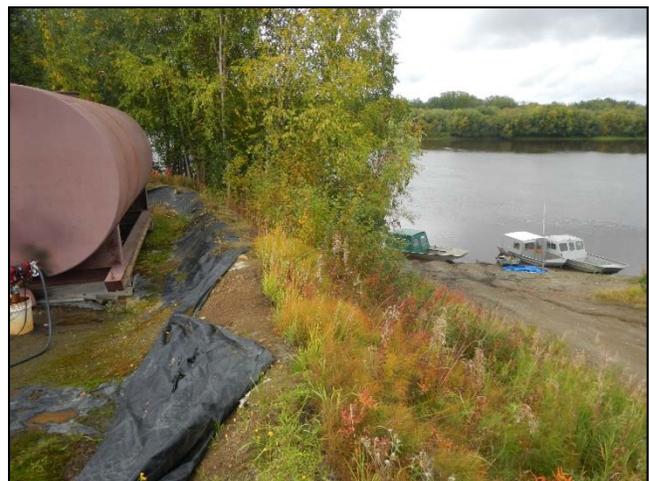
- **Zho-Tse Corporation Tank Farm, 62.655038/-159.534417 (Active)** – This tank farm has multiple horizontal fuel tanks: 3 large tanks, 3 medium tanks, and 2 small tanks. All are located in a lined earthen berm. However, the liner is in very poor condition with sand and vegetation growing in it. This tank farm also functions as the community gas station. It is located about 40 feet from an eroding bank of the Innoko River.

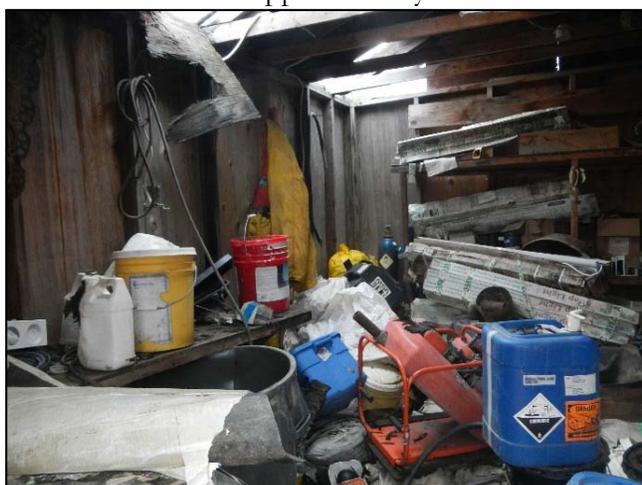
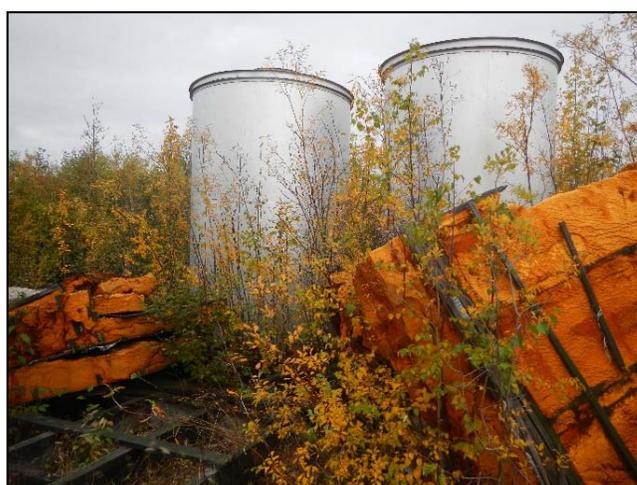
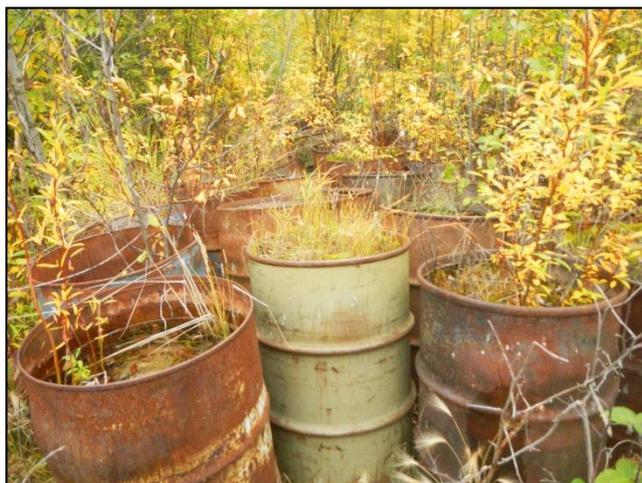
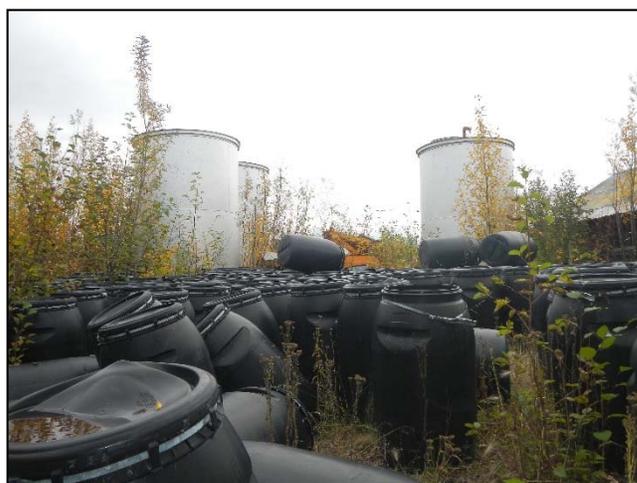
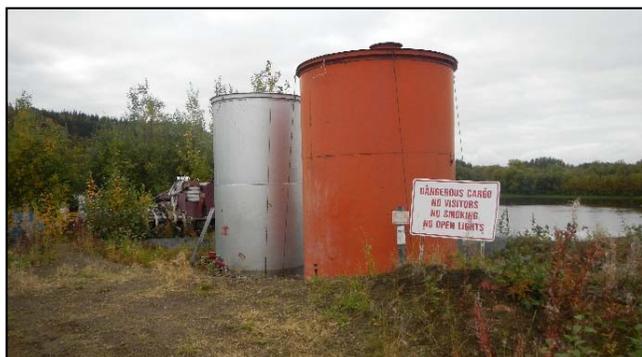
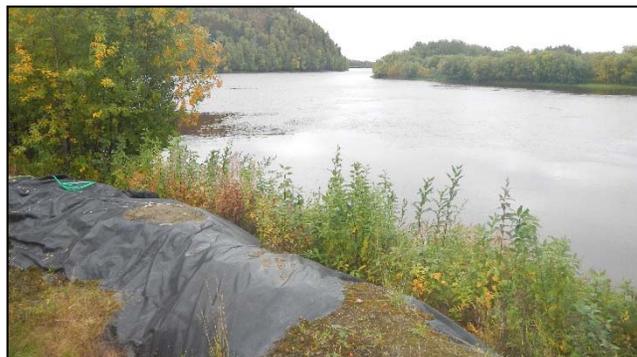
- **City Tank Farm, 62.657605/-159.534266 (Active)** – This is an active Contaminated Site (File ID 2446.38.001) due to historic fuel spills, two in 1994 and one in 1995. The Contaminated Site database states 35 drums of contaminated soil were reportedly taken to the landfill in 1994. However, there were approximately this number of drums on site with alders growing from soil in the drums. The tanks are owned by the City of Shageluk, but most appeared to be inactive. There are three grey fuel tanks in a lined earthen berm that contained several inches of water. Approximately 130 feet south were two additional tanks (red and grey) that were also in a lined earthen berm. Additionally the site includes an old fire truck and a dilapidated shed filled with paint, corrosives, lead acid batteries, fluorescent lights, and flammable pressurized gases. The site also contains 120-150 empty, black plastic 55 gallon drums, all previously filled with salt water/brine that were removed from a “freezer building” around 2000. The drums acted as insulation to keep food cold all year long, in the days before electrical refrigeration had arrived in the village. There are also large chunks of building insulation, from the freezer building. It is located a little over 10 feet to the bank of the Innoko River. The grey and red tanks are approximately 5 feet from the Innoko River, on a bank that shows signs of erosion and the other tanks are approximately 10 feet from the Innoko River.
