Alaska Department Environmental Conservation (ADEC) Solid Waste Program (Trisha Bower, Sandra Woods, and Rebecca Colvin) conducted a Coastal Impact Assistance Program (CIAP), Waste Erosion Assessment and Review (WEAR) site visit for the Village of Shaktoolik, September 14th, 2012. Jolene Auliye, IGAP Coordinator and Edgar Jackson Jr., Landfill Operator helped coordinate our visit. The following narrative is a brief description of our findings during the September inspection.

WEAR Sites

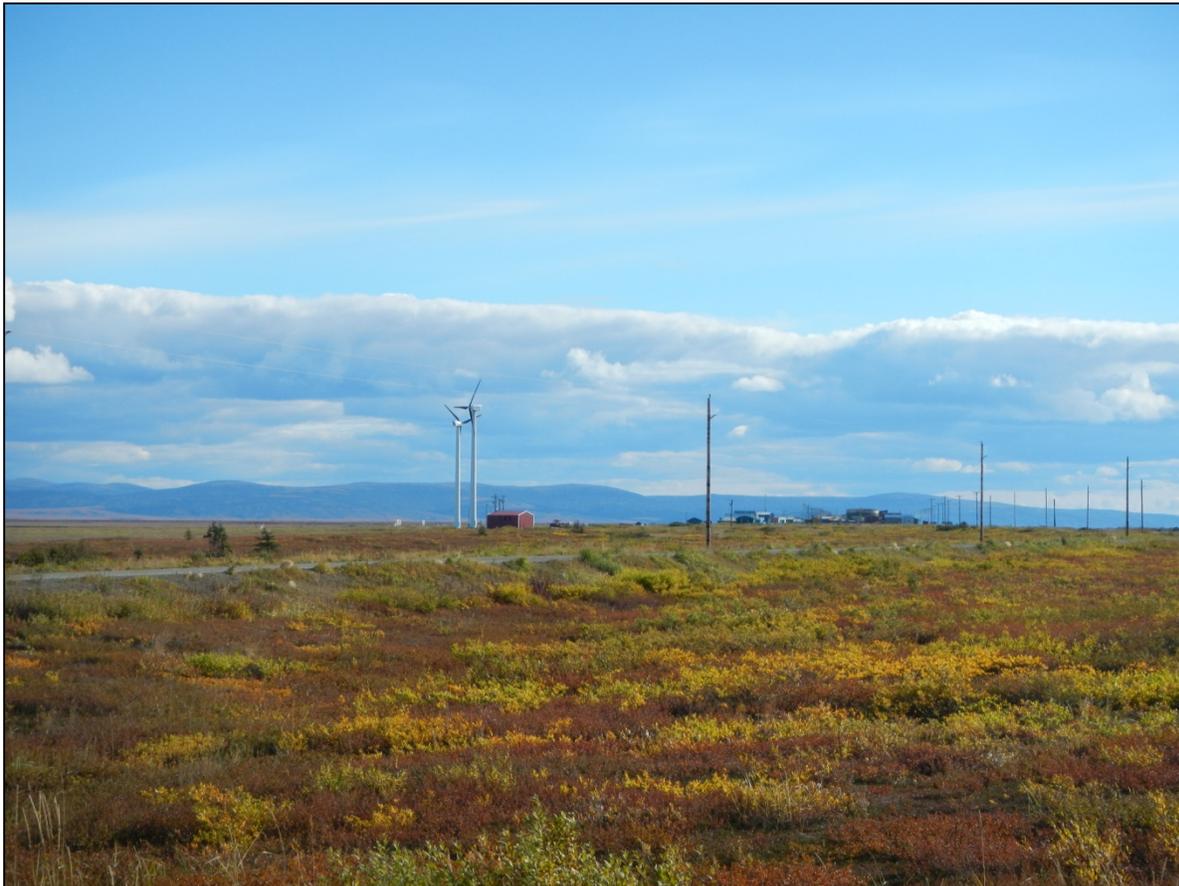
- **ADOT & PF Airport Building, 64.36598/-161.215839 (Closed)** – The ADOT&PF Airport Building is a closed Contaminated Site (File ID 620.38.001). The gravel and underlying soil beneath the concrete slab foundation is contaminated. As the contamination is completely covered by the existing building, the site is considered closed unless new information becomes available that indicates the contamination may pose a threat to human health or the environment. This site is located between 2 water bodies, approximately 500 feet from the Norton Sound and 1,050 feet from Shaktoolik Bay. It was reported the beach experiences considerable erosion during storm surges. The community has an evacuation road in the event of a severe storm.

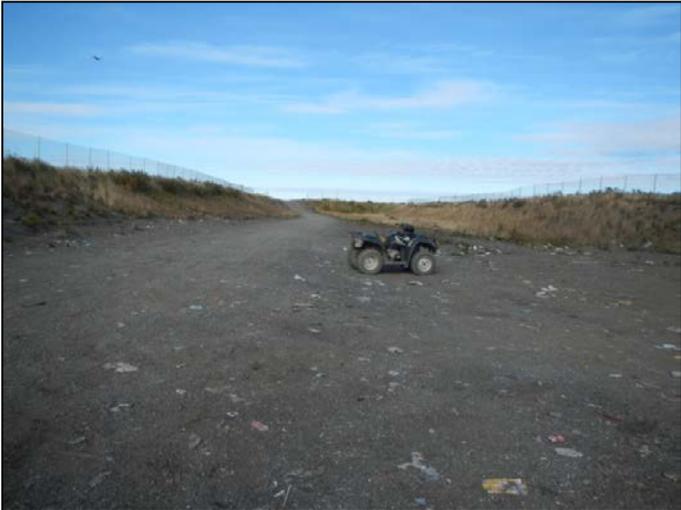
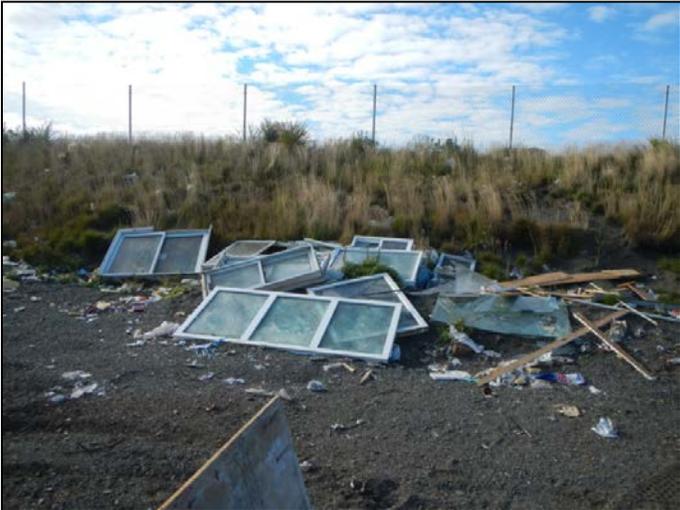
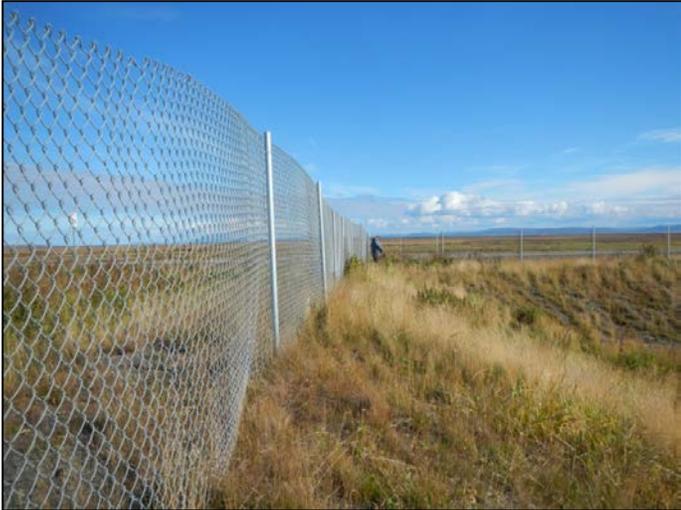
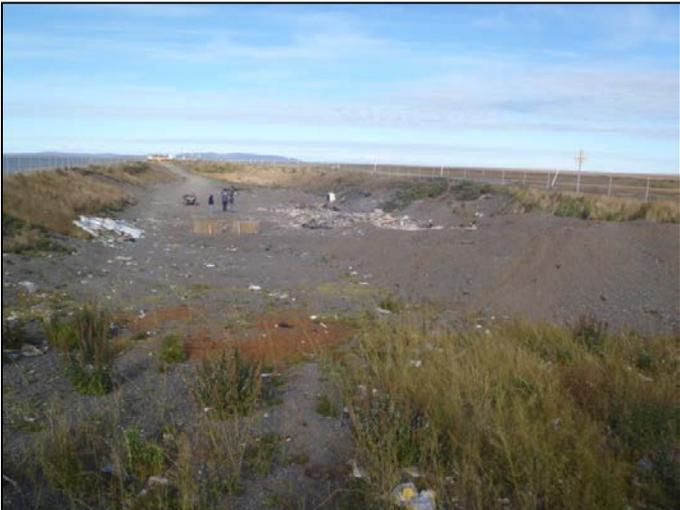
➤ **Landfill, 64.344206/-161.176747 (Active)** — The landfill is a fenced trench and fill landfill and was constructed within the last 5 years. There is currently a part-time Landfill Operator to manage the landfill and so there is adequate waste separation and diversion. There is a voluntary collection program in Shaktoolik, but the majority of the community’s waste is brought to the landfill by self-haulers. The current IGAP Program staff collect and recycle/backhaul fluorescent lights, aluminum cans, used oil, household batteries, lead acid batteries, and scrap metal diverting it from the landfill. Shaktoolik has successfully backhauled over 15 shipping vans full of scrap metal out of the community over the past 2 years and is planning to continue this program in 2013. This site is located between two water bodies: the Norton Sound is approximately 65 feet to the west and the Tagoomenik River is approximately 275 feet to the east.

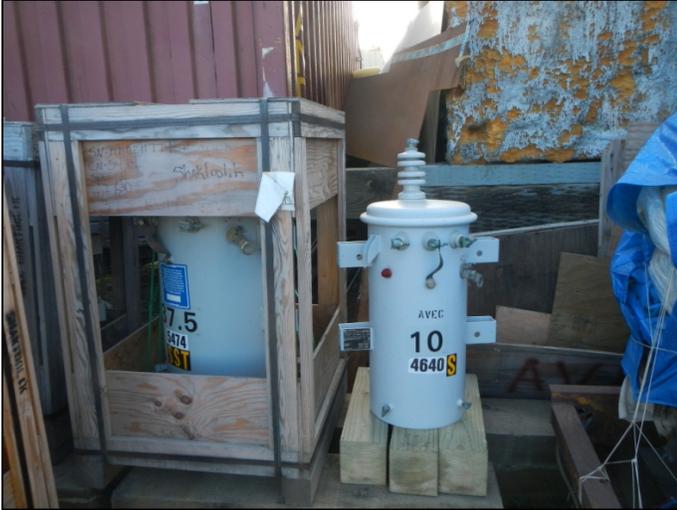
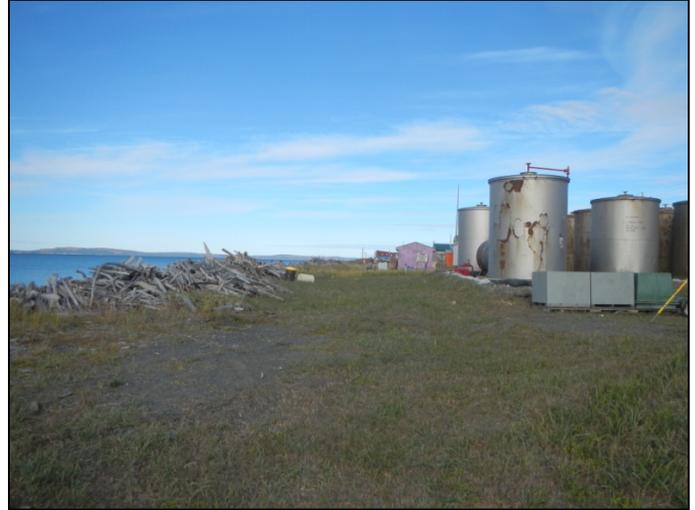
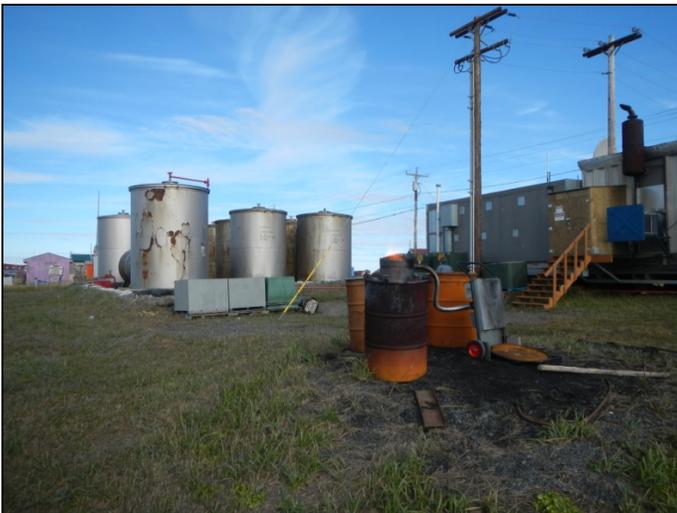
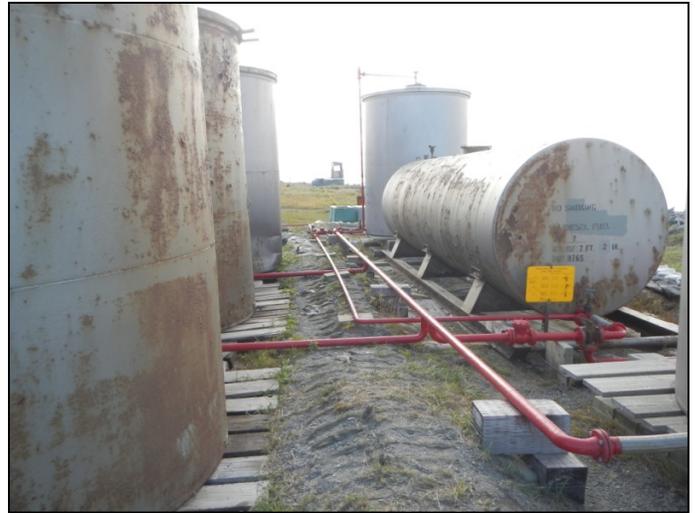
- **Tank Farm, 64.350809/ -161.188927 (Active)** – The current tank farm is located approximately 500 feet from the Norton Sound and .528 feet from Shaktoolik Bay. It consists of 8 vertical, diesel tanks (capacity less than 10,000 gallons each) and 1 horizontal, diesel tank (9,765 gallons). The site is within a lined, earthen berm. The US Army Corps of Engineers 2009 study Alaska Baseline Erosion Assessment stated driftwood was deposited only a few feet from this site after a 2005 storm.

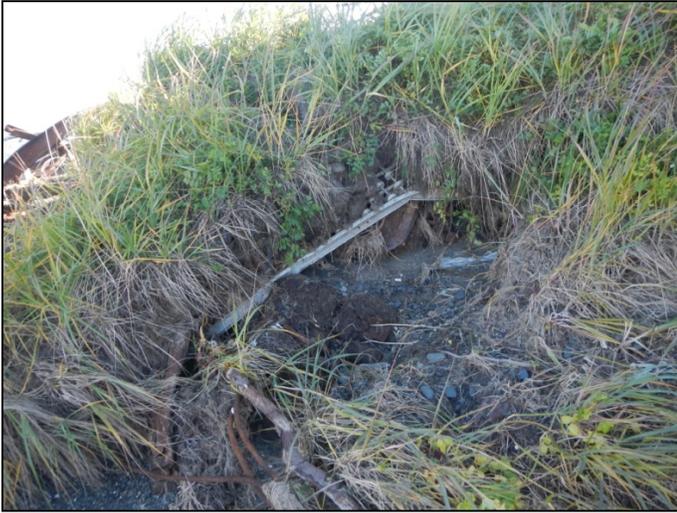
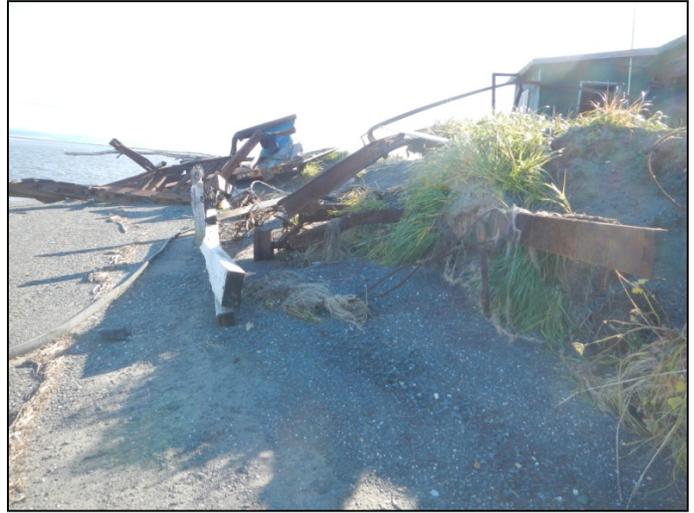
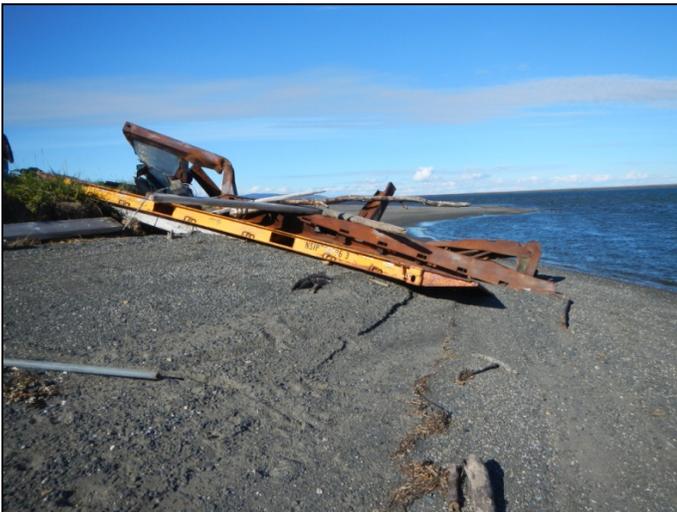
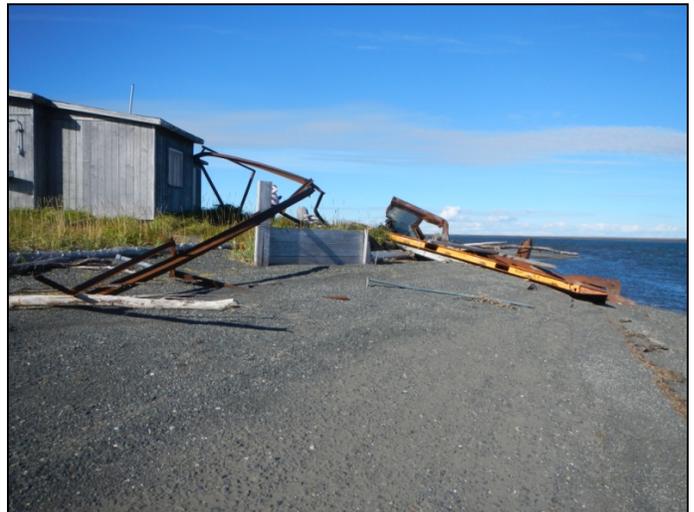
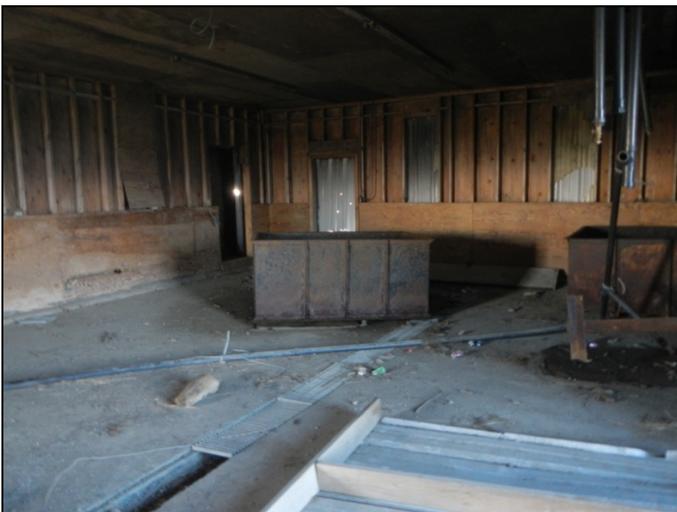
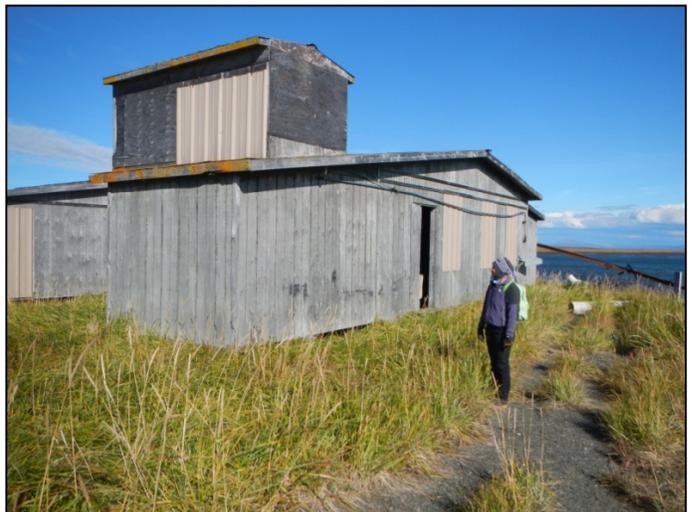
- **Fish Processing Plant, 64.375561/-161.222491 (Abandoned)** – An abandoned fish processing plant is located 10 feet from the Shaktoolik Bay and is actively eroding into the river. The building has been stripped of any metal of value and interior components so that only the structure remains. The building should be removed as it is a navigation hazard and could impact subsistence gathering.

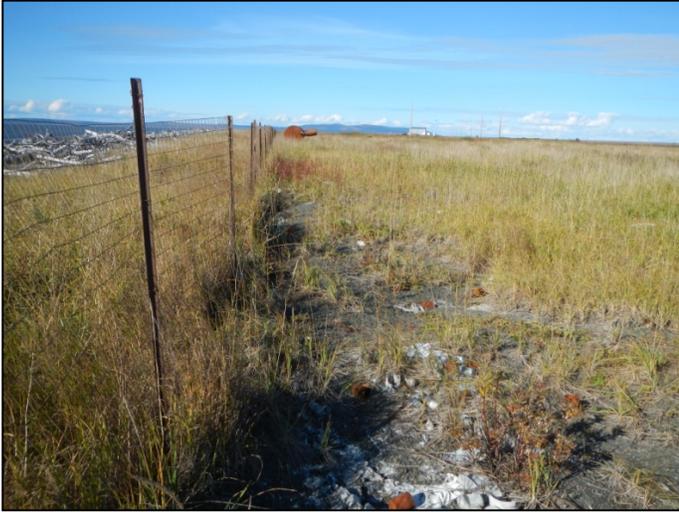
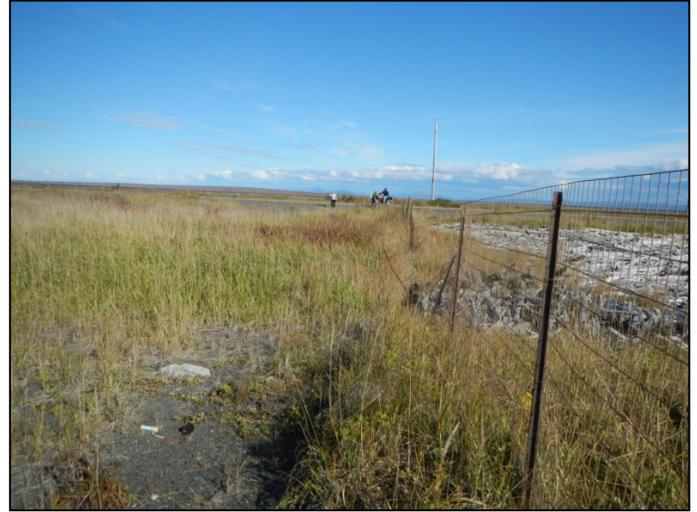
- **Closed Landfill, 64.361536/-161.210919 (Closed)** – The closed Shaktoolik landfill operated for over 10 years and received municipal solid waste, special wastes, and construction and demolition wastes. This landfill was closed and covered with gravel and sand within the last 5 years. The closed landfill is adequately vegetated. The Norton Sound is approximately 35 feet to the west and Shaktoolik Bay is approximately 1,475 feet east of the closed Shaktoolik landfill.
