The 5,878 ton *Princess Kathleen*, built by John Brown & Co. of Glasgow, Scotland, launched in 1924.

Princess Kathleen Unified Command - 2010

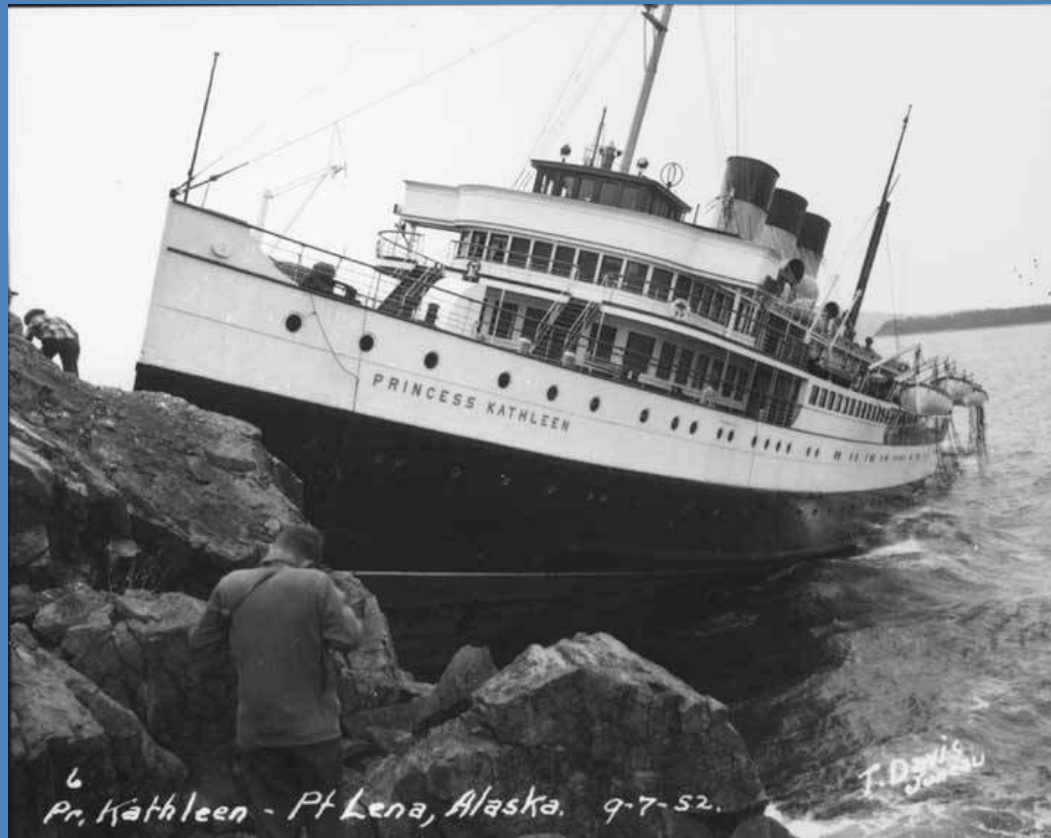
The Princess Kathleen grounded at Point Lena at 2:58 AM on September 7, 1952.

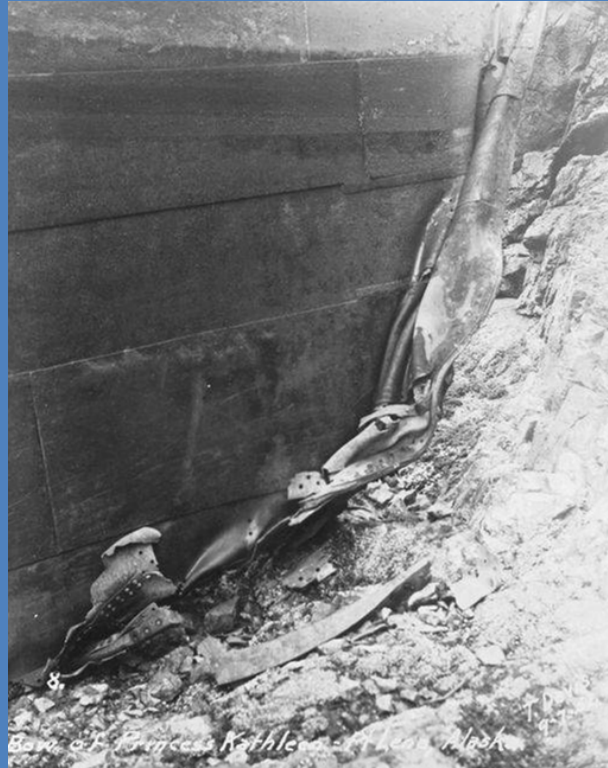
After assessing damage to the bow, the Captain attempted to back the ship off the rocks, but was unable to move the *Princess Kathleen*.

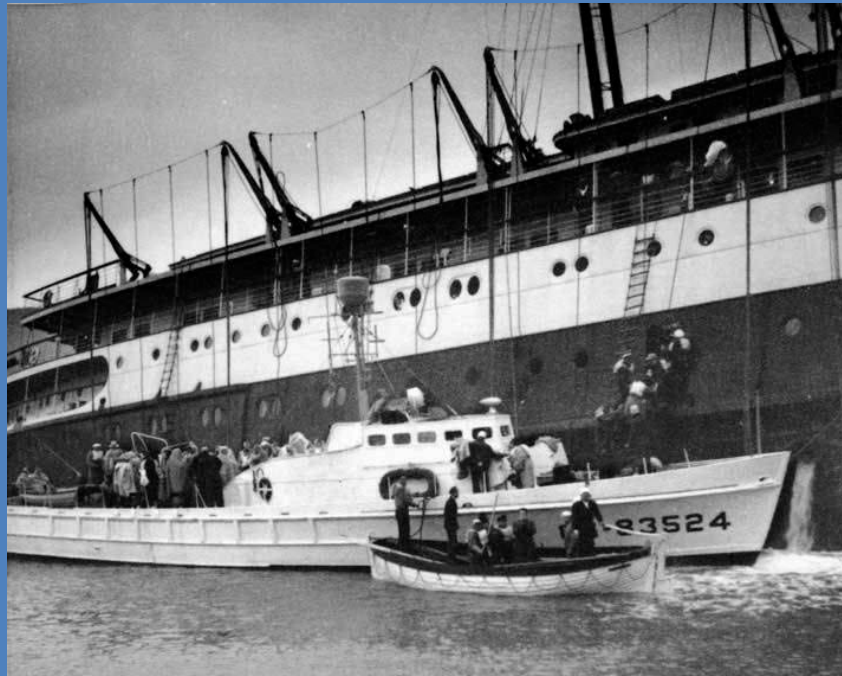
As the tide fell, the vessel took on a list and the wind increased driving the stern against the rocks. By 5:30 AM the list was 19 degrees and the captain evacuated the passengers. By 9:00 AM all 307 passengers had safely disembarked.

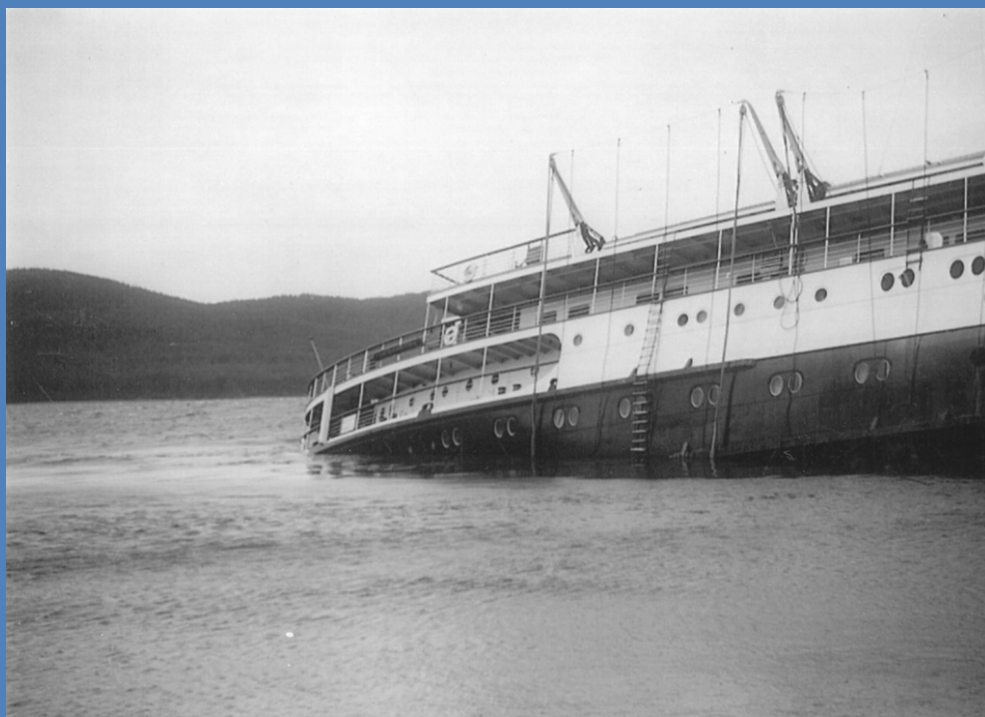
The stern of the *Princess Kathleen* started to flood with the incoming tide. With the bow still on the rocks the vessel flooded further until, at 11:30 AM, the captain and crew abandoned ship.

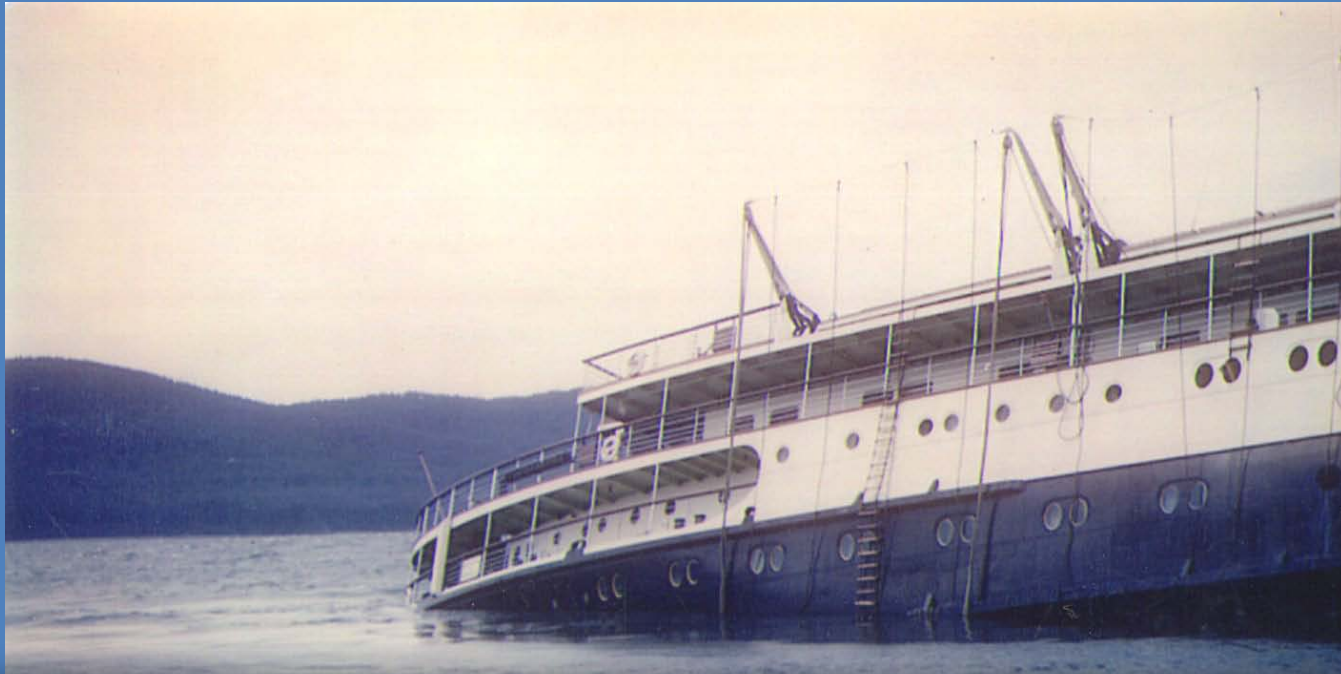
At 12:30 PM, almost 10 hours after the grounding, *Princess Kathleen* slid from Point Lena.

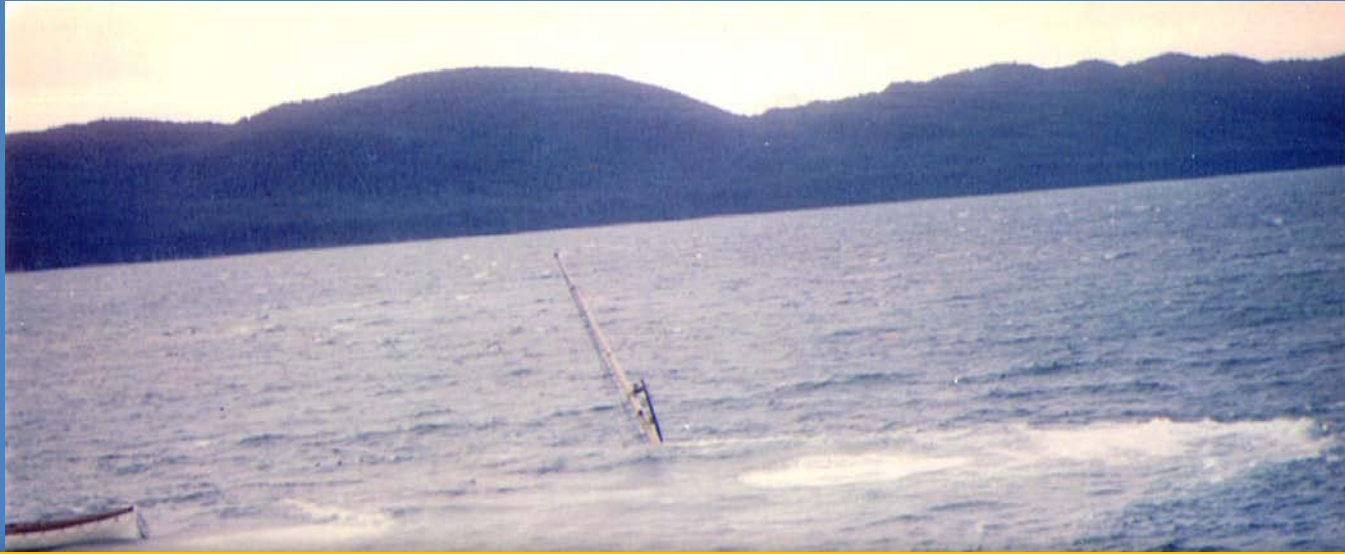
The stern now rests in approximately 140 feet of water, the bow in 40 feet. The depth of water, location of the wreck and age of *Princess Kathleen* made salvage too difficult and costly. Public perception at the time was fuel didn't represent a serious risk to the environment. No fuel recovery or cleanup operations were mounted.

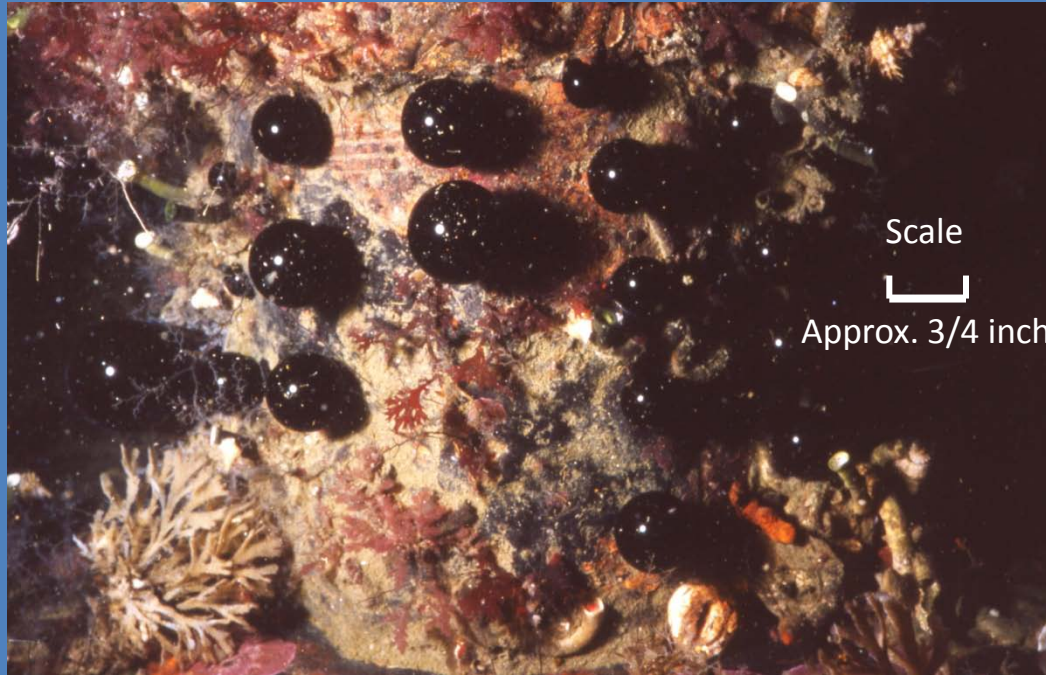
Marble sized collections of bunker oil leak from a threaded pipe.

Recreational divers note and document small quantities of oil leaking from *Princess Kathleen*. Oil discharge is limited to a single location.

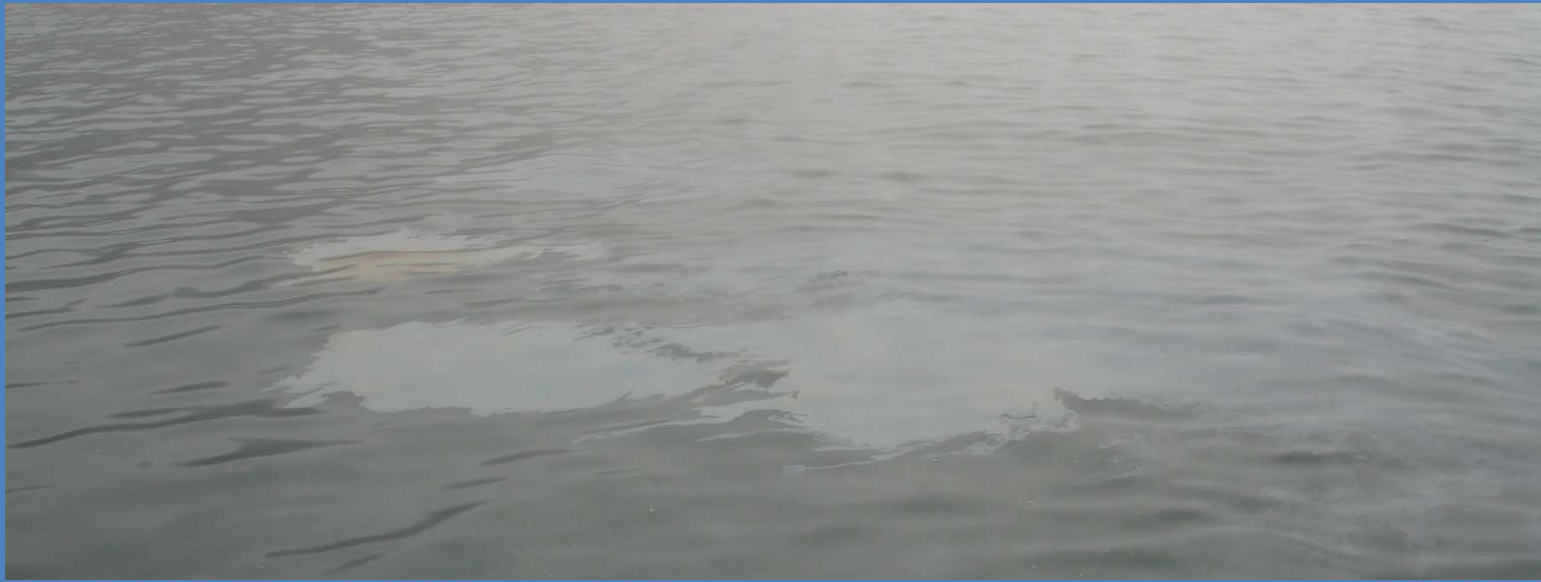
Reports to Department of Environmental Conservation and Coast Guard of non-recoverable oil discharges and rainbow sheens increase. There are occasional reports of small “tar balls” on beaches around Point Lena.

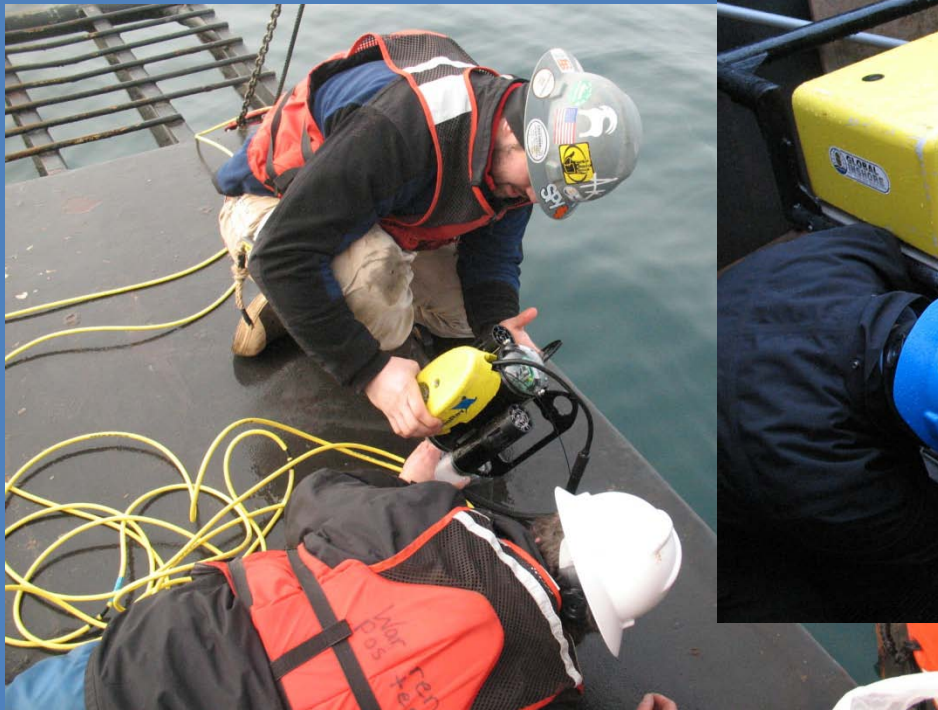
Both photos taken by USCG – Sector Juneau

The Coast Guard contracted with Global Offshore Divers to conduct an assessment on *Princess Kathleen* using Remotely Operated Vehicles (ROVs).

The initial Remote Operated Vehicle (ROV) assessment documented oil escaping from the interior of the vessel via broken port holes during certain tide cycles.

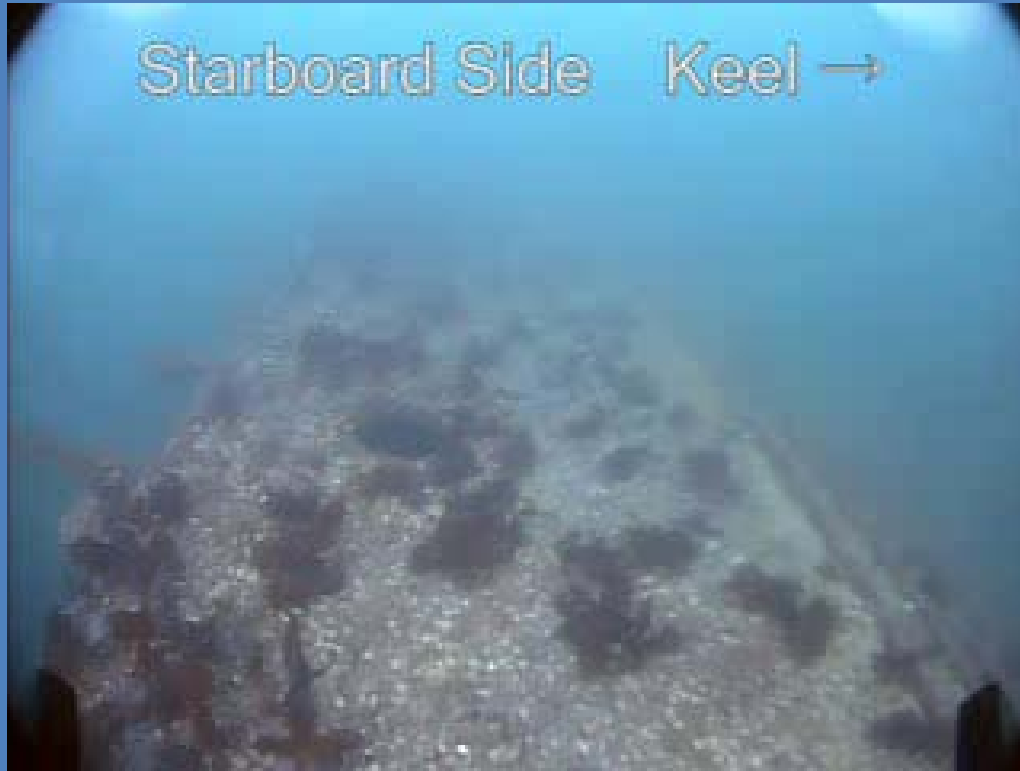
Starboard Side Keel →

The Remote Operated Vehicles (ROVs) assessed the starboard side of *Princess Kathleen*, the port side is laying against the seafloor prohibiting ROV access.

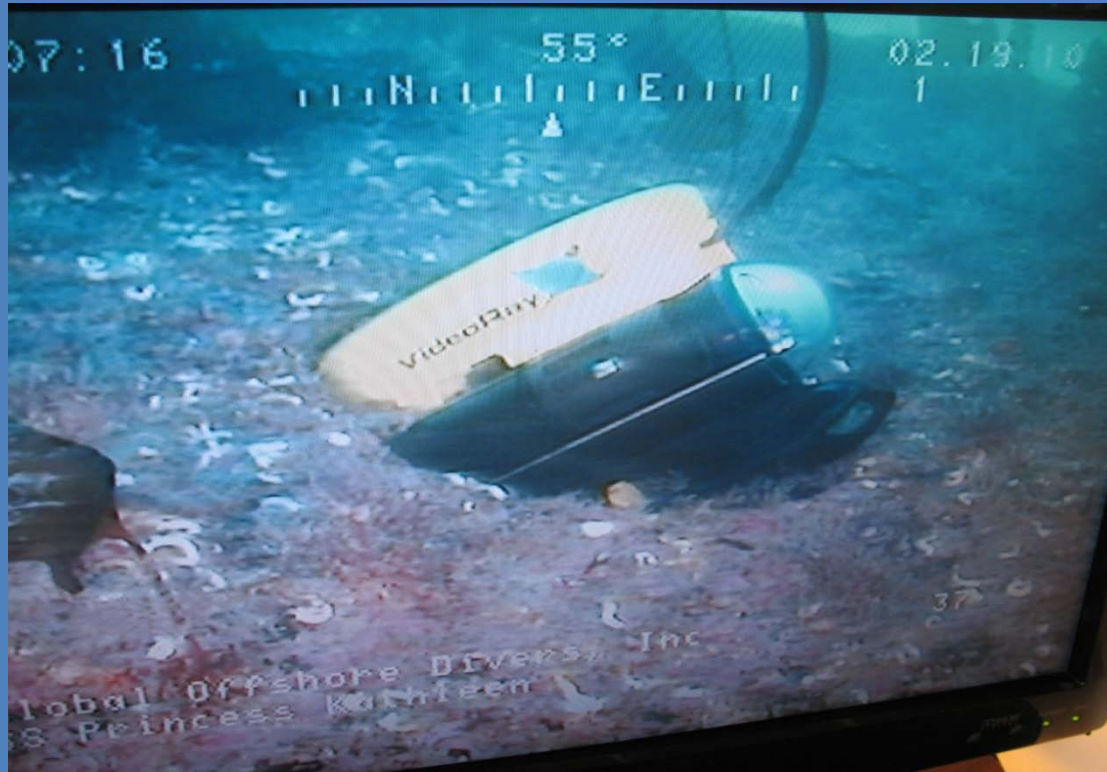
The Remote Operated Vehicles (ROVs) were unable to enter *Princess Kathleen*, but the mini-ROV was able to record video while looking inside the open portholes and open doorways.
