ALASKA DEPARTMENT OF ENVIRONMENTAL CONSERVATION
Division of Spill Prevention and Response
Prevention Preparedness and Response Program
SITUATION REPORT (SITREP)

F/V *Masonic* Grounding Spanish Islands

SITREP #: 2

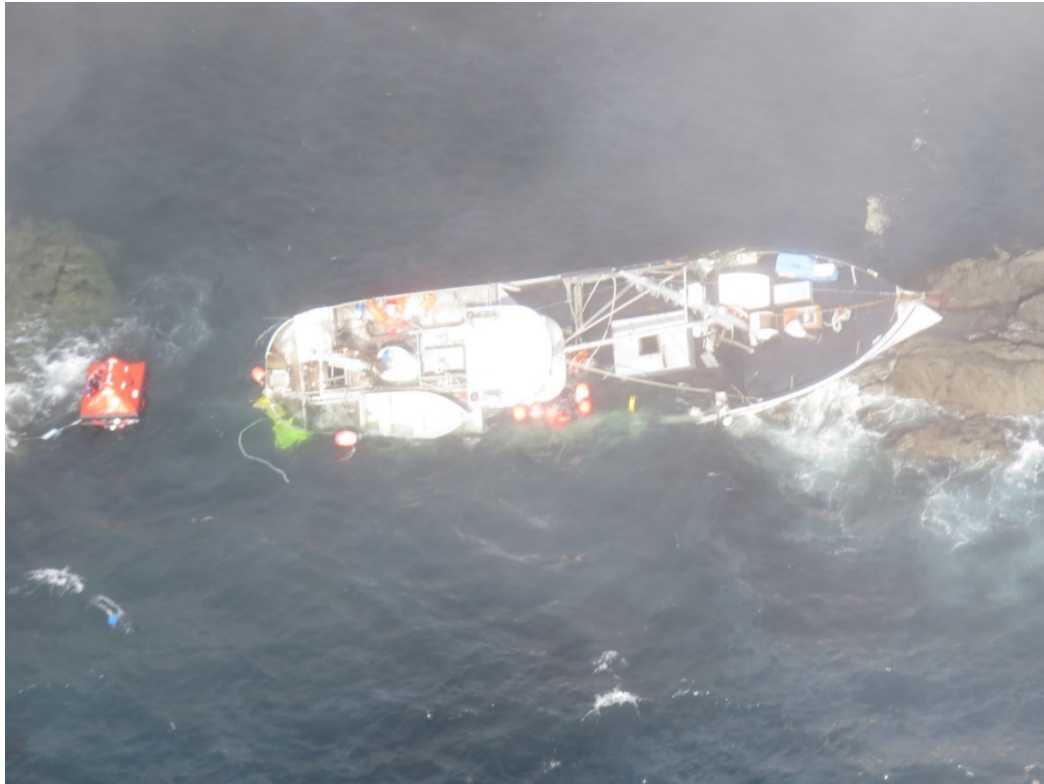
The F/V Masonic as seen from an overflight. May 9, 2019. Photo: USCG Air Station Sitka.

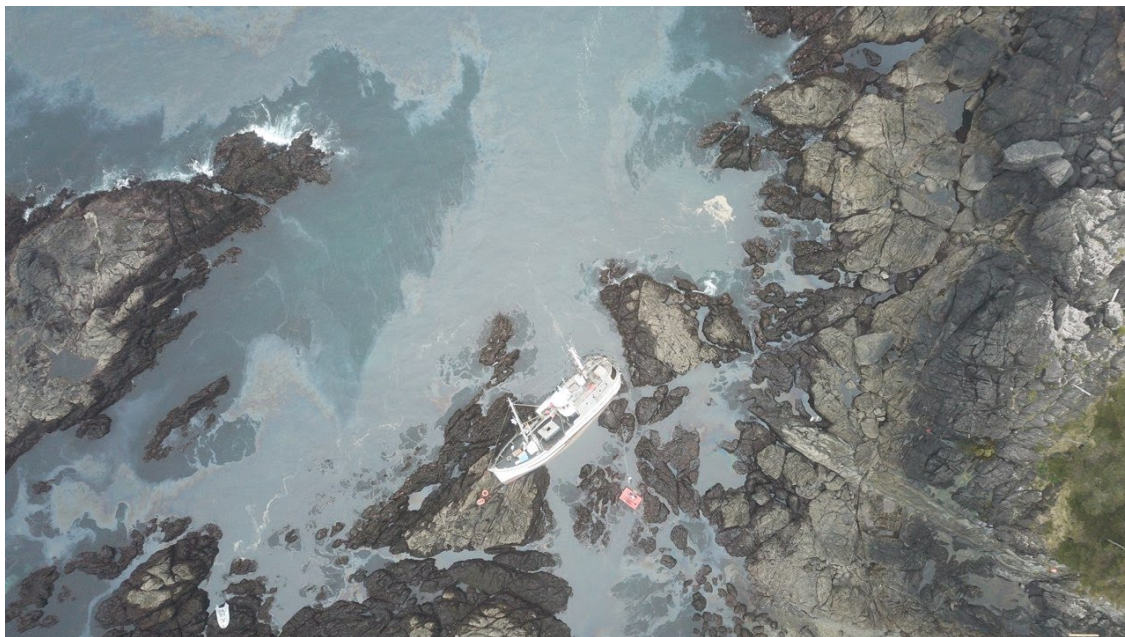
TYPE/AMOUNT OF POTENTIAL PRODUCT SPILLED: The PRP estimates that there is 2,000 gallons of diesel and 150 gallons of lubricant oils onboard. **A release was observed by personnel on shore and also through drone photos. At this time, the quantity of the release is unknown.**

Drone photo of the F/V Masonic and associated sheen. May 10, 2019. Photo: Hanson Maritime.

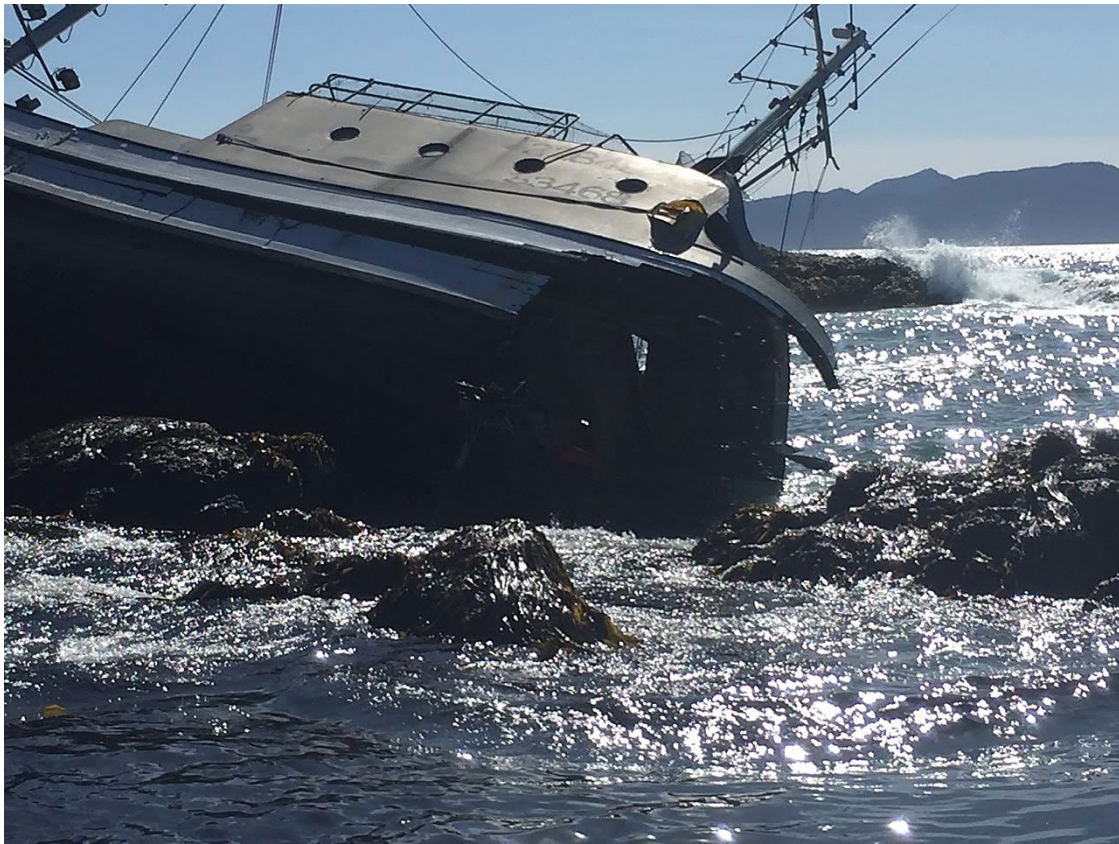
The F/V *Masonic* at low tide. The stern and decks have experienced significant damage over the past few days. May 12, 2019. Photo: *Hanson Maritime*.

FUTURE PLANS AND RECOMMENDATIONS: The recovery efforts are moving towards salvage based on the deterioration of the vessel and safety concerns. However, there is focus on inventorying the remaining pollution sources and mitigating any further releases.
