Campbell Lake Tributary Water Quality Investigation

July 2012 through June 2013

Prepared for the Alaska Department of Environmental Conservation

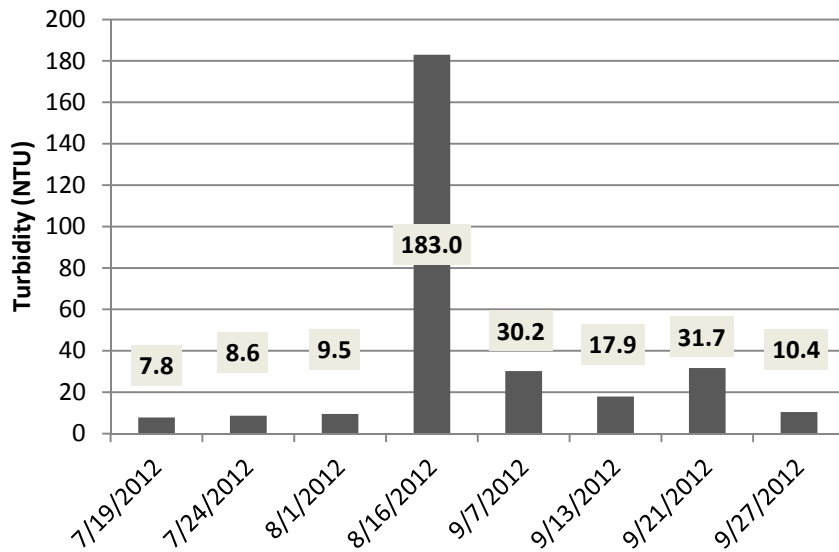
Figure 3. Turbidity downstream from Victor Road on sampling dates during the summer and fall of 2012.

Stream water turbidity was consistently high in Campbell Lake Tributary and often exhibited extremely high values. Stream water turbidity from water samples collected below Victor Road near Campbell Lake on all sampling dates are shown in Figures 1 and 2. Turbidity was > 5 NTU on all sampling dates (100 %), 73% of the samples were > 10 NTU, and 20% of the samples were > 100 NTU. The natural conditions for turbidity in this stream were not measured, therefore we could not evaluate compliance with WQS. However, based on our 20 years of experience sampling streams with Southcentral Alaska, turbidity in non-glacial streams is less than 5 NTU, except during high spring and storm flows. The highest turbidity measurements occurred on August 16, 2012, and February 14 and June 24, 2013. Stream flow was not measured on February 14 or June 24.

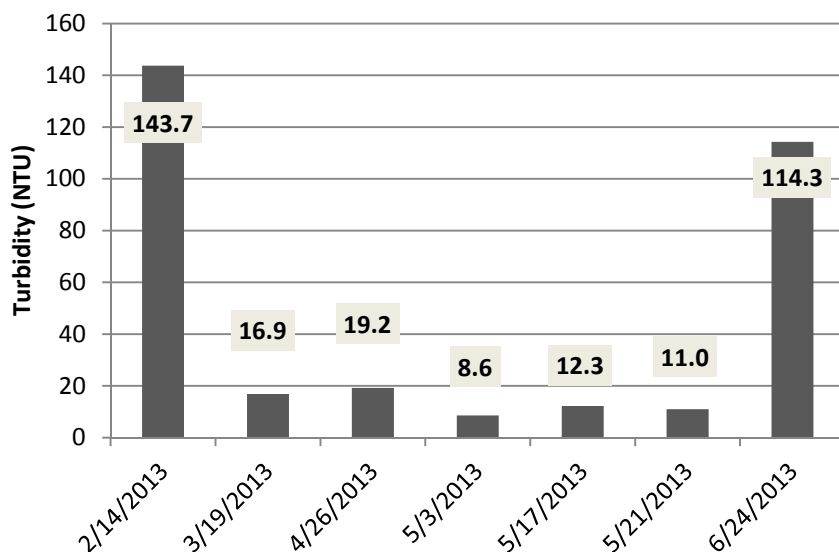
Figure 4. Turbidity downstream from Victor Road during winter and spring of 2013.

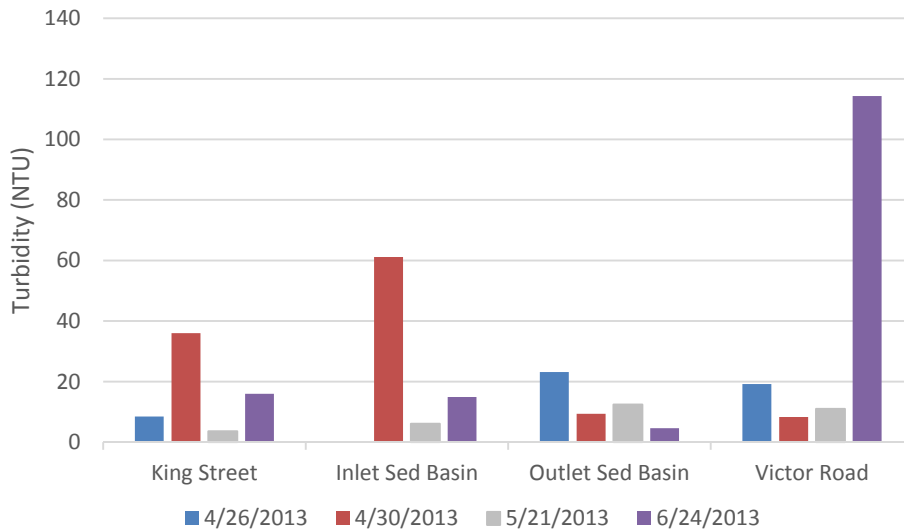
Figure 5. Turbidity in Campbell Lake Tributary on 4 dates from King Street to Victor Road.

Testing the effectiveness of the C street sediment basin was not a study objective. However, the high turbidity measured at our sampling locations lead to increased sample collection upstream on 4 dates during the spring of 2013 (Figure 5). On April 24, Turbidity increased from 8 NTU at King Street to 23 NTU below the sediment basin (sediment inlet was ice covered). Similarly, on May 21 turbidity increased from 6 NTU at the inlet to 12 NTU at the outlet of the sediment basin. However, on the other dates turbidity decreased from 60 to 9 NTU and from 14 to 4 NTU from the inlet to the outlet of the sediment basin. On June 24, turbidity was over 100 NTU at Victor Road, but less than 5 NTU at the outlet of the sediment basin upstream. Therefore, while the sediment basin does not appear to be effective under all conditions, the large increases in turbidity appear to be occurring due to inputs downstream.

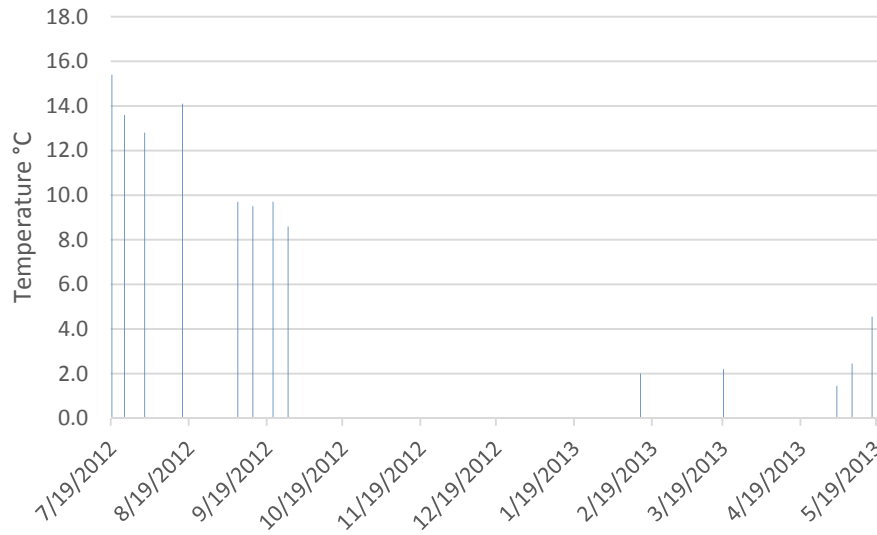
Figure 6. Stream water temperature on all sampling dates from July 2012 through June 2013.

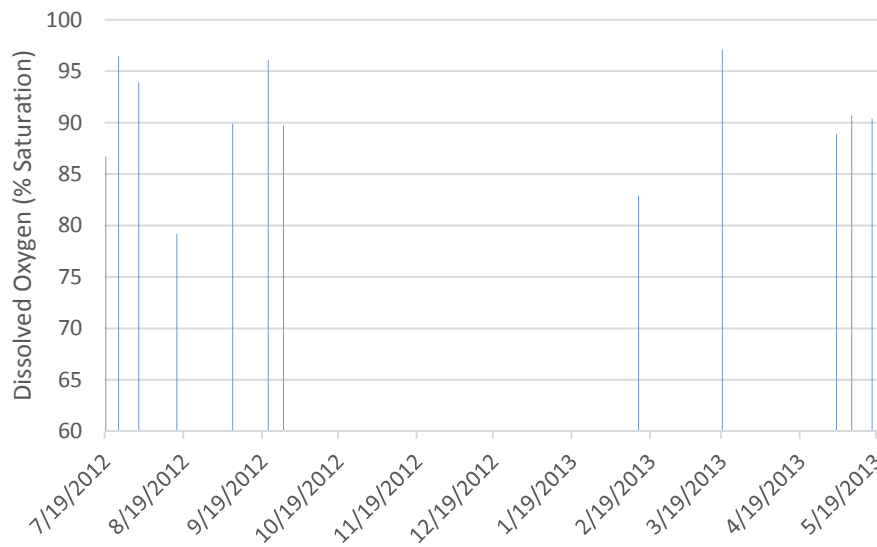
Figure 7. Dissolved oxygen as percent saturation for each sampling date showing relative low stream values below saturation.

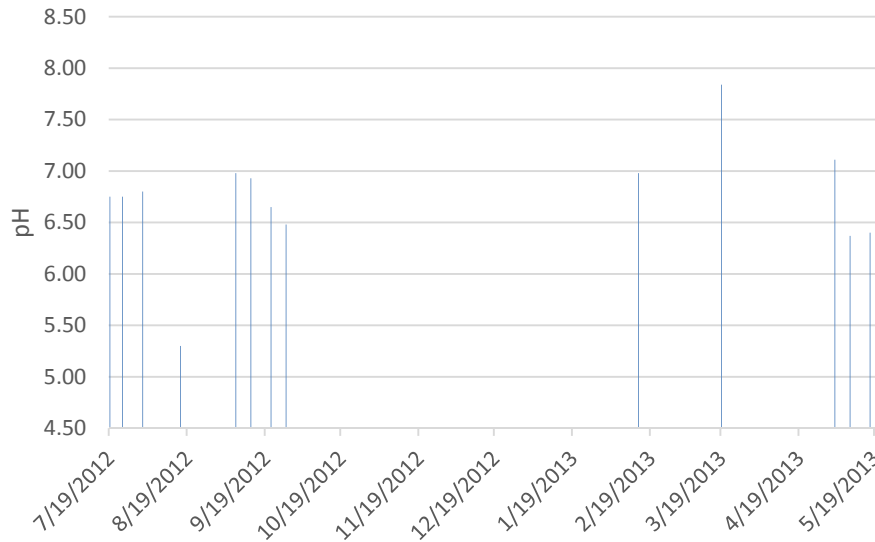
Figure 8. Stream water pH for all sampling dates showing value below neutral with extreme low values on some sampling dates. Stream water pH was higher during winter.

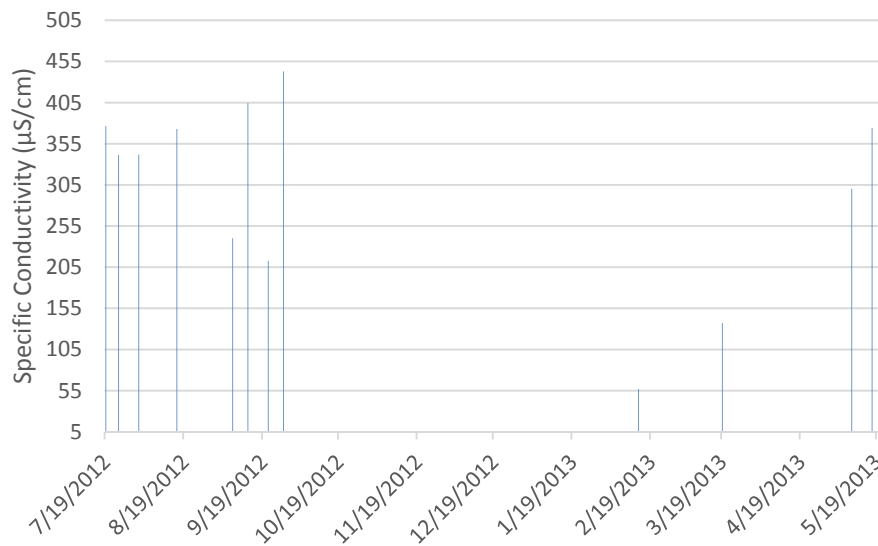
Figure 9. Specific conductivity on all sampling dates showing high concentrations of dissolved ions except during winter.

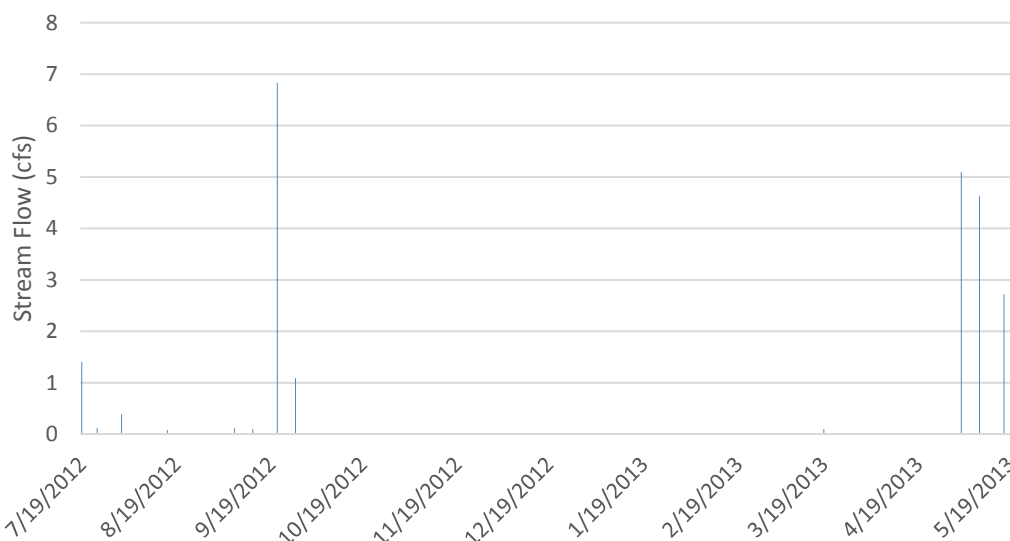
Figure 10. Stream flow as measured on each sampling date. Flows were much less than 1 cfs on most dates with the exception of a fall storm and during spring runoff.

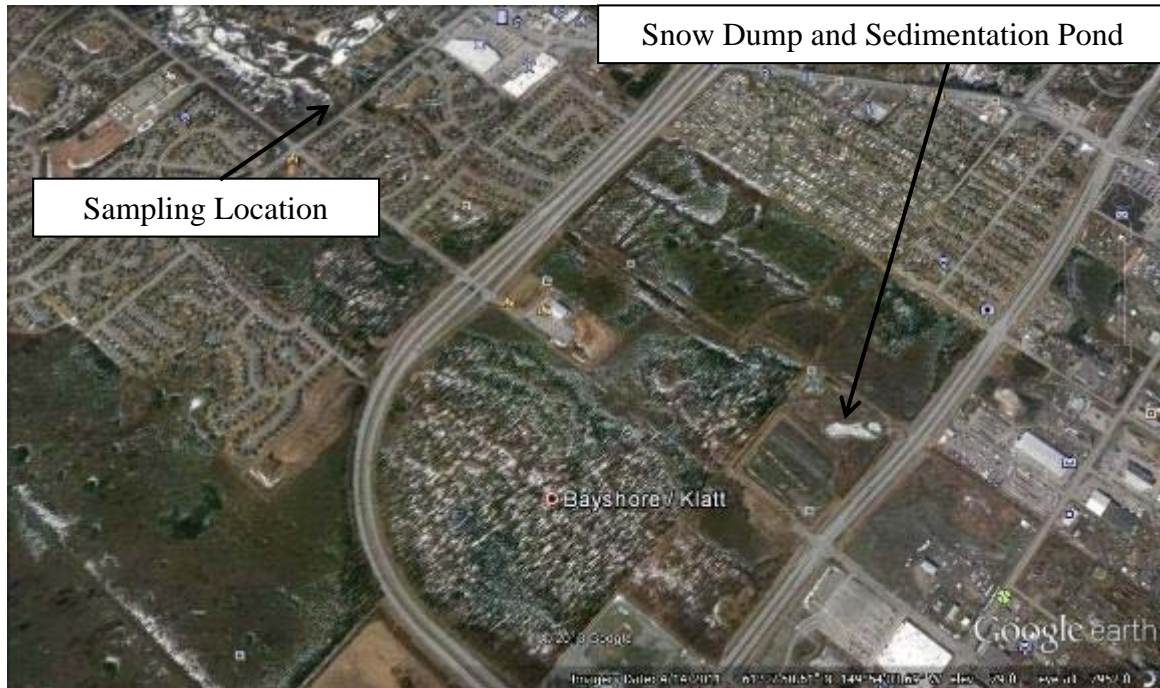
Photograph 1. Aerial view of Campbell Lake Tributary showing the location of the snow dump and sediment basin on the West side of C street and the sampling location on the West side of Victor Road. The tributary flows underground from the sediment basin to Victor Road.

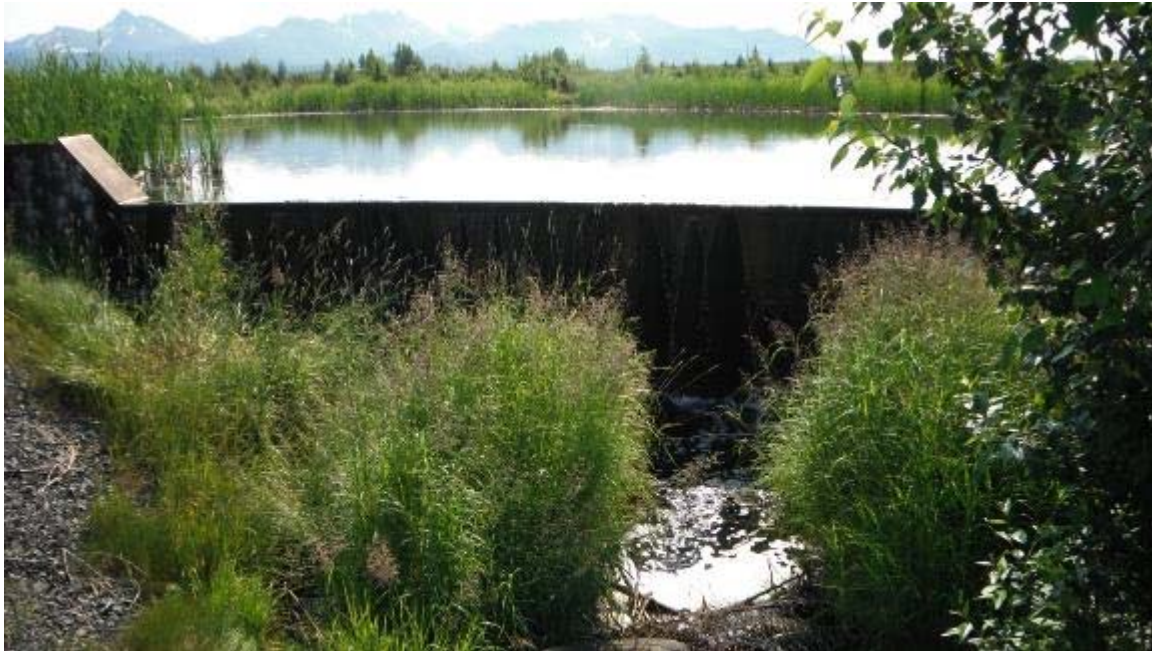
Photograph 6. Outlet C street sedimentation pond spillway on July 19, 2012. Campbell Lake tributary enters a culvert at this location and reemerges on the west side of Victor Road.

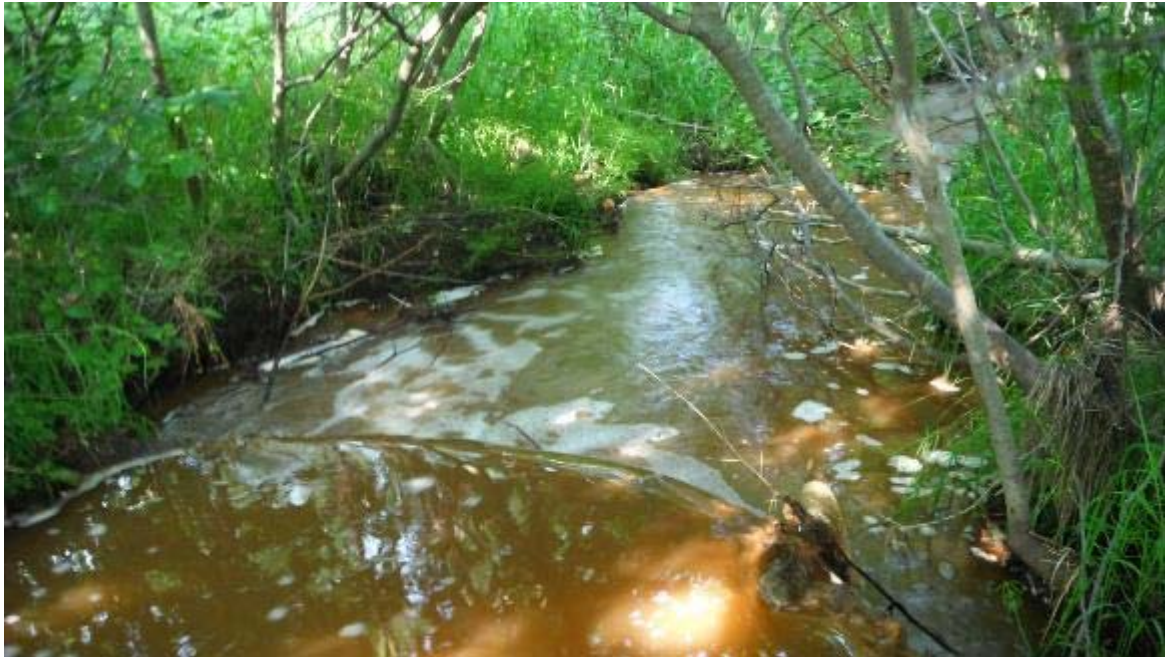
Photograph 8. Campbell Lake tributary on July 19, 2012, showing coir log check dam and turbid water (7.8 NTU).

Garbage and debris were observed in the stream on all sampling dates and there was a foam buildup on most dates at the Victor Road culvert outlet. There is a coir log check dam in the stream that was present on all sampling dates. This check dam serves no apparent purpose and should be removed. Garbage (plastic bags) was also present in the stream on most sampling dates.

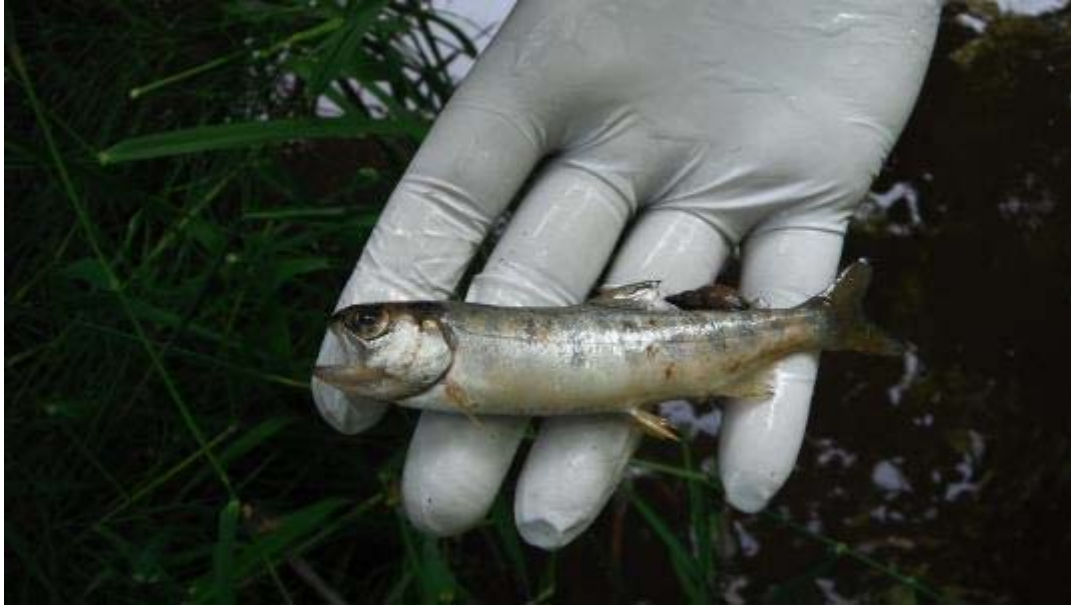
Photograph 10. Chinook salmon mortality from Campbell Lake tributary collected on July 19, 2012.

Dead or dying juvenile salmon were observed in the stream on multiple occasions. Dead Chinook salmon juveniles were submitted to the ADFG fish pathology laboratory for evaluation. Pathological findings were not conclusive; however, a brown film was observed on fish gills consistent with oxidized iron precipitate (Phippen et al. 2008, see Appendix B for ADFG reports).

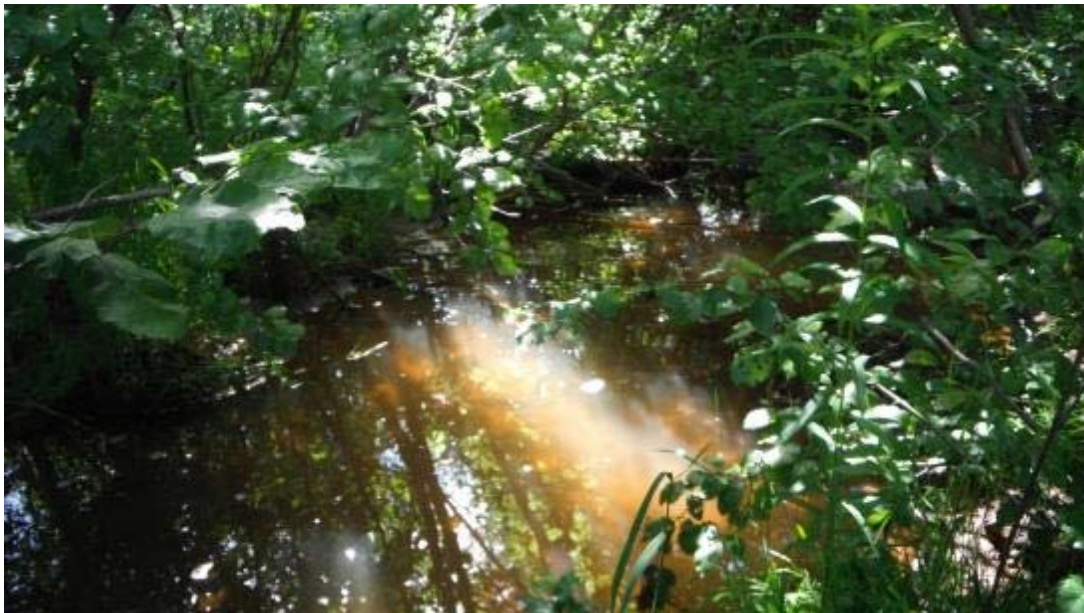
Photograph 11. Sampling site downstream from Victor Road on July 24. Turbidity was 8.62 NTU

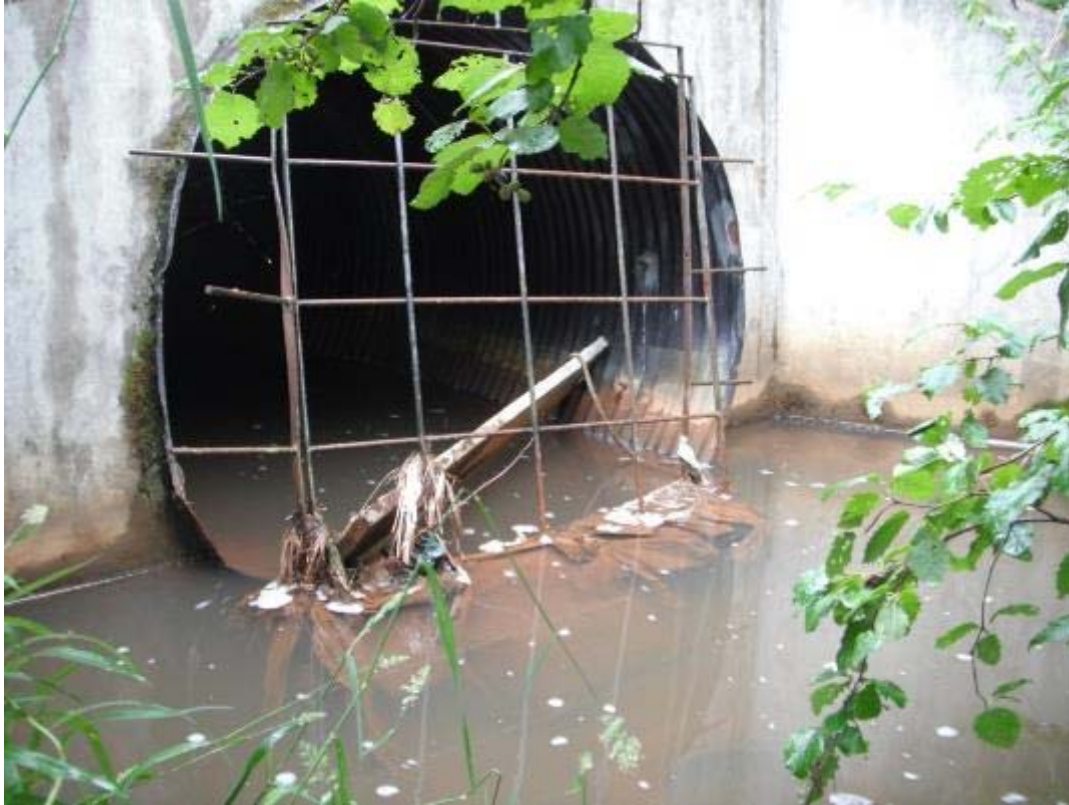
Photograph 12. Outlet of Victor Road culvert on August 1, 2012. Turbidity was 9.51 NTU.

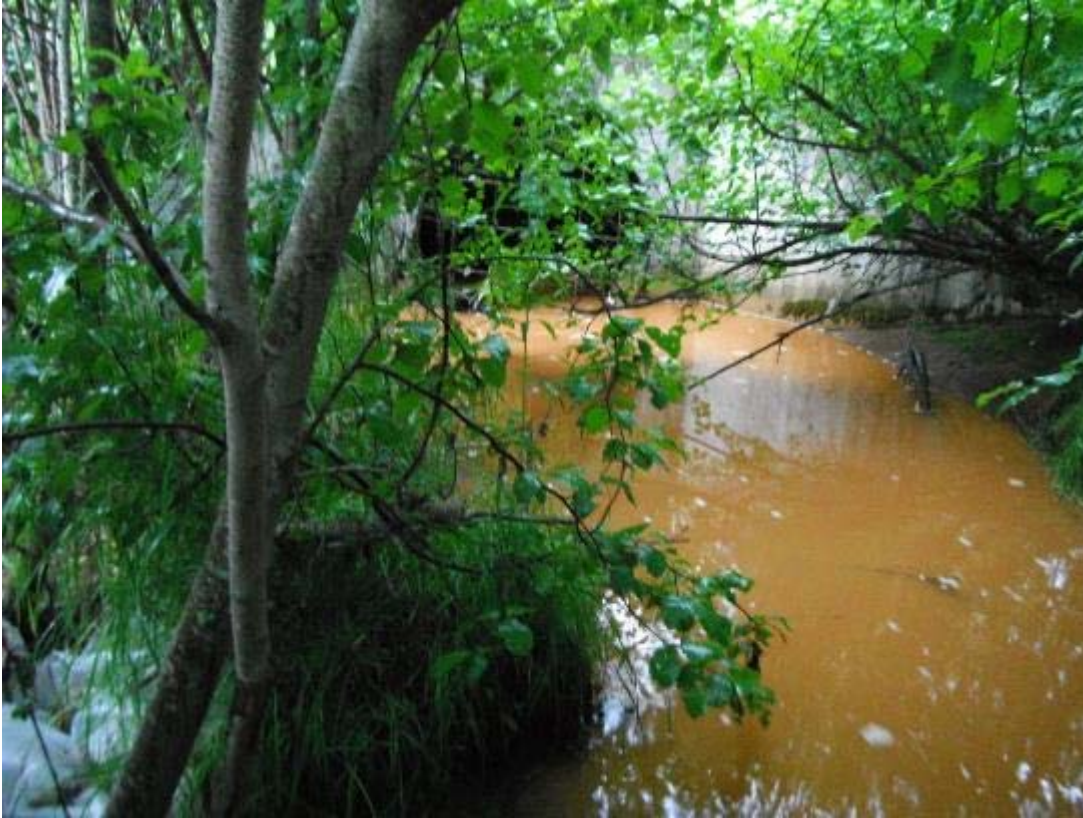
Photograph 13. Outlet of Victor Road Culvert on August 16, 2012. Turbidity was 183 NTU.

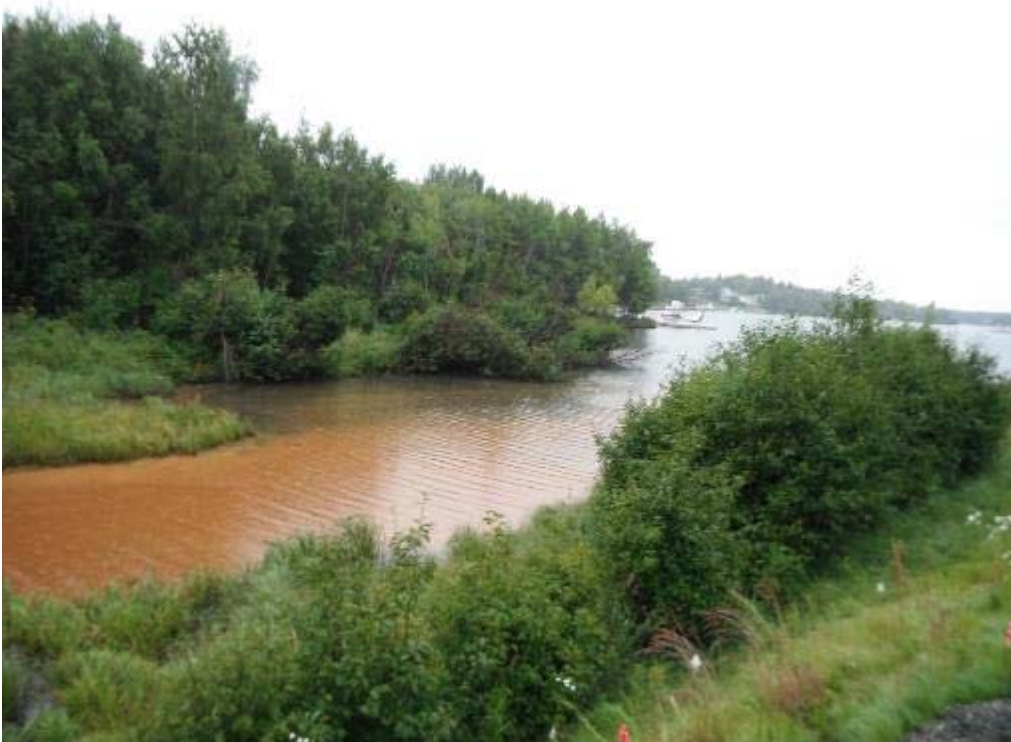
Photograph 14. Plume of turbid water entering Campbell Lake on August 16, 2012.

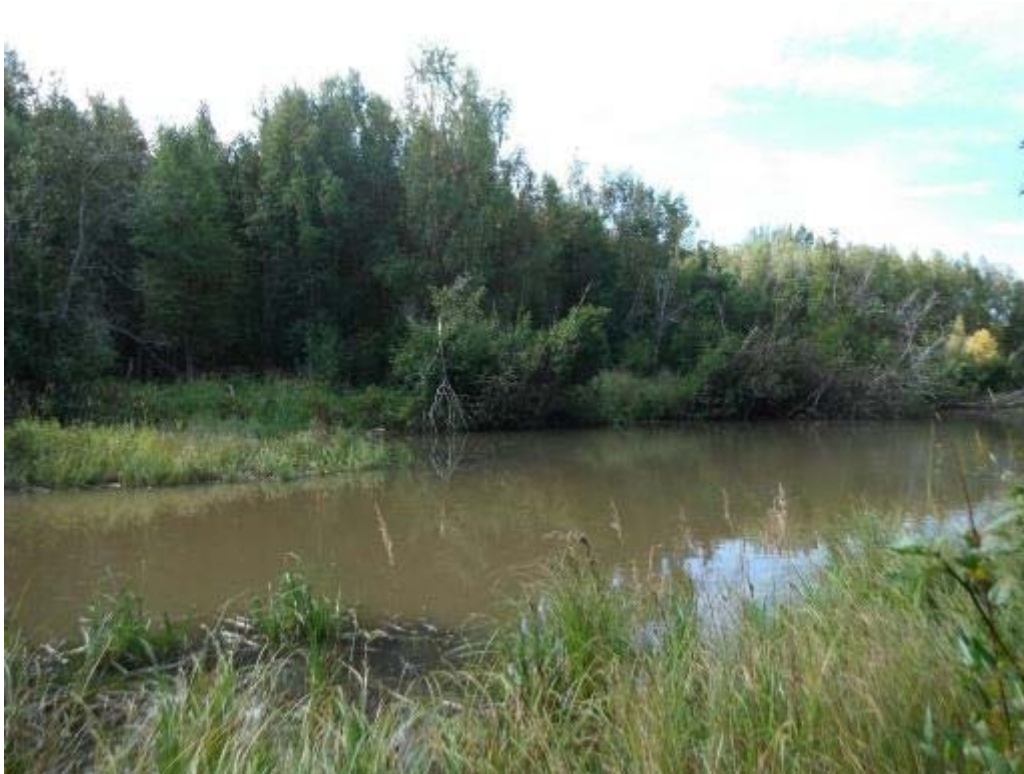
Photograph 15. September 7, 2012. Turbidity 30.2 NTU

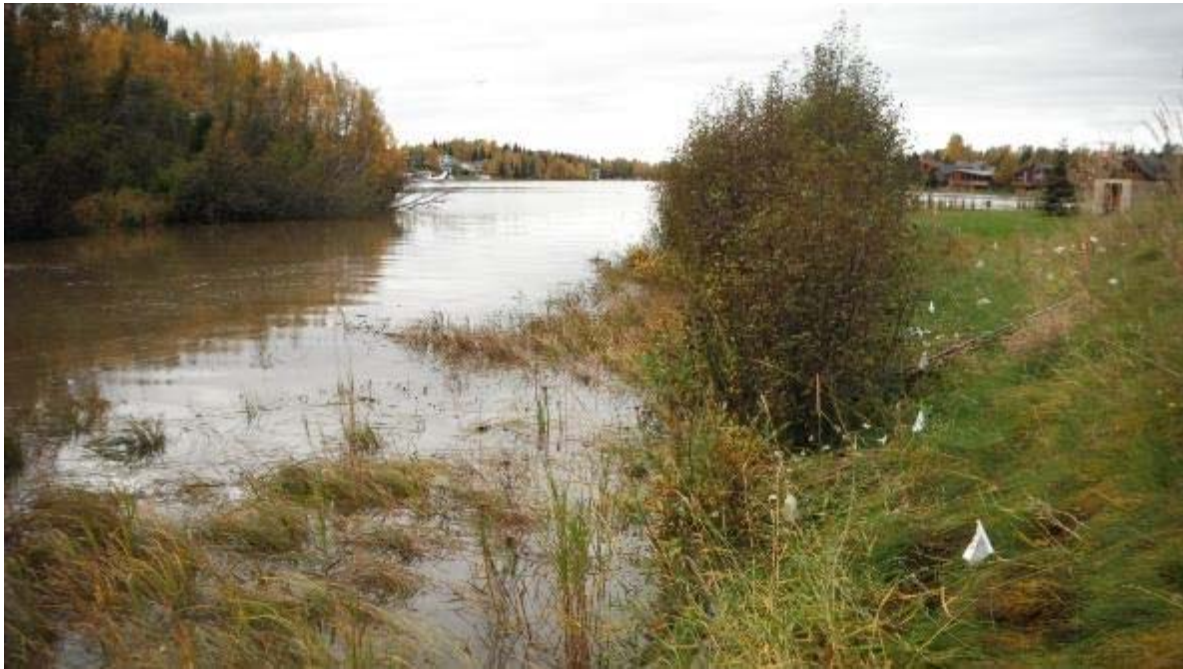
Photograph 17. Mouth of Campbell Lake Tributary on September 21, 2012. Turbidity was 31.7 NTU.

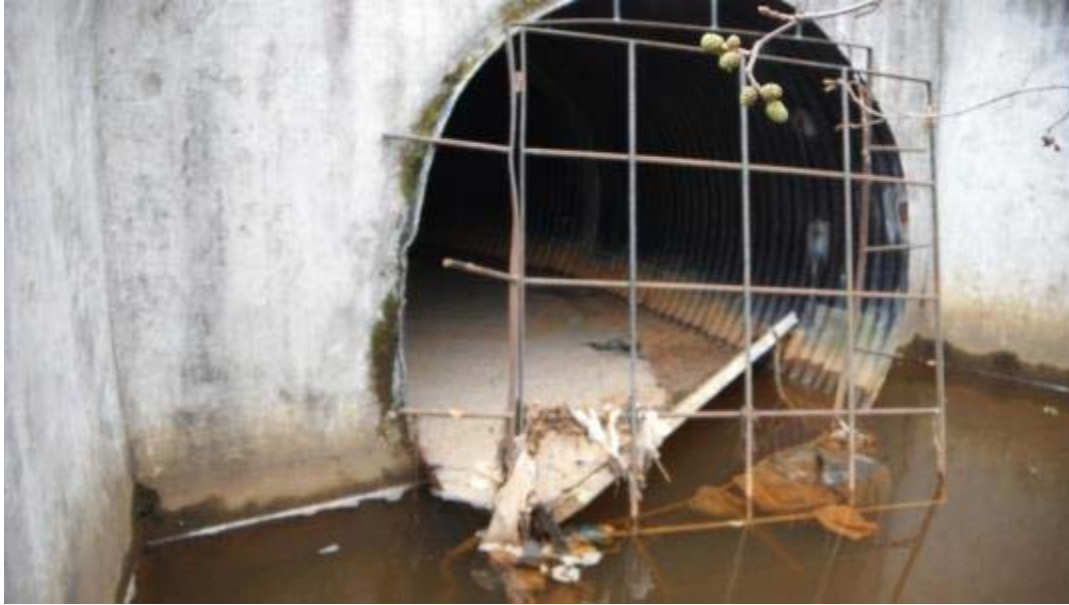
Photograph 19. Foam and debris at Victor Road culvert outlet on September 27, 2012. Turbidity was 10.4 NTU.

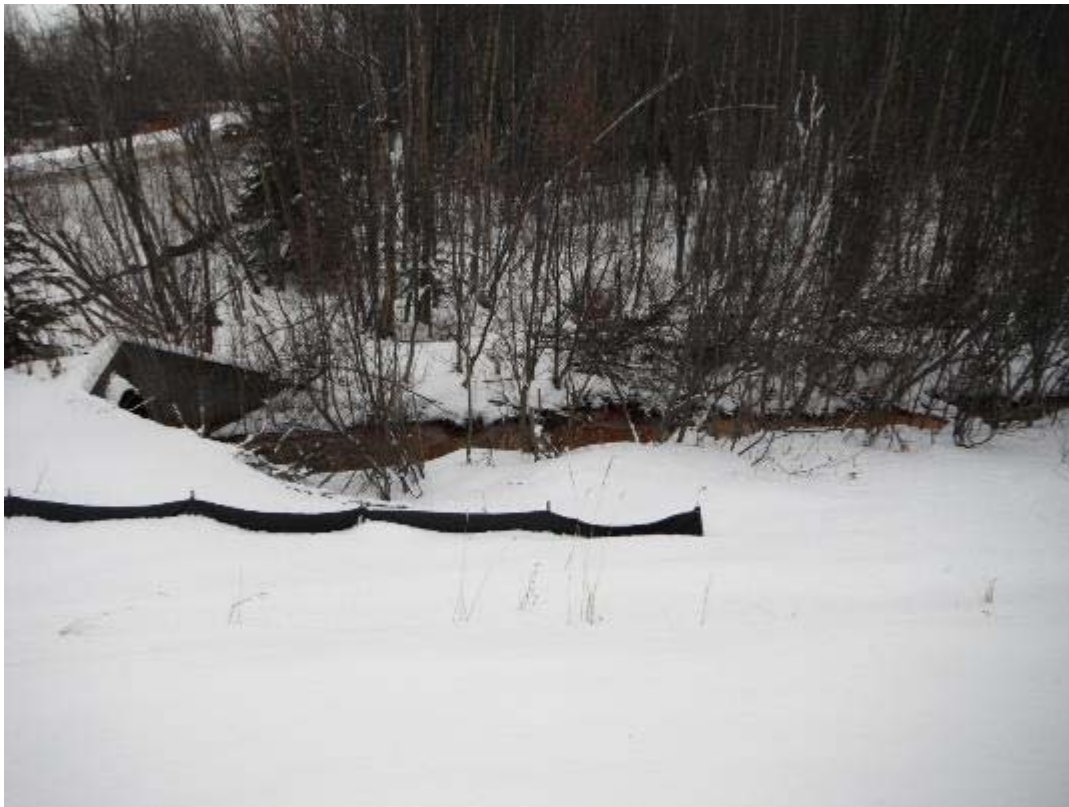
Photograph 20. Open water downstream from Victor Road culvert on February 14, 2013. Turbidity was 143.7 NTU.

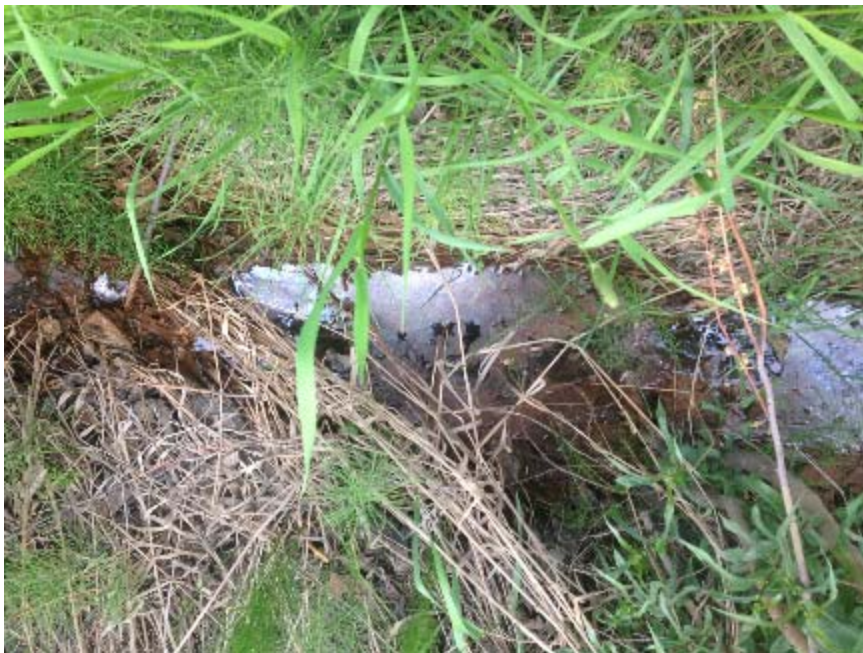
Photograph 23. Sheen caused by iron oxidizing bacteria near King Street.

The orange colored flocculent is oxidized iron deposits caused by the bacteria *Leptothrix* (see Appendix A). The bacterium oxidizes iron which accumulates in the sheath surrounding the organism. *Leptothrix* is present in waters with low dissolved oxygen and reduced iron. This bacterium is also responsible for the oily sheen often observed in stagnant wetland pools or streams or in groundwater seeps. Conditions that support *Leptothrix* occur naturally in wetland streams or in areas of upwelling iron-rich groundwater. Human sources of carbon rich anaerobic conditions, such as wastewater facilities, also promote proliferation of this bacterium. High dissolved carbon concentrations are also one cause of the presence of foam in streams. Therefore, the sources of oxygen poor high carbon waters should be used to determine if the orange flocculent is natural or due to a human caused pollutant.
