DEPARTMENT OF ENVIRONMENTAL CONSERVATION  
NONPOINT SOURCE POLLUTION PROGRAM  
ACWA NPS WATER QUALITY GRANT

FY 2006  
**FINAL REPORT**

PROJECT #: ACWA-06-10

**Watershed Protection and Recovery for  
Jordan Creek, Juneau, AK**

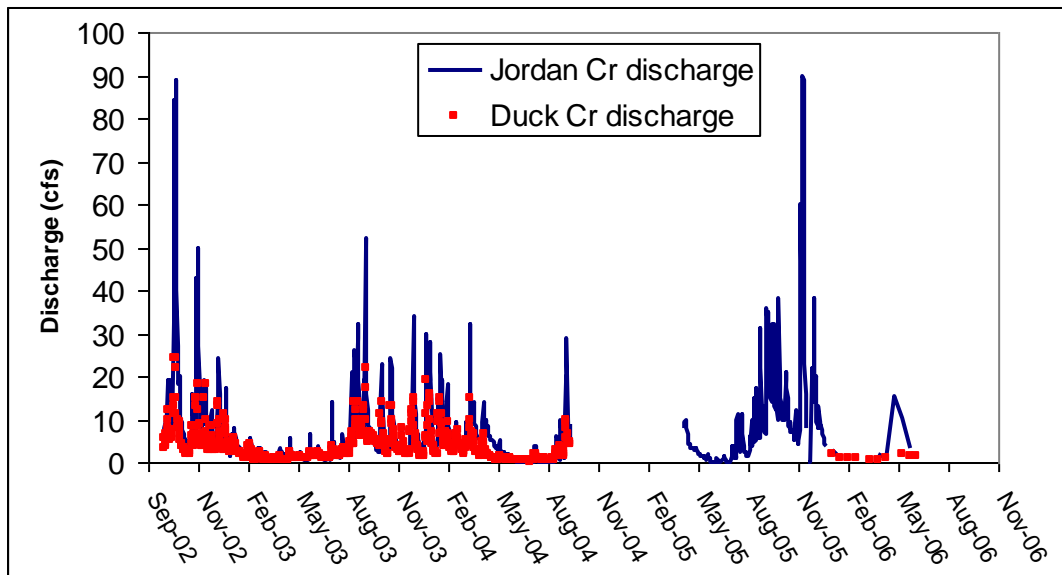
**Figure 2.** Discharge on Duck and Jordan Creeks. Data based on USGS stream gage data, until January, 2006. (Data from September, 2005 on are provisional). Measurements since January 2006 are based on manually gaging using a pygmy flow meter.

Discharge during the study year was measured by the USGS through December, 2006 (provisional data) and by the authors from January- June, 2006 on each sampling event. Measurements indicate that flow reached 90 cfs during record rains in November, 2005; but otherwise tended to be less than about 15 cfs. On all dates measured between January and June, 2006, flow did not exceed 15 cfs and was either frozen or flowing at <3 cfs during much of the spring.

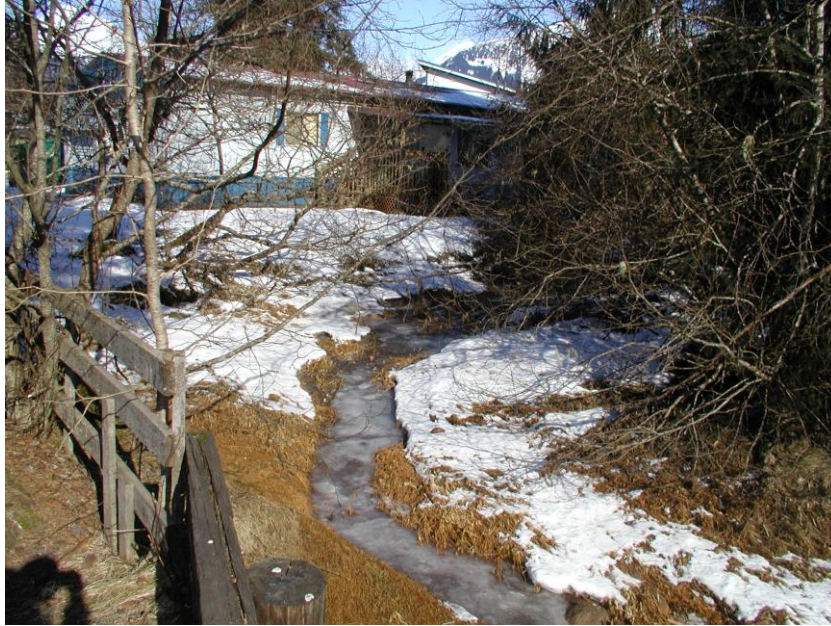
**Figure 3a.** Site JC-A, showing the frozen stream channel on 3/15/06, when the air temperature was  $-15^{\circ}\text{C}$  in Juneau.. Flowing water was present at the site on all other sampling events. Also visible is a house situated within a few meters of the streambank, exemplifying the rising encroachment of urbanization along Jordan Creek.

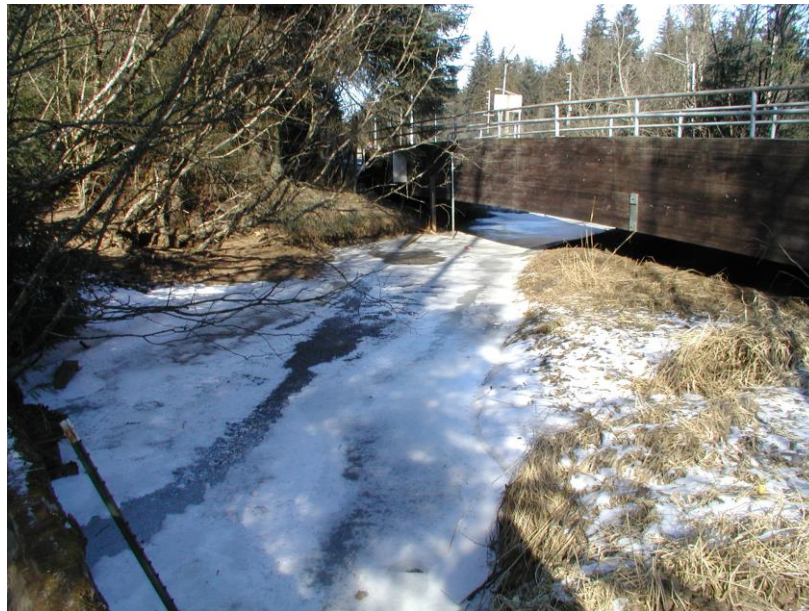
**Figure 3b.** Site JC-B, showing frozen conditions on 3/15/2006. The ice was too thick to break manually.

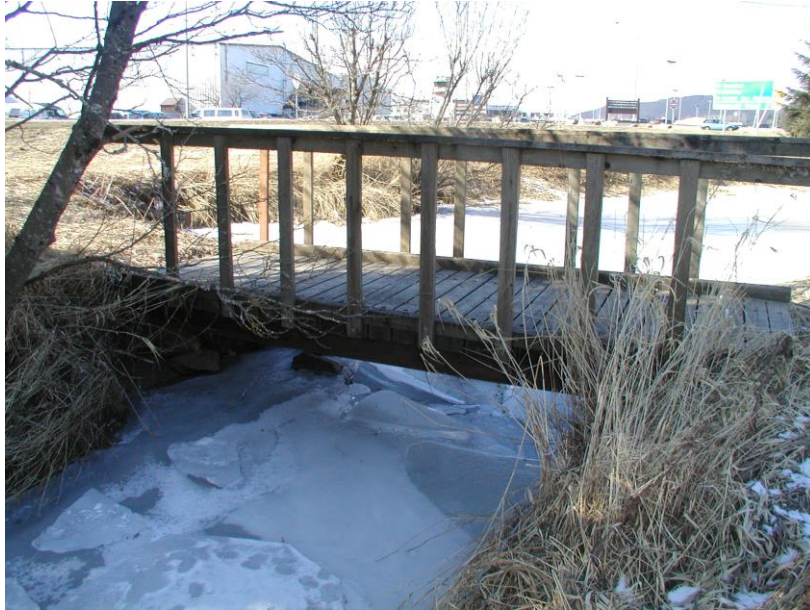
**Figure 3c.** Site JC-C, showing broken ice (with no water underneath), on March 15, 2006 when air temperatures reached  $-15^{\circ}\text{C}$  in Juneau. No flow was observed at the site for approximately 2 months, from late February to late April, 2006. During this no-flow period, the channel was either completely dry or contained disconnected pockets of ice and/or snow.

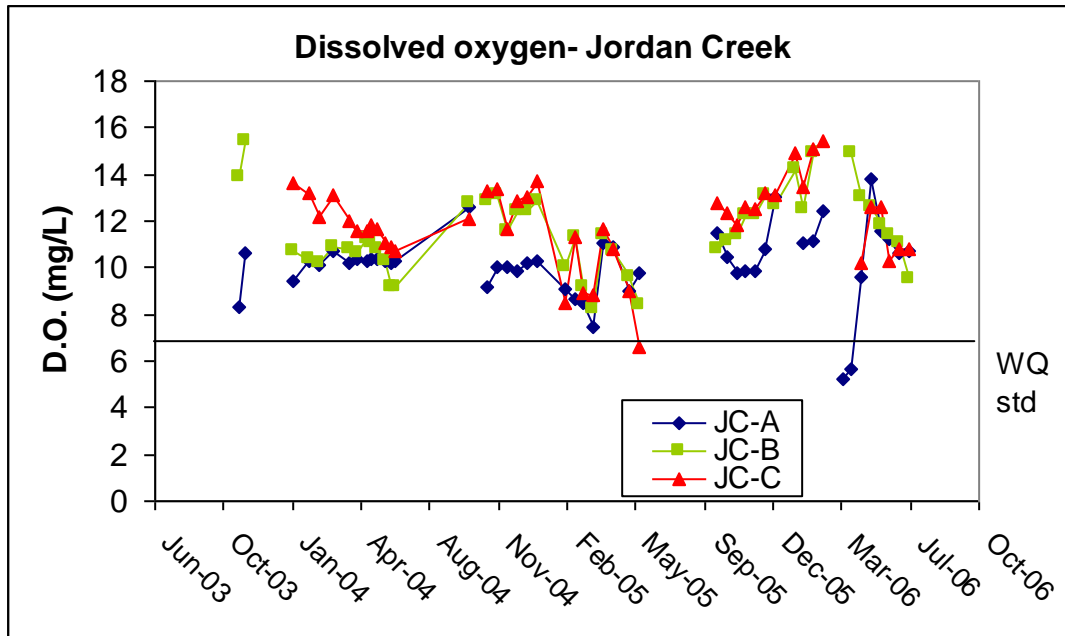
**Figure 4.** Dissolved oxygen at the 3 Jordan Creek sites. Graph shows D.O. data for this project (July 2005- June 2006) and previous data collected by UAS (beginning in 10/2003).

Dissolved oxygen was generally good at the 3 Jordan Creek sites, and typically ranged between 10 and 15 mg/L (Table 2, Figure 4). The only violations occurred at JC-A, where dissolved oxygen levels fell below the State of Alaska water quality limit of 7.0 mg/L for the growth and propagation of fish, shellfish, and other aquatic life on two occasions (3/25/06 and 4/7/06) (DEC, 2006). On these dates, ice formed a surface layer on the stream and limited oxygenation of the water, which was clearly derived from groundwater a short distance upstream. Average dissolved oxygen concentrations increased in a downstream direction (Table 2).

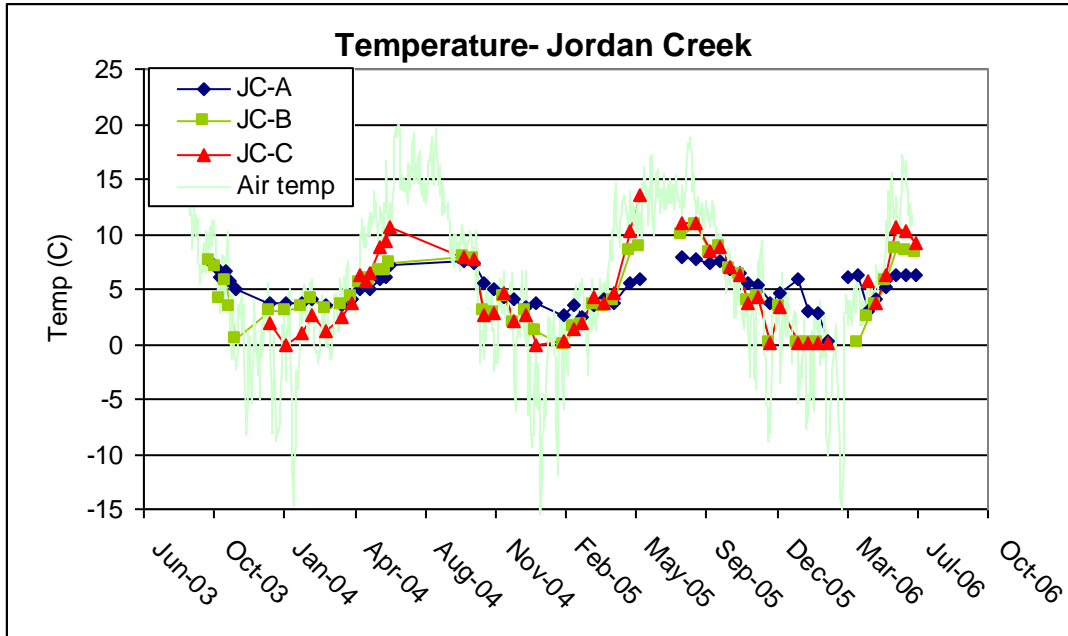
**Figure 9:** Water temperature at the three sampling locations on Jordan Creek, with Juneau airport air temperatures overlain to show the close relationship between air and water temperatures. Data shown include data collected in FY 05 as well from October 2003- June 2005.

Water temperature in Jordan Creek shows strong seasonal variation, despite the flashy (event-controlled) discharge patterns on the stream. Figure 9 shows the temperature at the 3 Jordan Creek sites compared to Juneau air temperature. Comparison of water temperature at the three locations along Jordan Creek indicates that upstream site JC-A has generally lower summertime and warmer wintertime temperatures than does JC-B (Table 2), which is further indication of the groundwater upwelling at the sites because groundwater maintains a more stable temperature than does surface water. No exceedances of the Alaska water quality standard for spawning and incubation areas (13 °C) (DEC, 2006) occurred during this study year, although they have been documented in the past.

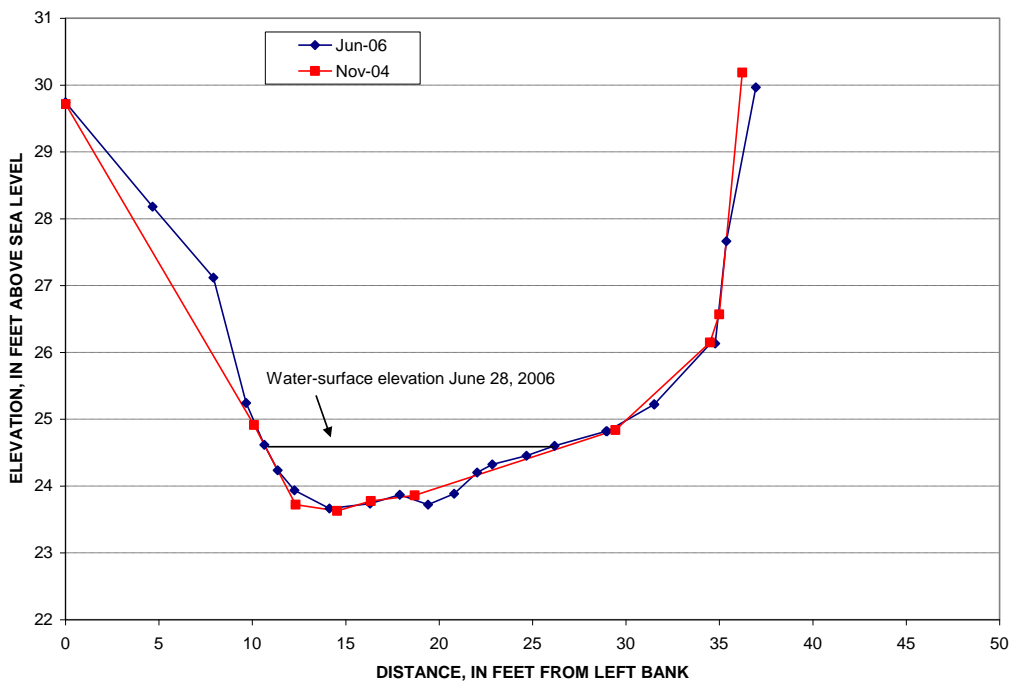
**Figure 1.** Cross section 1 showing changes over time in channel geometry.

Figures 1-3 depict the changes in channel geometry from November 2004 to June 2006 at the 3 locations surveyed. Cross section 1 exhibited the least amount of channel change between the two surveys. Cross section 2 appears to have scoured near the left bank. Cross section 3 maintained a similar channel configuration near the thalweg and appears to have deposited a small amount near the right bank. In general all three cross-sections surveyed maintained similar channel configurations despite relatively large flood events occurring in November of 2005. The USGS discontinued the Jordan Creek gaging station on October 1, 2005, however, a single discharge measurement of 90 ft<sup>3</sup>/s was made on Nov. 22 which approaches the maximum discharge recorded on Jordan Creek. While the cross sections surveyed indicates this reach of Jordan Creek may be relatively stable there may be other reaches within the drainage subject to sediment deposition.
