ATV Trail Mapping in Jordan Creek Watershed

FY 2006-2007

Prepared by
Juneau Watershed Partnership
for the
Department of Environmental Conservation
Nonpoint Source Pollution Program
Task # 5
Project ACWA-07-07

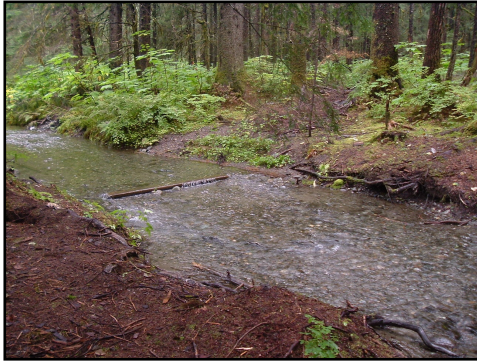
Photo 2. Revegetated ATV crossing on Jordan Creek at the end of Valley Blvd. Note the shadows of spawning pink salmon. August 29, 2006

The primary stream crossing that we observed was at the end of Valley Boulevard (Photo 2). This used to be a major access point to the trails but was successfully closed off by a Southeast Alaska Guidance Association (SAGA) crew organized by the U.S.

Fish & Wildlife Service in 2005. Earlier attempts of posting signs were unsuccessful as the signs were used as target practice and eventually stolen/ removed. The successful closure at Valley Boulevard consists of a heavy chain hung from two trees across the entranceway, a bullet-hole ridden sign, and hundreds of feet of felled trees crossing the trail. It appears that it was the removal of the trail (by covering it with downed trees) that closed this access point because, otherwise, people could have constructed a new way around the chain to access the trail.

It appears that people are trying to remove the felled trees that the USFWS and SAGA laid across the trail at the Valley Boulevard access point. ATV use should be continuously monitored in the watershed to prevent reopening of this and any other access points. Trailheads on private land at the end of Nancy Street and Sasha Ave. showed evidence that a motorized vehicle had been driven very short distances at these locations, but it did not appear that there was regular use and, due to the fact that they are on private land and do not connect with any other trails, they do not appear to actually be "trails". However, the greatest concern at these locations is that the vehicles are being driven through the actual stream, so these sites should also be monitored occasionally. A partnership between JWP and the Rough Riders will aid communication, education, and outreach of ATV use in sensitive riparian areas and will promote "peer pressure" among users. One of the most important things that can happen in CBJ for unauthorized ATV use is to provide designated ATV use areas for legal, controlled, and enforced riding. JWP and Rough Riders will continue to work with CBJ on this.

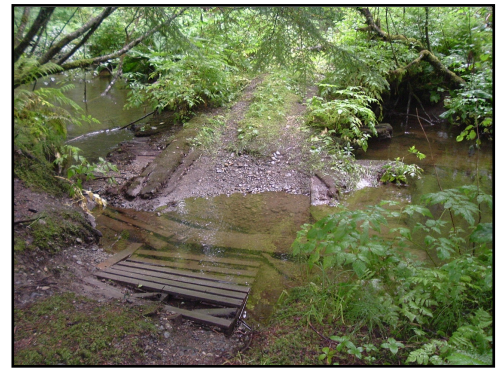
Trail development in Jordan Creek Watershed originated with historic logging and military roads. It is thought that the bridge at the end of Sasha Ave. was built as a crossing for one or both of these uses (Photo 1). No other older/ abandoned bridges like this were observed crossing Jordan Creek except

Photo 1. Abandoned bridge over Jordan Creek at end of Sasha Ave.

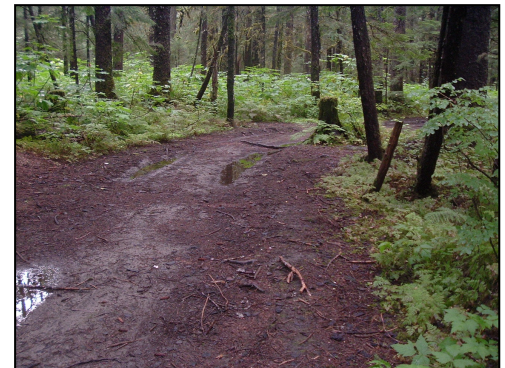
Photo 3: The old road in the forest at the base of Thunder Mountain in Jordan Creek Watershed. August 29, 2006

Boulevard we intersected the main trail in the area, the old logging road (Photo 3). This is the main path through the north-south axis of the watershed and has several spur trails shooting off of it. At the toe of several of the avalanche paths coming off Thunder Mountain there was evidence of ATV “high marking” and stream crossings on these tributaries (Photo 4). In several different places water from the tributaries left the channel and followed the path of

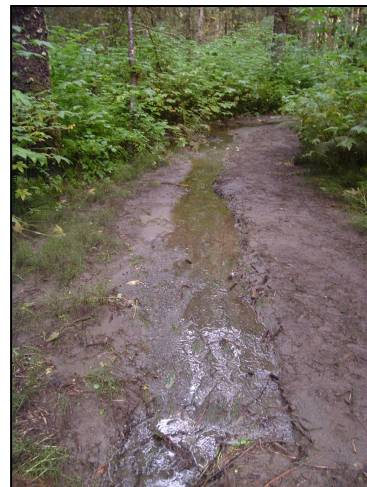
the ATV trails and was picking up and transporting fine sediment from the trail (Photo 5).

Photo 5. Jordan Creek tributary flow rerouted onto an unauthorized ATV trail. Notice the fine sediments that are being transported. August 29, 2006

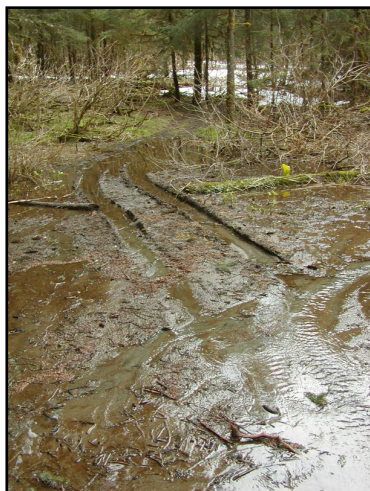
Photo 6. ATV tracks in the spring mud near an avalanche toe in Jordan Creek Watershed. May 2007.

In May 2007 JWP revisited the upper watershed to field-check the preliminary map and look for evidence of recent motorized activity. We only saw one set of new tracks near one of the avalanche paths (Photo 6), but that may have been because the late snowmelt kept folks out or washed away other tracks. Unfortunately, in addition to the tracks we also discovered empty gas cans left at a site that appeared to be a regular camping spot in the summer months (and a groundwater upwelling site in the spring) (Photo 7).

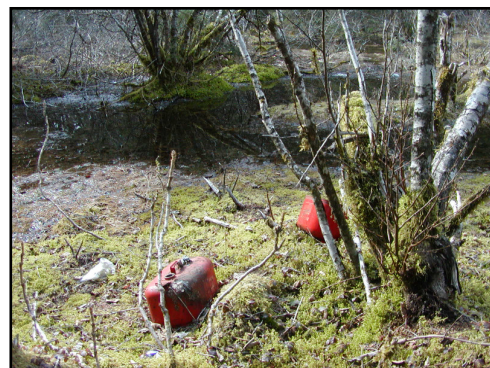
Photo 7. Gas cans left near a campsite next to Jordan Creek.

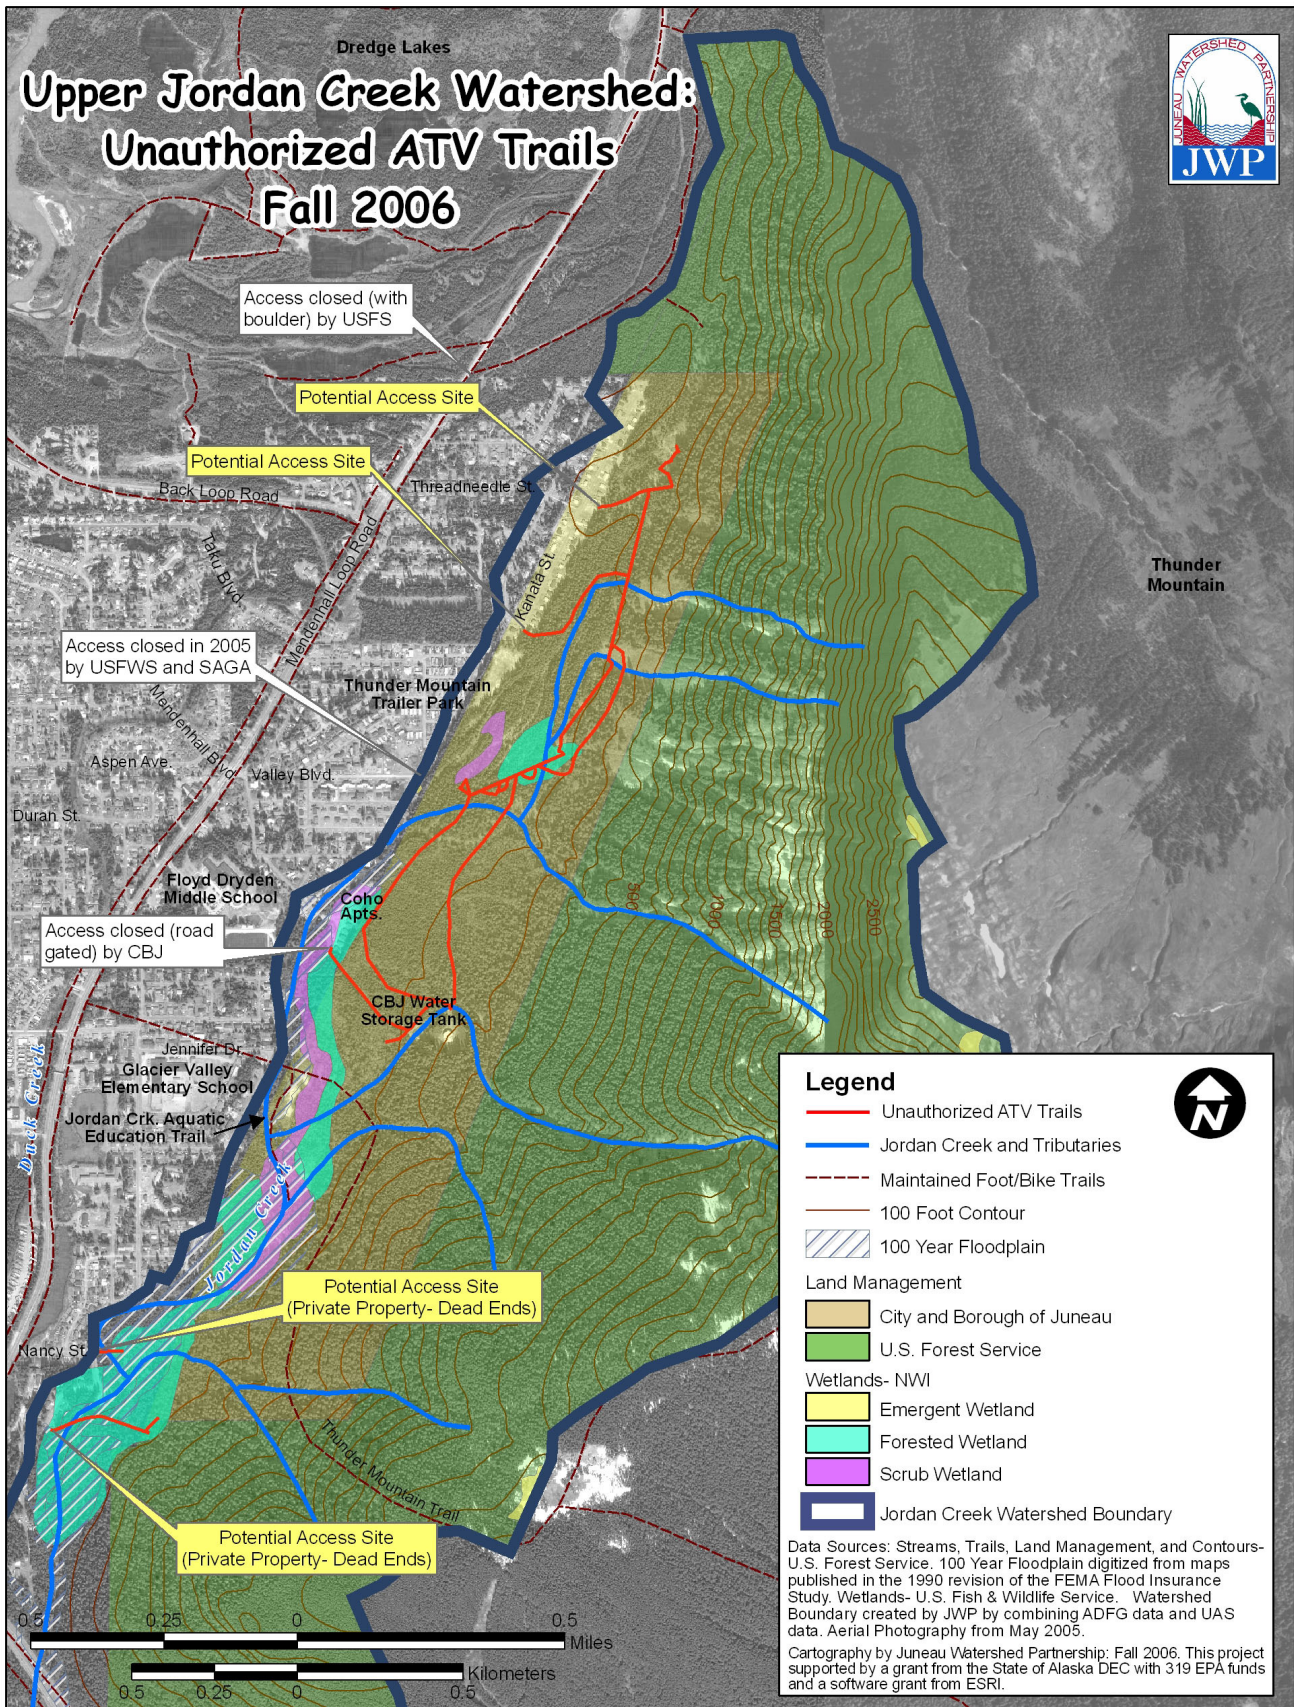
JWP staff walked the trails in the Jordan Creek Watershed with a GPS in an effort to map ATV use. Prior to heading into the field, we were warned that it would be difficult to obtain a satellite signal in such close proximity to Thunder Mountain, even with a higher quality GPS unit such as the Trimble GPS that was donated to this project by UAS. Consequently, in addition to walking the trails with the GPS unit, we nested point data when satellite reception was good and took hand notes to complement the GPS data and safeguard against the possibility of no data being stored. Once the data was downloaded, the GPS line data (trails) were compared with the nested points and hand drawings and it was determined that the digital line data was not 100% consistent. Therefore, after a first draft of the map was created, we revisited the area several more times to ground-truth the mapping effort and look for new signs of motorized use. The final map is located on the last page of this document.
