Lake Lucille Sediment Quality Sampling: Spatial Extent of Polluted Sediment due to Outfall Stormwater Inputs

Final Report for: Alaska Department of Environmental Conservation

August 2013

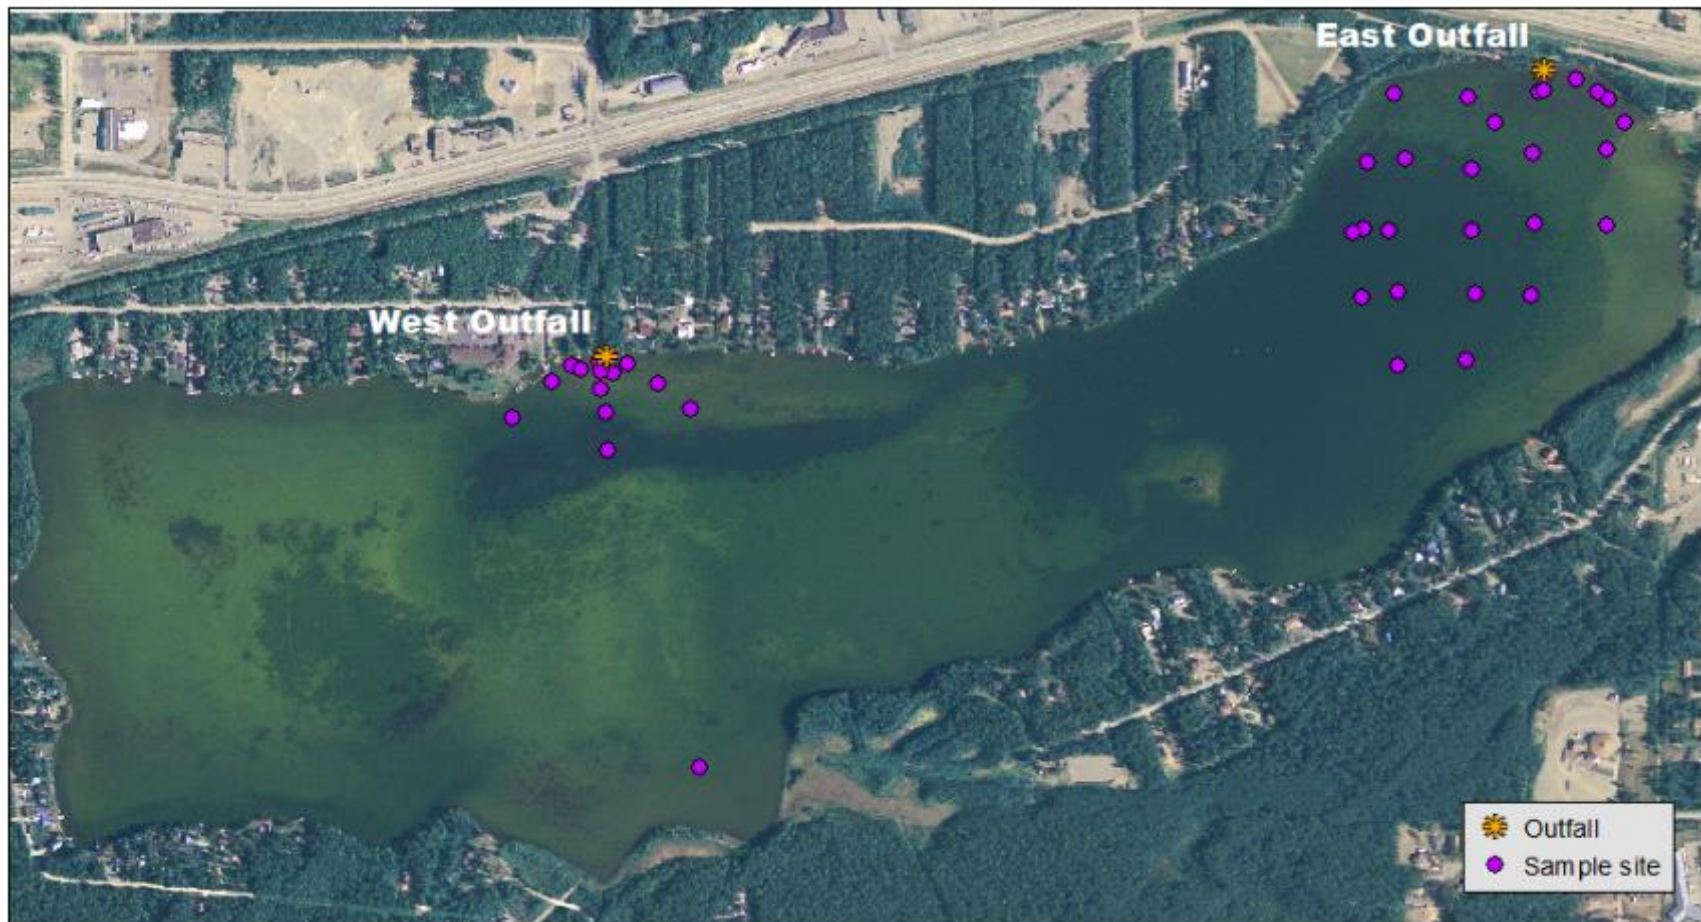
Figure 2. Aerial photograph of Lucile Lake showing east and west outfall and grid sampling locations. Initial sampling points around the east outfall were on a 100 m grid. Samples around the west outfall were collected 25, 50, 100, and 150 m from the outfall.

Initial sediment sampling was conducted on June 4, 2013. 27 samples were collected during the first sampling event. Results from this sampling were used to determine sampling locations for the second sampling event which occurred on June 20 and 21, 2013. 17 samples were collected during the second sampling event (Figure 2).

Initial sampling locations were distributed on a 100 m interval grid from the east outfall in order to determine the extent of contaminated sediments. Sampling locations were mapped in ArcGIS and were accessed by boat. Exact sampling locations were recorded with a handheld GPS receiver and triangulated to two points on the shore.

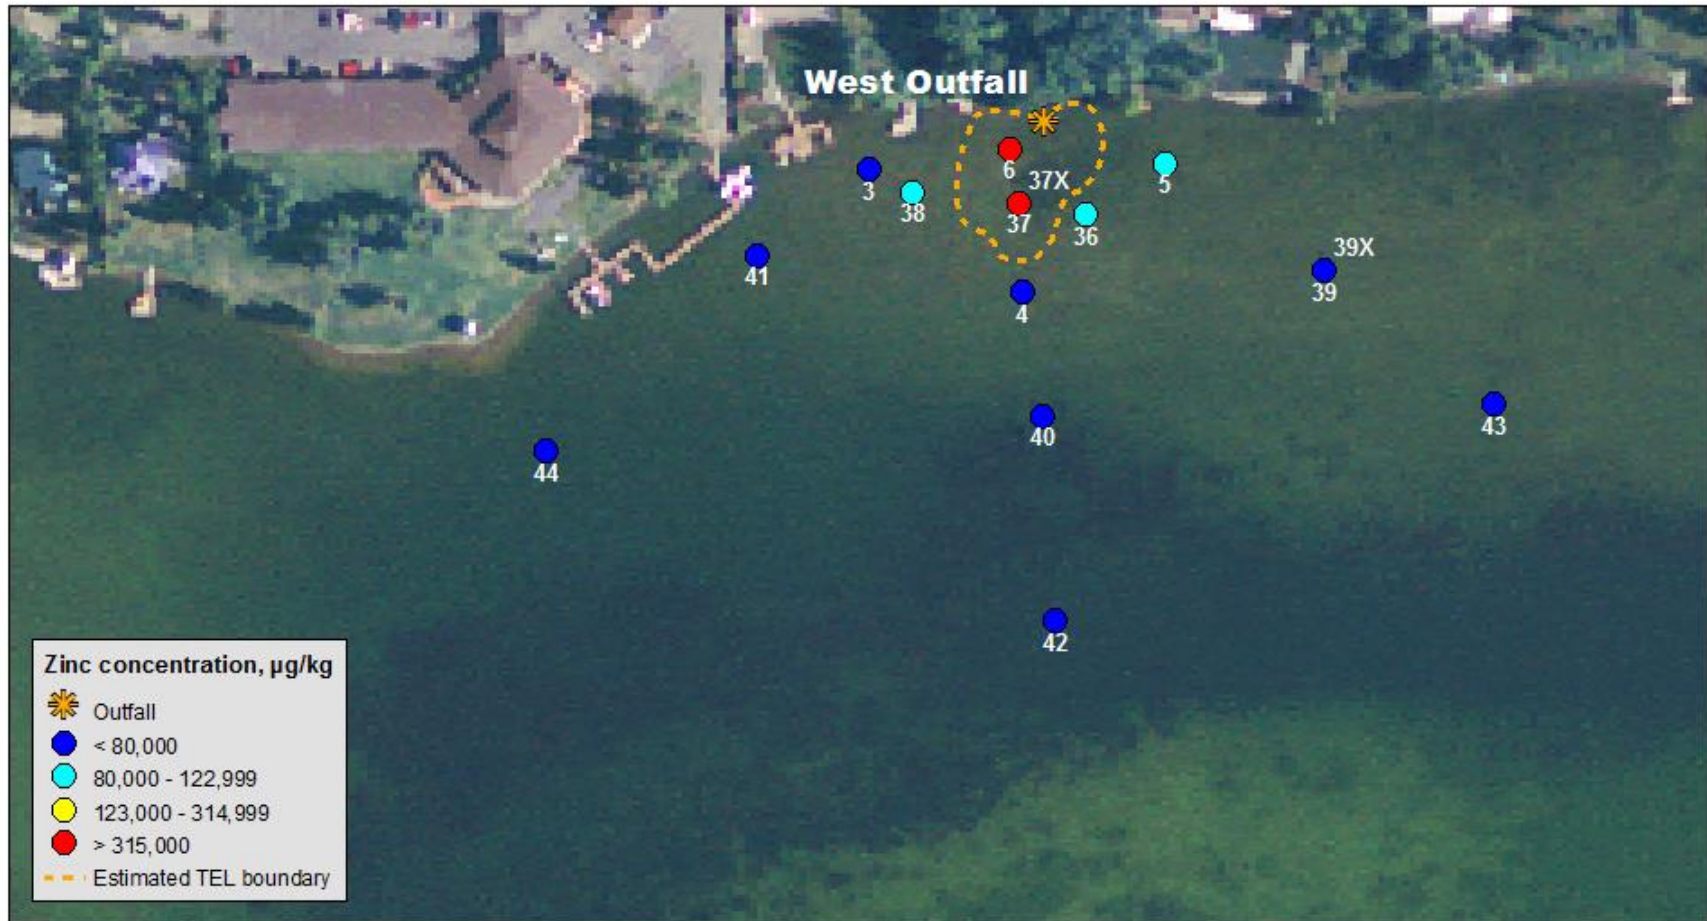
Zinc analysis revealed three sites with concentrations above TEL values and six sites with concentrations above PEL values (Figures 6 and 7). The largest area of estimated TEL value exceedances around the east outfall was due to concentrations of zinc at 18,033 m² (4.4 acres). The area of zinc TEL exceedances in the west basin was 1,340 m² (0.33 acres).

Figure 7. Distribution of bed sediment zinc concentrations adjacent to the west outfall. Yellow markers indicate sites where concentrations exceed TEL values and red markers indicate sites that exceed PEL values. Dashed line is estimated area where zinc concentrations are likely to exceed TEL values.

Because metals and PAHs are likely delivered to the lake during storm events that exceed the stormwater treatment capacity and overflow to outfalls, management options need to consider expansion of treatment facilities in order to reduce metal and PAH concentrations to levels within acceptable water quality standards. The likelihood of biological effects is increased with the prevalence of metal and PAH concentrations above the TEL values and is an even greater possibility with the results of some samples above the PEL values.

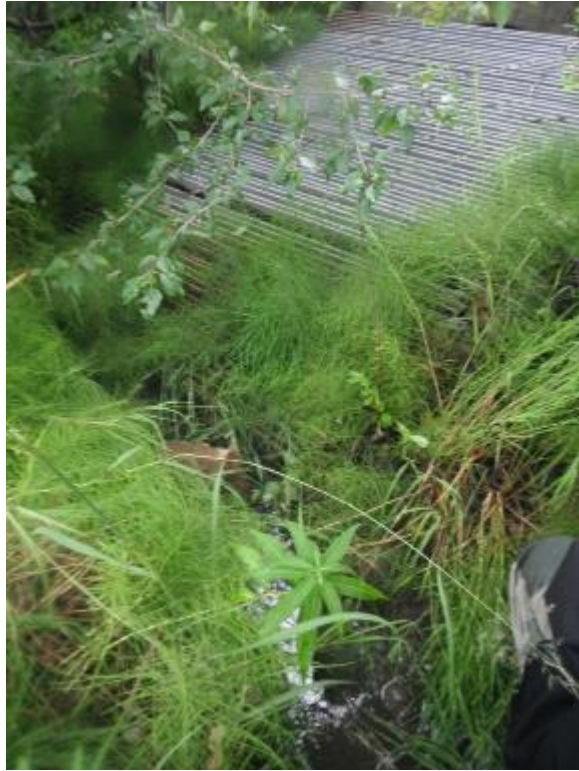
Photograph 1. Lake Lucile east outfall.

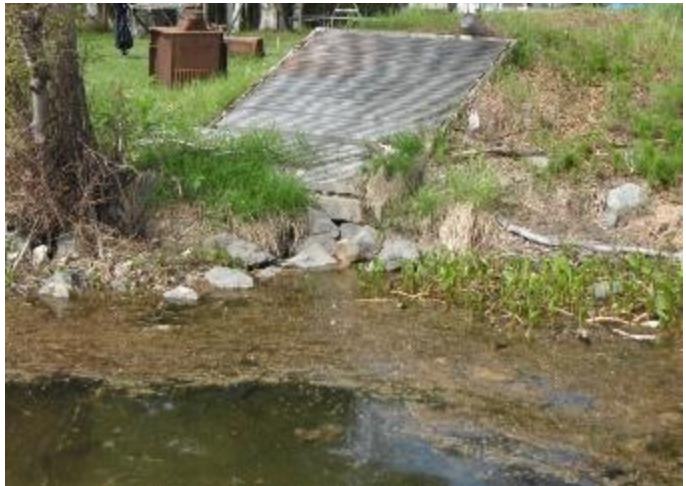
Photograph 2. Lake Lucile west outfall.

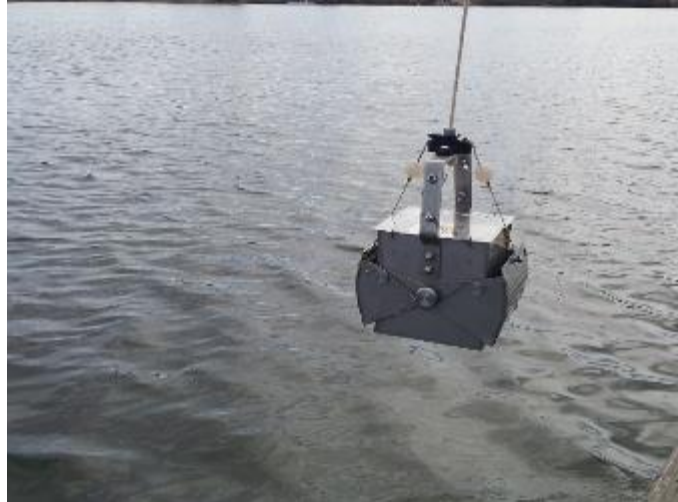
Sediment samples were collected using a Ponar dredge sampler. The sampler was rinsed in the lake three times at each sampling location prior to deployment. The sampler was released into the water column to submerge 15 cm into bottom sediments under the force of gravity. Once the sampler had settled into the bottom sediments, the messenger was released to trip the spring mechanism and close the dredge. The sampler was retrieved and the top opened to allow access to the sampler contents, which were observed for hydrocarbon sheen or odor. Clean, gloved hands collected sediment from the top 10 cm of the sample in a 250 ml glass bottle for metal and PAH analyses.

Photograph 3. Ponar dredge sampler.

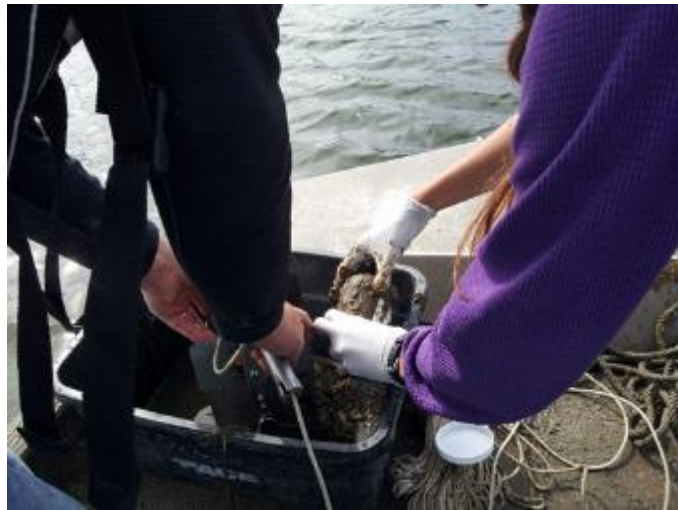
Photograph 4. Sediment collection from dredge sampler.

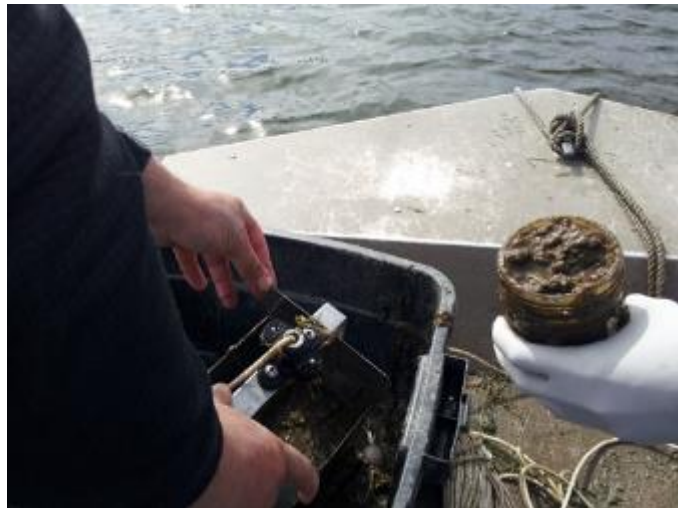
Photograph 5. Full sediment sample container.
