2007 Bark Monitoring Dive and Video Survey Report

Thorne Bay LTF

MAY 12, 2007 THROUGH MAY 16, 2007 SURVEY

Thorne Bay Log Transfer Facility

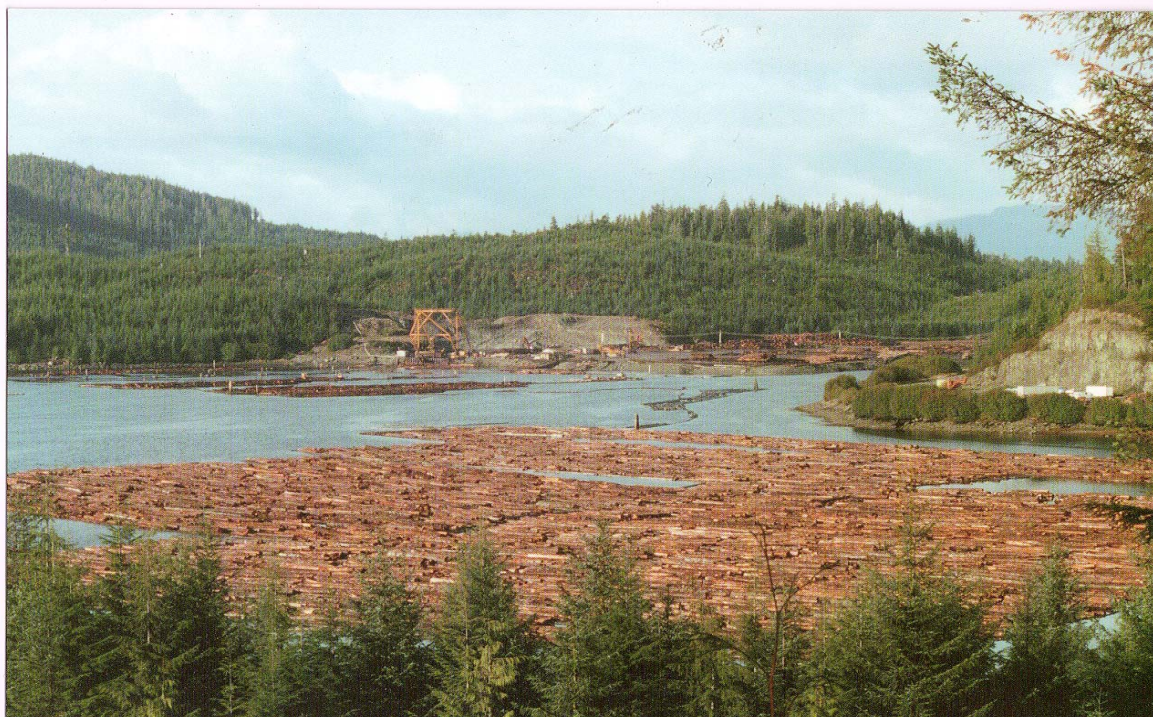
1992 photograph of the Thorne Bay Log Storage and Log transfer Facility by Diane Stittgen

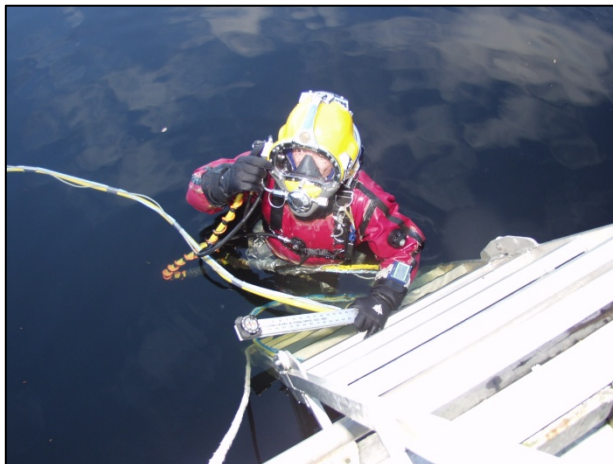
Figure 3 Radial transects HUB

The dive survey was conducted along radial transects that emanated from the central discharge hub. The fixed hub reference point for the transects radiating from the log transfer low angle ramp was initially located by assessing maps and diagrams provided by the US Forest Service. The hub location was then “fixed” at the center of the drive down ramp by DGPS coordinates.

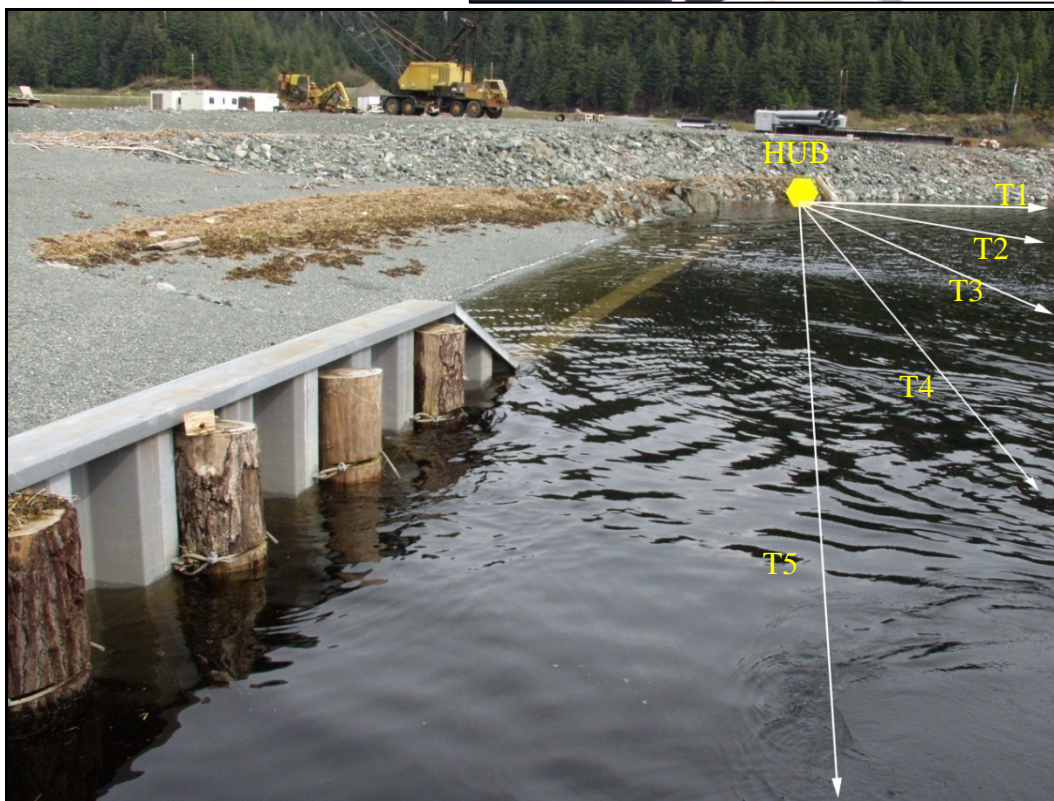
The reference hub was located as close as possible to the center of the discharge site to facilitate future reconnaissance. Five transects were established, radiating from the reference hub at 30-degree intervals. Two separate magnetic compasses were compared to determine the bearings.

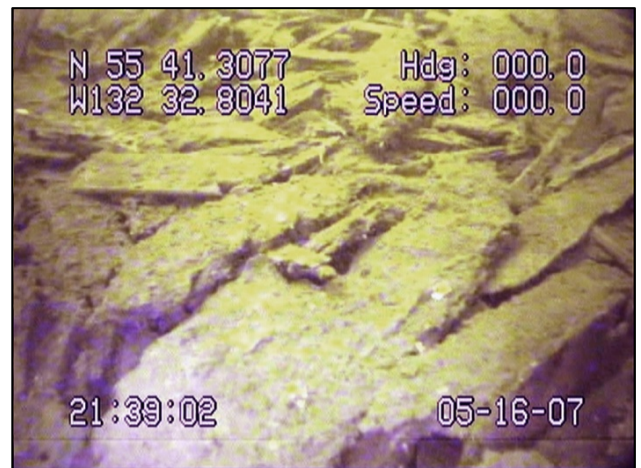
Plan View Video camera with satellite overlay

The Video survey methods used are approved by ADEC. The system is comprised of a 12 channel satellite receiver providing DGPS and WAAS coordinates to shipboard navigation and infrared camera equipment. The satellite receiving antenna is located directly above the sample point being observed. The camera is weighted and lowered on lead line from the vessel to within 2 vertical feet of the sample point. The infrared camera records the substrate condition for at least 60 seconds, this video feed is

combined with a live satellite data stream that includes; Latitude and Longitude (to the fourth decimal point), speed, heading, time (Greenwich mean time) and date. The video is then edited to the 30 second segment that includes the projected sample point location. This survey also included Video “stills”.

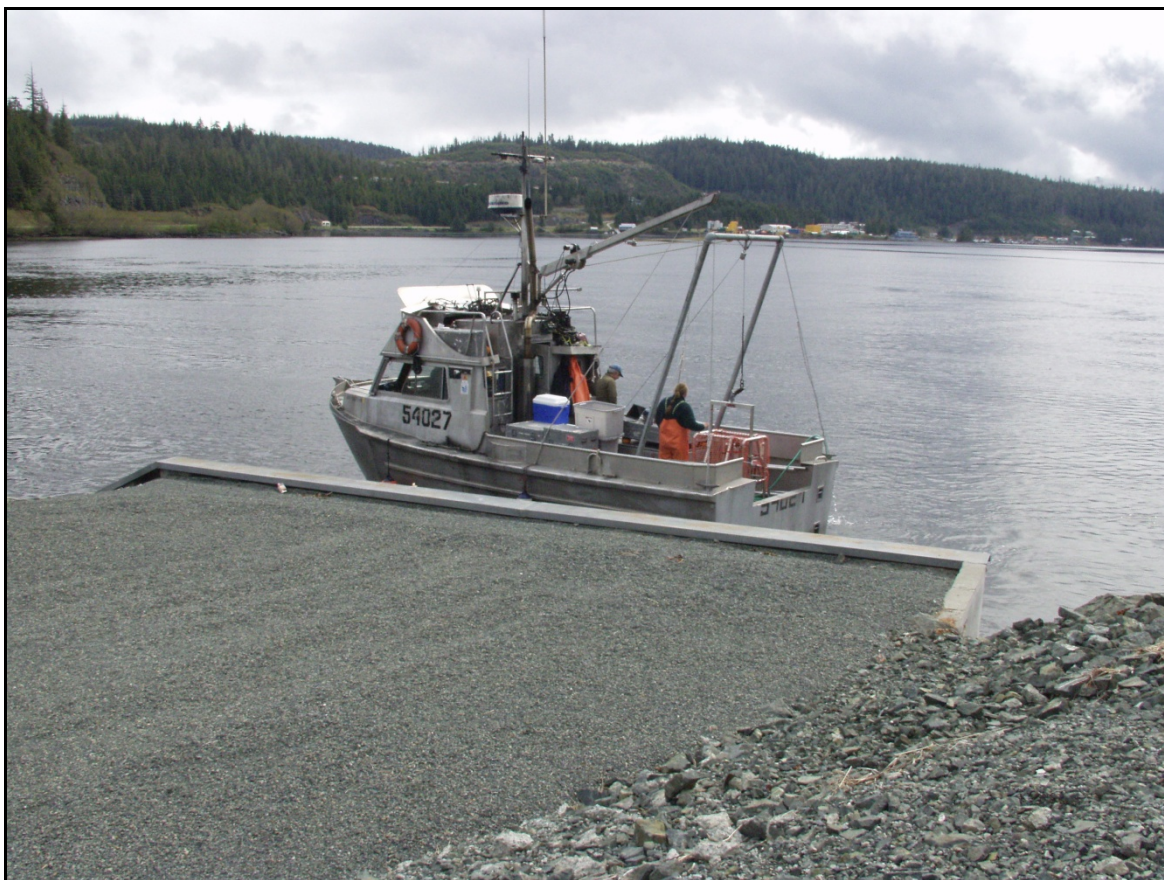
Figure 9 Log Transfer Facility *Hub Coordinates: 55 41 304 N 132 32 924 W*

Seven parallel transects, emanating from a bearing line located at the south end of the LTF marine Area, traversed the bottom on bearings labeled: T1 - T7 at 278 degrees. A total of 67 sample locations at a 75 and 150 -foot interval distances was assessed. Two additional reference stations were also observed with a similar bottom type, in an area of Thorne Bay that had not been used for log storage activities.

Five radial transects emanating from the central discharge hub were assessed by standard bark monitoring methods. A total of 84 sample points was observed during the dive survey. Site conditions remained steady with winds less than 5 knots and overcast skies. Surveying concluded at 4:35 p.m. on May 16, 2007 during mid tide. The tidal station (subordinate station #1423) was used for depth corrections, reporting a 6.0 ft tide level at 4:30 p.m. The tidal current velocity was estimated to be 0.0 knots. The horizontal visibility remained constant and was estimated to be 10 feet. The grade for these transects remained fairly flat.

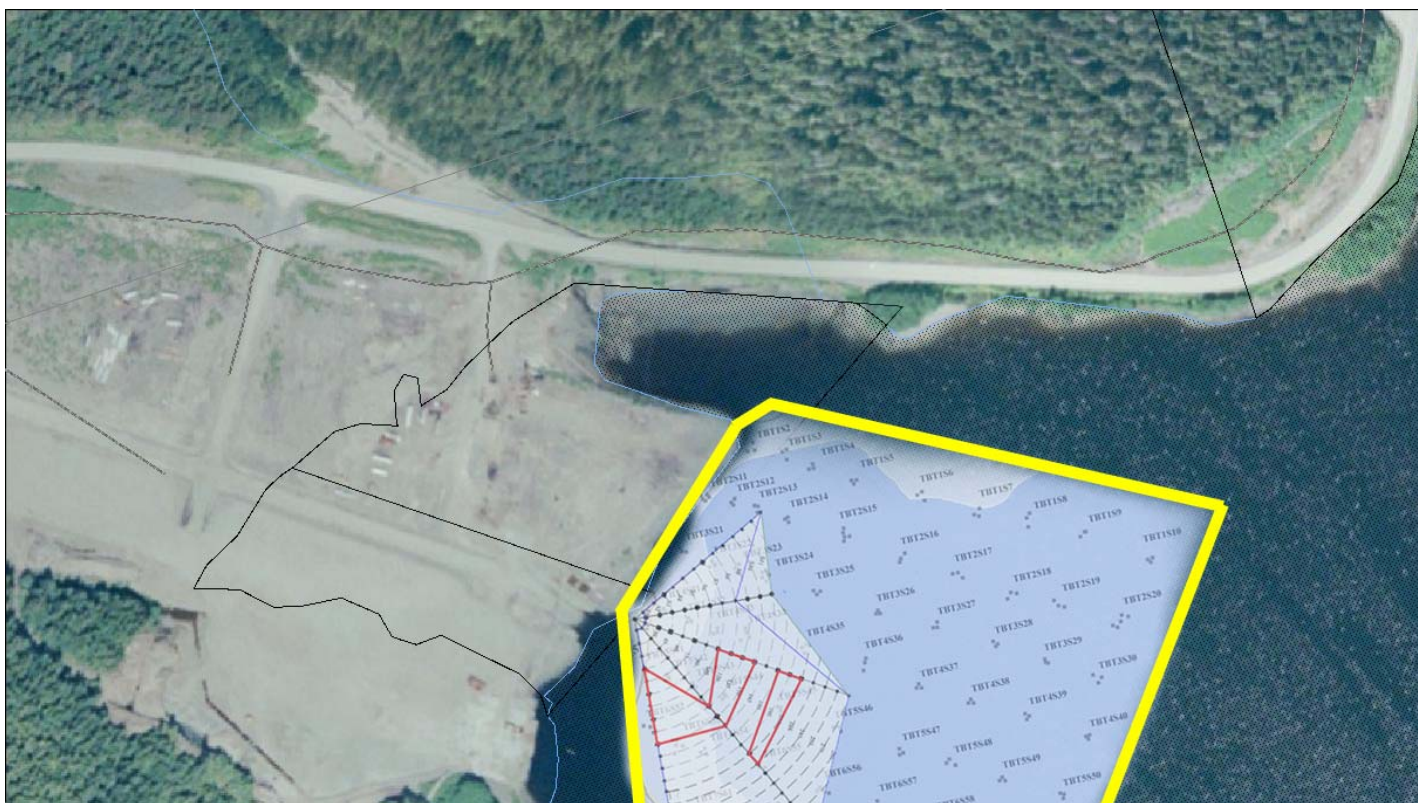
Figure 12 Transect maps overlaid on Satellite image with lease boundaries.

This is an overlay of a satellite image and transect diagram from this study. The survey area comprised two leased areas. The first (as indicated by the thin black lines) is ADL 51827 (Operated by the Tongass National Forest). The next is the area of water in the right of the photograph; ADL 101596 (Formally operated by the Ketchikan Pulp Company). It should be noted that at the time of this report, a portion of lease ADL 51827 is being conveyed to the City of Thorne Bay, Alaska.

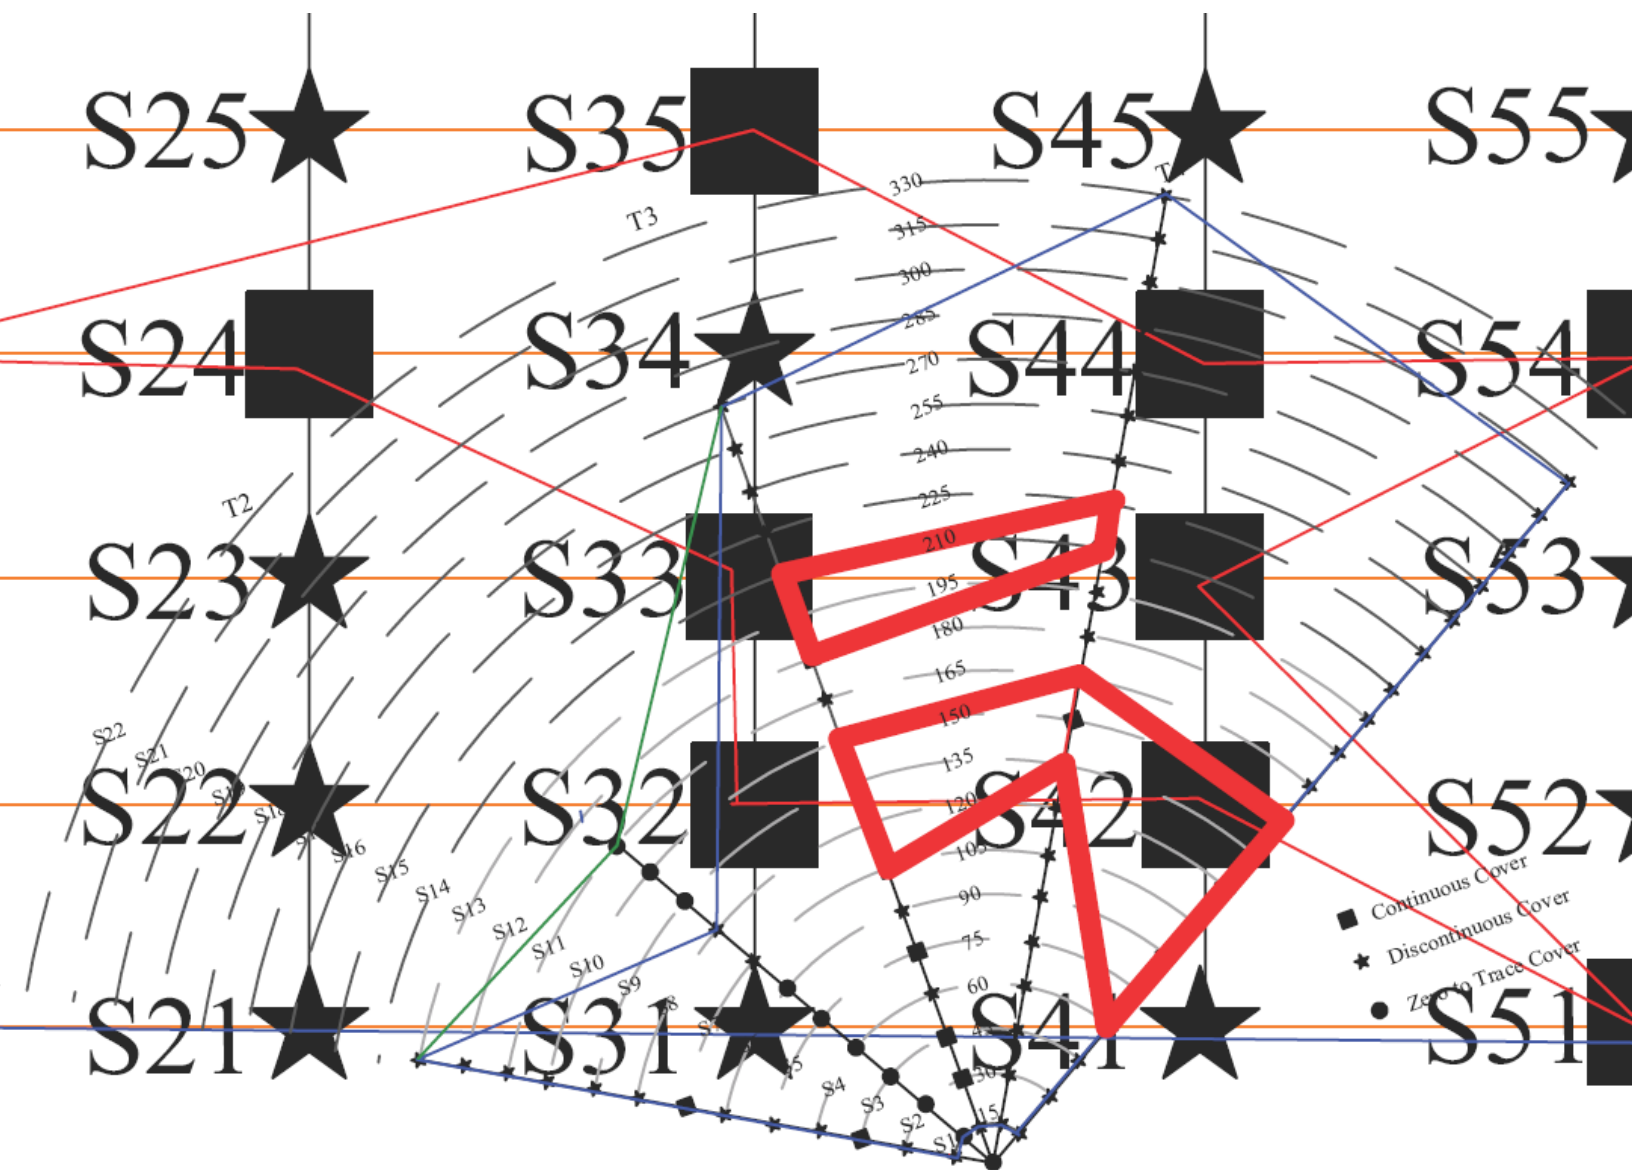
Figure 18 Enlarge area of Combined Radial and Parallel Diagram

The enlarged area of the calculation diagram above demonstrates how the parallel Plan View Video transect grid interacted with the radial Dive survey array. The higher resolution (Sampling every 15 feet in the radial array and every 75 feet in the parallel grid) of the radial array, produced reduced findings within an area of continuous bark cover.
