**FINAL**  
**JORDAN CREEK WATERSHED**  
**RECOVERY AND MANAGEMENT PLAN**

JUNEAU  
WATERSHED  
PARTNERSHIP

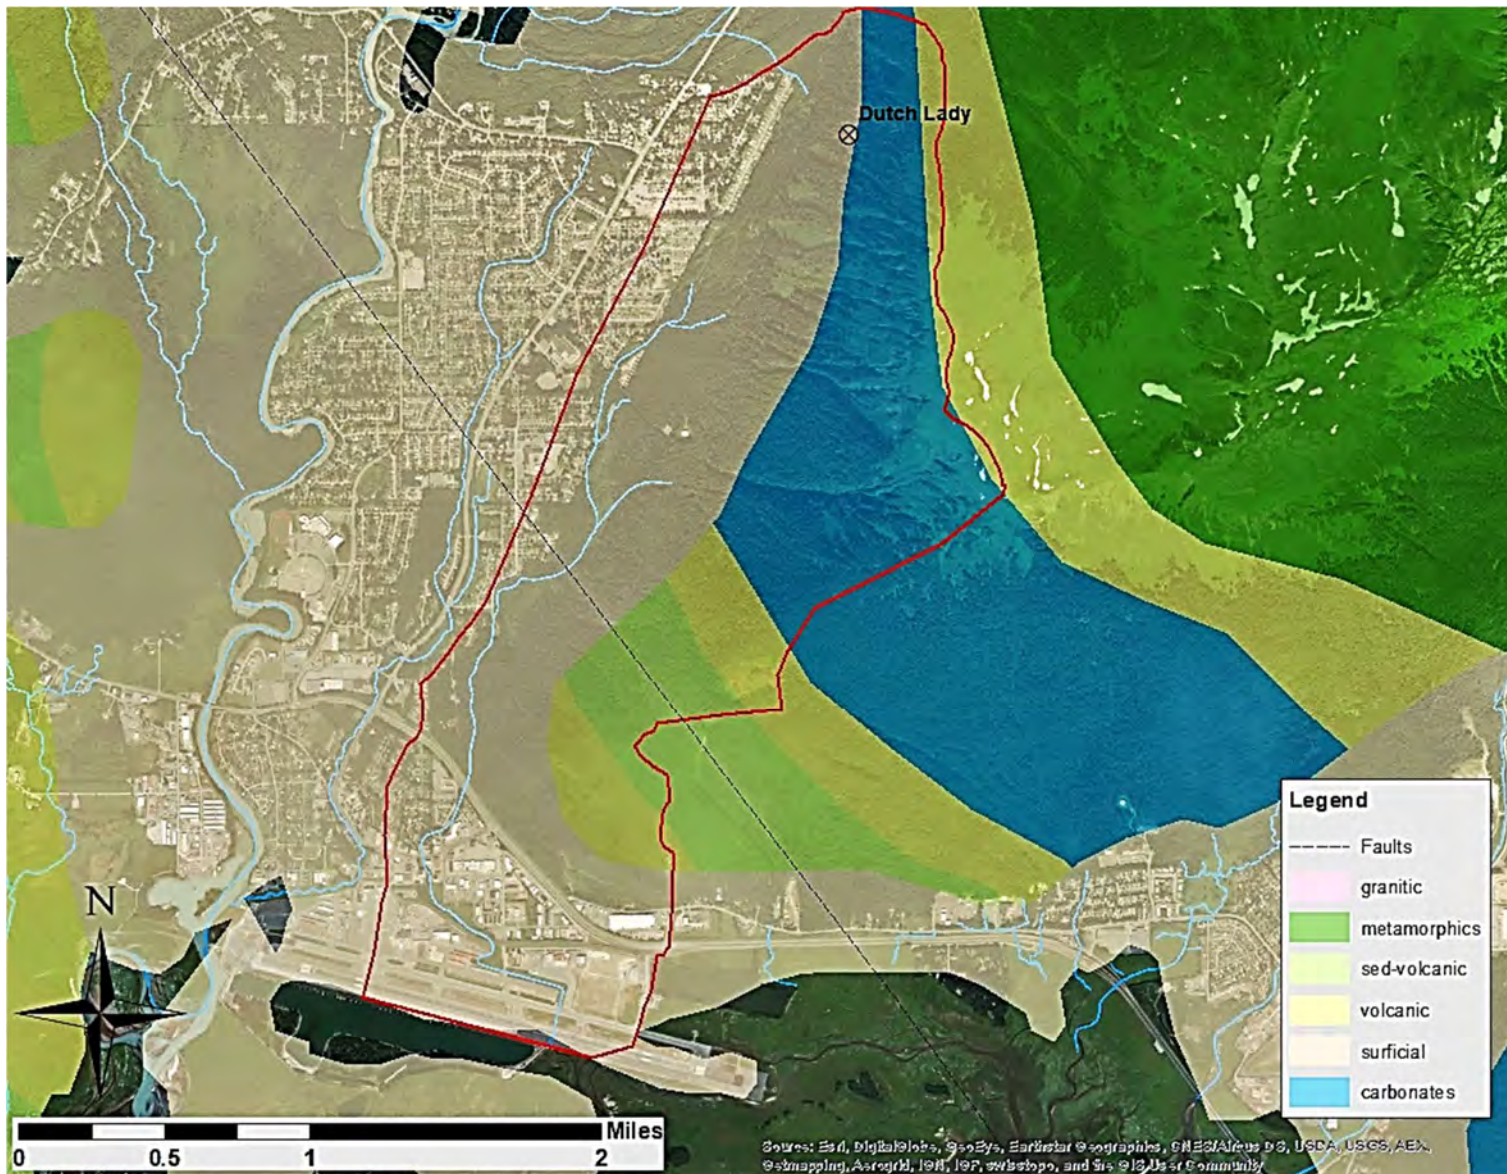
Figure 4. Bedrock geology of the Jordan Creek watershed including other geologic features.

On Thunder Mountain, bedrock consists of volcanic and sedimentary rocks from the Cretaceous and Jurassic periods. This includes rock types such as breccia, tuff, greywacke, slate, and conglomerates. There is also a band of carbonate rock (carbonaceous slate phyllite) from the Triassic Period in the upper watershed. Such carbonate rocks located throughout the area are the source of Juneau's most successful mines. An inactive prospect dubbed the "Dutch Lady" is located on Thunder Mountain within this band of carbonate rocks (Figure 4). It was discovered prior to 1911 with main commodity being gold. This is the only documented prospect in the watershed. There are several local faults in the Juneau area: the Gastineau Channel fault and the Fish Creek fault.

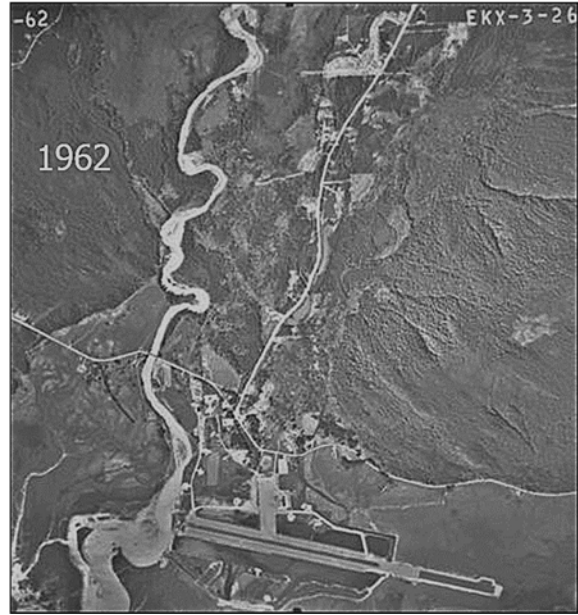
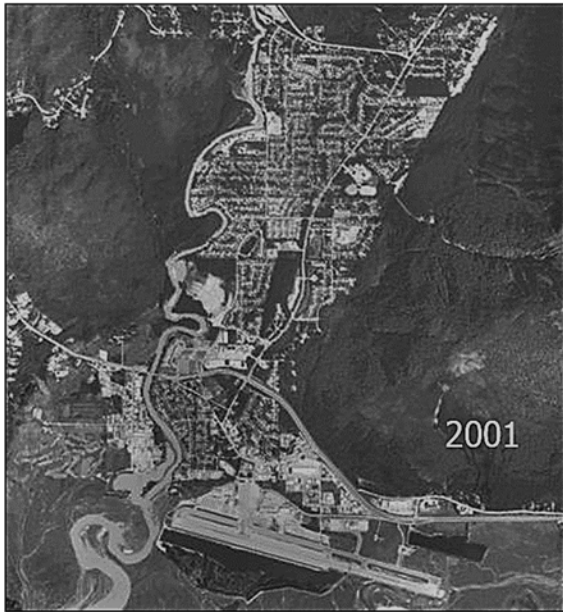
**Figure 14.** Series of aerial photos showing the progression of development in the Mendenhall Valley.

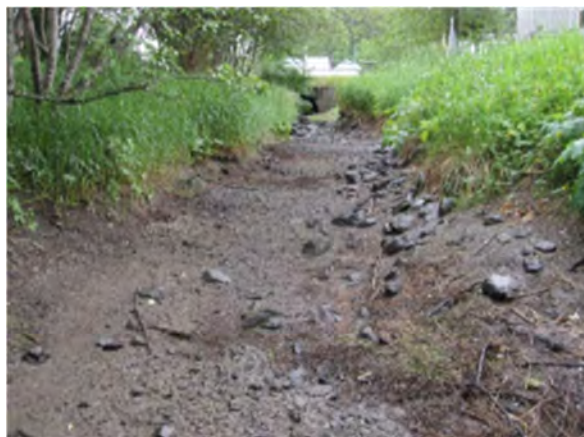
**Figure 17.** Jordan Creek downstream of Egan Drive during no flow conditions.

Lowering of the water table contributes to loss of stream flows in both Duck and Jordan Creeks, since the water table no longer intercepts the streambed (Neal, 2009; Host and Neal, 1999). An investigation by the USGS indicates Jordan Creek downstream of Egan Drive may dewater when flows at the former USGS

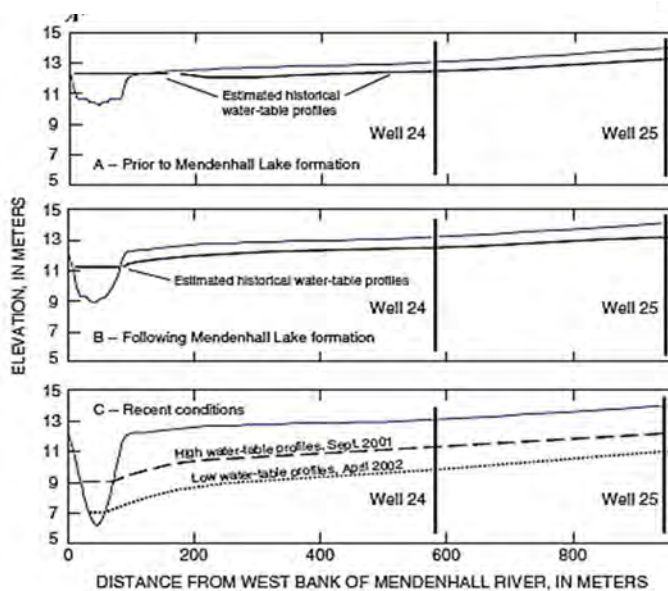
**Figure 18.** Mendenhall River incision and its effect on groundwater. Adapted from Neal (2009).

A combination of factors contributes to low and no flow conditions in Jordan Creek (Figure 17). USGS investigations found that low and no flow conditions are connected to regional uplift affecting the surface water – groundwater interactions in the valley. In response to regional uplift, the Mendenhall River is currently incising, or down-cutting, its channel, which lowers the local water table (Figure 18). Water table elevations in the Mendenhall Valley have decreased by 3.7 centimeter (1.5 inch) per year over the last two decades (Walter et al 2004). In 2009, water table elevations in the Mendenhall Valley ranged from 1.5 to 3.2 meters (~5 – 10.5 feet) below the land surface (Neal, 2009).

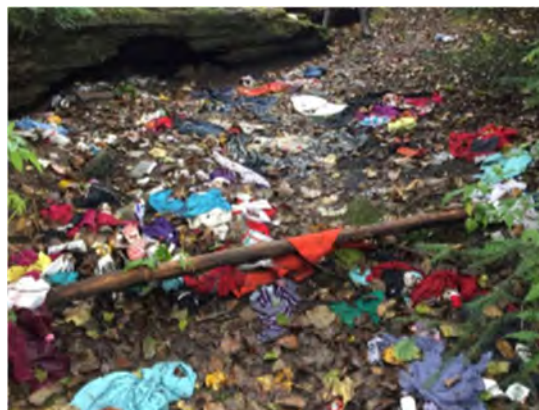
**Figure 20.** Example of litter found along Jordan Creek. This site is on lower Jordan Creek, just downstream of Egan Drive.

Jordan Creek was listed as impaired for residues based on professional judgment. Due to this, a technical analysis of data to evaluate any improvements is not possible. Areas along Jordan Creek continue to have problems with litter and debris that do not meet the WQS criterion (Figures 20 and 21). Litter and debris observed in Jordan Creek throughout the years include lumber scraps, plywood, paper, plastics, glass, metal, household garbage, clothing, and hazardous items such as fuel containers, batteries, and abandoned cars.

The primary sources of debris in the creek are direct inputs from littering or dumping, and indirect inputs from residential, commercial, and industrial areas where litter or loose or improperly stored garbage can be carried into the creek by wind, snowmelt, runoff, or wildlife. Littering is a chronic problem where roads and buildings are close to the creek, but is especially pronounced near food and convenience store businesses in the lower portion of the creek. Litter is also commonly associated with illegal campsites and dumps sites that occur throughout the watershed.

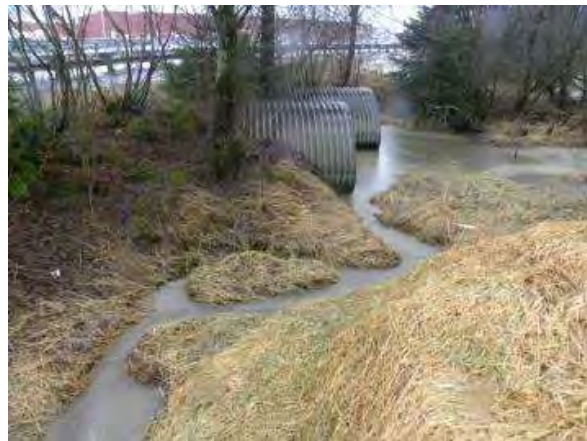
**Figure 22.** Turbid stormwater discharges to Jordan Creek from the Crest Street ditch near Yandukin Drive. Photo Courtesy of John Hudson.

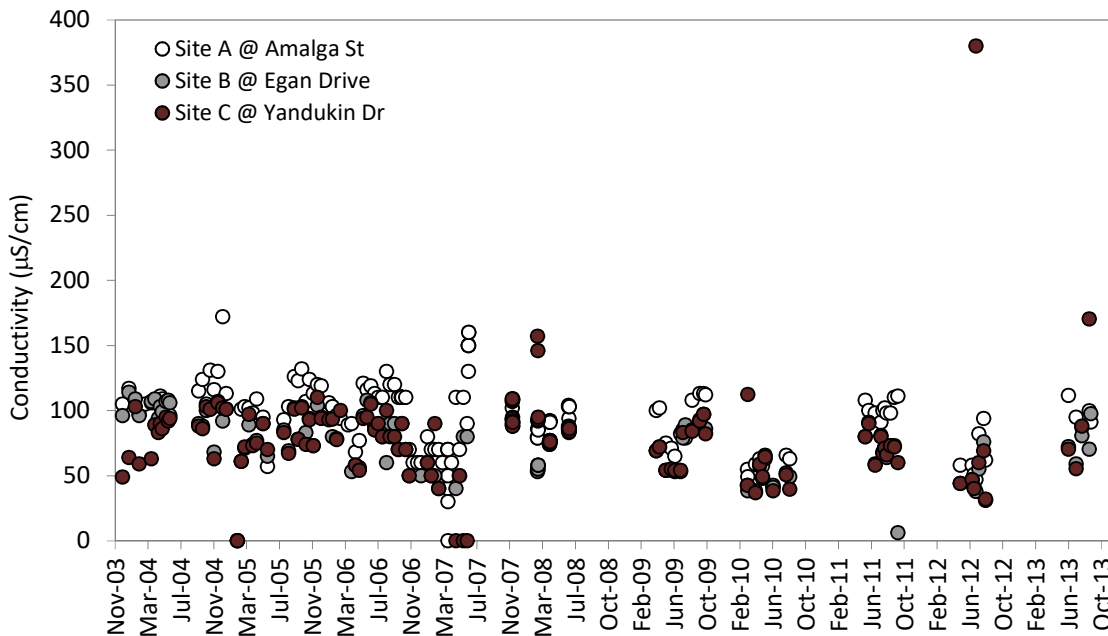
**Figure 25.** Specific conductance measurements at three sites on Jordan Creek between November 2003 and October 2013.

The state has not outlined specific WQS for conductivity. Values for conductivity measured on Jordan Creek ranged from -0.04 to as high as 380 micro-Siemens per centimeter ( $\mu\text{S}/\text{cm}$ ) over the 10-year period. The overall 10-year average is about 84  $\mu\text{S}/\text{cm}$ . The high conductivity values are likely reflective of the urban uses of the watershed. Nagorski et al (2004) noted that conductivity measurements were twice that measured for Montana Creek, which has not been as impacted by urban development.

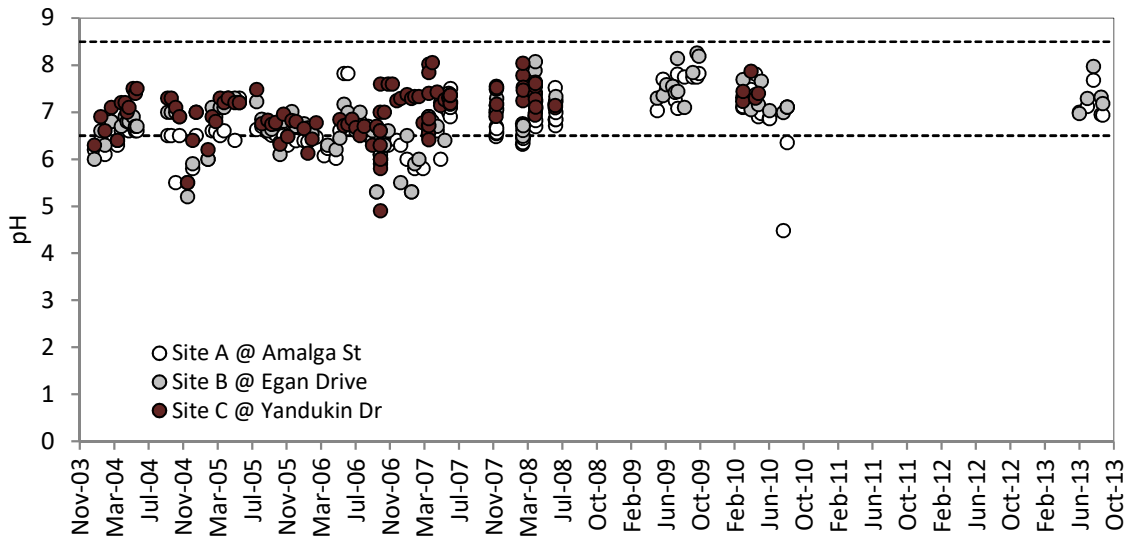
**Figure 30.** pH measurements at three sites on Jordan Creek between November 2003 and October 2013. The Water Quality Standard requires waters to be between 6.5 and 8.5, shown by the dashed lines.

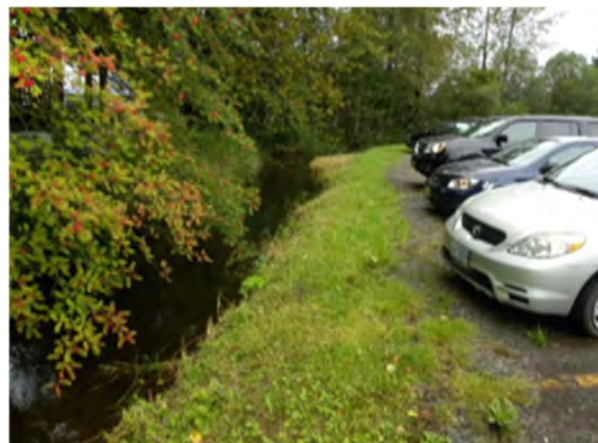
**Figure 37.** An example of an encroaching parking lot on lower Jordan Creek.

The upper watershed still has its riparian areas intact, and at least part of it is protected as state and federal public land holdings. However, development in the lower watershed encroaches on the stream and has resulted in loss or alteration of much of the riparian area (Figure 37). This is a concern for the lower watershed as it can be contributing to poor instream habitat and water quality problems.

According to a 2003 habitat survey conducted on Jordan Creek by the ADF&G, riparian disturbance affected nearly half (2.81 km) of the entire surveyed area (5.87 km). Urban/commercial landscaping was the most commonly observed riparian disturbance, with all occurrences noted between the airport and Egan Highway.

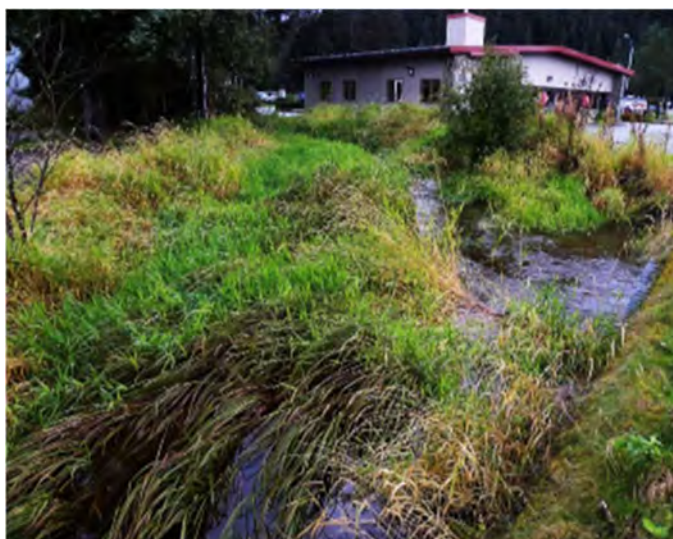
**Figure 38.** Reed canarygrass constricting the channel of Jordan Creek and blocking flow from passing through one of the Glacier Highway culverts.

Reed canary grass is currently the greatest threat as it is one of the most prevalent and highly invasive plants in the watershed, and is already impacting stream hydrology and habitat. It forms dense monocultures that displace native plant communities and constrict stream channels by promoting deposition of sediment. Such impacts can be seen throughout the lower Jordan Creek area. For example, the inlet to one of the Glacier Highway culverts is nearly blocked by reed canarygrass (Figure 38) and channel constriction is evident in the CBJ-owned greenbelt south of Jordan Avenue. Carson Dorn (2002) noted that channel constriction from “weeds” contributes to flooding problems in the lower watershed.

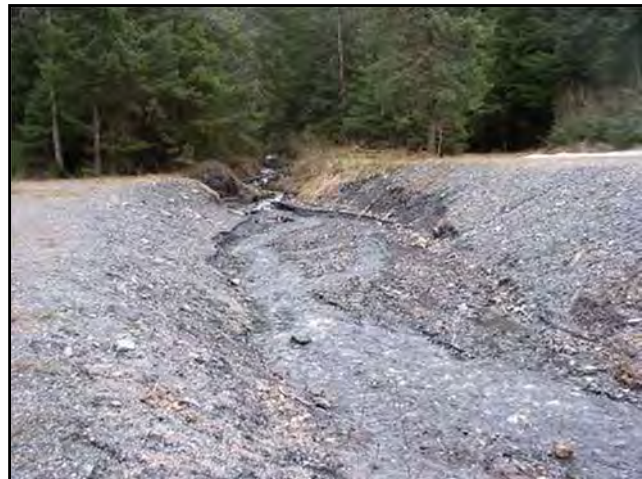
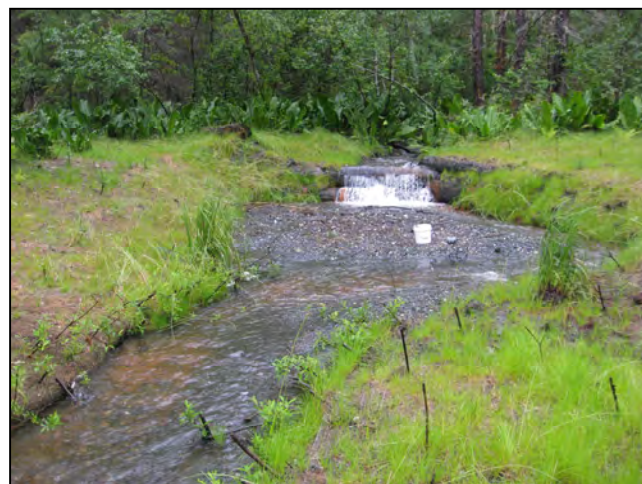
**Figure 40.** The East Valley Reservoir tributary before (above) and after (below) restoration. Photos from JWP's archives.

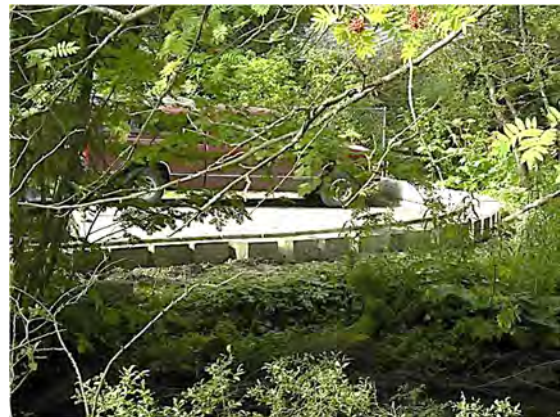
**Figure 41.** Successful streambank stabilization behind Race Realty. Photo from JWP Archives.

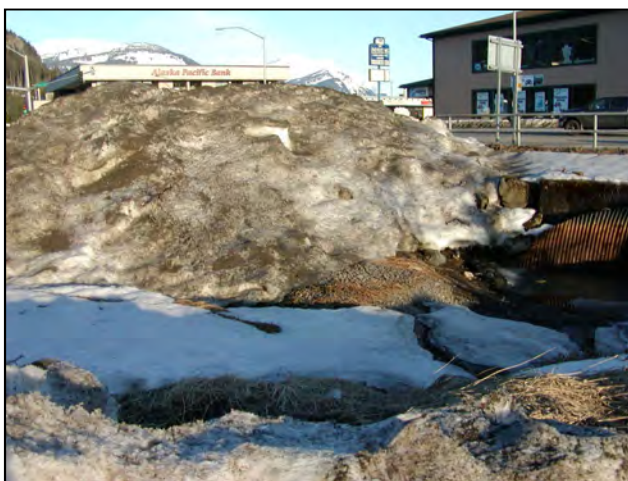
**Figure 42.** Snow being stored near Jordan Creek at Glacier Highway. The snow has been pushed into the creek and is depositing sediment in the streambed. Photo from JWP's archives.

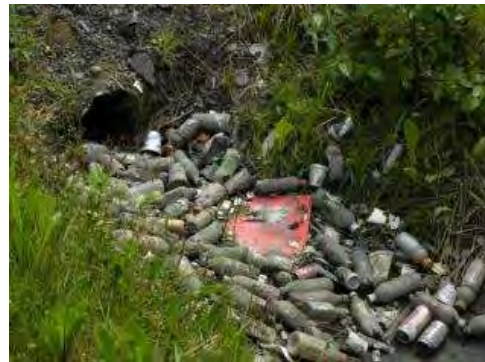
**Figure 43.** Garbage and sediment collected in the Trout Street ditch. Photo courtesy of John Hudson.
