ALASKA DEPARTMENT OF ENVIRONMENTAL CONSERVATION
Division of Spill Prevention and Response
Prevention Preparedness and Response Program
SITUATION REPORT (SITREP)

Port William Shuyak Island Bunker C Spill

SITREP #: 5

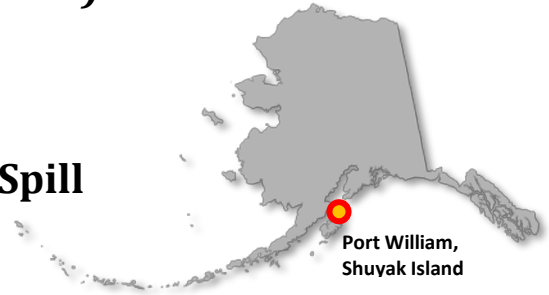
RESPONSE ACTION: **A total 3,550 feet** of oil spill containment boom has been deployed to contain the Bunker C oil within the immediate area of the collapsed structures. The boom continues to keep the Bunker C and debris from the collapsed structure within the inner ring of boom. Oil absorbent material has been placed inside of the hard boom and is successfully collecting oil at each tide cycle. To date, **351** bags of oiled absorbent material have been collected. Due to the collapse of the structure there is a large amount of contaminated debris that is collecting within the containment boom. **The incident management team has approved the salvage plan to remove the collapsed structure and large oil debris from the site. Collection of debris within the boom continues as weather permits. A multi-agency Shoreline Cleanup and Assessment Technique (SCAT) team has completed the initial evaluation of the impacted beach area on March 12 and 13 and is scheduled to continue the inspection and evaluation of cleanup techniques.**

FUTURE PLANS AND RECOMMENDATIONS: The salvage plan will be executed as soon as equipment is able to be mobilized to the location. Weather conditions have hampered response operations. Boom maintenance and collection of oiled absorbent material and beach cleanup operations continue as weather permits.

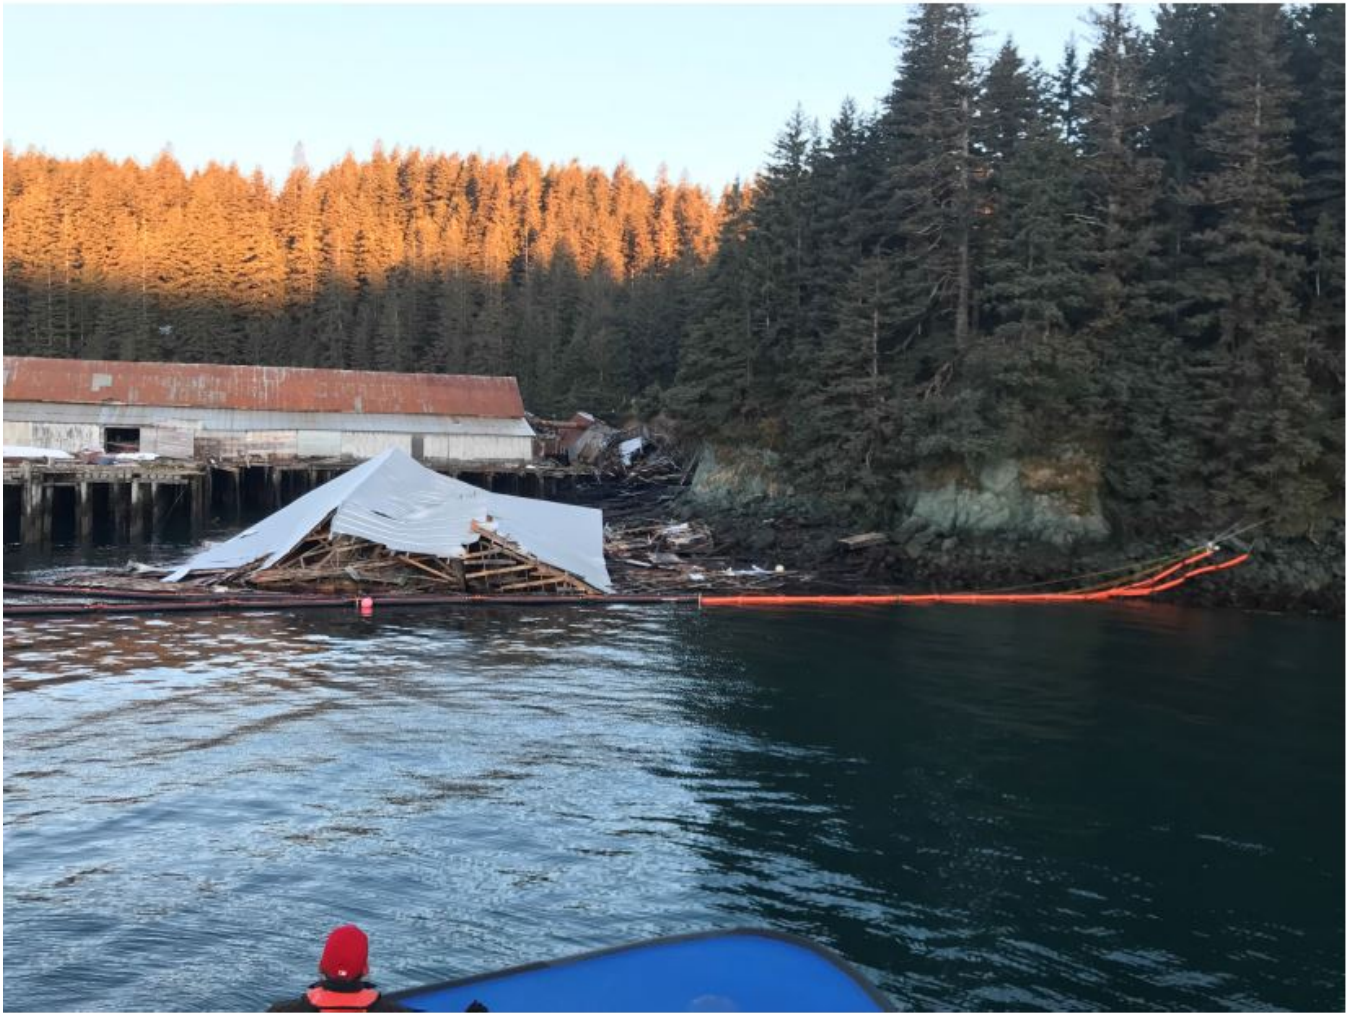
CAUSE OF SPILL: The dock structure supporting the building collapsed. This caused much of the building, along with the 3,000 gallon fuel bladder and the contents of building to fall to the shoreline and water below.

Photo of collapsed building containing bladder
Taken March 21, 2018 Photo credit: Global Diving and Salvage Inc.
