Re: Wrangell Byford Junkyard Cleanup

### **Background and activities to date**

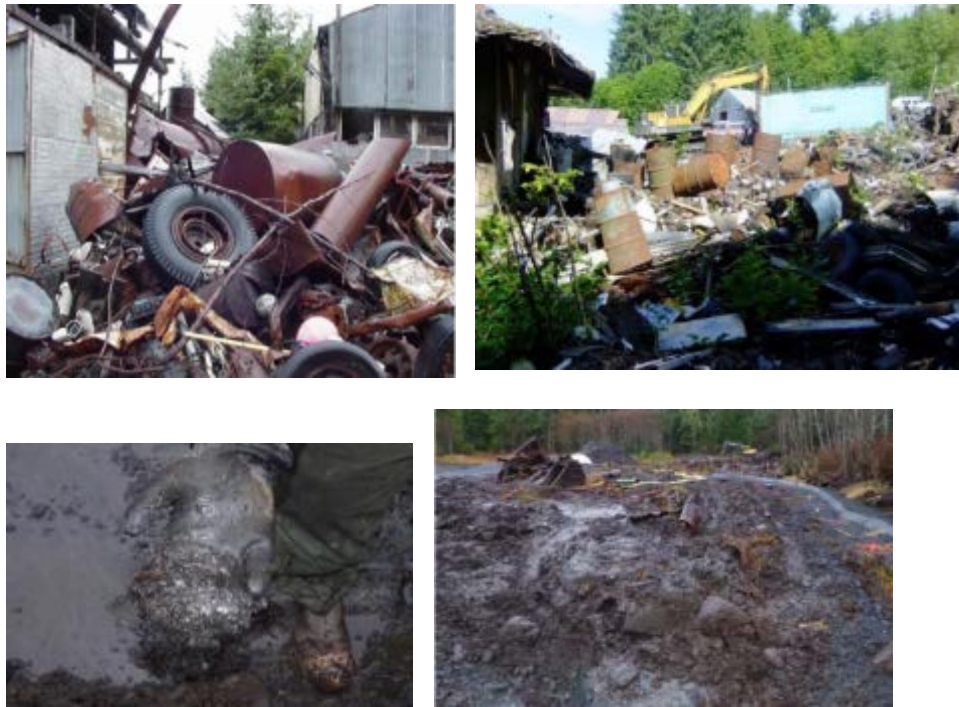
**Figure 1.**  
Wrangell Junkyard. Top two photos are from DEC website <https://dec.alaska.gov/spar/csp/sites/wrangell-junkyard>; Bottom two photos are from NRC, the cleanup contractor, from NRC updates March-July 2016.

The junkyard was known to have not only batteries, but also transformers, drum caches, and a burn area. Preliminary site characterizations were conducted in 2001 and 2002, with a thorough investigation in 2015.<sup>5</sup> Contaminants in concentrations greater than regulatory standards included

- At the debris pile, soil with antimony (Sb), arsenic (As), cadmium (Cd), chromium (Cr), lead (Pb), nickel (Ni), and thallium (Tl). Subsurface soil had these and copper (Cu), silver (Ag), and zinc (Zn).

- At the drum cache, soil had high As, Cr, Pb, mercury (Hg), Ni, diesel (DRO), and other hydrocarbons (PAHs) and toxic organic material (SVOCs). Subsurface soil only had high As, Cr and DRO.

- At the burn pile areas, soil had high Sb, As, Cd, Cr, Cu, Pb, Ni, Tl, Zn, DRO, PAHs, two SVOCs, and one PCB. Subsurface soil had As, Cd, Cr, Cu, Pb, and DRO. The burn pile was sampled in six different areas. All of the contaminants listed above were not detected in every sample, but in general most soil samples had high Sb, As, Cd, Cr, Cu, Pb and DROs and most subsurface soil had high Pb and Cr. Detection of organics (PAHs, SVOCs, PCBs) was rare.

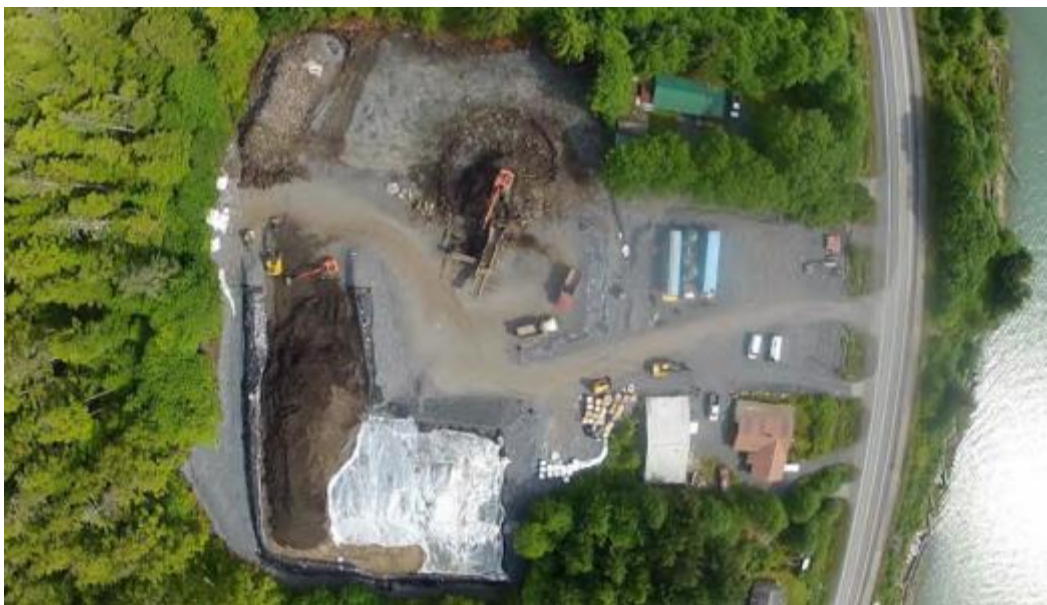
**Figure 2. Wrangell Junkyard with soil treatment, July 2016.** From NRC weekly updates March-July 2016.

Under the assumption that lead was the only contaminant of concern, soil was treated with a commercial product, EcoBond, to stabilize lead and reduce lead leaching after solid materials were removed and shipped off-site. EcoBond has apparently been used widely, including by DEC, at lead-contaminated sites. It contains phosphate ( $\text{PO}_4^{3-}$ ), which is attracted to lead (Pb).

Soil contaminated by batteries can have lead carbonates, lead sulfates, lead oxides as well as lead sorbed onto clay and organic matter that are natural components of the local soil.<sup>8</sup> Adding phosphate causes these lead compounds to dissolve more quickly; the dissolved lead is then available to make a strong lead-phosphate bond that is mostly insoluble (not likely to leach).<sup>9</sup> At this point, the soil is treated but has not been moved to a final repository.

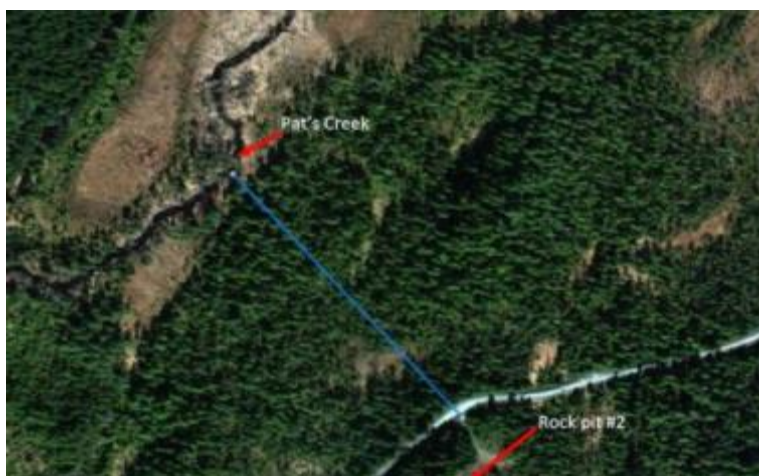
**Figure 4. Distance from quarry to Pat's Creek.** From DEC memo from Sally Schlichting, February 2 2018

The rock quarry area has a high water table. Landfills are not to be placed in such areas, unless they are kept two feet above the surface. For this reason, drainage rock has been placed on the floor of the quarry. The drainage slopes towards the entrance of the quarry, in the direction of Pat’s Creek Road. Pat’s Creek, an anadromous creek in a long valley, is 0.19 miles from the quarry and Pat’s Lake is 0.9 miles away.<sup>15</sup>

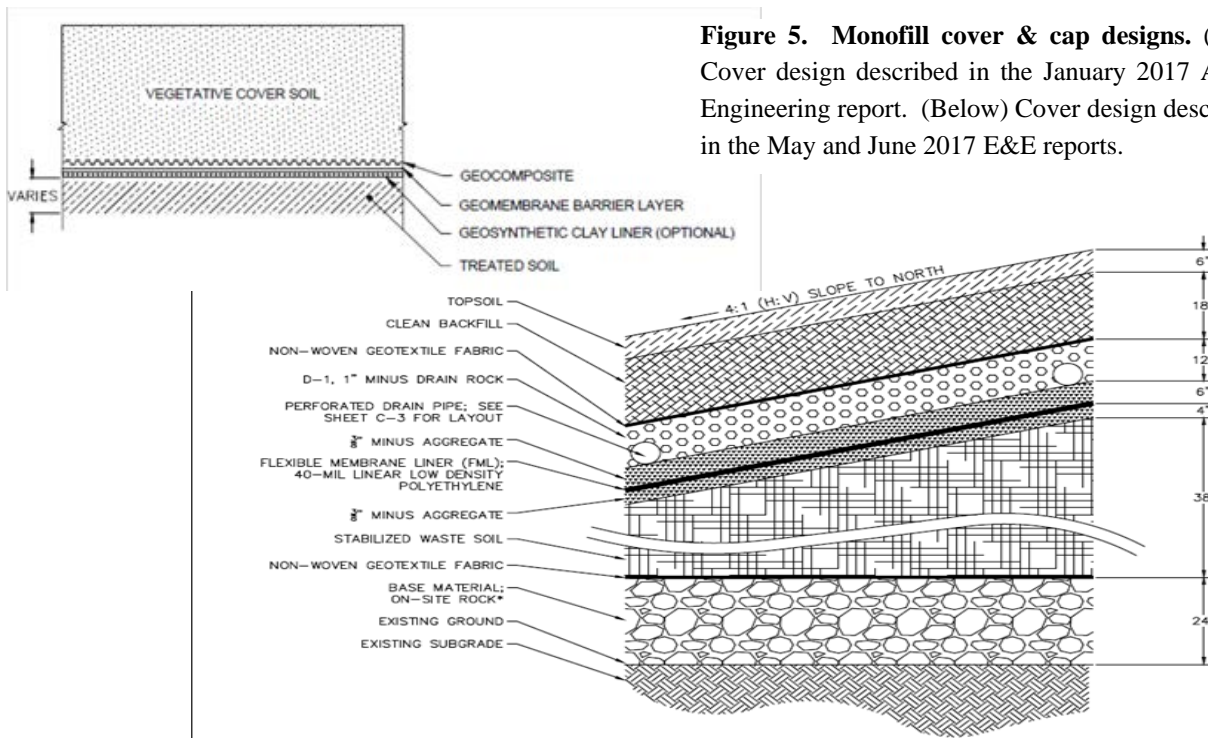
**Figure 5. Monofill cover & cap designs.** (Left) Cover design described in the January 2017 Ahtna Engineering report. (Below) Cover design described in the May and June 2017 E&E reports.

January 2017 Ahtna report described the cap as consisting, from the soil up, of a geosynthetic clay liner (GCL) covered with a 60 mil HDPE liner, with geotextile above that and topped with two feet of soil that would be vegetated. The clay and HDPE liners limit water from reaching the soil; vegetation acts to prevent erosion and provide evapotranspiration for some of the rain and snow. A detailed infiltration analysis was conducted. The cover with the GCL should only allow about one gallon of surface water per acre per year to infiltrate into the treated soil; however if the

GCL is not used, the infiltration could be around 280 gallons per acre per year. HDPE liners are rolls of material welded together at the seams; they perform best when there are no gaps, tears, or cracks, which in turn require folds and wrinkles in the rolls to be smoothed.

The May 2017 E&E Design report<sup>18</sup> has replaced the geosynthetic clay liner with four inches of 3/8" aggregate, and replaces the 60 mil HDPE with a thinner 40 mil LLDPE barrier. It adds perforated drainage pipe embedded in another layer of 3/8" aggregate and D-1 drain rock. It keeps the upper layer of geotextile and soil with vegetation. The E&E report states that the 40 mil LLDPE barrier "will easily meet" the legal requirements for limiting infiltration<sup>19</sup> but there is no clear table describing seepage rates as there was in the Ahtna report. The detailed infiltration analysis appears to have been done for uncovered soil with a result of 780 gallons per acre infiltrating per *day*, or 72,200 gallons per acre per year. The attachment with outputs of the infiltration model was not accompanied by a clear table of results that the layman could understand.

Two covers were discussed in documents. Essentially DEC appears to have replaced the GCL barrier of the 2017 Ahtna report with a drainage pipe and the HDPE barrier with a more flexible LLDPE barrier that is less susceptible to cracks and tears. However, it was the GCL barrier that really kept rainwater from infiltrating into the soil pile. I would think that the GCL layer tied into chimney rock would provide sufficient drainage, and do a better job of keeping water away from the treated soil. If drainage pipe provides an advantage, what would be the cost of placing both drainage pipe and GCL within the cover?

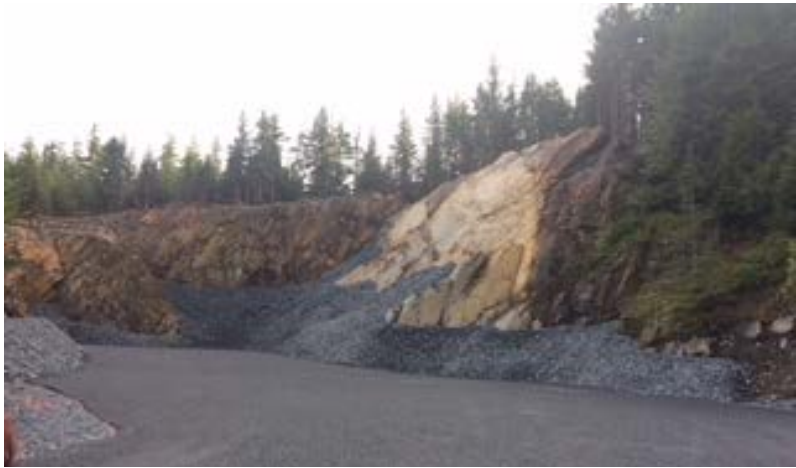
**Figure 6. Rock Pit #2, prepared for soil placement.** Aggregate has been placed on the floor of the quarry to create a smooth surface for soil placement. Some Chimney Rock for drainage has been placed. Photo by Chris Hatton, Wrangell Cooperative Association IGAP.

The quarry floor has already been covered with drainage rock, and the beginning of chimney drain rock has been placed. Additional rock to build the monofill is expected to come from the berm currently surrounding the stockpiled soil<sup>20</sup> or the BW quarry; BW quarry rock will be sprayed with herbicide before placement to reduce the risk of transporting invasive species like hawkweed.<sup>21</sup>

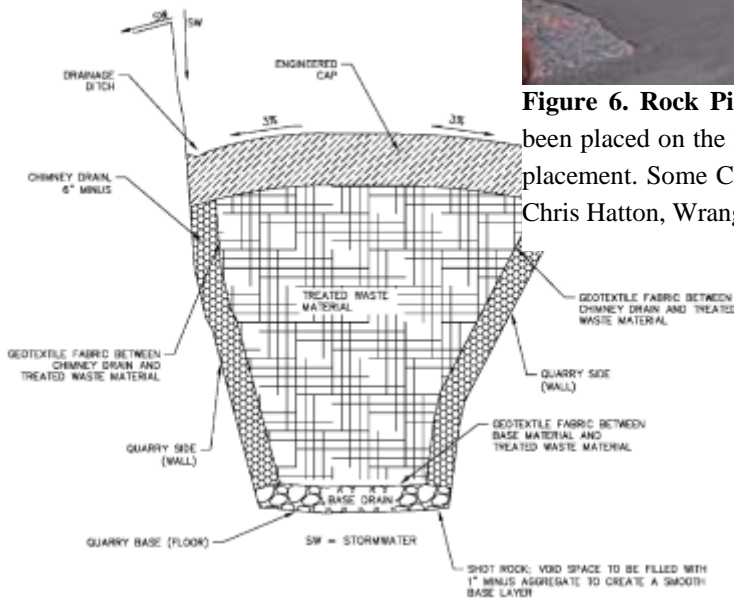
**Figure 7. Monofill drainage design.** From E&E 2017.

The design does not include a liner or a liner/leachate system. The cost for such a system is minimal, about \$135,000.<sup>22</sup> The reasons for not incorporating this in the design were that a liner would collect water and be subject to freeze-thaw action that could cause cracking and leakage, and a liner/leachate system would require thousands of feet of pipe to collect the leachate. The design without the liner/leachate system was expected to allow

The monofill is designed to direct stormwater runoff off the cover into a French drain that would split, with drainage apparently discharging near the mouth of the quarry and through a culvert on the opposite side of Pat’s Creek Road.<sup>25</sup> This information is provided in a single figure in the Monofill Baseline Sampling report; site inspection and Basis of Design drawings provide no information on the final outfall for drainage. There is no estimate of the monthly or seasonal drainage flow at the outfall in any documents I reviewed.

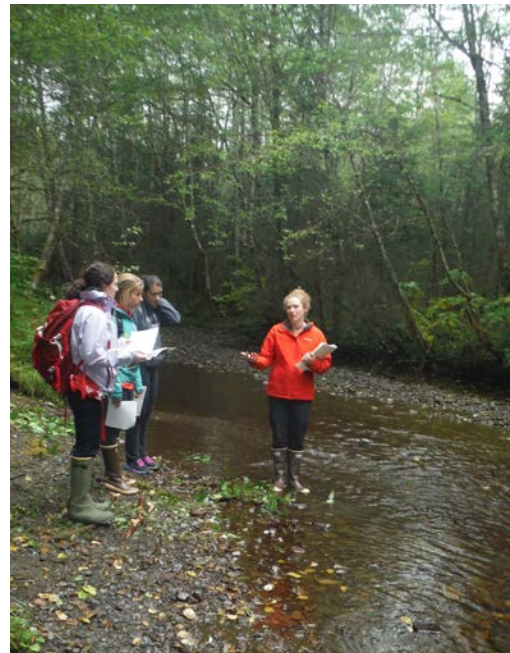
**Figure 8. Pat's Creek.** Photo from Kim Wickman, Wrangell Cooperative Association IGAP.

The potentially fractured rock of the quarry floor and the intent to divert surface drainage to or near a salmon stream are ecological risks. Backup plans are necessary to address the “What if”. What if – lead or phosphate or arsenic are determined to be increasing at the culvert outfall? What if – soil porewater seeps below drainage rock into groundwater?

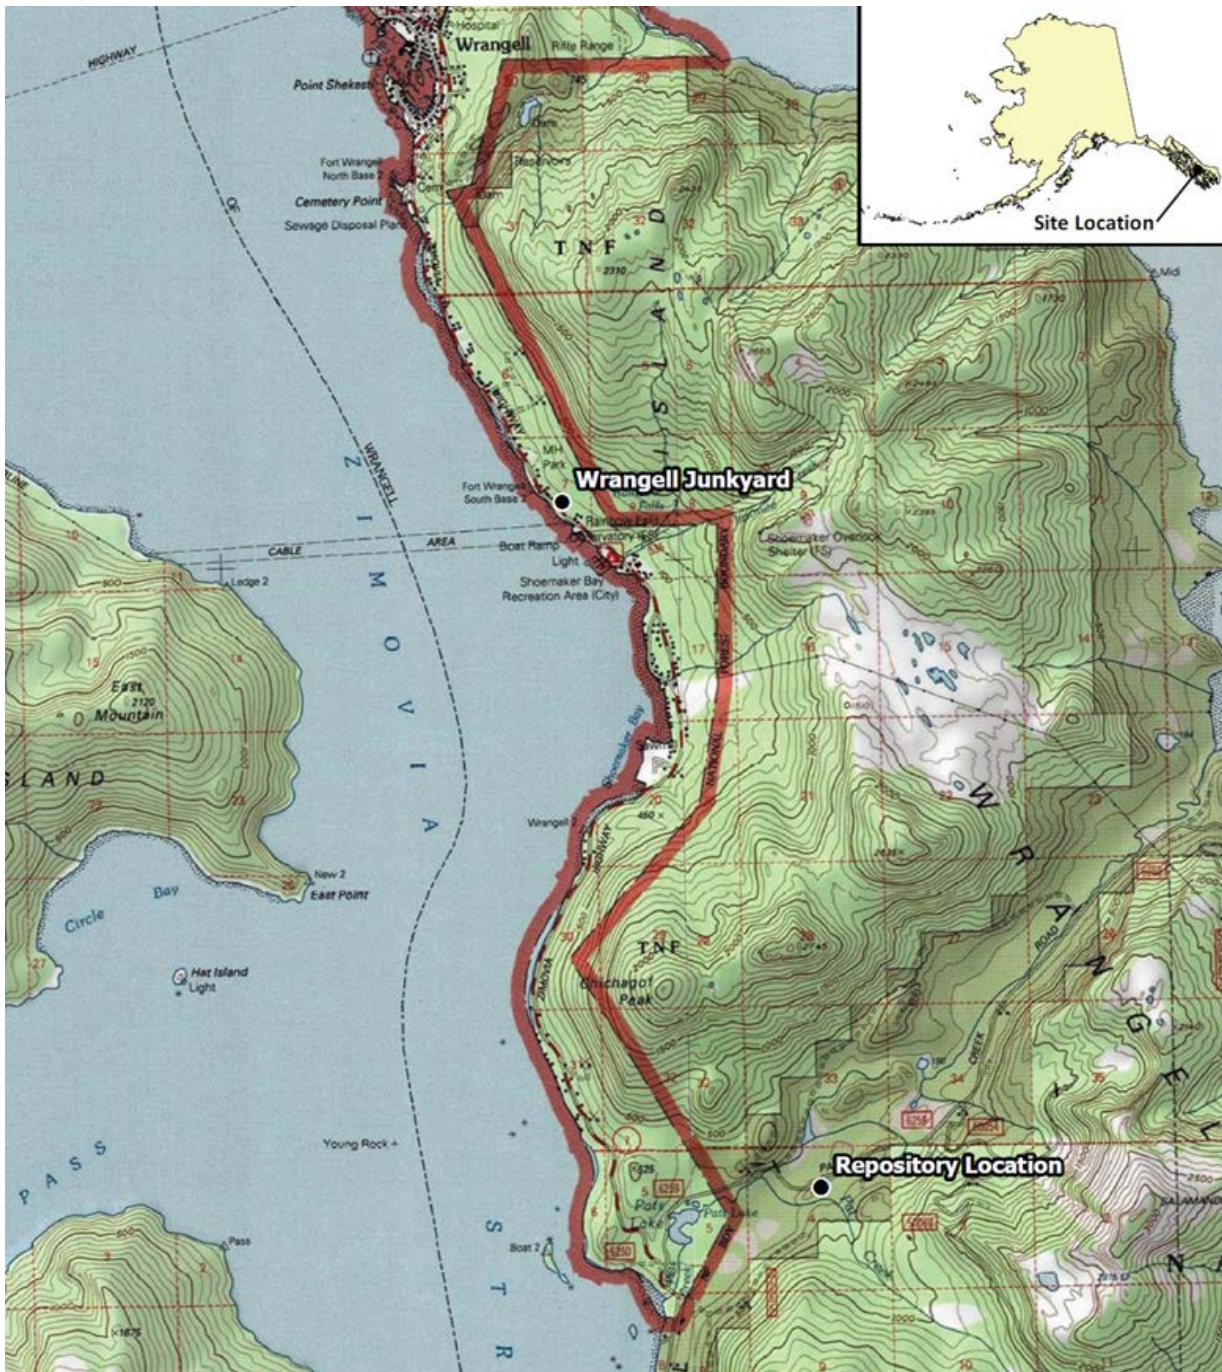
**Attachment: Rock Pit #2 location and photos**

From E&E Basis of Design report, June 2017

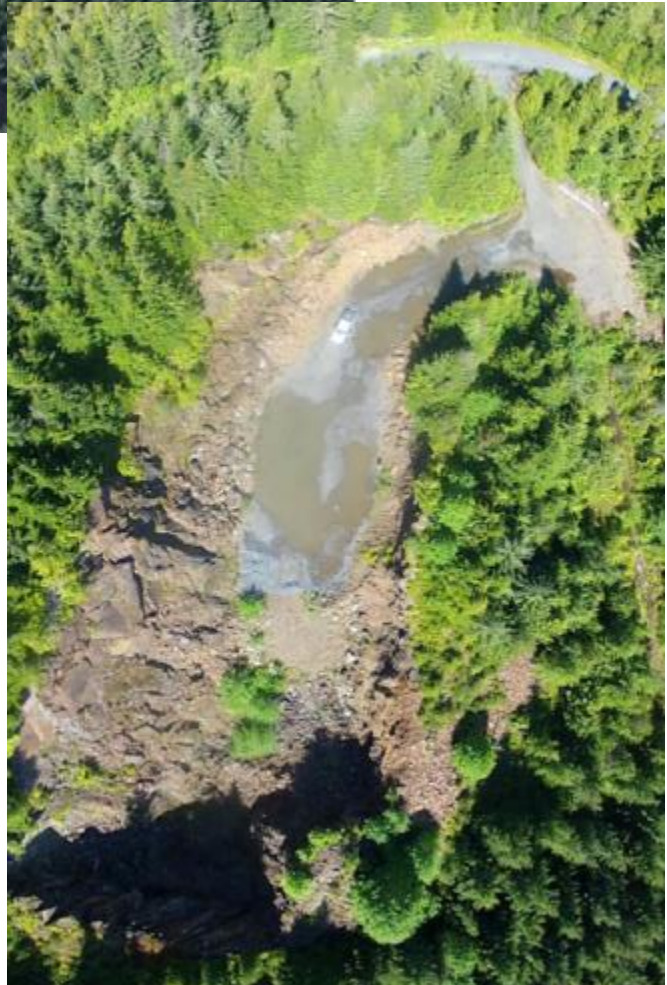
**Attachment: Monitoring well at Rock Pit #2.** Monofill design showing direction of drainage. The top of the page represents “East” direction. At the mouth of the quarry on the eastern wall is the remaining monitoring well. Two decommissioned wells are noted as red circles in the quarry. Teal colored arrows represent the direction of groundwater flow. Blue arrows represent the direction of drainage along chimney rock and out the French drain and culvert; drainage splits and appears to discharge directly out the French drain to the northeast of the quarry and goes through a culvert under Pat’s Road to discharge to the northwest of the quarry. From Nortech 2017. Diagram by PDC Engineers, Topographic Survey Plan “Base Course” Wrangell Monofill.
