EDWARD K. THOMAS BUILDING
JORDAN CREEK
GREEN INFRASTRUCTURE PROJECT
FINAL REPORT

JUNEAU WATERSHED PARTNERSHIP

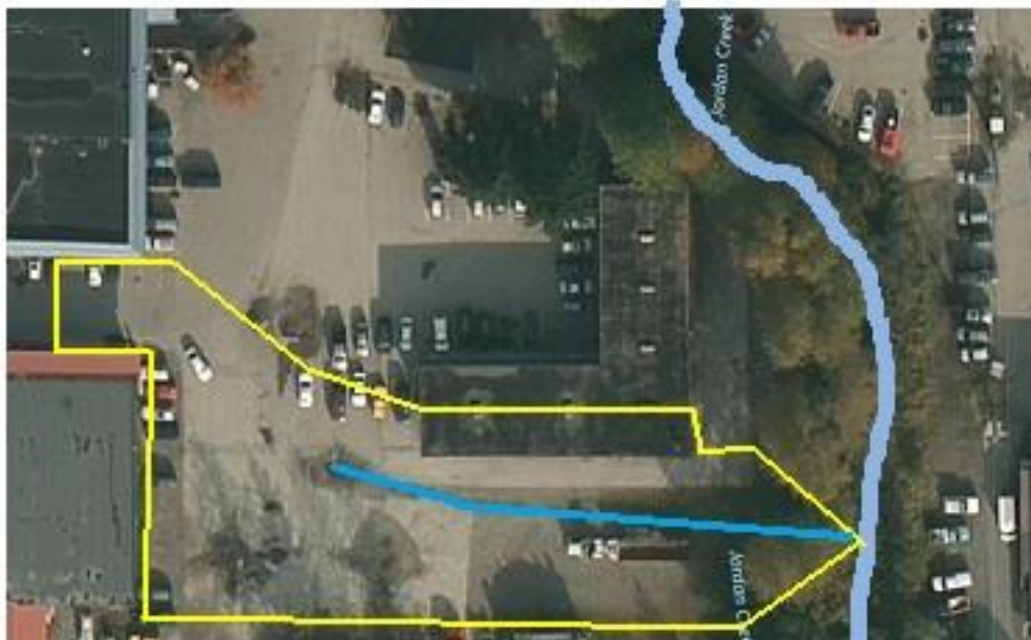
Figure 3. The Edward K Thomas Building project site showing the area contributing to the stormwater discharging to Jordan Creek in yellow.

Due to pavement wearing and setting, stormwater from the adjoining paved surfaces circumvents the storm sewer system, flows across the unpaved driver training area, and discharges untreated into Jordan Creek. The area contributing to the stormwater discharge is 36,000 ft² (0.83 acres) (Figure 3 and 4).

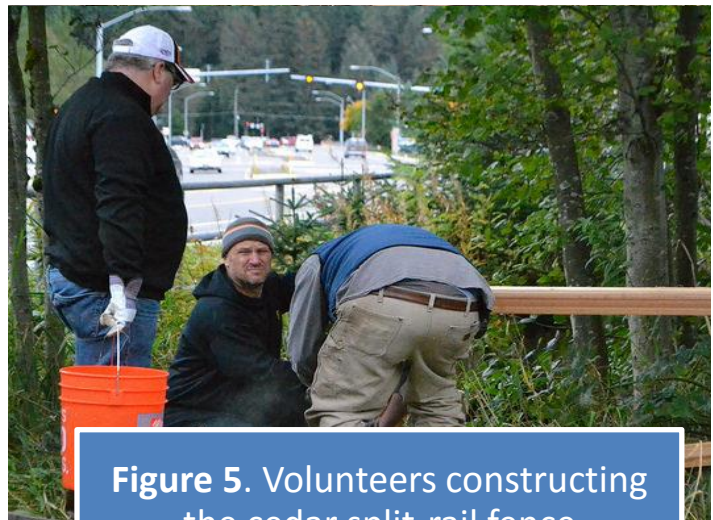
Figure 5. Volunteers constructing the cedar split-rail fence

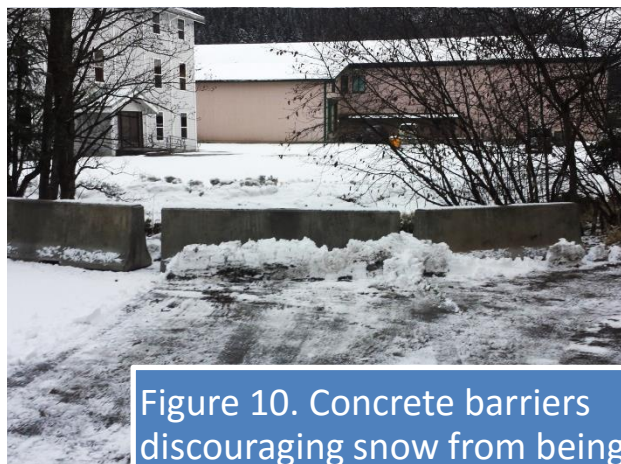
Figure 10. Concrete barriers discouraging snow from being plowed into the creek.

The other element of this project is the cedar split-rail fence and concrete barriers. These benefit Jordan Creek by discouraging snow from being plowed into the riparian area, reducing snow as a source of sediment and other pollutants. The concrete barriers were placed in the locations with the highest impact, where snow was most frequently pushed into the stream. Concrete barriers were also placed in front of the rain garden in order to protect it from the trucks using the adjacent parking lot. However, the barriers do not prevent a snow plow operator from lifting snow over the barrier, so on-going observation and discussions with CCHITA may be needed to ensure proper winter maintenance techniques.

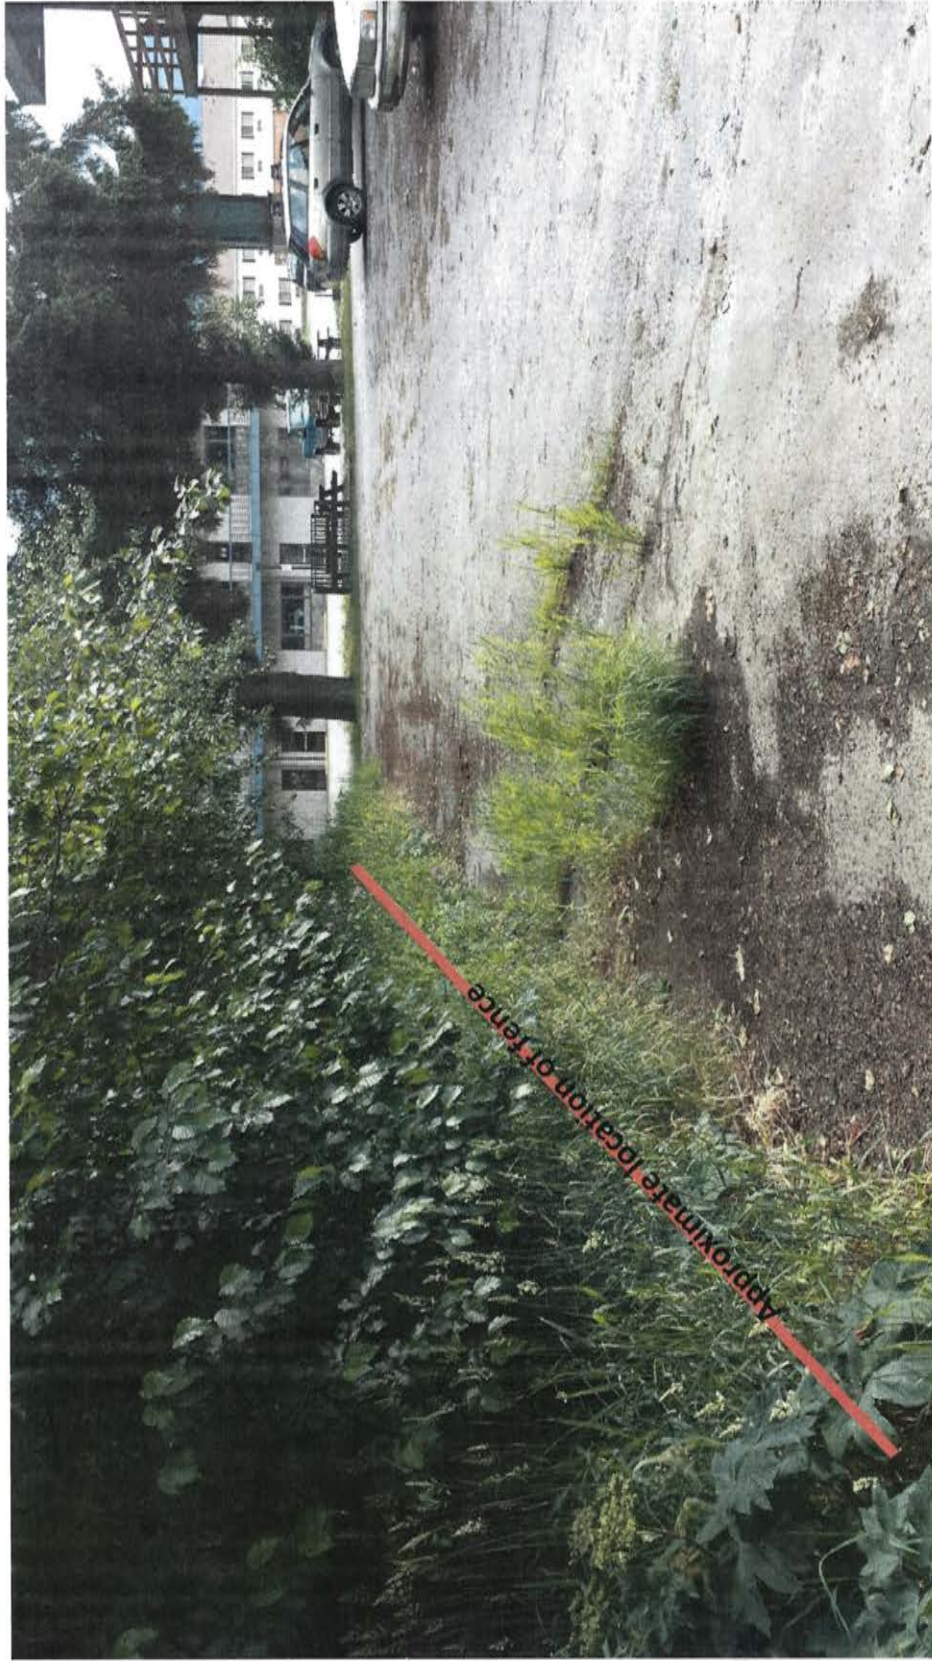
Figure 5. Northern most end of property, looking south. Split rail fence will be placed along the edge of pavement, in the vegetation, as shown.

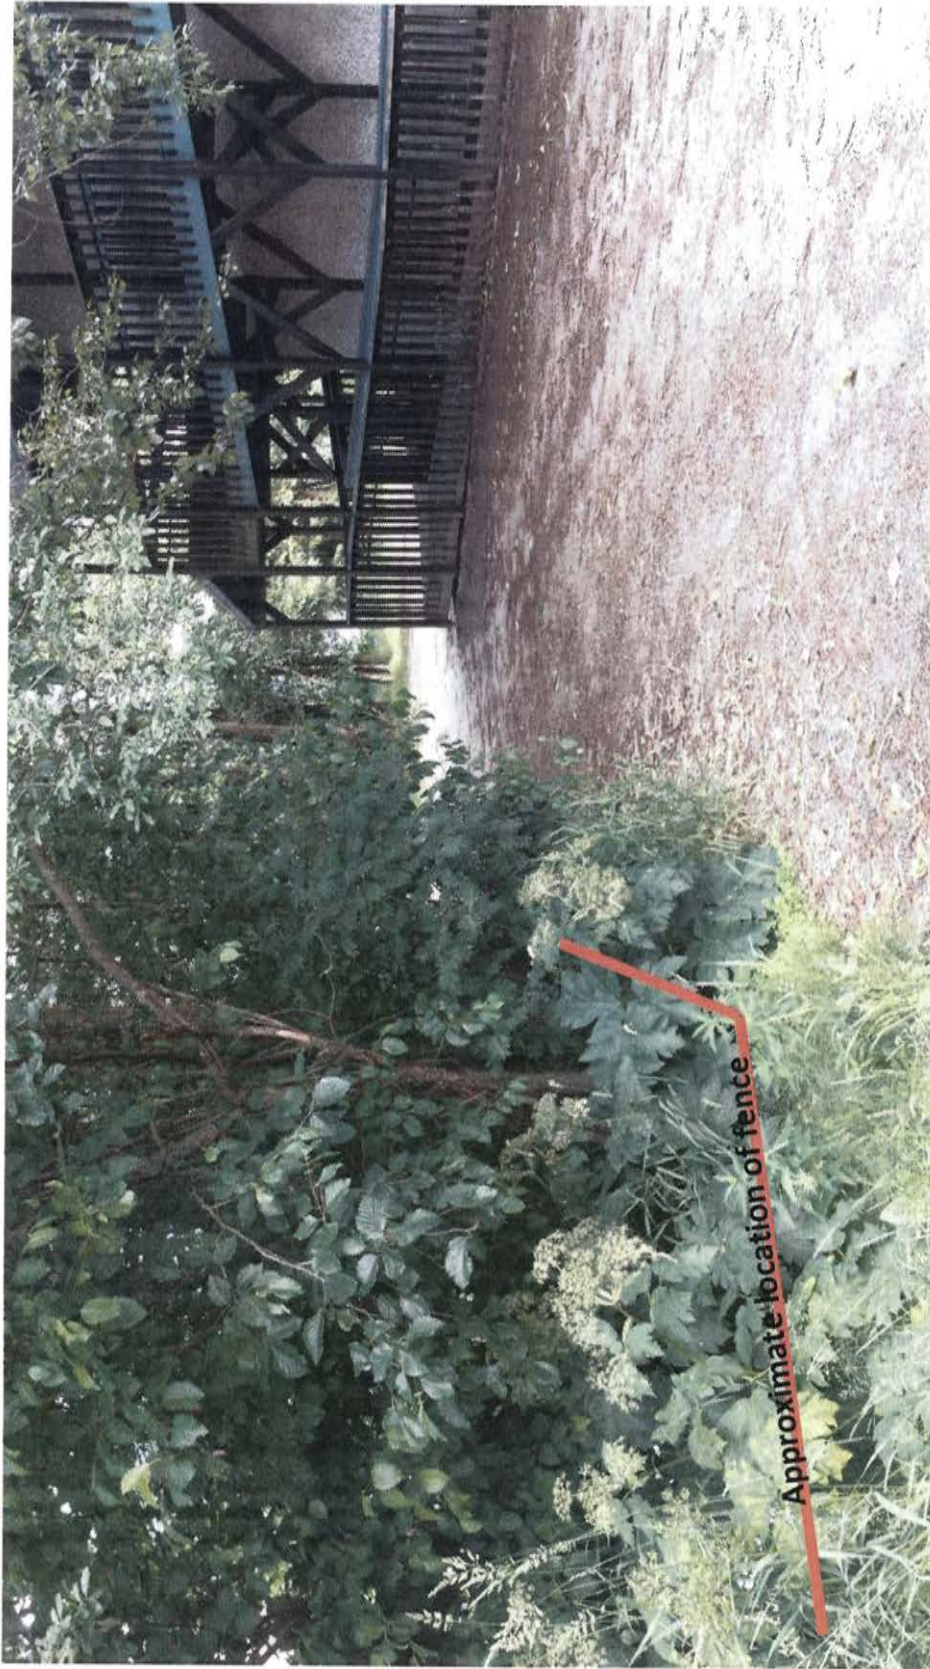
Figure 6. North side of the Edward K Thomas Building, looking east toward back parking lot. Concrete barrier will be placed along the edge of pavement within the vegetation on the corner at this location because snow is piled here and often is pushed into the stream.

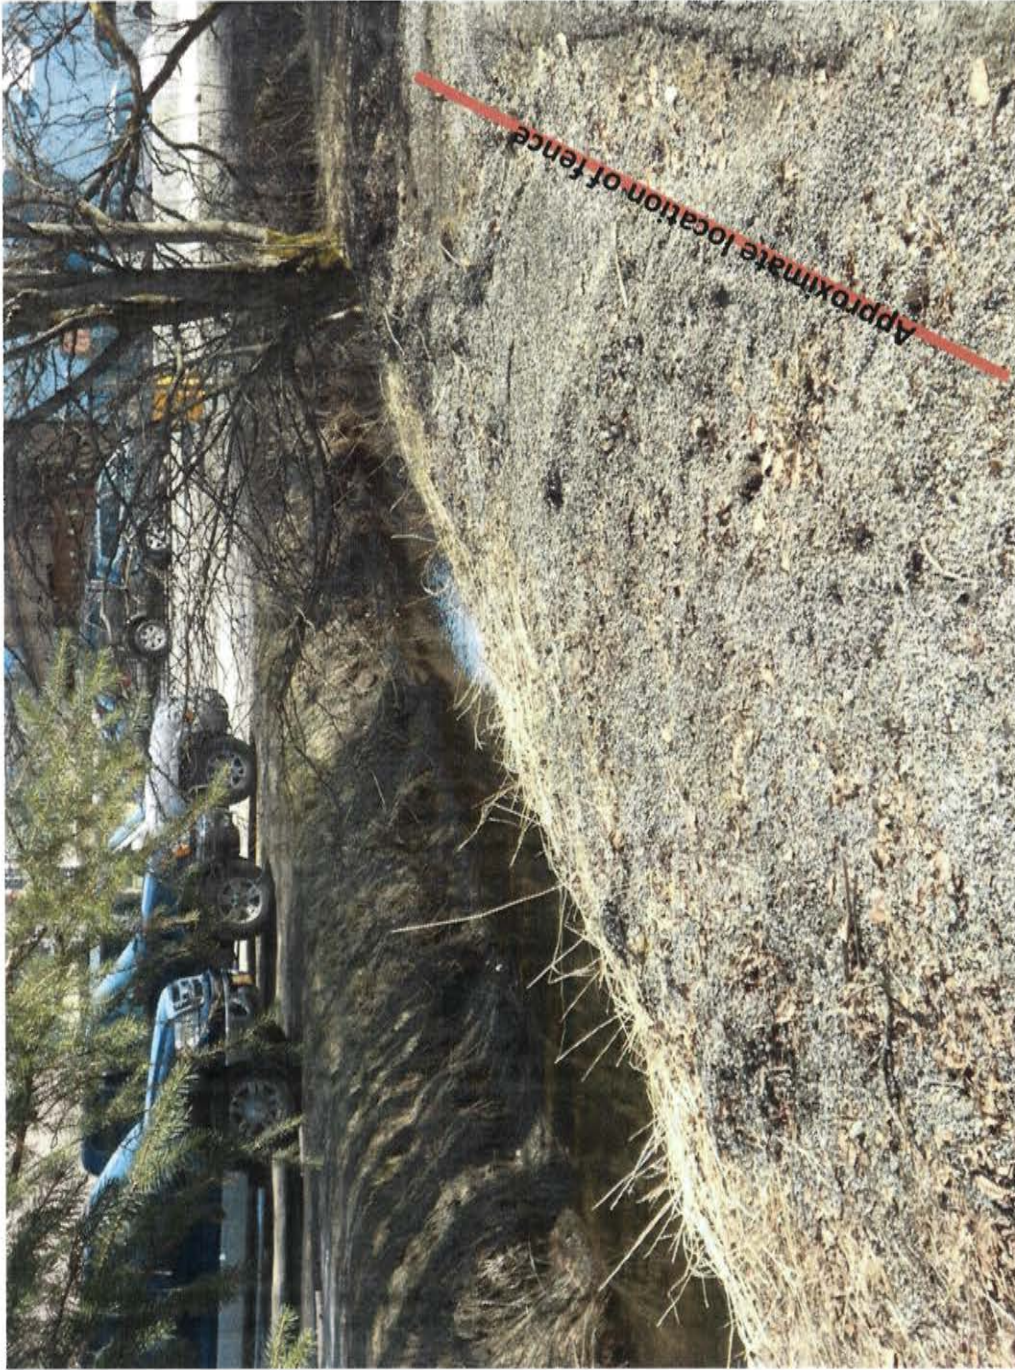
Figure 7. North side of the Edward K Thomas Building, looking east toward back parking lot. Concrete barrier will be placed along the edge of pavement within the vegetation (not yet emerged in this photo) due to risk of impact from plow; however, this length may be replaced with split rail fence depending on funds and land-owner preference.

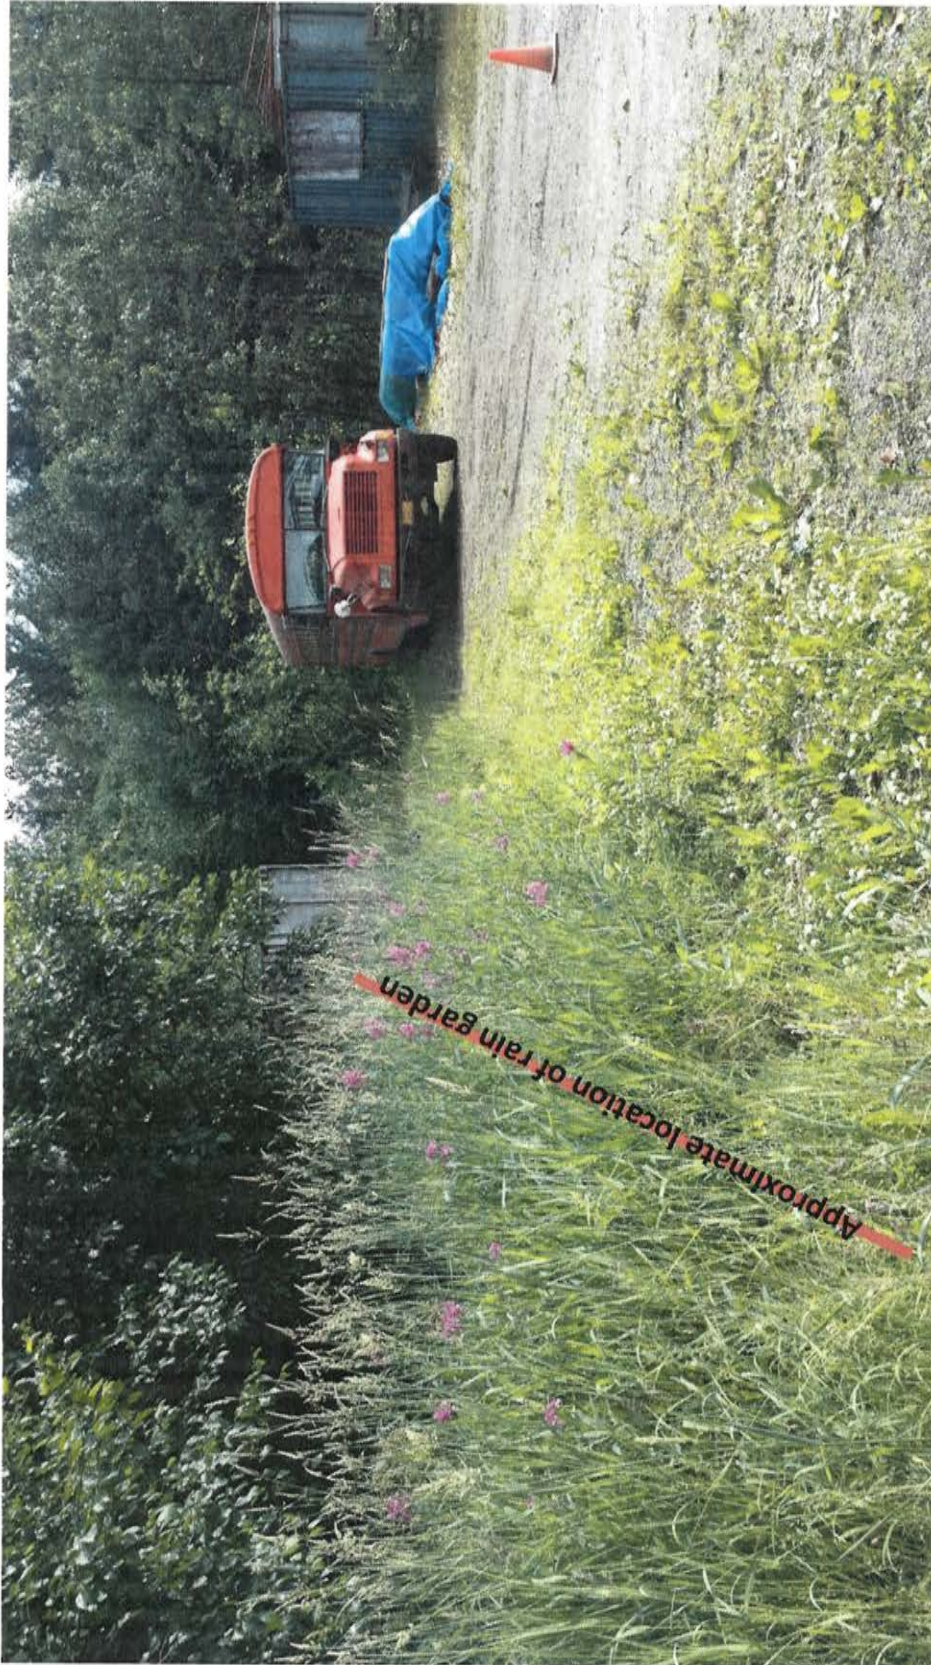
Figure 8. Edge of driver training area where the rain garden will be located. The rain garden will encompass the area from near the tree line to just outside the vegetated area. The length of the rain garden will end just before the connex in the background.

The rain garden will be within 35 to 50 feet from Jordan Creek. The rain garden will require approximately 270 yards of excavation and placement of approximately 120 yards of gravel and topsoil. Rain gardens are not specifically listed in the CBJ Manual of Stormwater Best Management Practices. However, the Infiltration Basin BMP states, "the basin can be designed as ... a shallow earthen rain garden." Therefore, the rain garden was sized according to the procedure outlined in the CBJ Manual for the Infiltration Basin BMP (attached). The calculated water quality design volume is approximately 3,368 ft³. The rain garden will be vegetated using native plants during construction and will be re-planted in the spring of 2016.

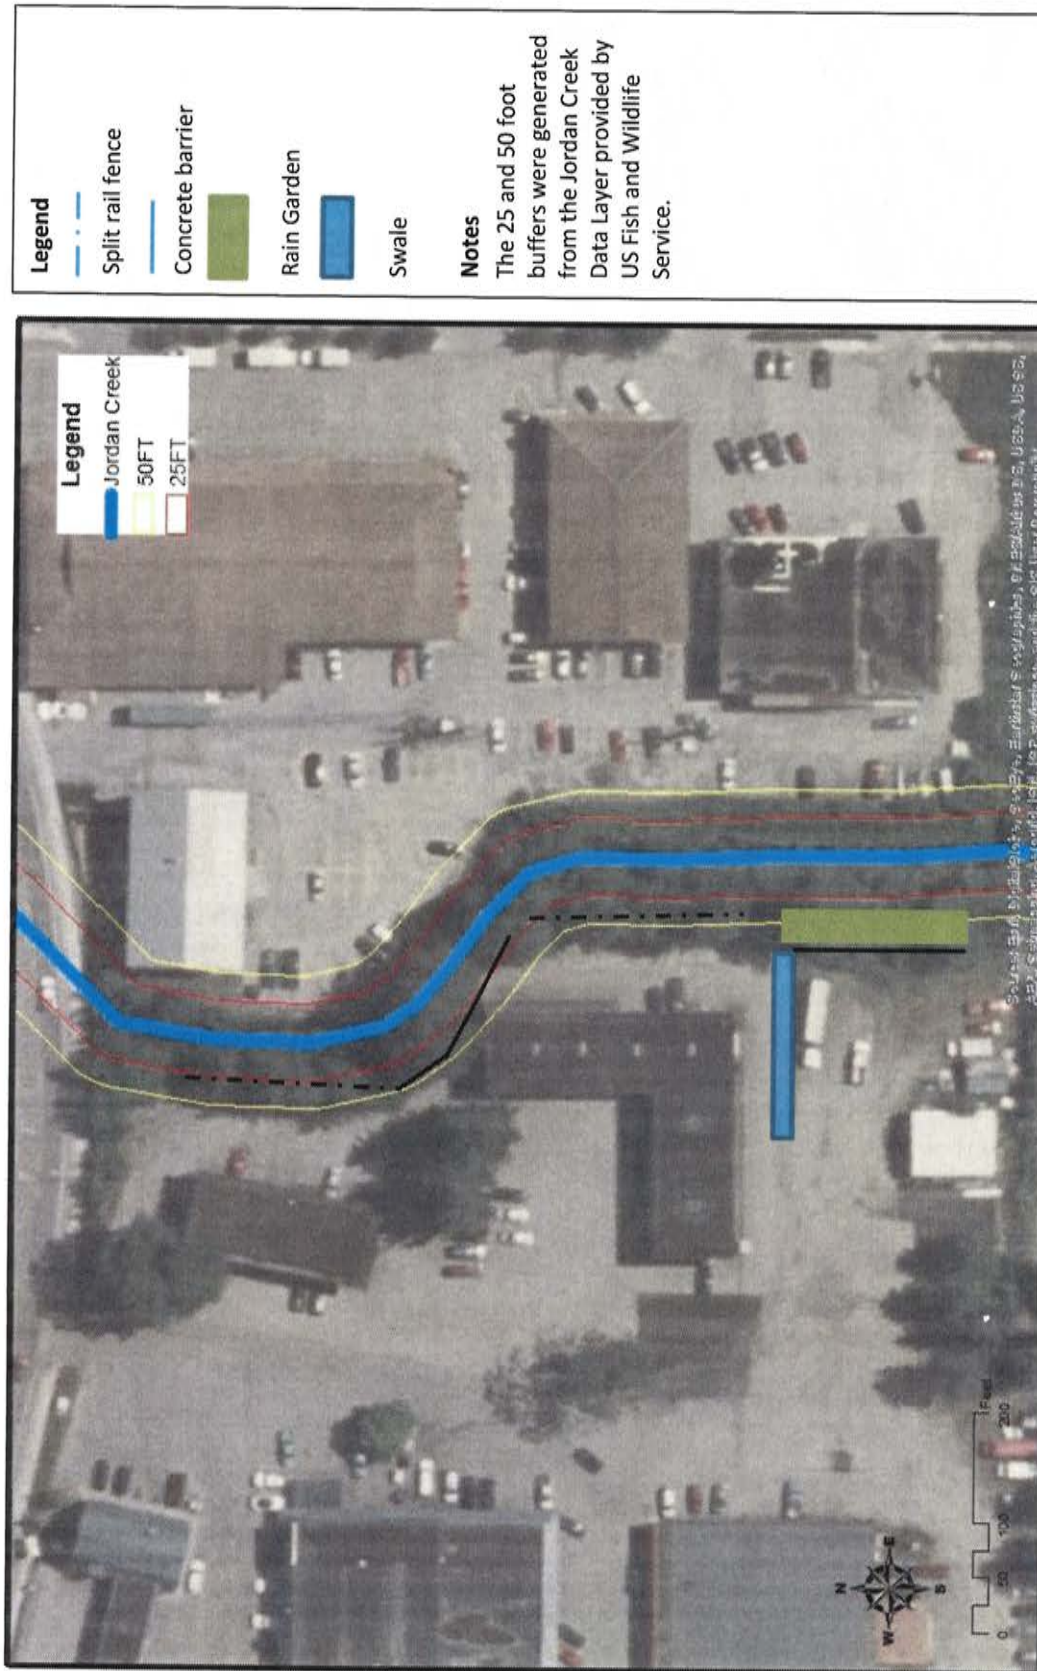
Figure 4. Plan Set showing the fence, rain garden and swale in relation to the Jordan Creek habitat setbacks.

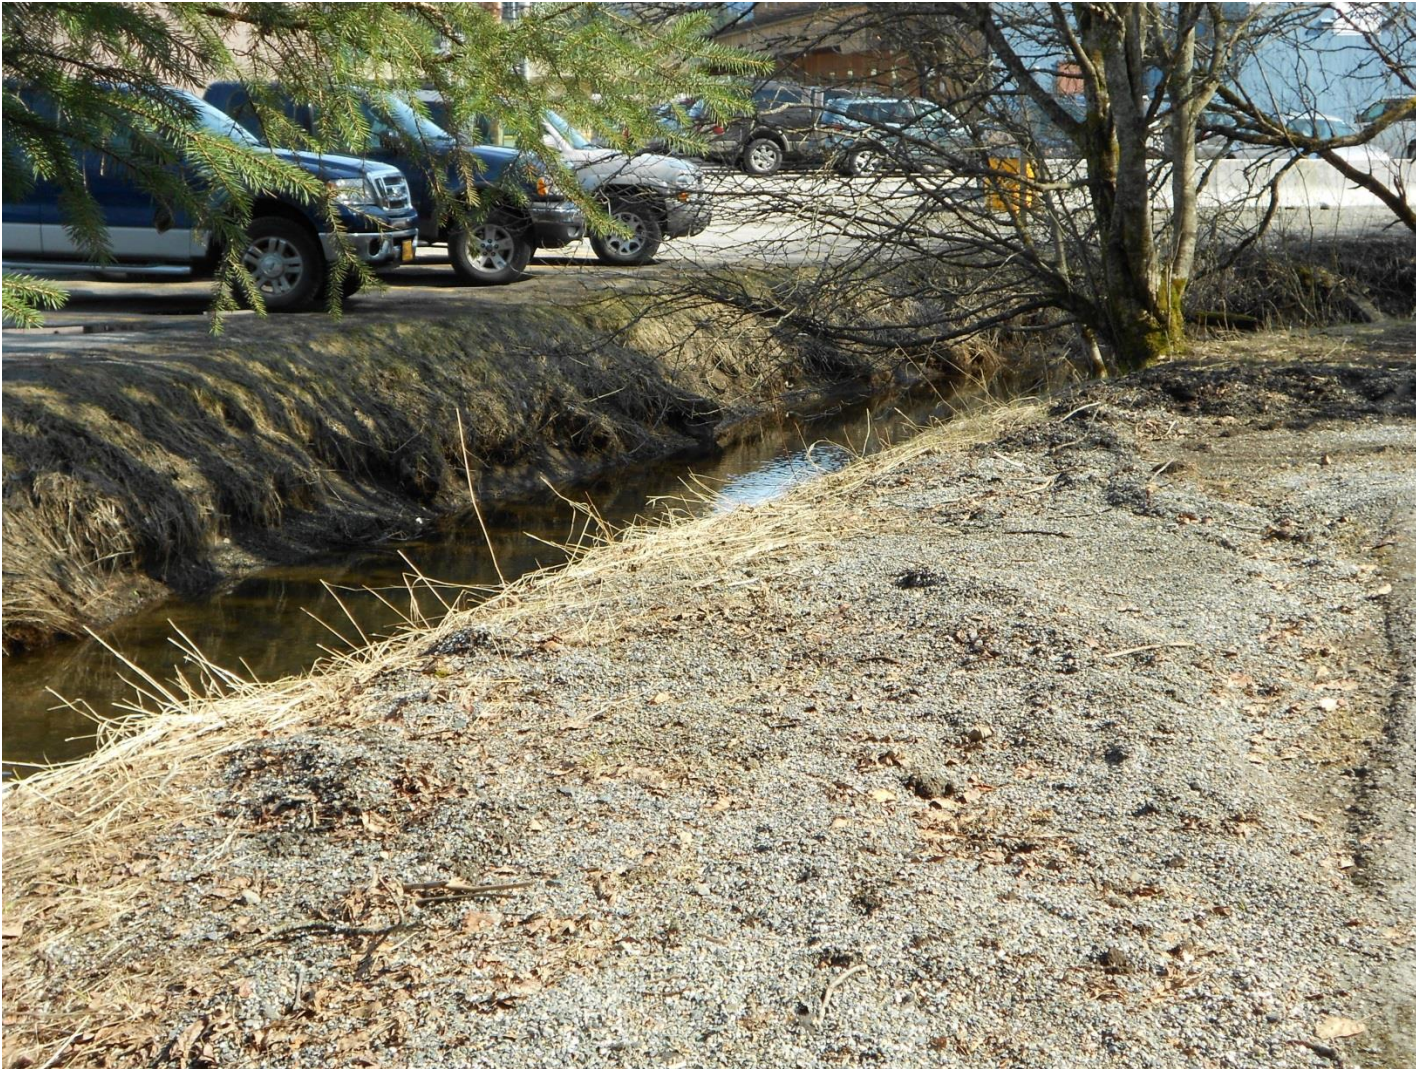
Figure 3. North side of the Edward K Thomas Building, looking east toward back parking lot. Note the sediment from melted snow. Vegetation not yet emerged. Photo taken April 2014.

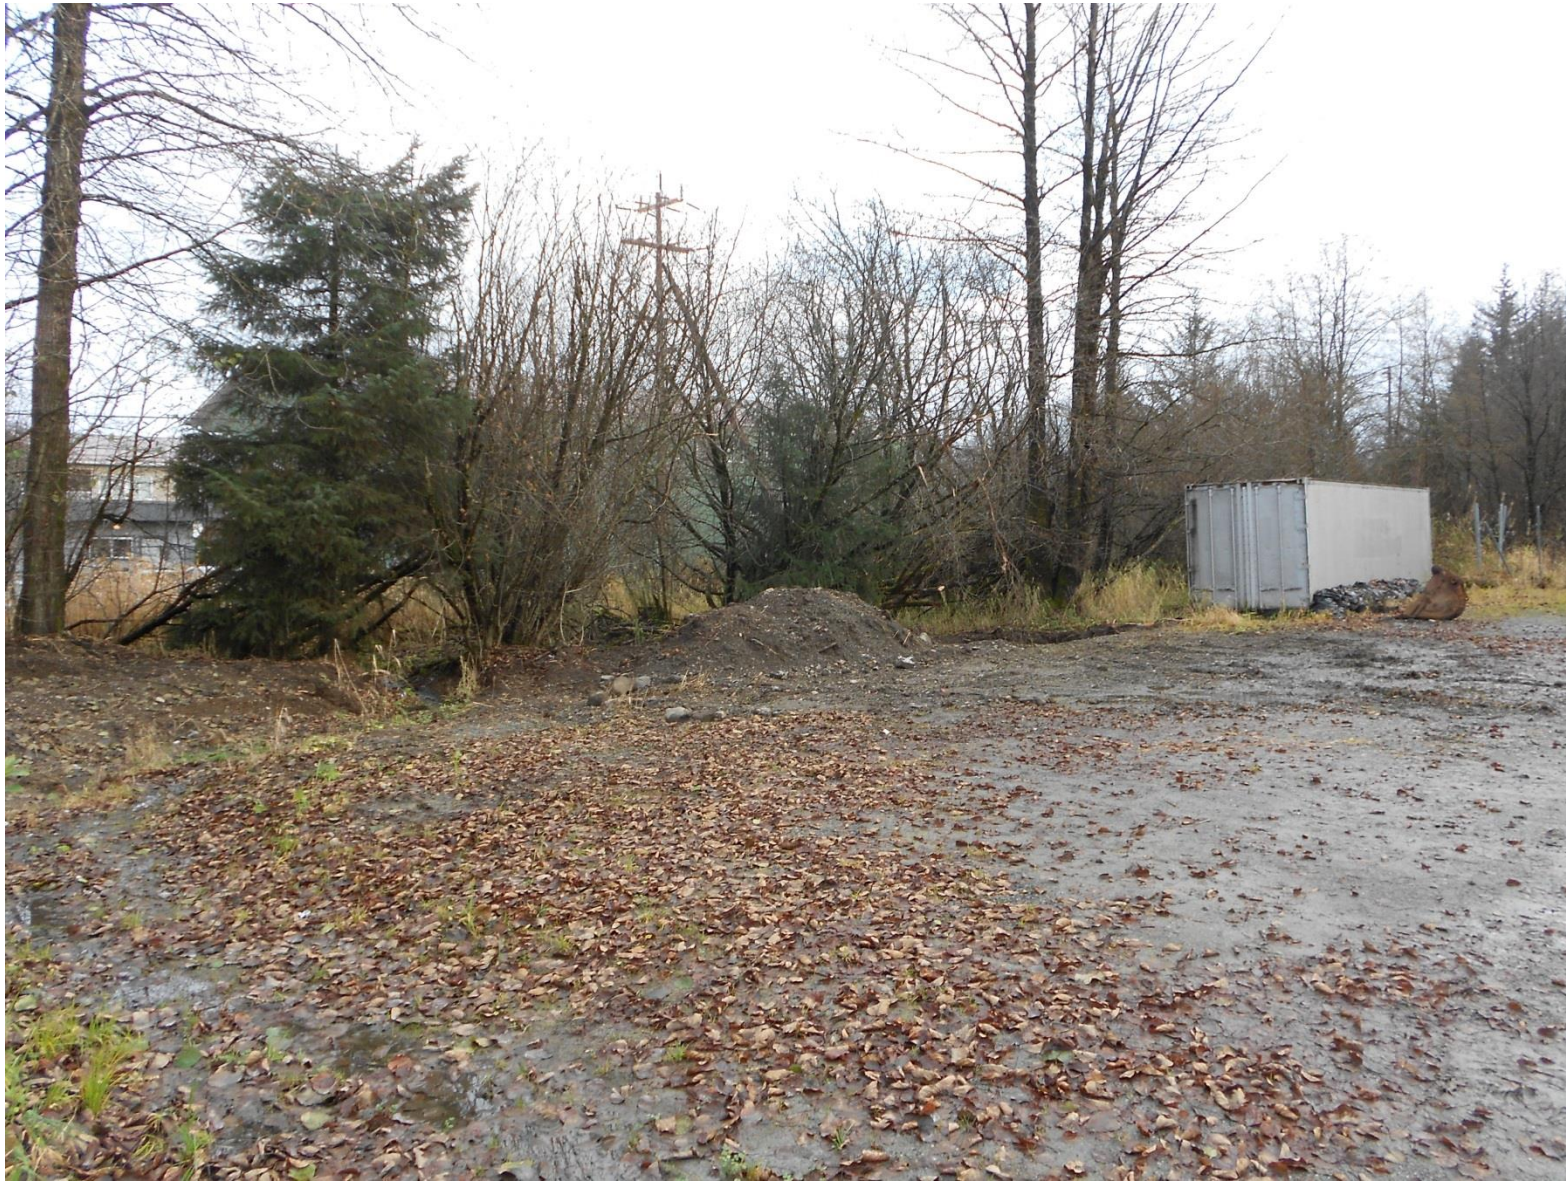
Figure 22. Start of rain garden excavation. Photo taken November 2015.

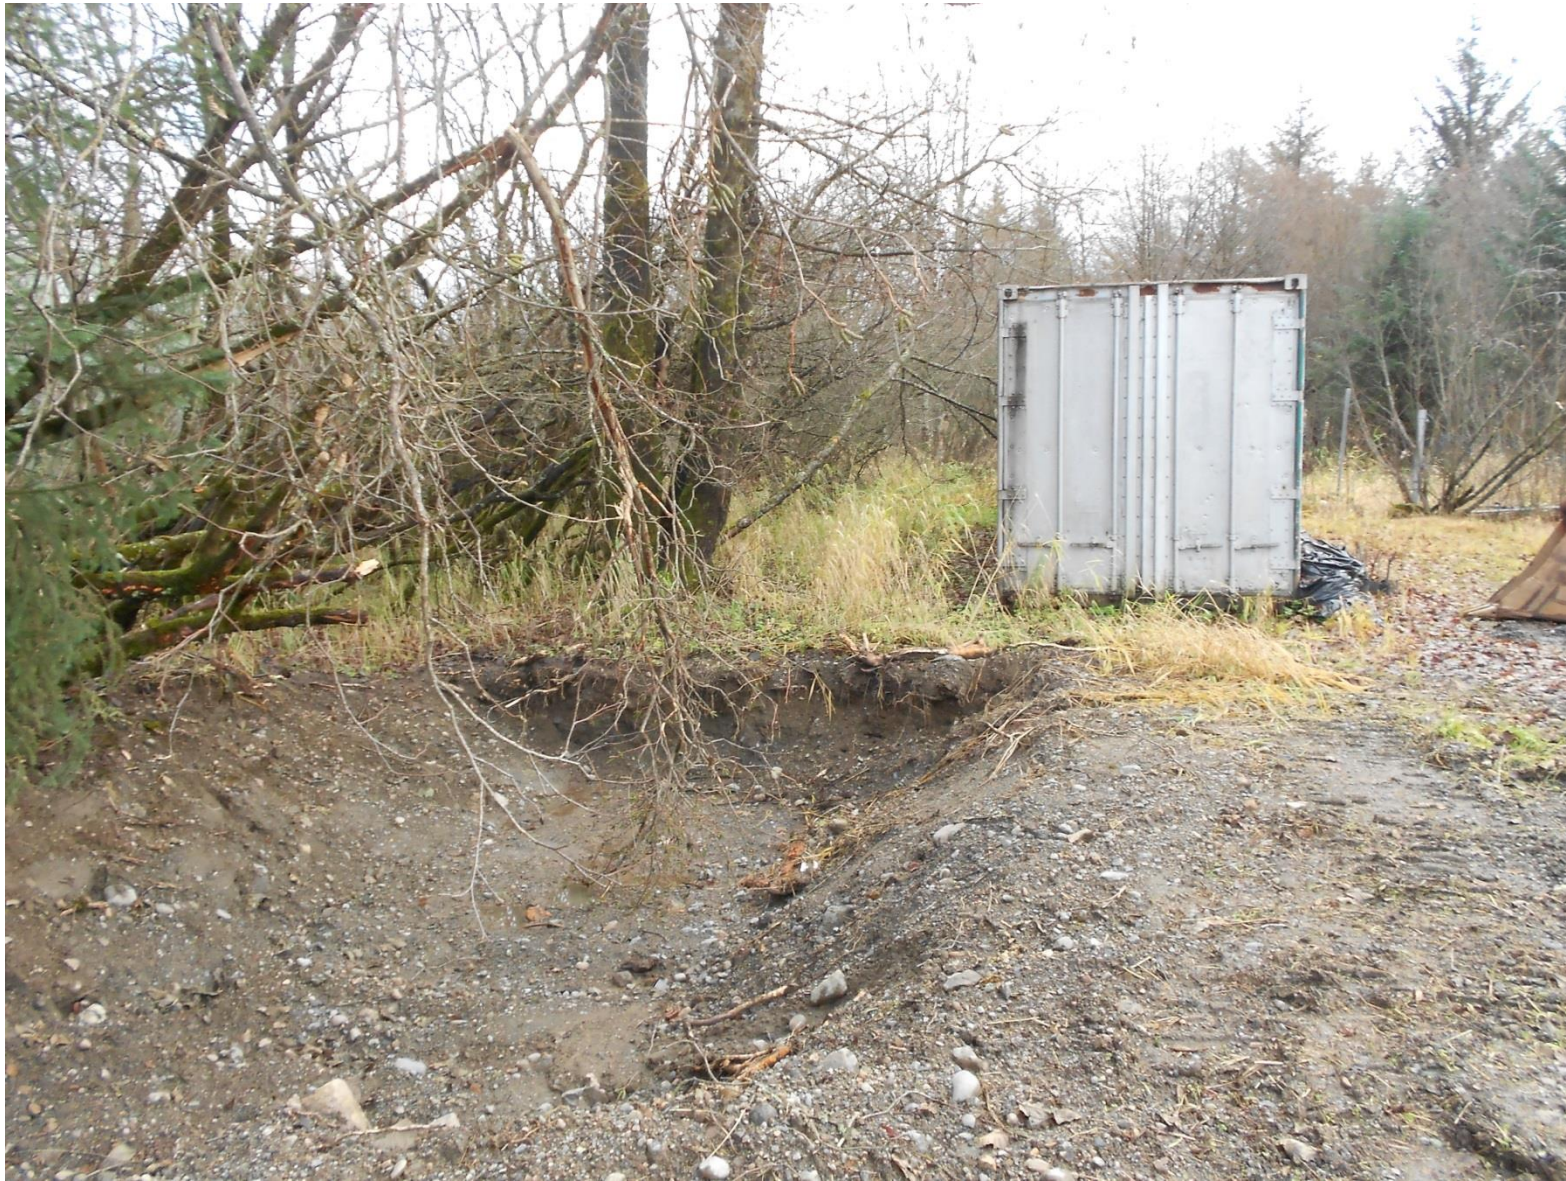
Figure 23. Close-up of the rain garden excavation. Photo taken November 2015.

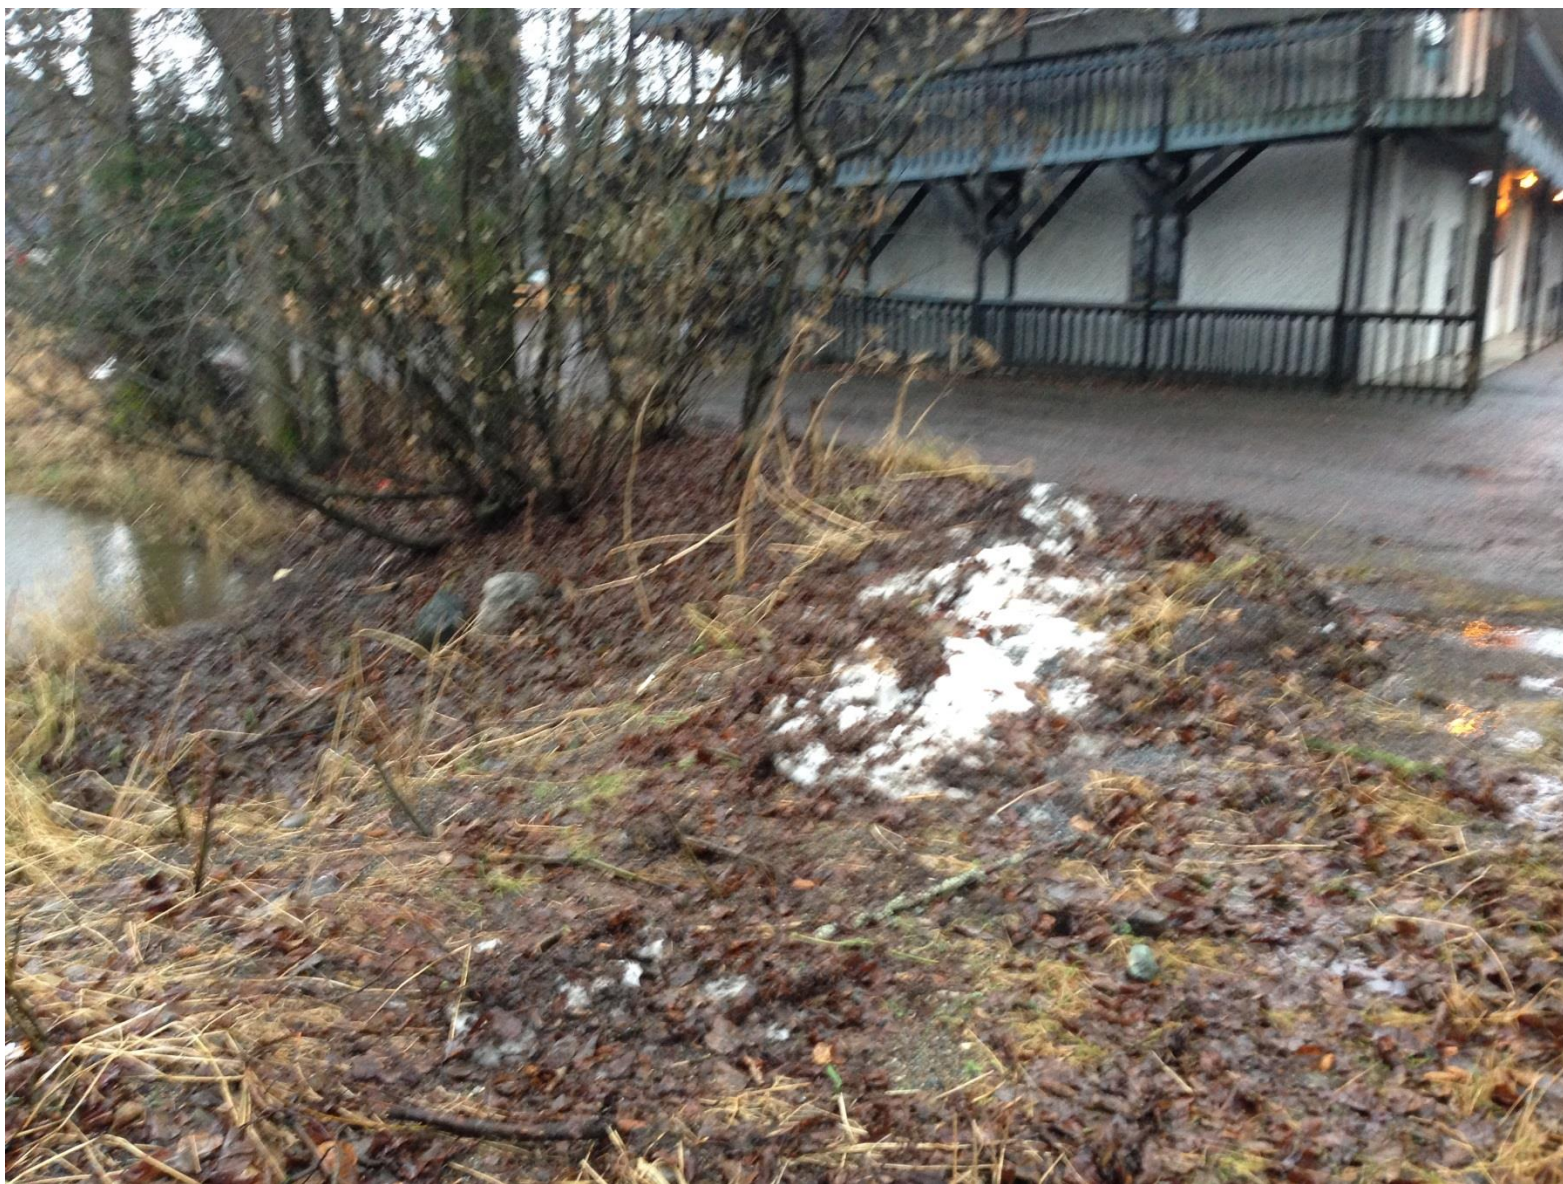
Figure 24. Snow plowed into area with new riparian plantings. Photo taken November 2015 by DEC.

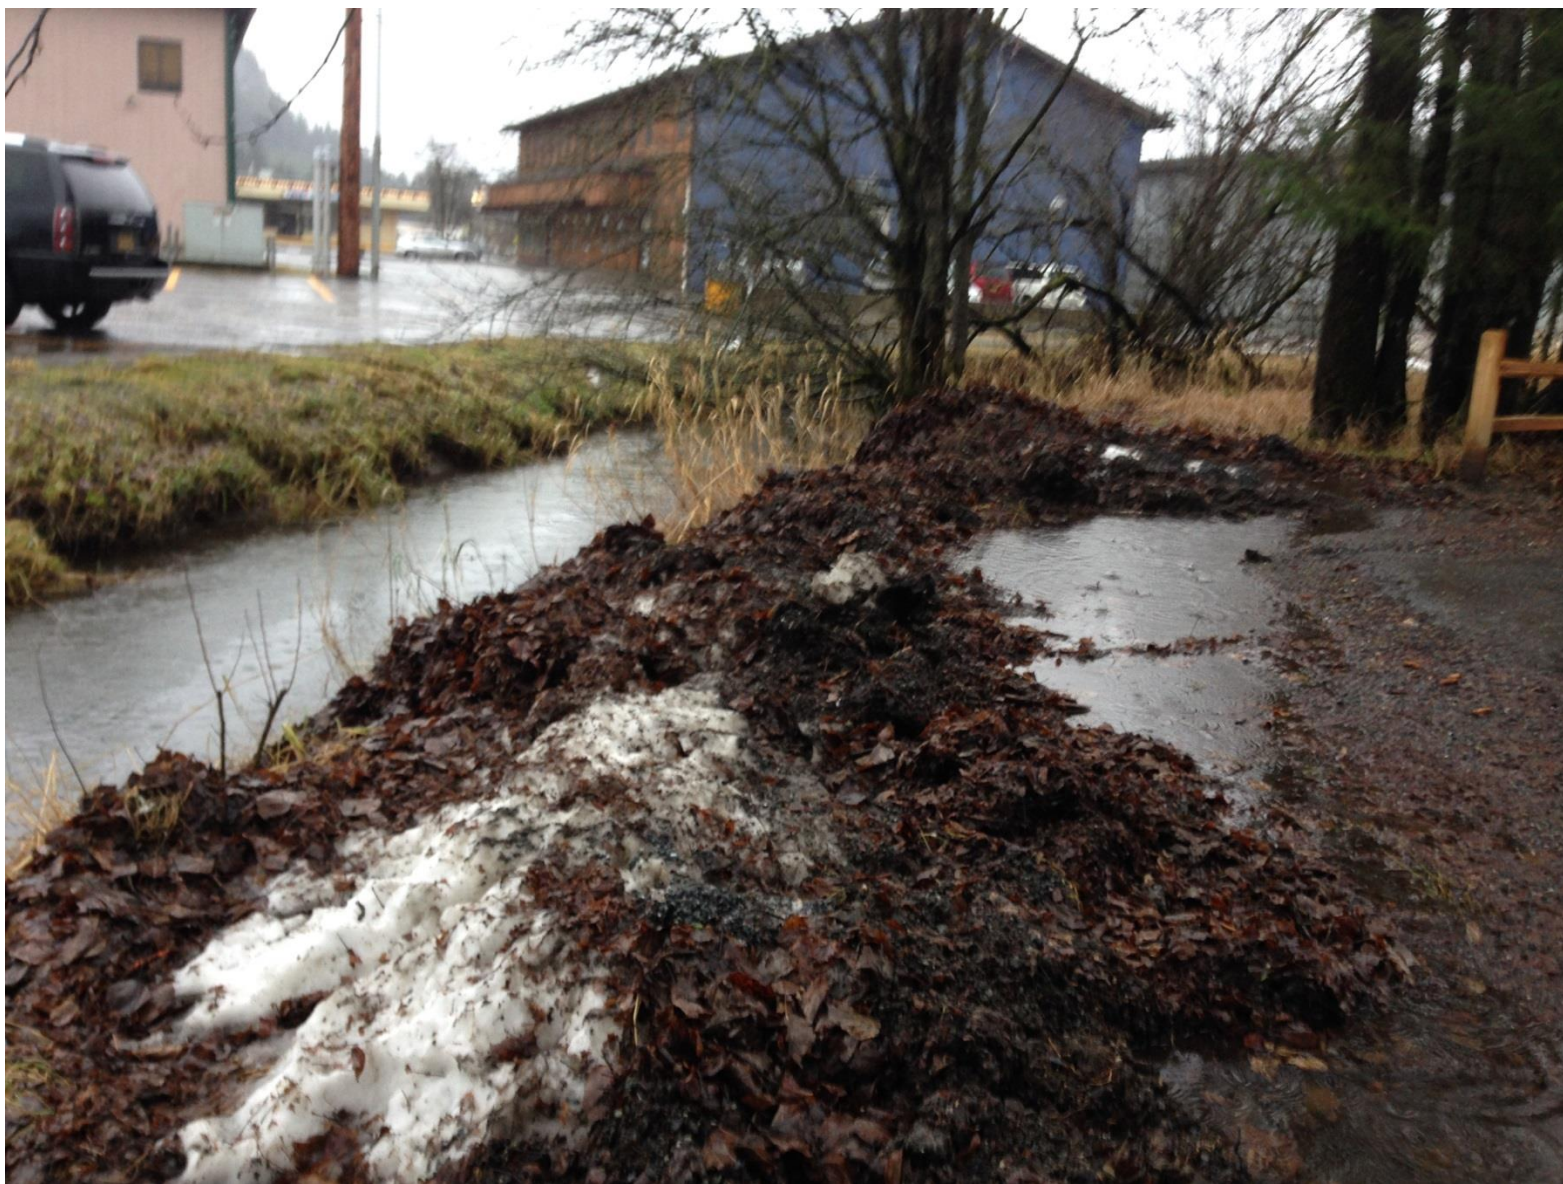
Figure 25. Snow plowed into area with new riparian plantings. Photo taken November 2015 by DEC.

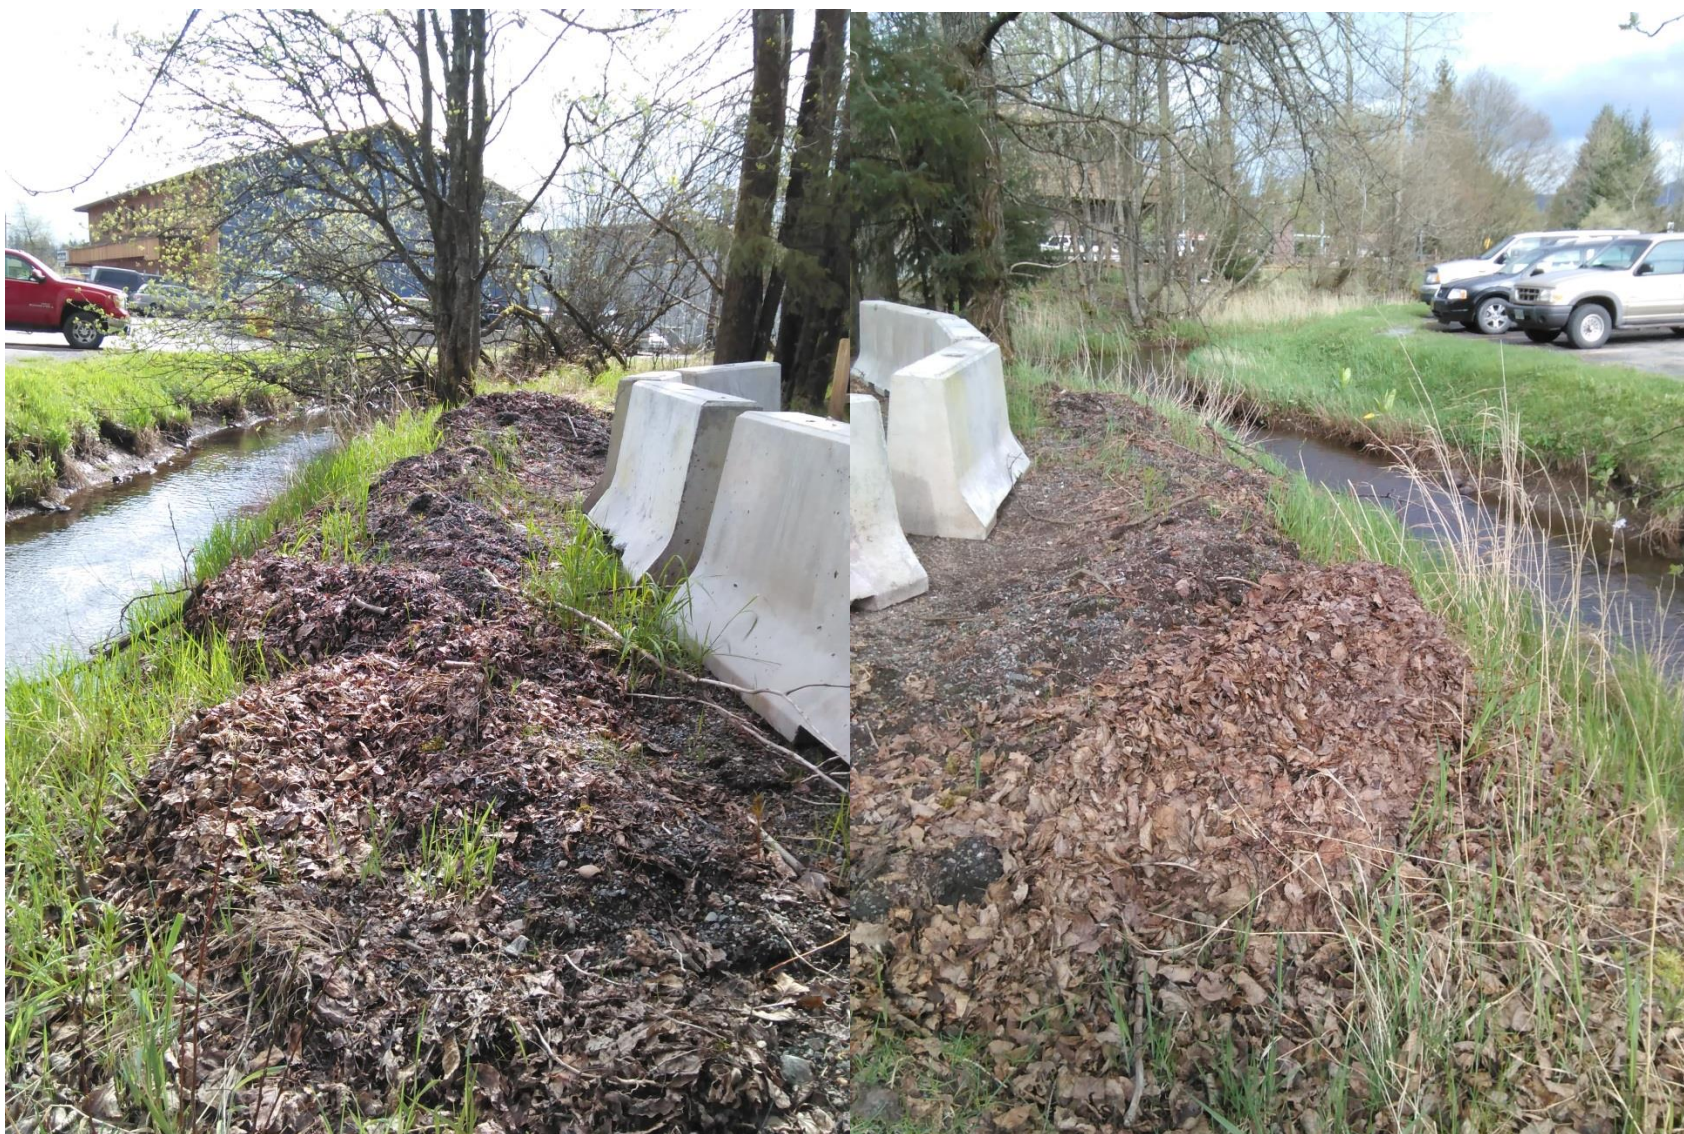
Figure 30. Spring assessment of riparian plantings at the back corner of property looking downstream (left) and upstream (right). Winter plowing caused the leaf and sediment deposits prior to placement of the concrete barriers. This location is the most impacted from last winter. Photos taken by JWP on April 15, 2015.

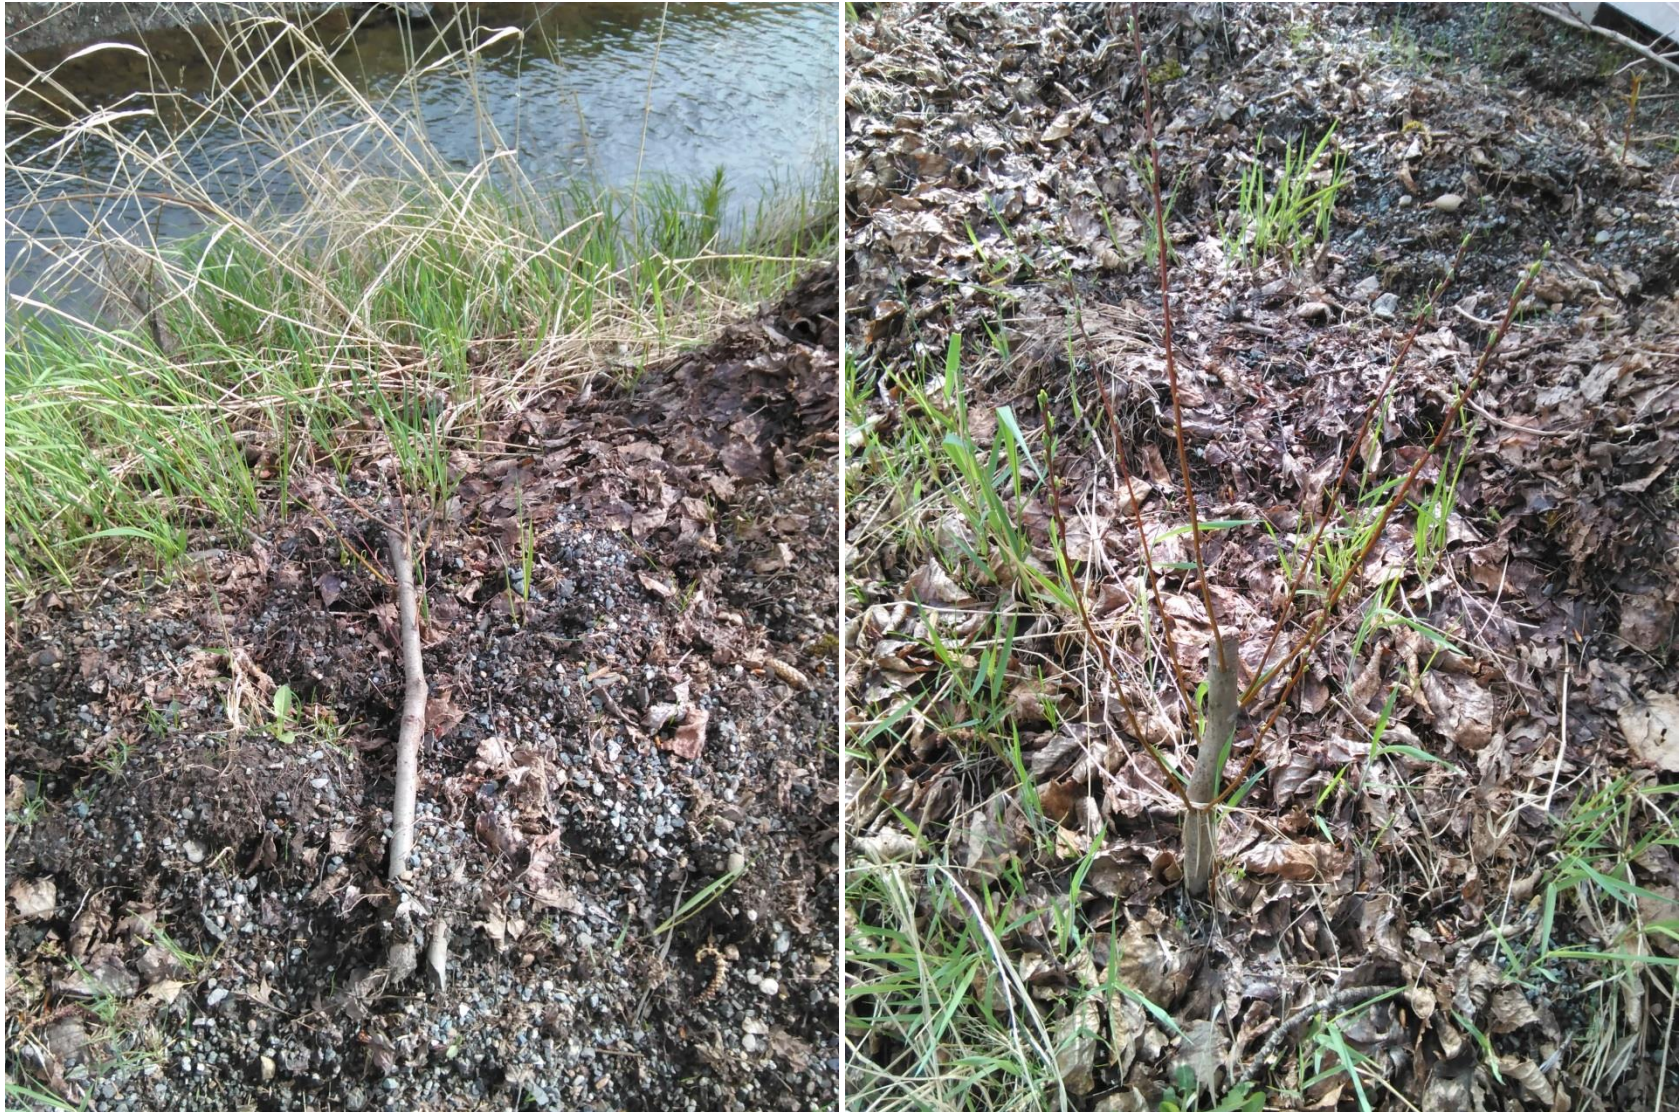
Figure 31. Spring assessment of riparian plantings at the back corner of property with examples of plants that were damaged (left) and plants that are thriving (right). This location is the most impacted from last winter. Photos taken by JWP on April 15, 2016.
