EDWARD K. THOMAS BUILDING
JORDAN CREEK
GREEN INFRASTRUCTURE PROJECT
FINAL REPORT

JUNEAU WATERSHED PARTNERSHIP

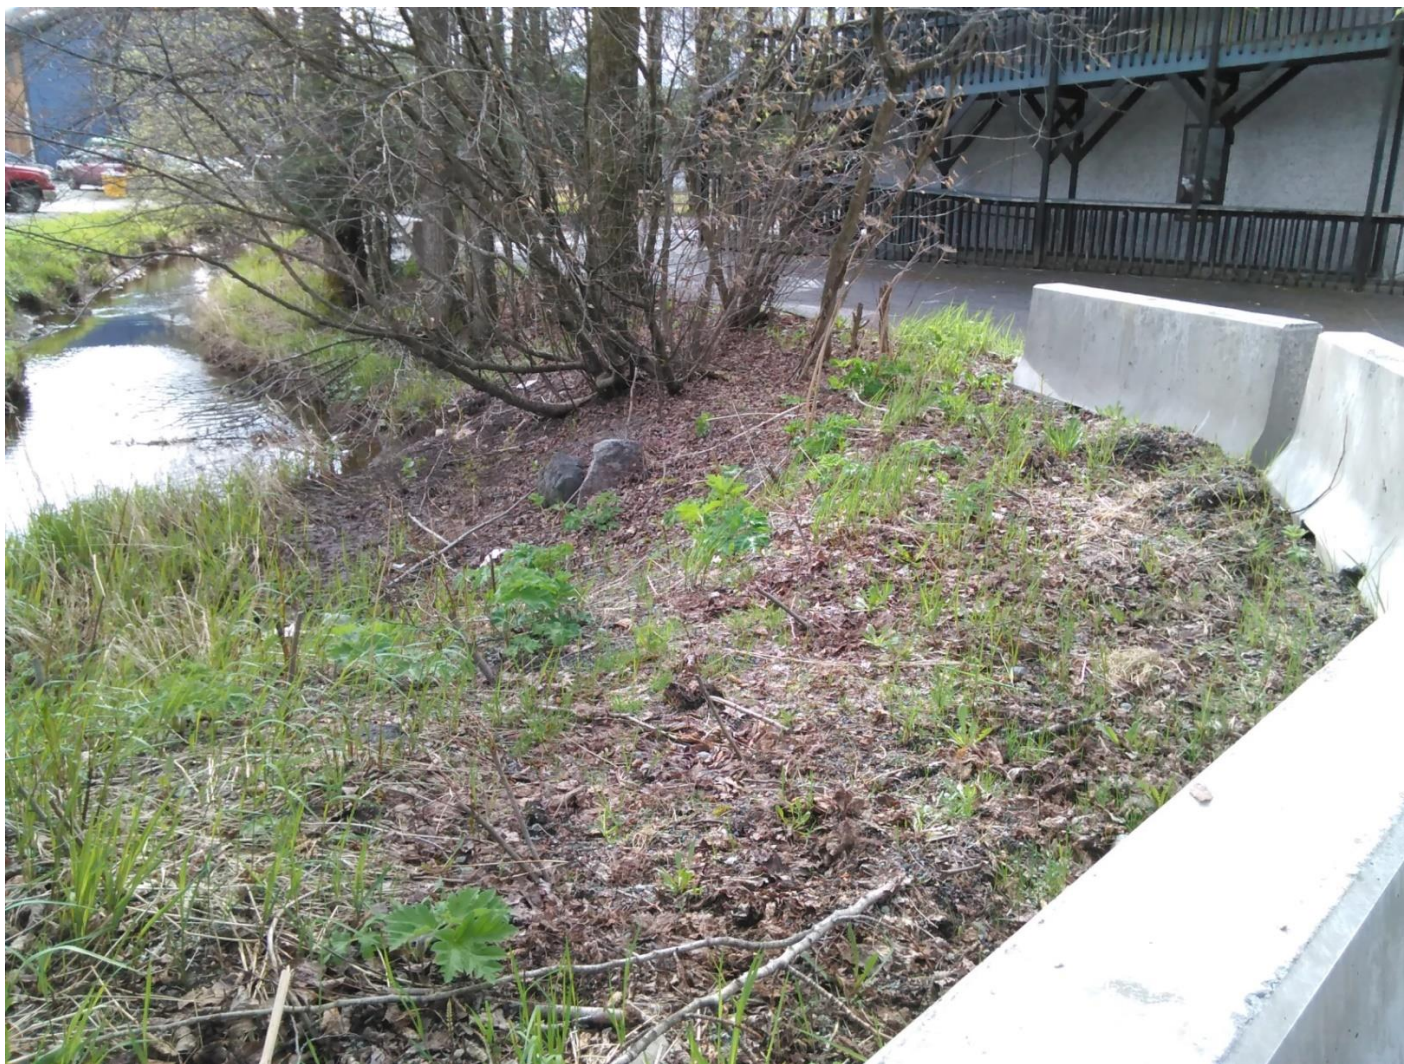
Figure 32. Spring assessment of riparian plantings at the front corner of the property. Winter plowing caused the leaf and sediment deposits prior to placement of the concrete barriers. However, this location was not as impacted as the back corner from last winter. Photos taken by JWP on April 15, 2016.

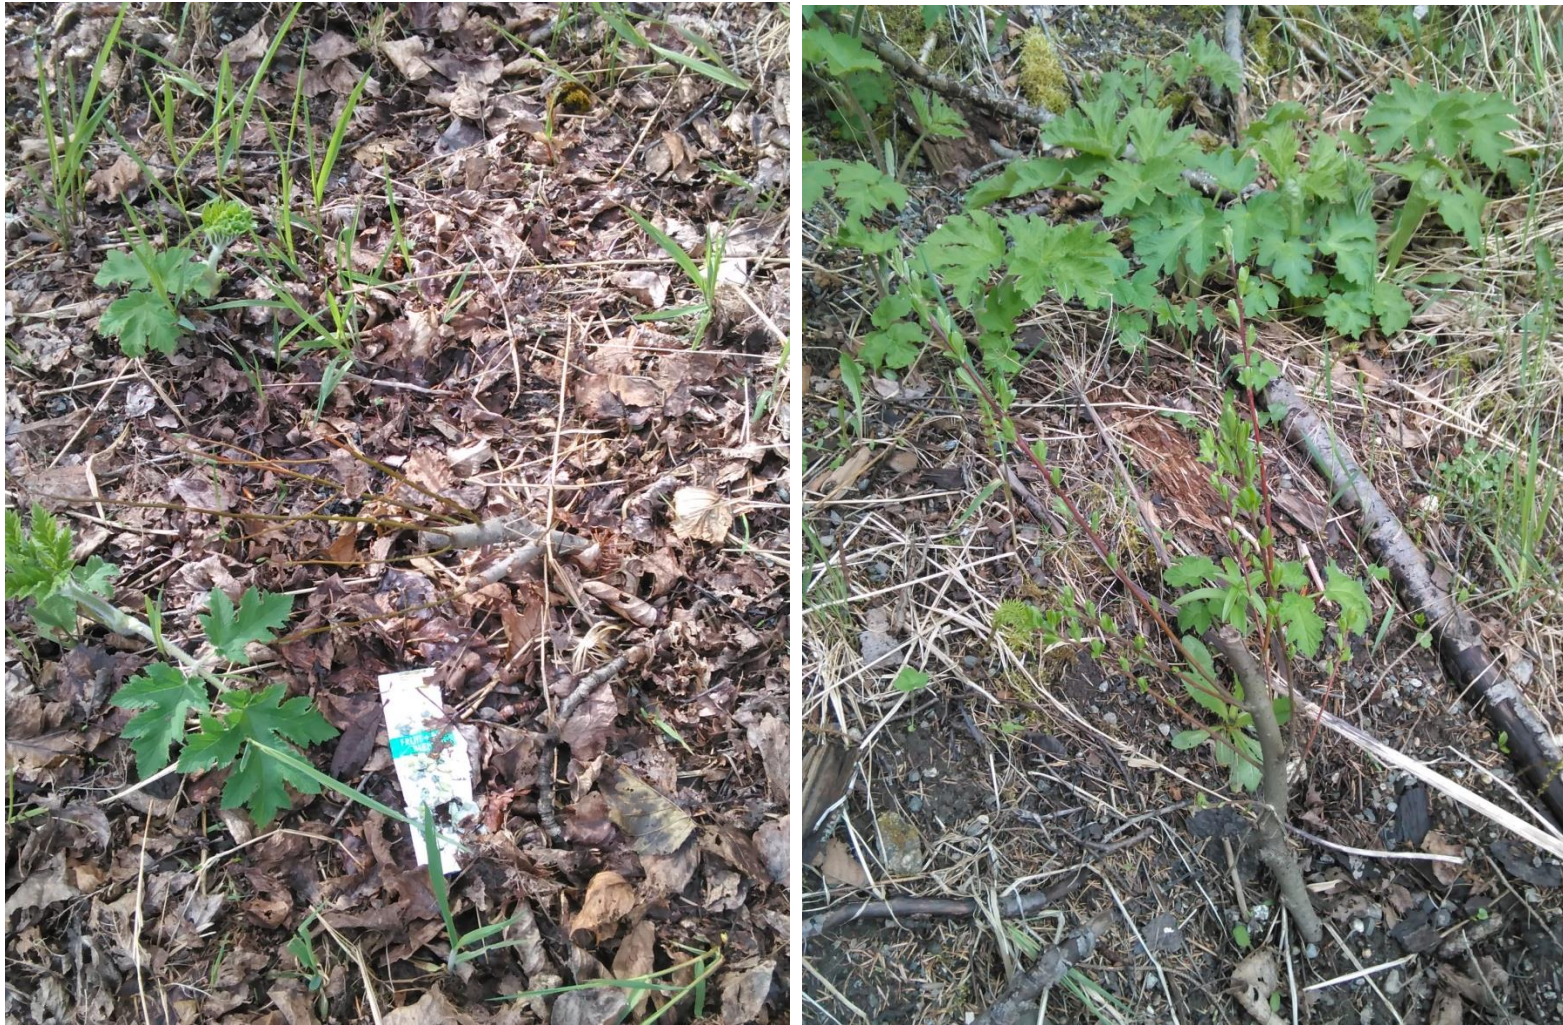
Figure 33. Spring assessment of riparian plantings at the front corner of property with examples of plants that were damaged (left) and plants that are thriving (right). This location was mildly impacted from last winter. Photos taken by JWP on April 15, 2016.

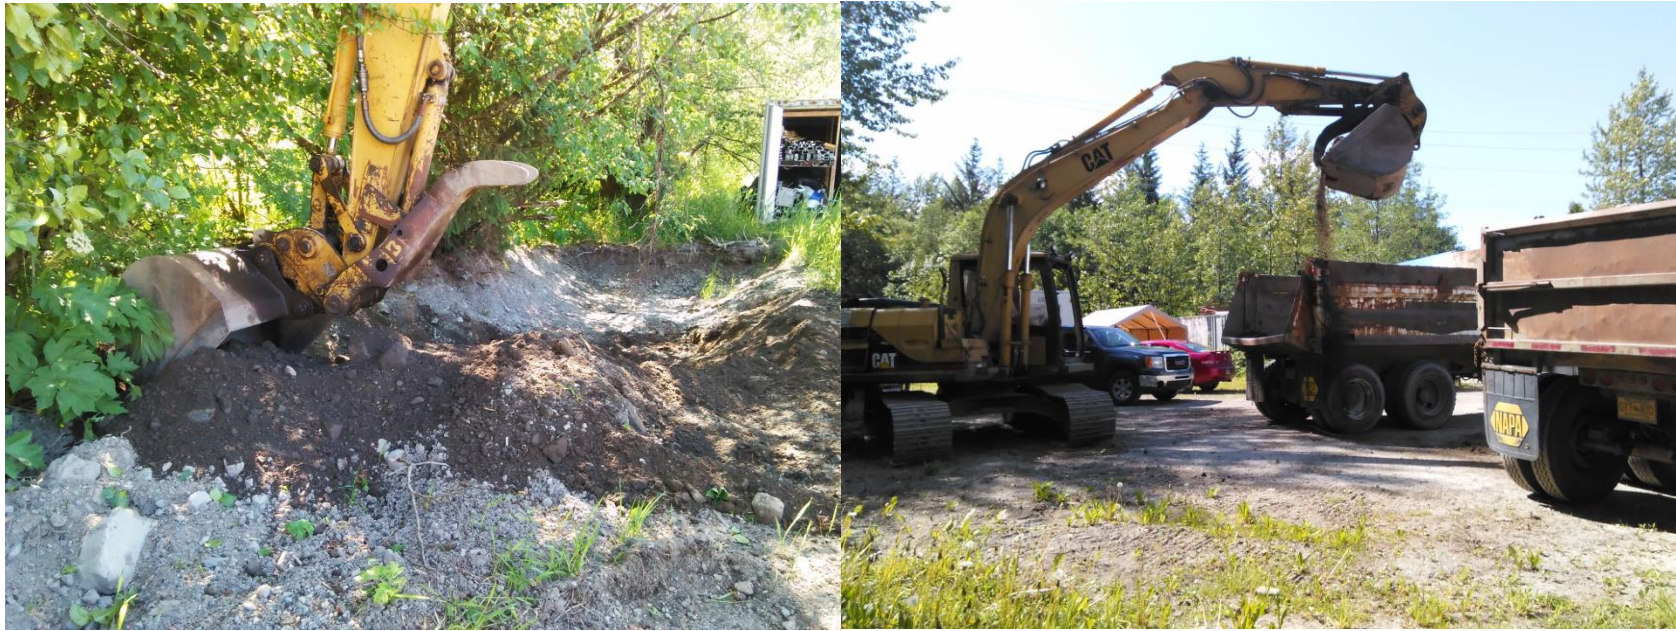
Figure 34. Start of the final construction of the rain garden on May 28, 2016. Photos taken by JWP.

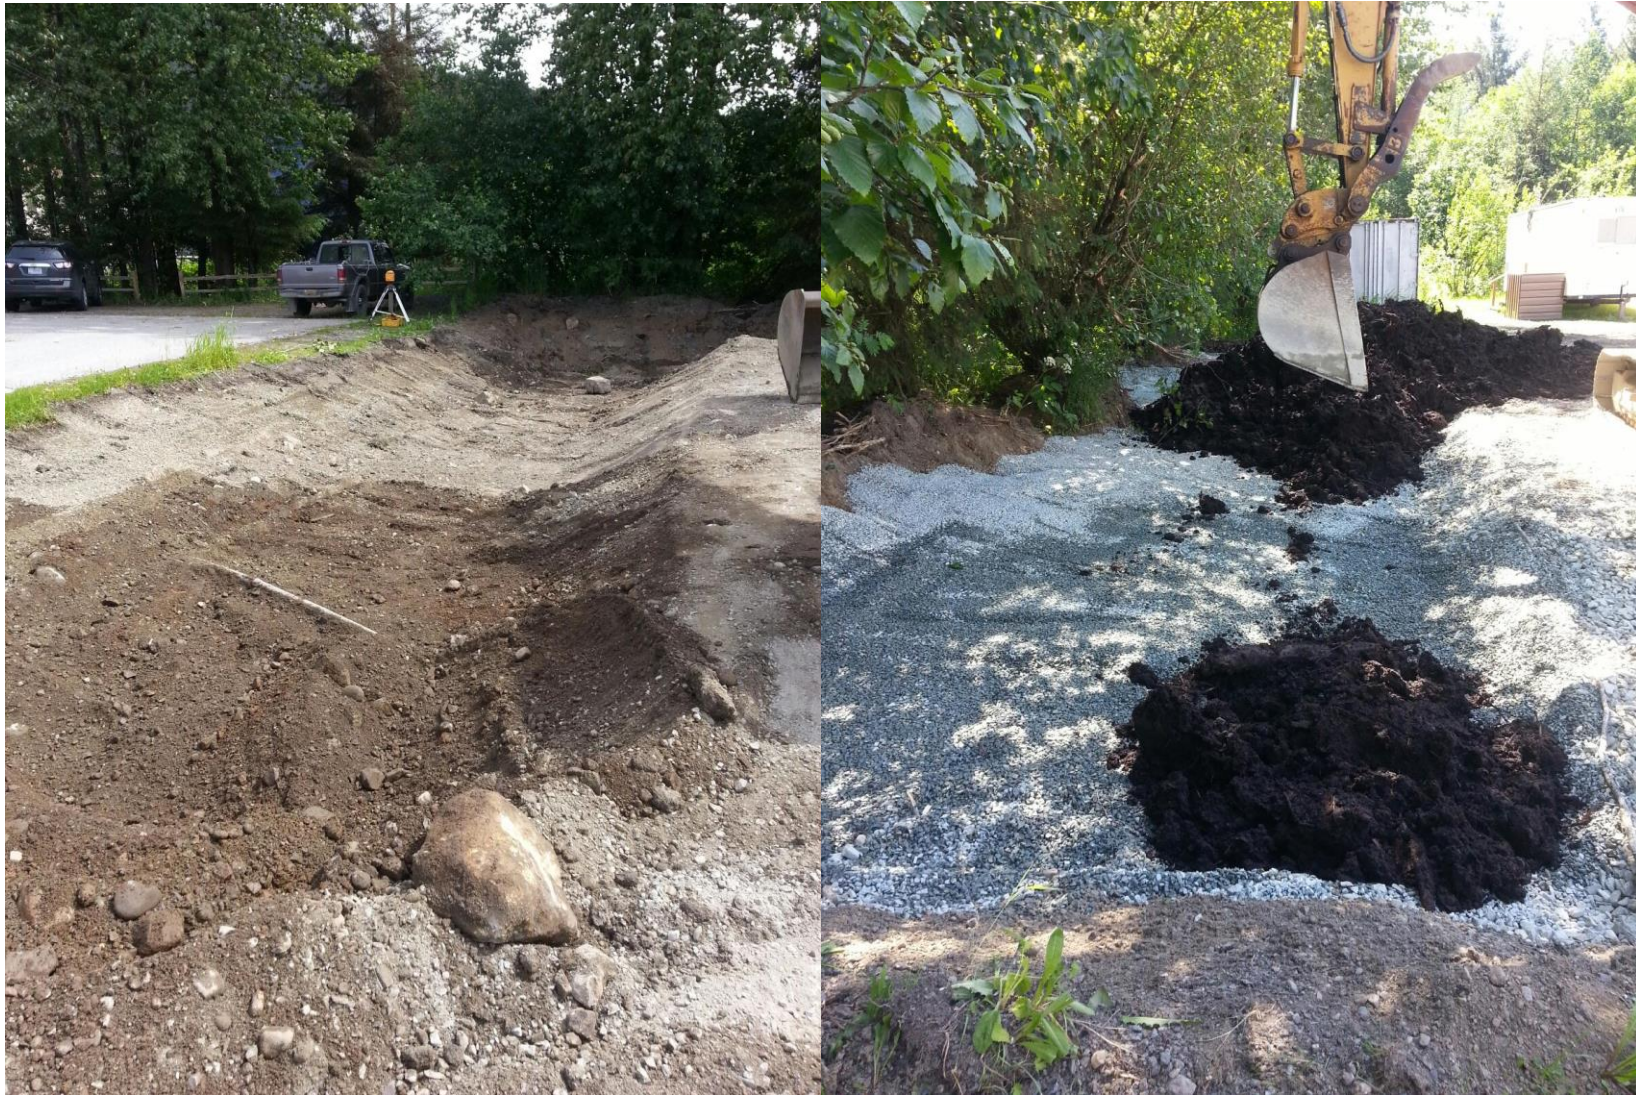
Figure 35. Construction of the rain garden and rock swale continues. The rock swale excavation (left) and placement of drain rock and top soil in the rain garden (right). Photos taken by Dave Hanna, SOURCE, LLC., on June 9, 2016.

The rain garden was constructed smaller than the conceptual design dimensions in order to prevent damaging or removing existing riparian trees and to stay within the limits allowed by CCTHITA. A rock swale was included to help stabilize the flow path, since the parking lot is not being paved, as well as providing some pre-treatment of the run-off prior to it entering the rain garden. This should reduce the amount of surface water and sediment entering the rain garden and, therefore, also reduce the associated maintenance. The infiltration capacity of the rain garden combined with the infiltration

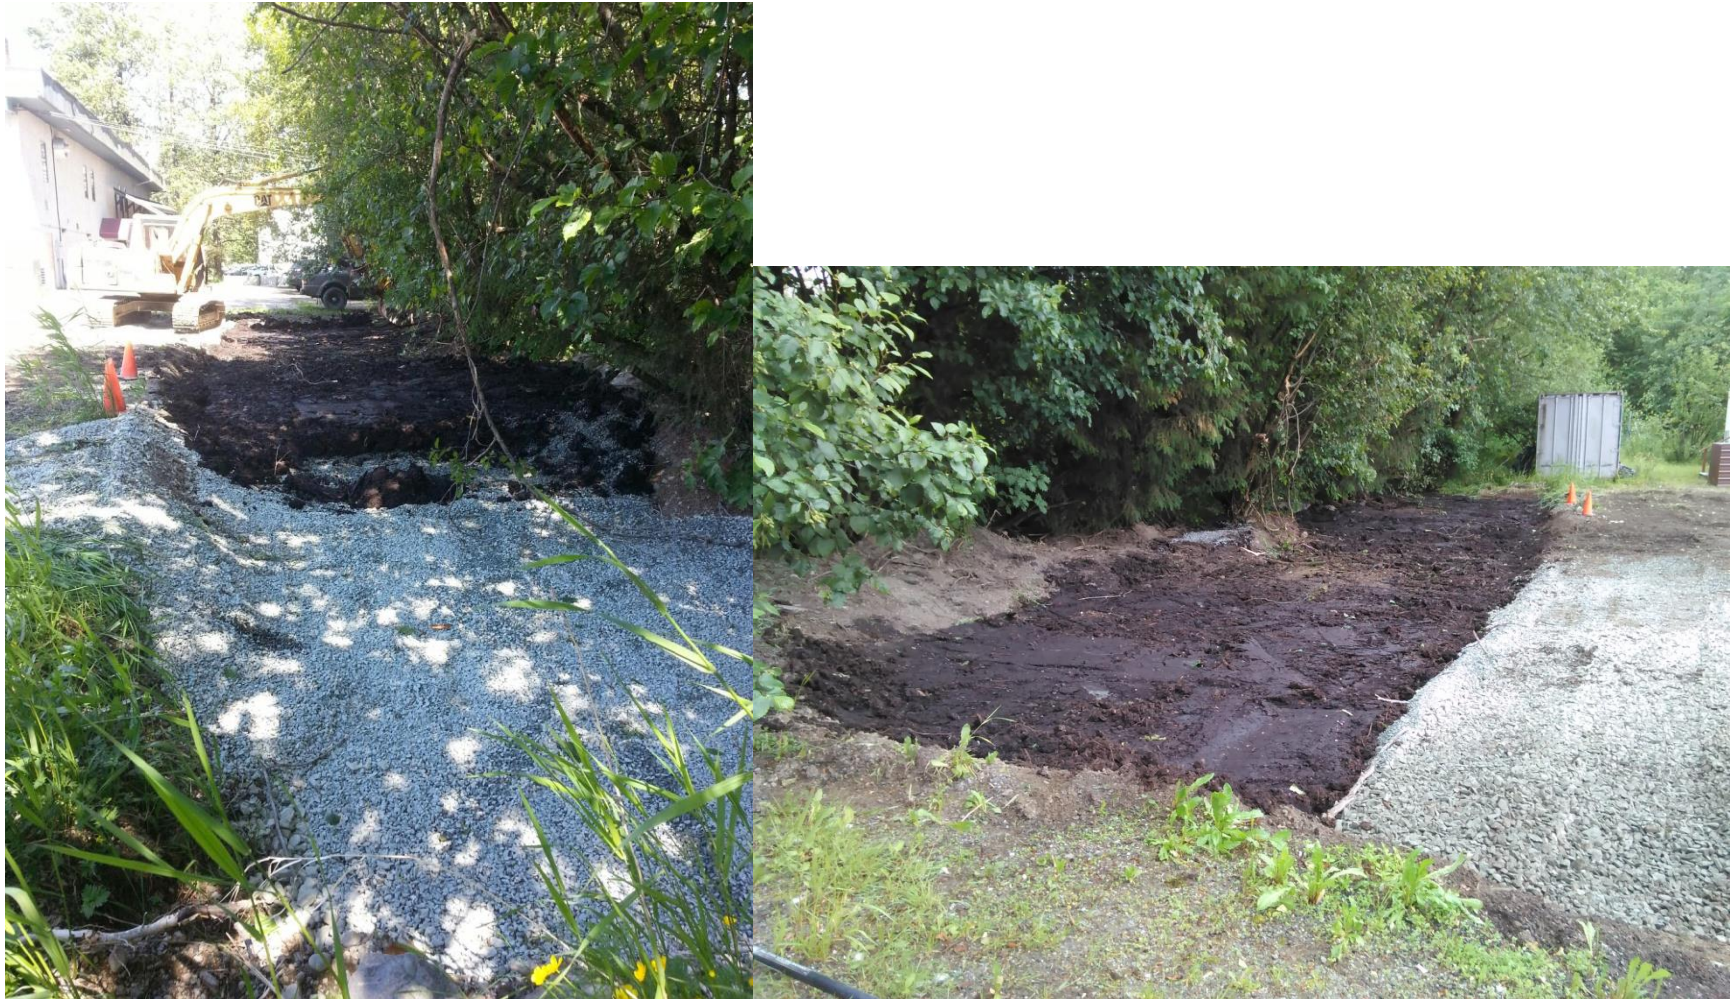
Figure 36. Another view of the drain rock and top soil in the rain garden, at various stages of placement. Photo on left taken by Dave Hanna, SOURCE, LLC., on June 9, 2016. Photo on right taken by JWP on June 11, 2016 prior to planting.
