FY 2006  
**FINAL REPORT**

PROJECT #: ACWA-06-09

**Watershed Protection and Recovery for  
Duck Creek, Juneau, AK**

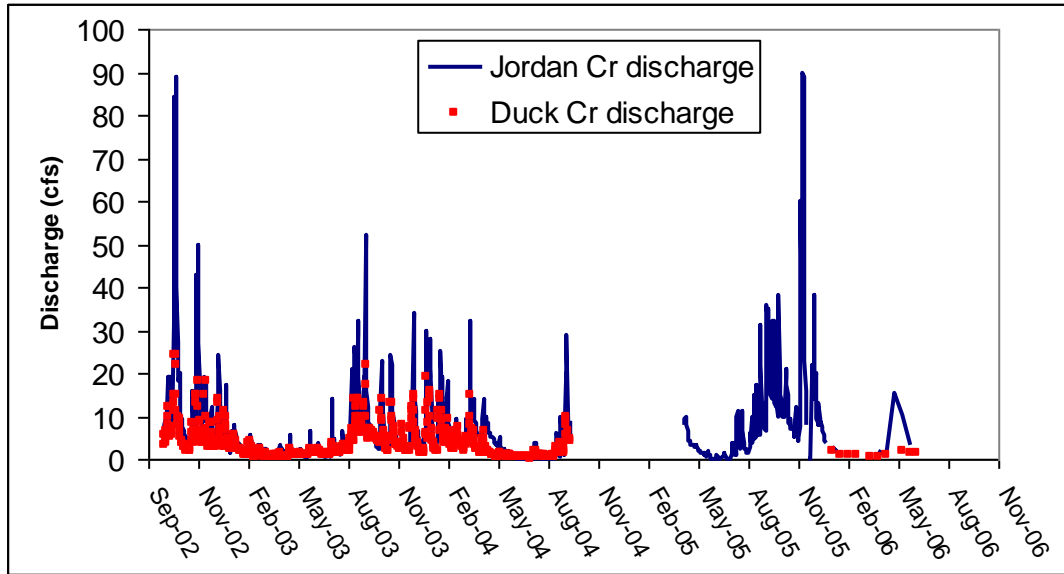
**Figure 2.** Discharge on Duck and Jordan Creeks. Data based on USGS stream gage data, until January, 2006. (Data from September, 2005 on are provisional). Measurements since January 2006 are based on manually gaging using a pygmy flow meter.

Although continuous discharge data were unavailable for Duck Creek, examination of historic data at the site and on neighboring Jordan Creek, as well as field observations, indicates that Duck Creek is generally a flashy stream that responds to and recovers quickly from local precipitation events. There is little seasonal variation to the stream. In contrast to the Mendenhall River, whose flow is predictably maximal during summer glacial melting, Duck Creek discharge is a reflection of precipitation in the area (Figure

2). Therefore, flows are generally lowest and least flashy during the spring and early summer, and highest and flashiest during the fall and early winter.

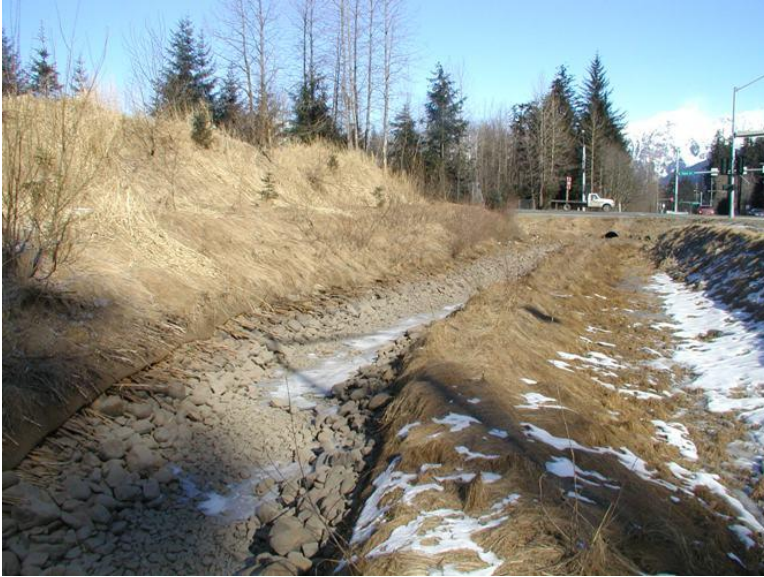
**Figure 3a.** Site DC-C, showing no flow, on March 15, 2006 when air temperatures reached  $-15^{\circ}\text{C}$  in Juneau. No flow was observed at the site for 2 months, from late February to late April, 2006. During this no-flow period, the channel was either completely dry or contained small, stagnant ponds.

Water quantity was often higher at the upstream sites; DC-B and DC-A clearly had significant groundwater contributions that maintained consistent baseflows in the channel even during cold spells in the winter when air temperatures fell to as low as  $-15^{\circ}\text{C}$  (in March, 2006) (Figures 3a-c). DC-C site had no surface flow during portions of the late spring and summer (no flow on sampling dates between late February and late April, 2006) (Figure 3a). Loss of flow is an obvious major concern for salmonids attempting to utilize Duck Creek as habitat for rearing, spawning, and egg incubation. Discharge measurement made between January and June, 2006 never exceeded a meager 2.1 cfs (at site DC-2).

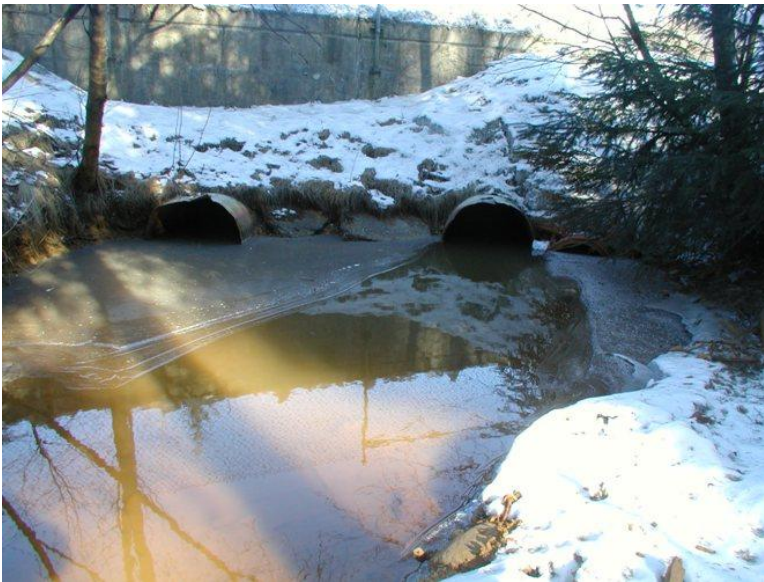
**Figure 3b.** Site DC-B, showing unfrozen water, indicating strong groundwater inputs while the air temperature was as low as  $-15^{\circ}\text{C}$  in Juneau on 3/15/05. Water was present at the site on all sampling events.

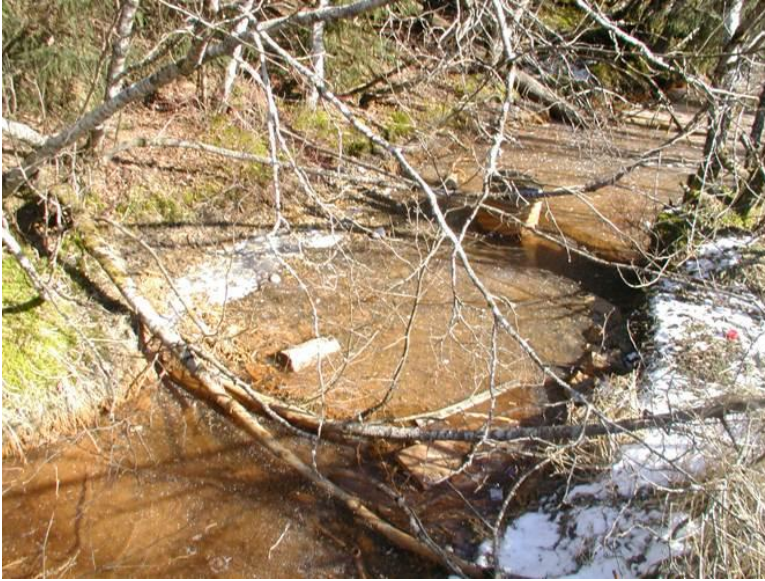
**Figure 3c.** Site DC-A, showing largely unfrozen water (with a thin cover of ice), indicating strong groundwater inputs while the air temperature was as low as  $-15^{\circ}\text{C}$  in Juneau on 3/15/05. Water was present at the site on all sampling events. Also visible is the orange staining of the iron floc, which is particularly abundant at this upper site.

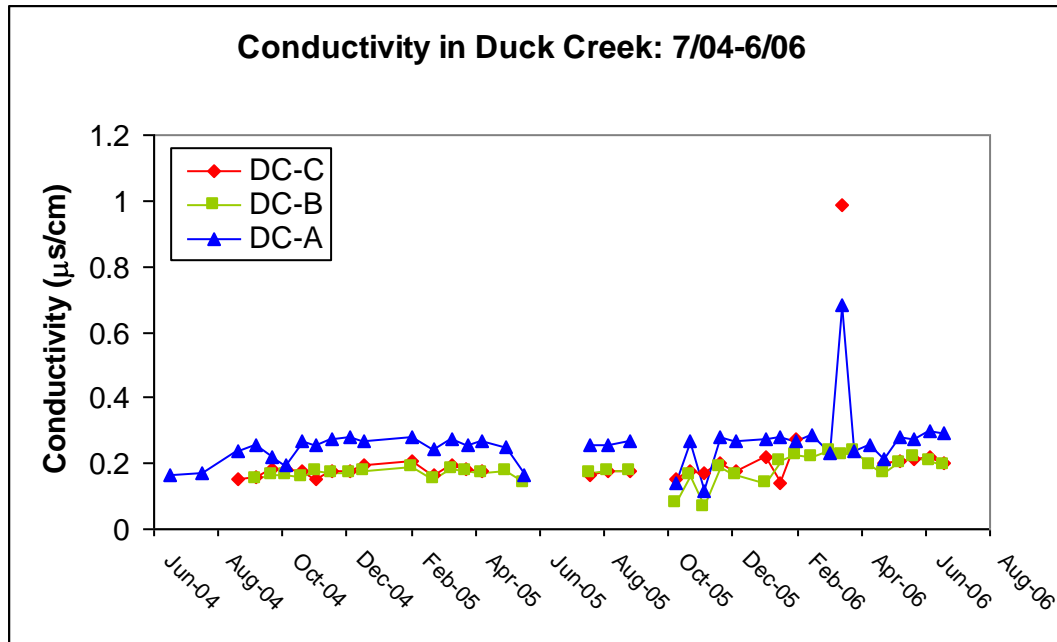
**Figure 5.** Conductivity values at the 3 sampling sties on Duck Creek. Graph includes data from year (2004-2005) prior to the current study year (2005-2006). The high values at DC-C and DC-A occur with high chloride concentrations and may be indicative of road salt runoff.

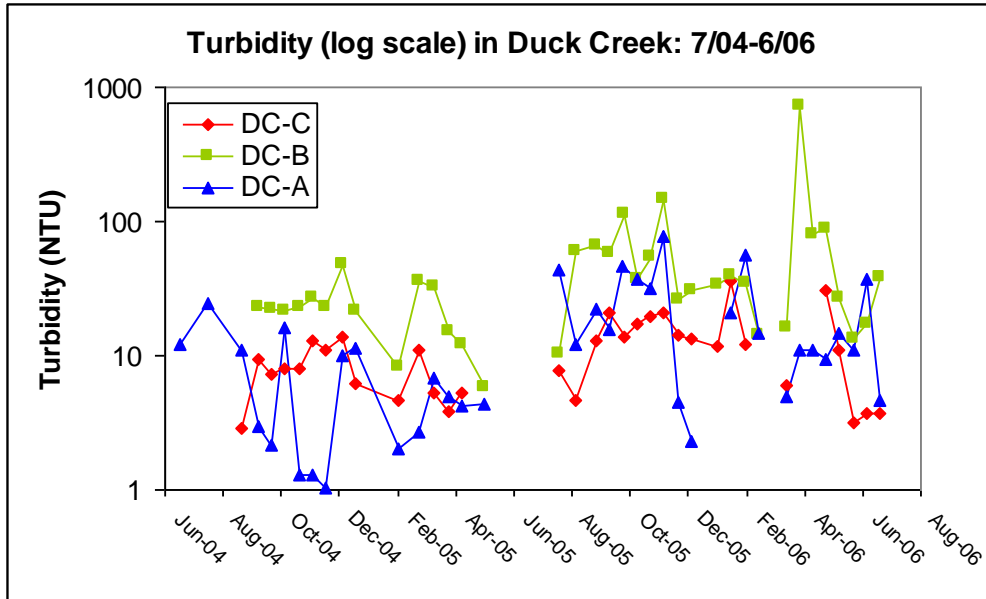
**Figure 7.** Turbidity (NTU) at the three Duck Creek sites. Note log scale.

The state of Alaska water quality standards for turbidity dictate that to protect fish and wildlife, turbidity may not exceed 25 nephelometric turbidity units (NTUs) above natural background conditions. Turbidity is not a direct measurement of solids, but is related to the amount of suspended material in the water column because it is a measure of light attenuation due to absorption and reflection by solids. Turbidity can be expected to closely parallel total suspended solids (TSS). Depending on sampling date and location, Duck Creek water clarity varies significantly. Significant variation in turbidity and TSS values was observed within a single sampling location as well and this is most obvious at the site representing the unimproved section of Duck Creek, DC-A. Turbidity and TSS measurements at all three sites indicate persistent water quality problems on Duck Creek. Mean turbidity and TSS values were lowest at DC-C (Table 2), but were considerably high and in violation of the state water quality standards at DC-B and DC-A (Figure 7).

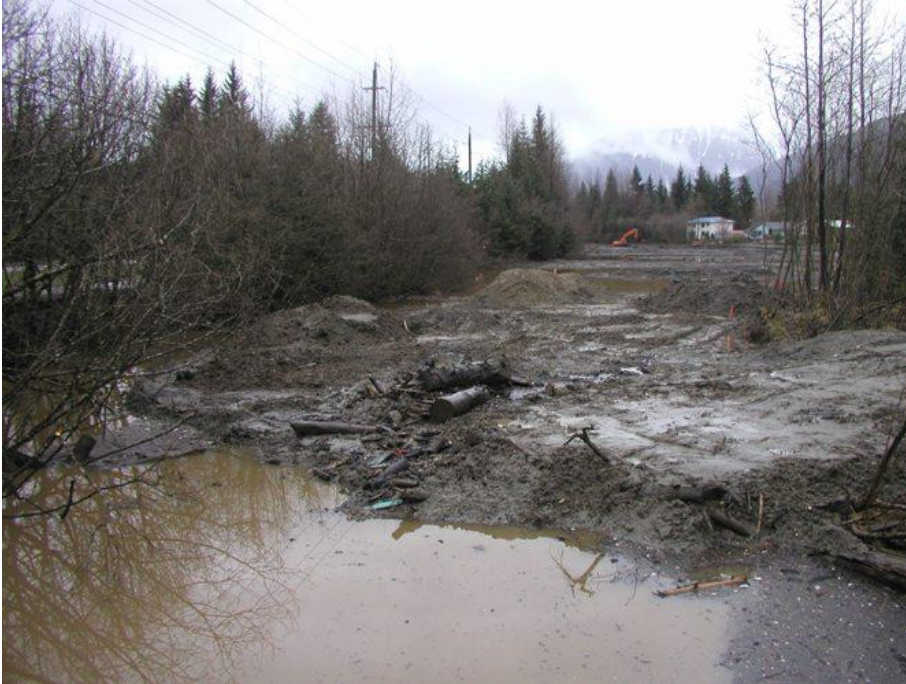
**Figure 9a.** Photo taken upstream of the Nancy Street bridge and site DC-B on 4/7/06, when sediment was being actively dumped into Duck Creek as part of the wetlands construction project. The activity greatly elevated turbidity and TSS levels downstream.

Mean turbidity values at DC-B are skewed due to the remarkably high value of 735 NTU found on 4/7/06, when immediately upstream, loose sediments were being dumped directly into Duck Creek as part of the wetlands construction project (Figures 9a and 9b). On this date, the TSS value jumped to 377 mg/L (Figure 8). These conditions were clearly violations of state standards; however, these conditions are expected to be temporary as long as construction of the wetlands continues upstream. The high TSS value collected on 6/16/06 at DC-A is likely an artifact of sampling error; the stream at DC-A did not appear particularly turbid on the date. Loose iron floc is highly abundant at the site, and the slightest physical disturbance of the streambed by the sampler can introduce large amount of floc into the sample bottle (Figure 10).

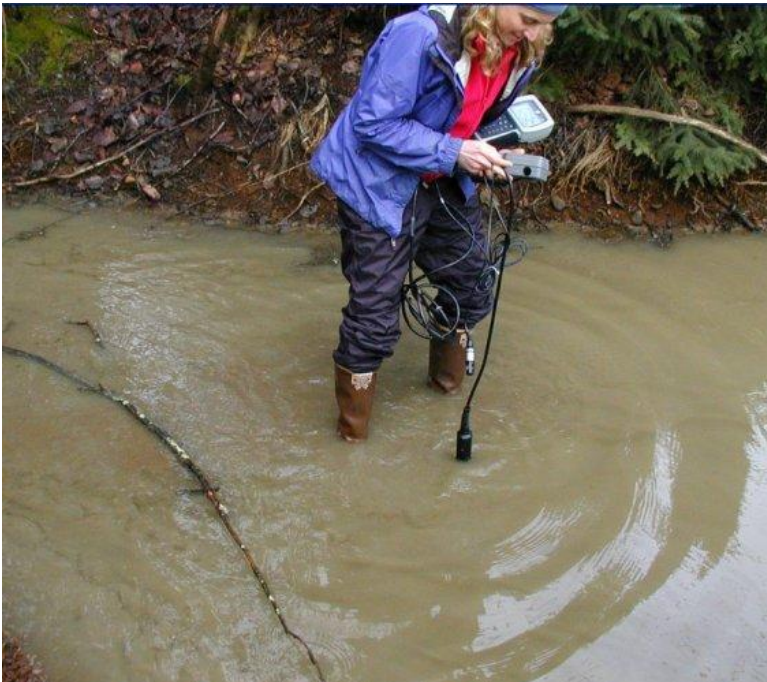
**Figure 9b.** Photo of sampling in situ water quality parameters in Duck Creek at site DC-B on 4/7/05 when active construction of the Nancy Street wetlands was underway immediately upstream of the site. Notice the extremely turbid coloration of the water.

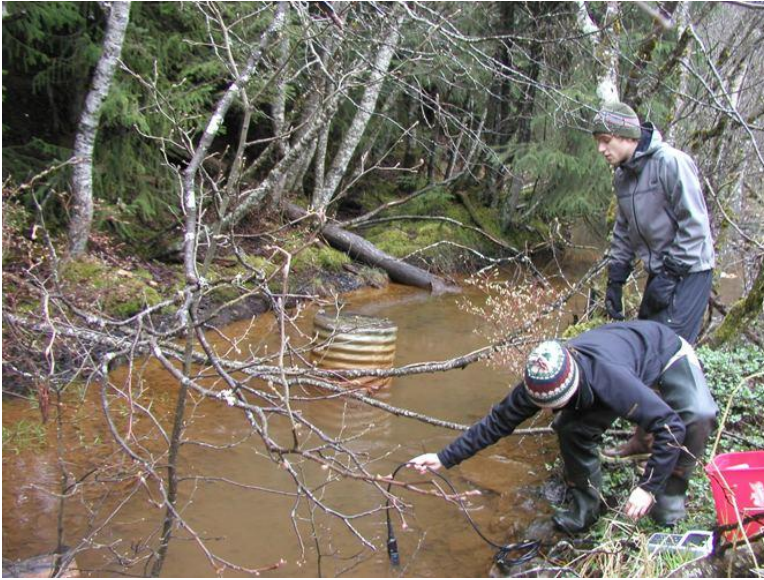
**Figure 10.** *Sampling at site DC-A in April, 2006. The thick coating of iron floc on the streambed is easily disturbed by any activity (including sampling) in the stream. Caution is taken to avoid introducing re-suspended floc into the turbidity and TSS sample bottles, but this is not always possible.*
