FY 2006  
**FINAL REPORT**

PROJECT #: ACWA-06-11

**Watershed Protection and Recovery for  
Pederson Hill Creek, Juneau, AK**

**July 2006**

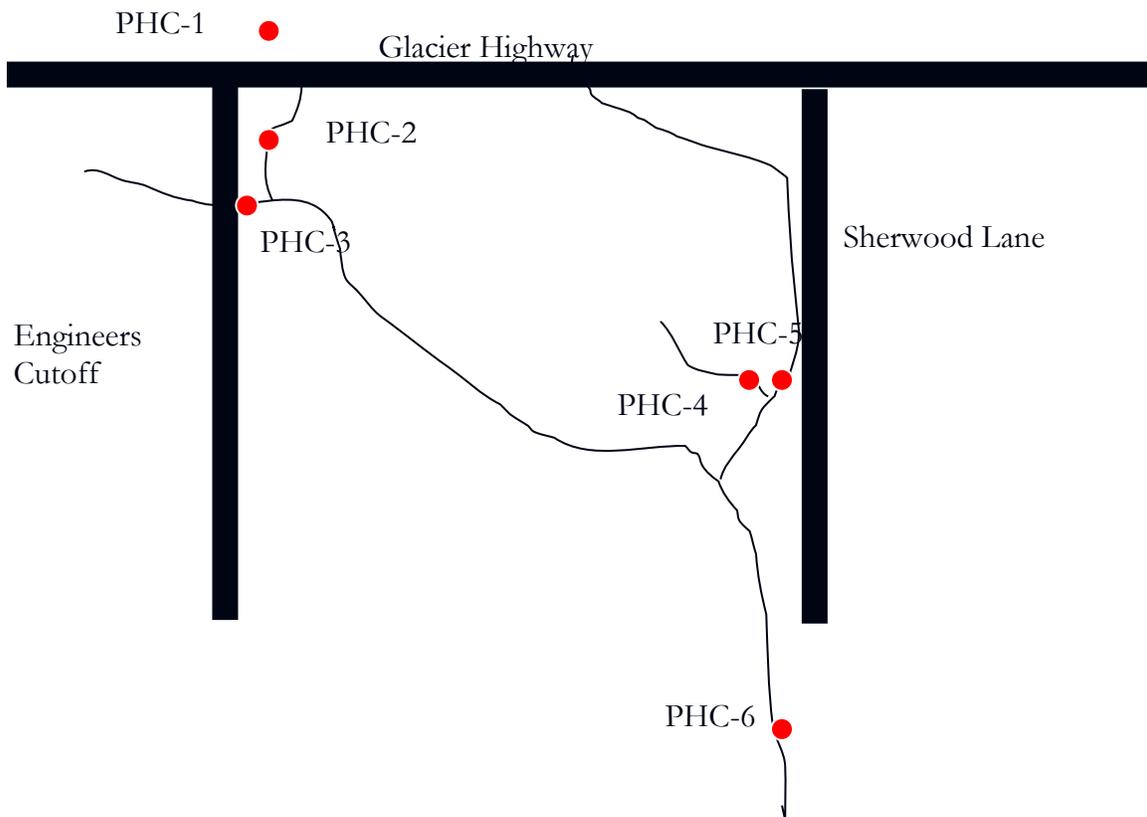
**Figure 3.** Sketch of location of sampling sites along Pederson Hill Creek. The area shown above is equivalent to the orange inset in Figure 2.

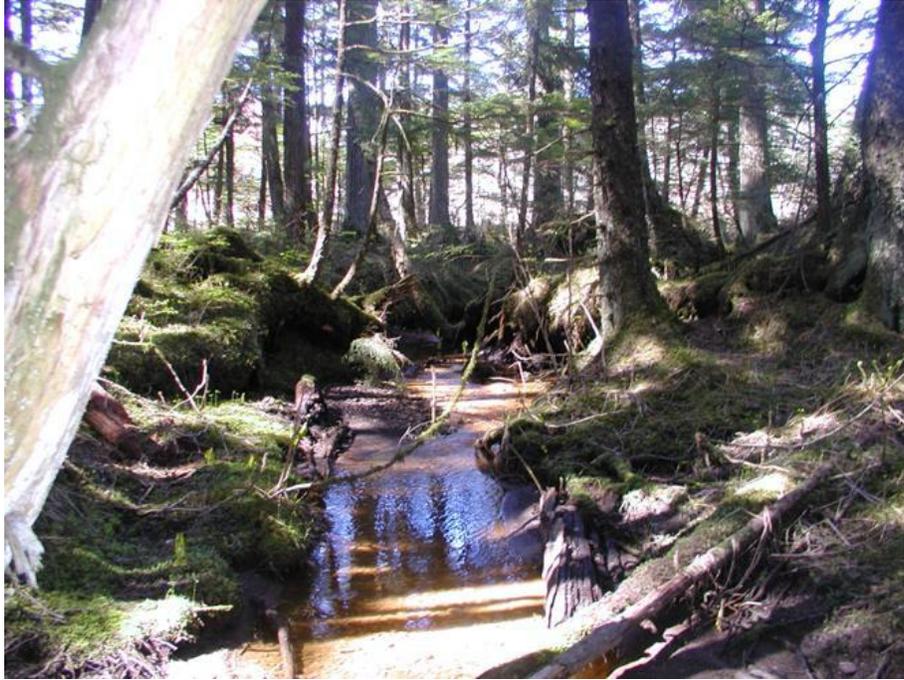
- Site PHC-3: This sampling site was selected because of historically high measurements of fecal coliform bacteria in past studies. The source is primarily a residential development across Engineers Cutoff, runs under the road through a culvert. Accessible on the maintained nature trail in this area. (Photo: Figure 4)

**Figure 4.** *Pederson Hill Creek at site PHC-3, near the intersection of Glacier Highway and Engineers Cutoff Road; site accessible on the nature trail footpath. May, 2006.*

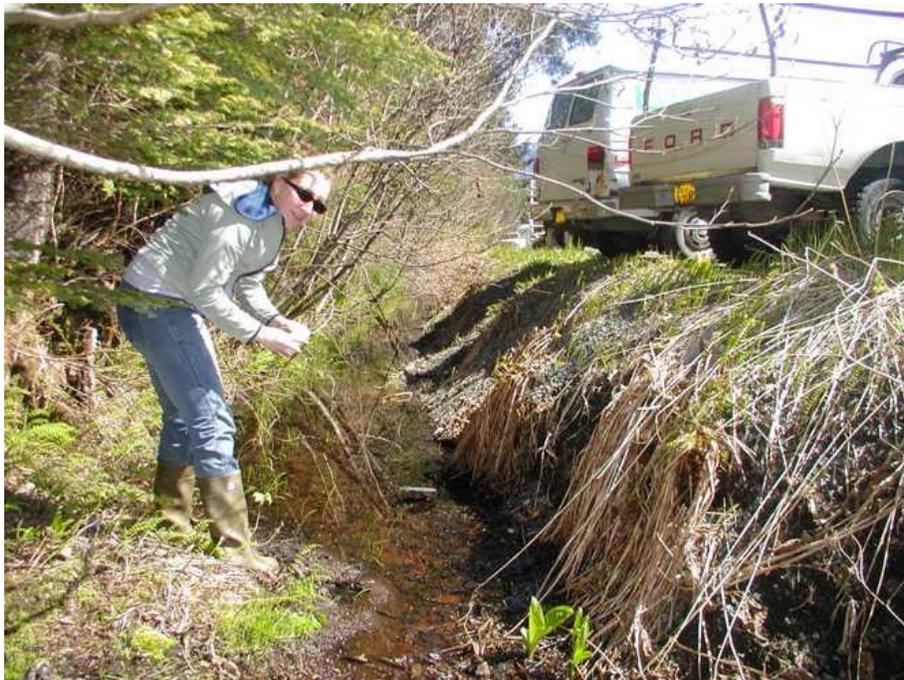
- Site PHC-5: The east side of the fork described in PHC-4 was selected again due to historically high reports of fecal coliform bacteria. It contains the runoff from the parking lot and office buildings on Sherwood Lane. (Photo: Figure 5)

**Figure 5.** *Pederson Hill Creek at site PHC-5, flowing along the edge of the parking lot for the office buildings on Sherwood Lane. May, 2006.*

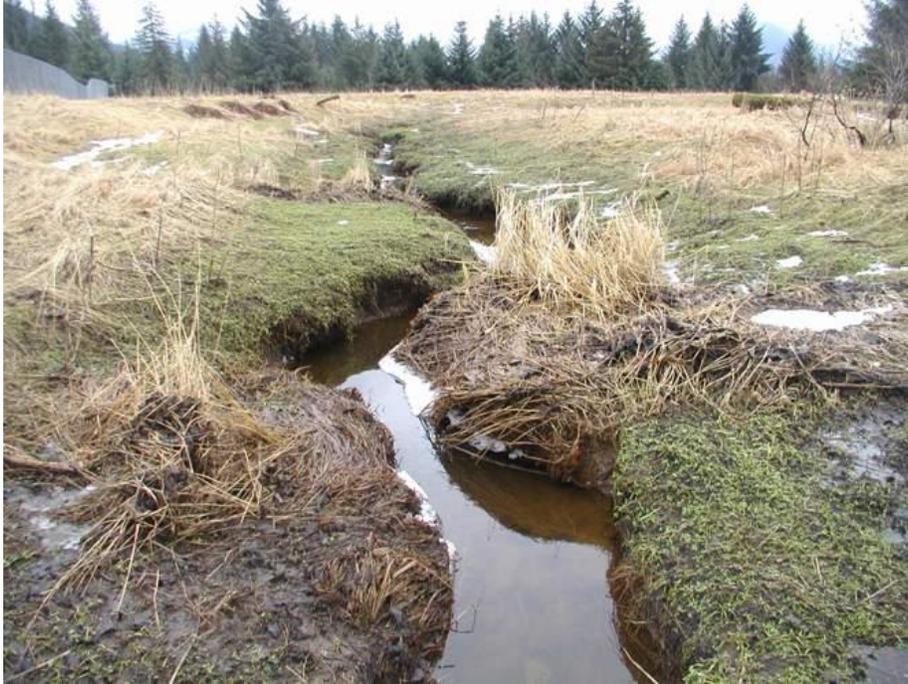
- Site PHC-6: This site is reached by driving to the end of Sherwood Lane. The road goes to gravel, and has a small turn around. A short walk through tall grass leads to a footbridge, the sampling site. This is the lowest point in the stream used for collection, and has higher flow levels than the upper sites. (Figure 6)

**Figure 6.** *Pederson Hill Creek- Downstream view from the footbridge at PHC-6. February, 2006.*
