**EFFECTIVENESS OF PAVING ON AIRBORNE
PARTICULATE MATTER:
A PRELIMINARY ASSESSMENT OF FUGITIVE DUST
FROM ROADS IN KOTZEBUE, ALASKA**

Project Report (2002-2008)

**Prepared for
Alaska Department of Transportation & Public Facilities**

**Monitoring and Quality Assurance
Division of Air Quality
Department of Environmental Conservation
Anchorage
August 2011**

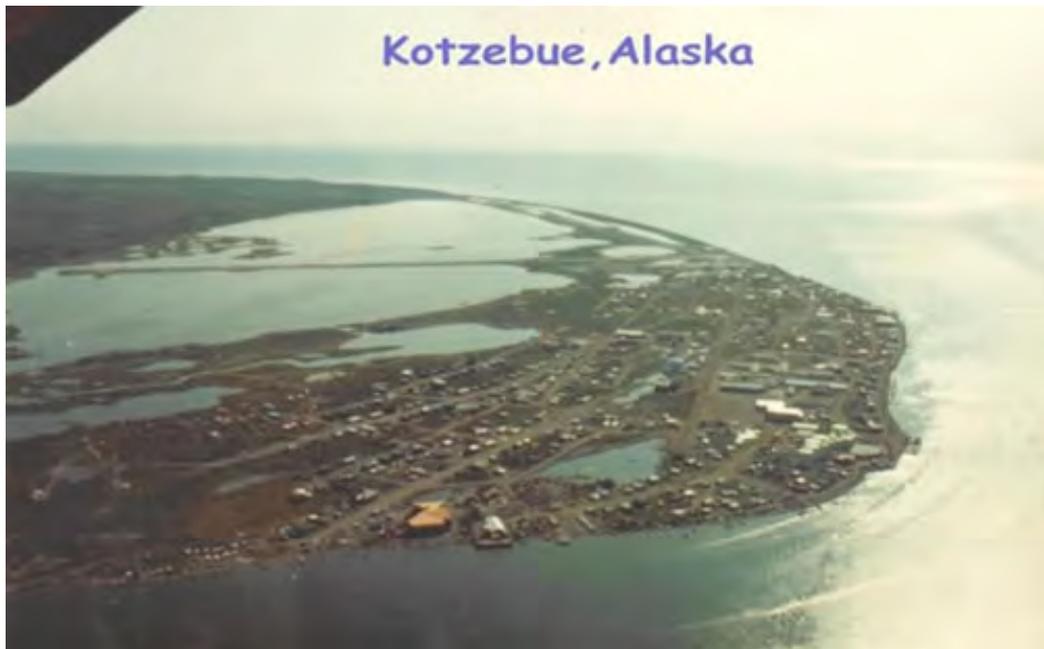
Figure 1: Kotzebue, Alaska – aerial photo looking southwest into the Chukchi Sea

Kotzebue, Alaska is located on the northern tip of the Baldwin Peninsula (66.89828° N Lat, 162.59585° W Long) roughly 26 miles above the Arctic Circle. The city is situated on a 3-mile-long silt based spit, which ranges in width from 1,100 to 3,600 feet. An aerial photo of the community is displayed in Figure 1. According to the Alaska Department of Community and Economic Development (DCED) the current population (2005) was recorded at 3,120 residents. The city contains roughly 1000 housing units, which are connected by 26 miles of roadway. The road system, which is mainly gravel/silt mixture, is used by cars, trucks, motorcycles, four wheelers (ATVs), bicycles and pedestrians to transport residents within the community. Four wheelers are also used throughout the day as “recreation vehicles”. In the winter snow machines are also used for transportation making their way onto the road surface when it is snow covered. Previous to the start of any DEC monitoring, only Third Avenue had been paved. By the time Second Avenue

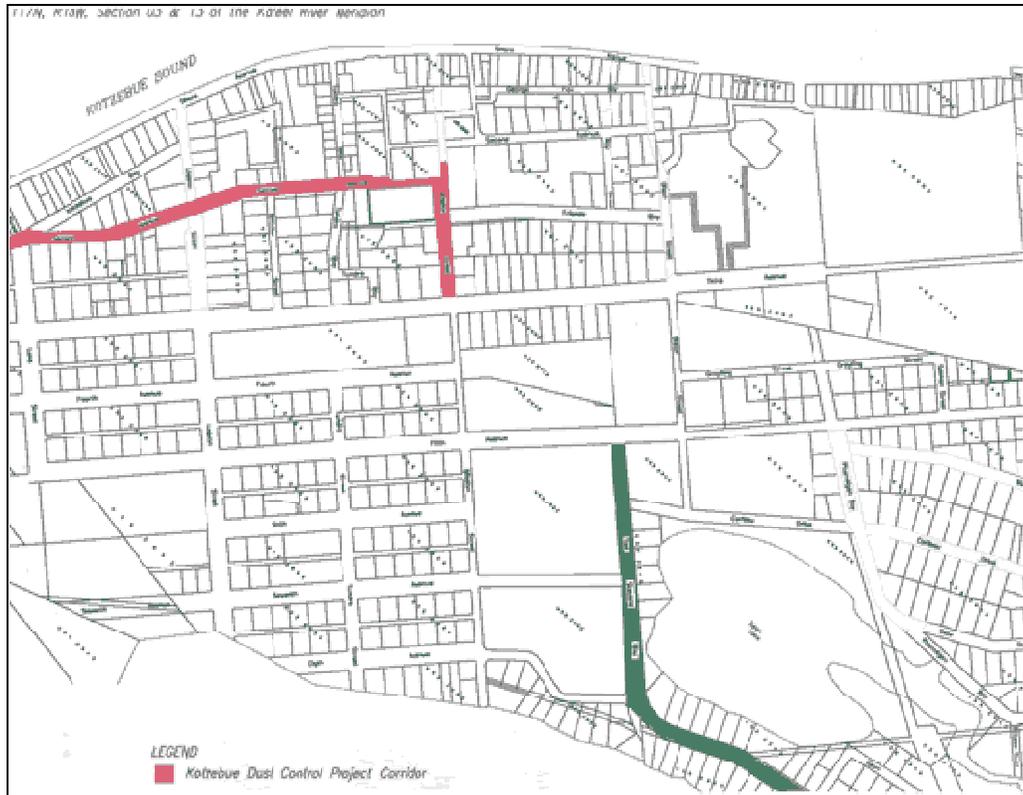
Figure 2: Kotzebue Dust Control Project Map, courtesy of DOT &PF, AK.
