ALASKA DEPARTMENT OF ENVIRONMENTAL CONSERVATION
Division of Spill Prevention and Response
Prevention Preparedness and Response Program
SITUATION REPORT (SITREP)

Dalton Hwy MP 36 Truck Rollover

SITREP # 2 and Final

SPILL #: 19309915401

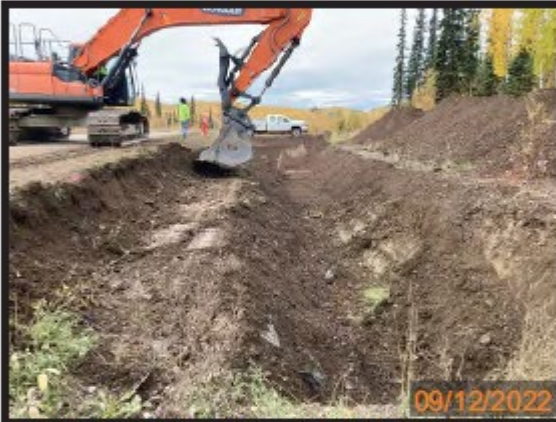
Photograph 3: Viewed Southwest- Removal and stockpiling of clean top 4' of prism

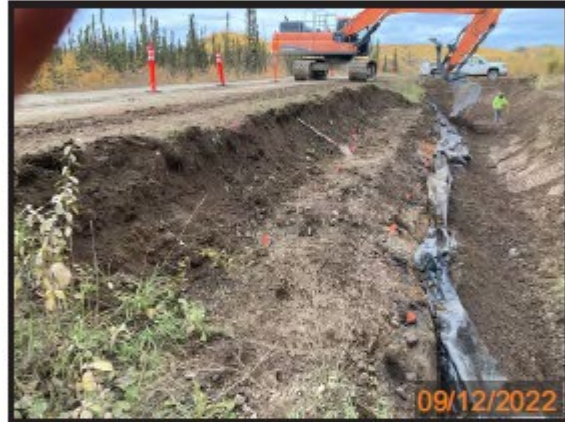
Photograph 4: Viewed Southwest-Flags marking field screen locations.

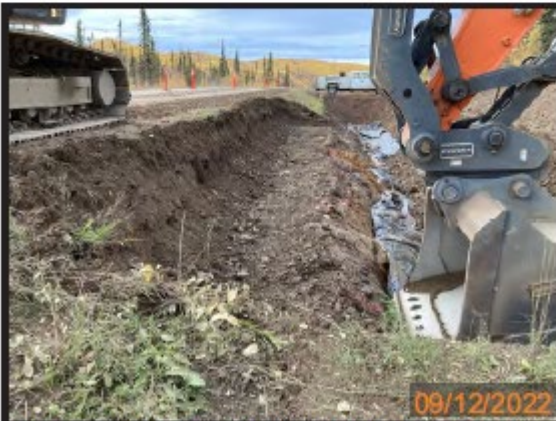
Photograph 5: Viewed Southwest- Removal of tyar liner covering the contaminated prism.

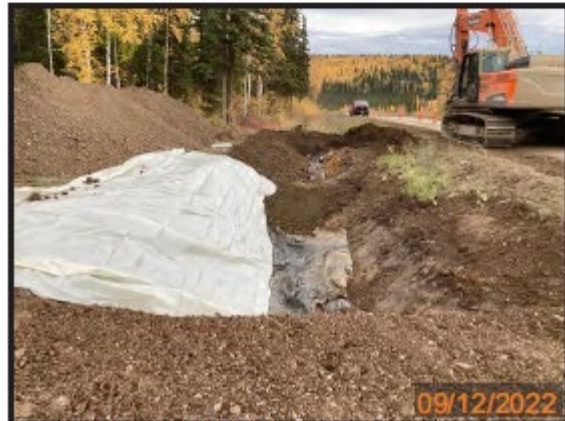
Photograph 6: Viewed Northeast- Liner placed in excavation for temporary stockpile of contaminated soils.

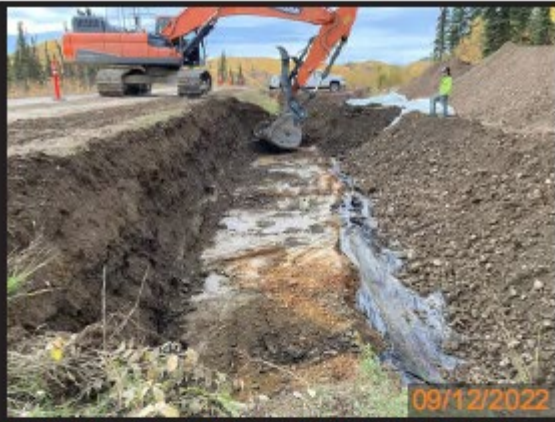
Photograph 7: Viewed Southwest- Removal and stockpiling of contaminated prism soils.

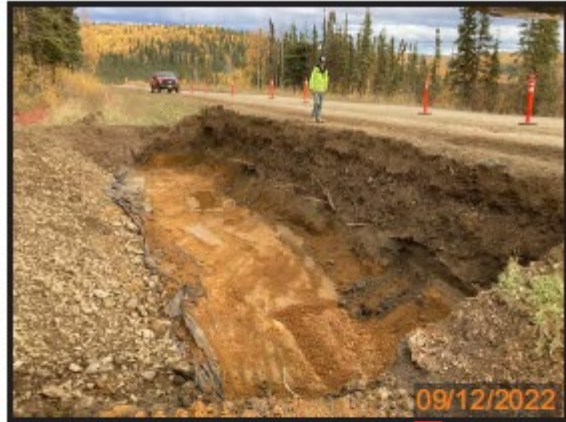
Photograph 8: Viewed Northeast- Continued removal and contaminated prism soils.

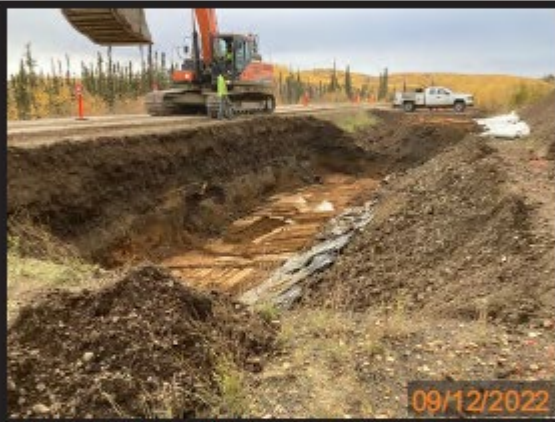
Photograph 9: Viewed Southwest- Contaminated soil removal with contaminated stockpile in the background.

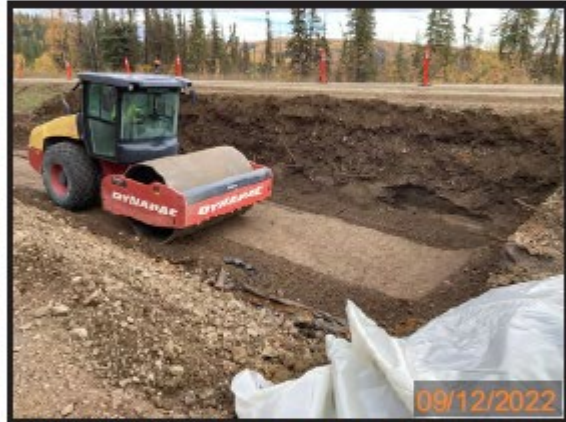
Photograph 10: Viewed East- Restoration of prism, compaction of lift of clean backfill.

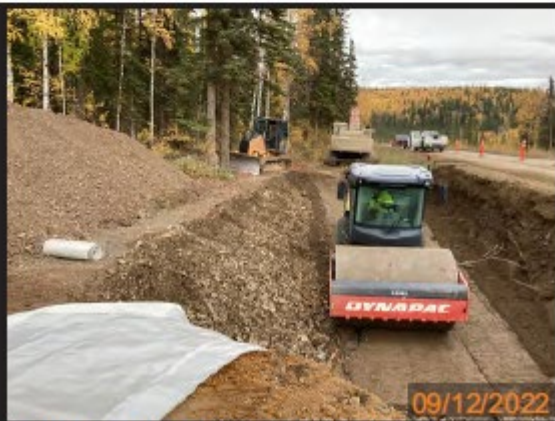
Photograph 11: Viewed Northeast- Adding compacted lifts/additional restoration of prism.

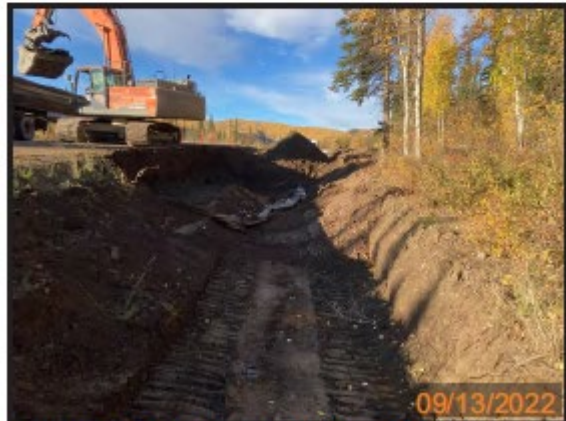
Photograph 12: Viewed Southwest- Direct loading of contaminated soils.

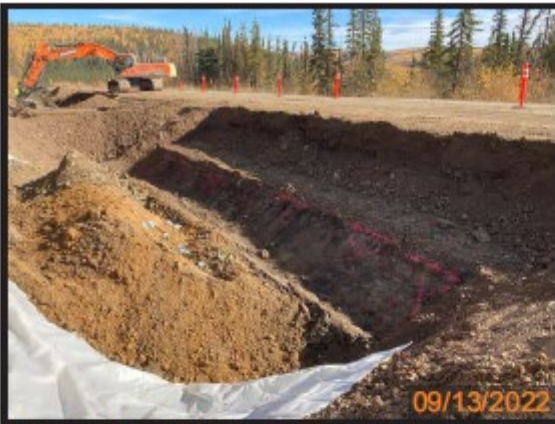
Photograph 13: Viewed East- Pink Xs marking contaminated soils remaining in the prism with contaminated stockpile in excavation.

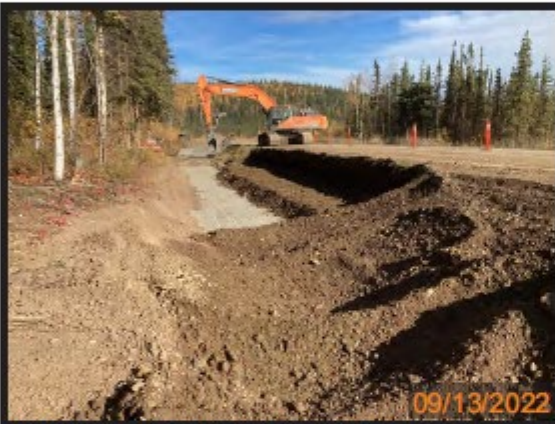
Photograph 15: Viewed Northeast- Placement of clean backfill and continued site restoration

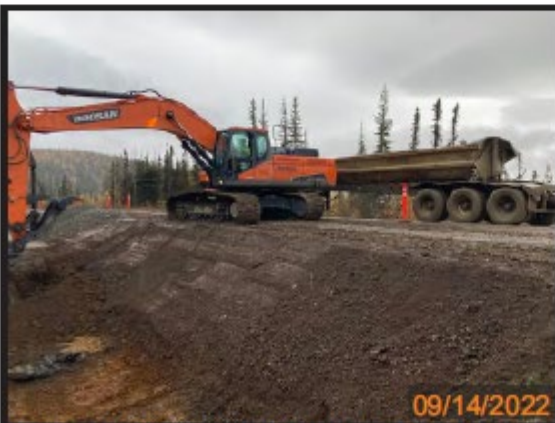
Photograph 17: Viewed East- Side dump truck staged for load out of contaminated soil stockpile.

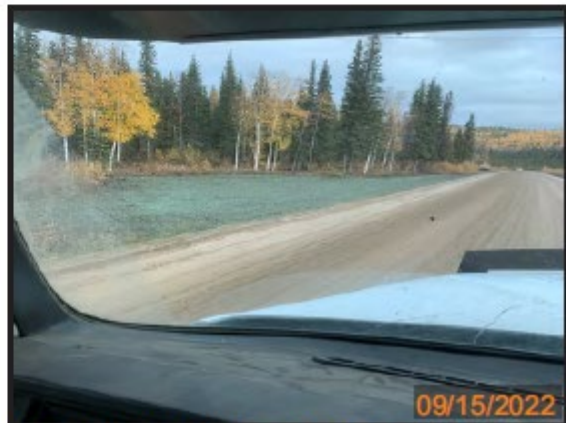
Photograph 18: Viewed North- Site following restoration and hydro-seeding.
