2022 Water Quality Final Report Kenai River, Alaska

Prepared by Sarah J. Apsens
Nonpoint Source Water Quality Section
Division of Water
Alaska Department of Environmental Conservation

June 2023

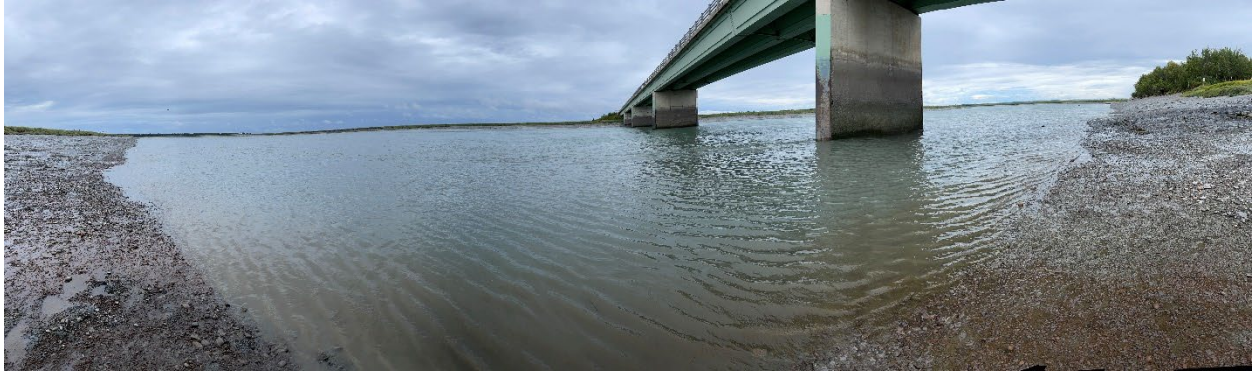
Figure A. 1. River mile 5 looking north. Photo collected in August 2022.

RM 5 was the monitoring location closest to the outlet of the Kenai River into Cook Inlet (Figure A. 1). This site is tidally influenced and often exhibited characteristics of estuarine habitats. The site was accessible on foot from a small parking lot off Bridge Access Road. Personal use fishing occurs in the spring for Eulachon (*Thaleichthys pacificus*) and in July for Sockeye salmon (*Oncorhynchus nerka*). Mud and silt were the dominant substrate at the site and turbid conditions were commonly observed. River mile 5 was historically monitored for pathogens under the Kenai BEACH Program from 2010 to 2020.

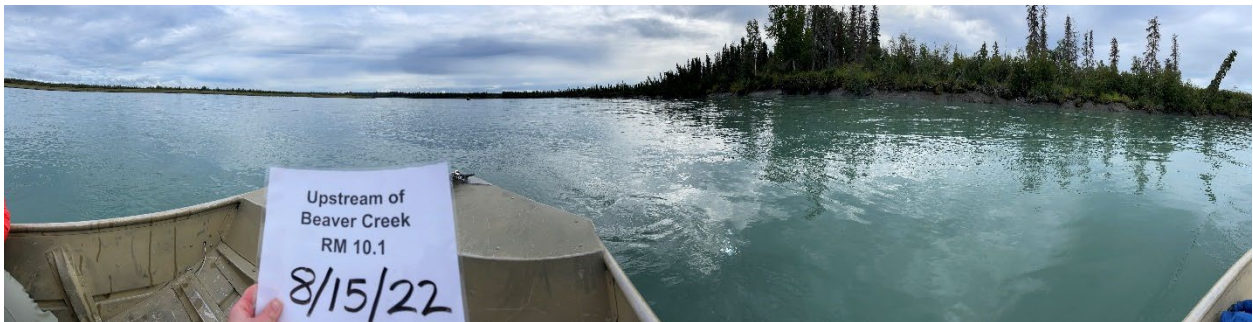
Figure A. 2. River mile 10.1 looking east. Boat facing upstream. Photo collected August 2022.

RM 10.1 was a boat accessible monitoring location upstream of the Beaver Creek tributary (Figure A. 2). Sample collection occurred river left of midchannel near a steep cut bank. Tidal influence was less noticeable than at RM 5. Seals were observed multiple times near this site. Fishing boats were often anchored downstream of sampling crew. The Multi-Agency Baseline Monitoring project also monitored a site upstream of Beaver Creek.

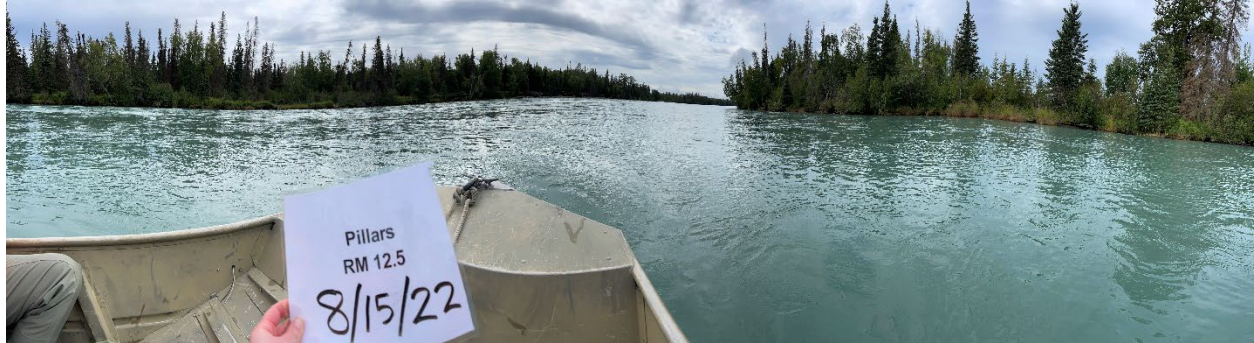
Figure A. 3. River mile 12.5 looking south. Boat is facing upstream. Photo collected August 2022.

RM 12.5 was a boat accessible monitoring location upstream of the Pillars Boat Launch (Figure A. 3). Sample collection occurred river right of a large island near a steep cut bank. This site was upstream of the Pillars Boat Launch and boat traffic was common.

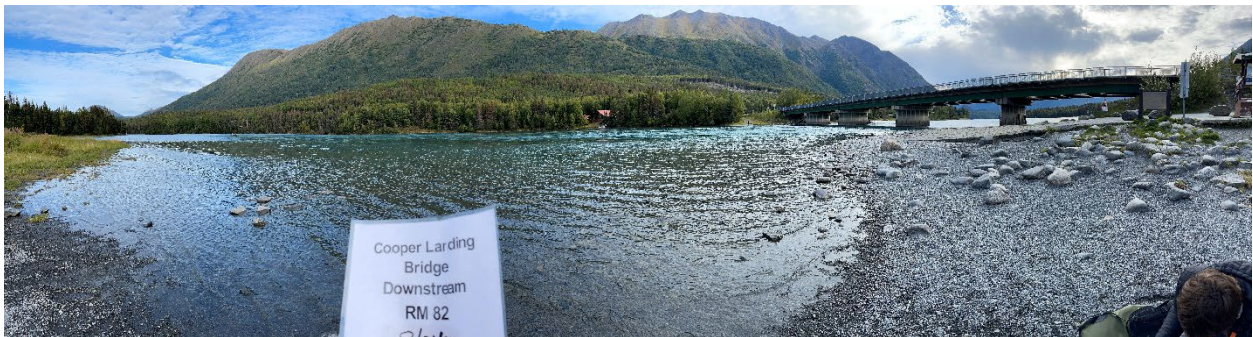
Figure A. 15. River mile 82 looking northeast. River mile 82.1 was located just upstream of the bridge (see upper right section of photo).

RM 82 and 82.1 were foot access sites located downstream and upstream of the Cooper Landing Bridge (Figure A.15). River mile 82 was located approximately 10m downstream of the boat launch. River mile 82.1 was located approximately 5 upstream of the bridge.
