Alaska Department of Environmental Conservation

Anchorage Creeks and Lakes Pathogen Survey 2020-2021

Final Report

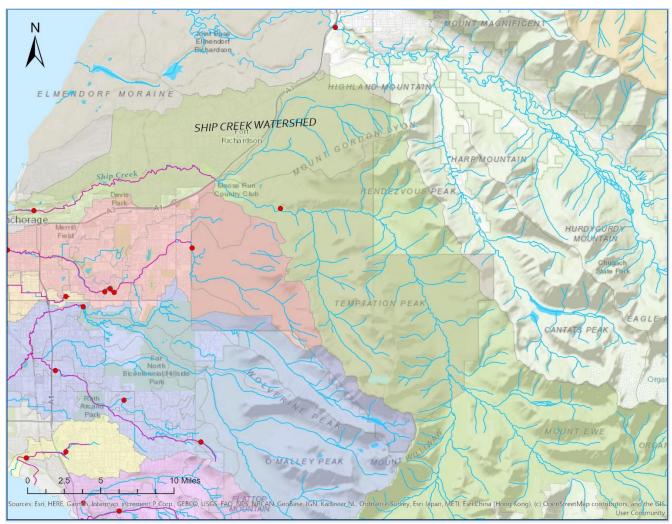
Figure 2. Map of the Ship Creek watershed and monitoring locations; impaired portions of streams are displayed in pink

Two monitoring locations were sampled on Ship Creek; fecal coliform and *E. coli* were sampled at the lower site, within the area of impairment, and only fecal coliform was sampled at the upper site, upstream of the impairment. There were no exceedances for fecal coliform at the upper site and no observed sources of pathogens. The lower site had exceedances for fecal coliform in both years and for *E. coli* in 2021 (Table 3). The 2004 TMDL for Ship Creek states that urban runoff is likely the main

conveyance transporting fecal coliform pollution into Ship Creek along with stormwater runoff and domestic and wild animals (ADEC, 2004). Based on the lower Ship Creek results, urban and stormwater runoff may be more prevalent and contributing to elevated results.

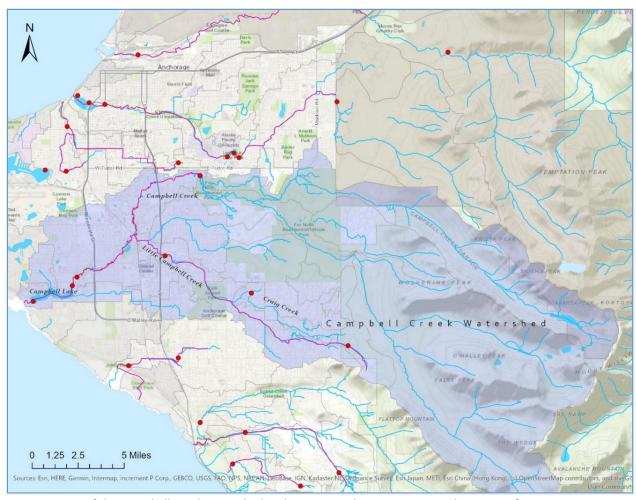
Figure 3. Map of the Campbell Creek watershed and monitoring locations; impaired portions of streams are displayed in pink

The Campbell Creek Watershed starts in the Chugach Mountains and drains an approximate area of 81 square miles before discharging into Turnagain Arm (Figure 3). The upper watershed is within Chugach State Park, the lower watershed is within urban Anchorage. Campbell Creek and other waterbodies within the watershed are important to the Anchorage area and provide outdoor recreation, aesthetic views, and habitat for many species. Little Campbell Creek was included on the 1998 303(d) list of impaired waters and a TMDL was established in 2004 (ADEC 2004a). Campbell Creek and Campbell Lake were included on the 2002/2003 303(d) list of impaired waters in the Integrated Water Quality Monitoring Assessment Report (ADEC, 2003) for fecal coliform and a TMDL was established for both waterbodies in 2006 (ADEC, 2006). Stormwater runoff was identified as the expected pollutant conveyance for all three of these waterbodies in the TMDLs (ADEC 2004a and ADEC 2006).

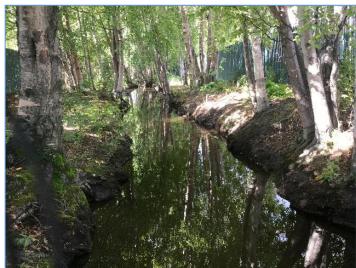
Figure 4a. Lower Little Campbell Creek in 2020

As Little Campbell Creek enters urbanized areas, it may become more polluted by stormwater runoff conveying fecal coliform. Lower Little Campbell Creek may have increased fecal coliform pollution due to its location within an industrialized area and near stormwater retention ponds. There are also several encampments along the creek. Data from the Anchorage Water and Wastewater Utility show that the industrial area around Lower Little Campbell Creek utilizes septic systems, which could also be a source of fecal coliform pollution in the case of a septic failure (AWWU 2021). The creek flows through part of the Alaska Zoo and Ruth Arcand Park, both areas house and are used by wildlife and domestic animals. One section of the creek downstream

of the lower sampling location was affected by a blockage of accumulated debris, causing higher water levels and lower flow. After sampling was completed in 2021, the blockage was removed, lowering water levels and increasing flow.

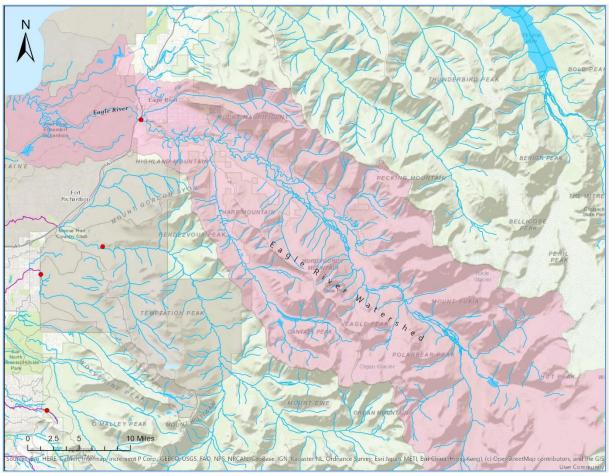
Figure 5. Map of the Eagle River watershed and monitoring location; impaired portions of streams are displayed in pink

One monitoring location was sampled on Eagle River (Figure 5). The monitoring location was sampled for both fecal coliform and *E. coli* and fecal coliform had results that exceed criteria in both years (Table 5). Preliminary analysis suggests urban and stormwater runoff could be contributing to elevated fecal coliform levels. The monitoring location is near a busy highway, residential neighborhoods, and the Eagle River campground. Eagle River also flows through urbanized areas upstream of the sample site. Failing septic systems from upstream neighborhoods are another potential pollutant source. MST sampling detected no markers for human, bird, or dog sources of pathogens.

DEC is proposing to collect additional pathogen data on Eagle River from multiple locations over the open water season (see 2023-2025 ACWA grant Request for Proposals).

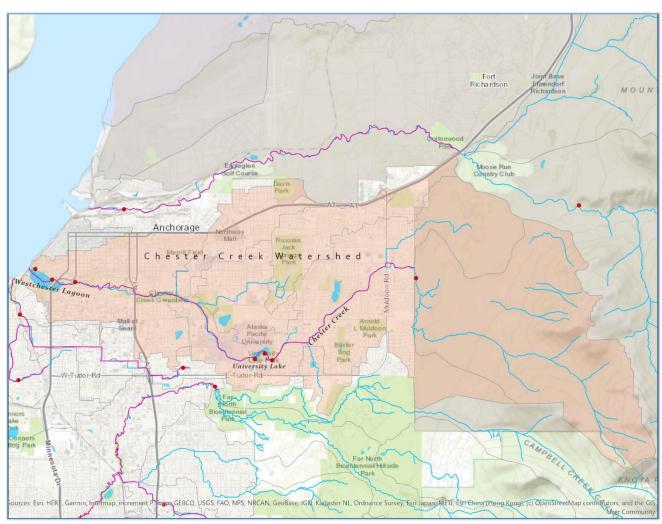
Figure 6. Map of the Chester Creek watershed and monitoring locations; impaired portions of streams are displayed in pink

The Chester Creek watershed heads in the Chugach Mountains on JBER and drains an approximate area of 30 square miles before discharging into Cook Inlet (Figure 6). The upstream reaches of Chester Creek are located on minimally disturbed lands and are not listed as impaired. The watershed contains Chester Creek, University Lake, and Westchester Lagoon. These waterbodies were first included on the 303(d) impaired waters list in 1990 for fecal coliform bacteria pollution with urban runoff identified as the pollutant conveyance, a combined TMDL was approved in May 2005 (ADEC 2005).

Seven monitoring locations (Table 6) were sampled in the Chester Creek watershed. Three sites had exceedances in both years: lower Chester Creek, midway Chester Creek, and University Lake inlet. All sampled sites had at least one exceedance. Sources of fecal coliform in the Chester Creek watershed are urban runoff, stormwater discharge, and wildlife/domestic animal waste (ADEC 2005). University Lake is located within a dog park and pet waste is a likely source of pathogens. Westchester Lagoon, located downtown in a busy park, is heavily used by waterfowl and for recreation during the summer months. Although wildlife and domestic animals contribute to some fecal pollution into these waterbodies, the largest source of fecal coliform most likely comes from urban and stormwater runoff.

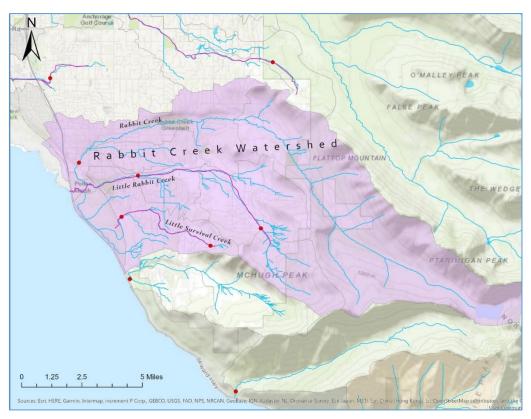
Figure 7. Rabbit Creek watershed and monitoring locations; impaired portions of streams are displayed in pink

The Rabbit Creek watershed is located in south Anchorage, heads in the Chugach Mountains, and drains approximately 24 square miles before discharging into Cook Inlet (Figure 7). A small portion of the upper watershed is located within Chugach State Park, and much of the lower watershed is in residential areas. Little Rabbit Creek and Little Survival Creek were included on the 1998 303(d) list of impaired waterbodies for fecal coliform, and TMDLs were established for both waterbodies in 2004 with stormwater runoff identified as the pollutant conveyance (ADEC 2004c, ADEC 2004d).

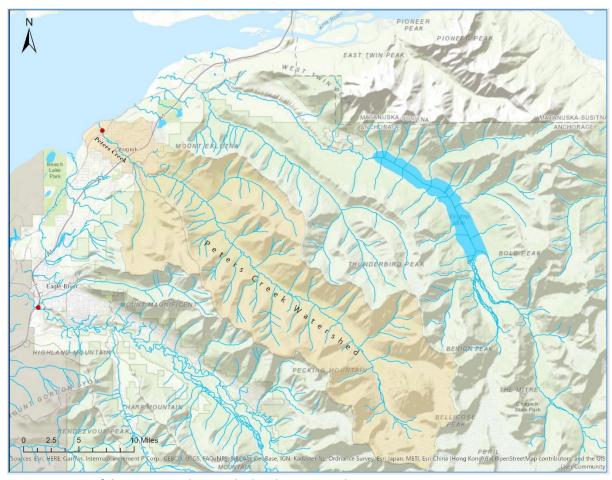
Figure 10. Map of the Peters Creek watershed and monitoring location

The Peters Creek watershed is located north of Anchorage, heads in the Chugach Mountains and drains an approximate area of 89 square miles before discharging into Knik Arm (Figure 10). Most of the generally undeveloped upper watershed is within Chugach State Park. The most developed area is the lower watershed where the Glenn Highway and communities of Birchwood, Chugiak, and Peters Creek are located. Peters Creek is not currently listed as impaired and was tested for fecal coliform and *E. coli*. The results for fecal coliform and *E. coli* did not exceed criteria; however, stormwater runoff from roads, neighborhoods, and the nearby Birchwood Airport can be a conveyance for pollutants (Table 10).

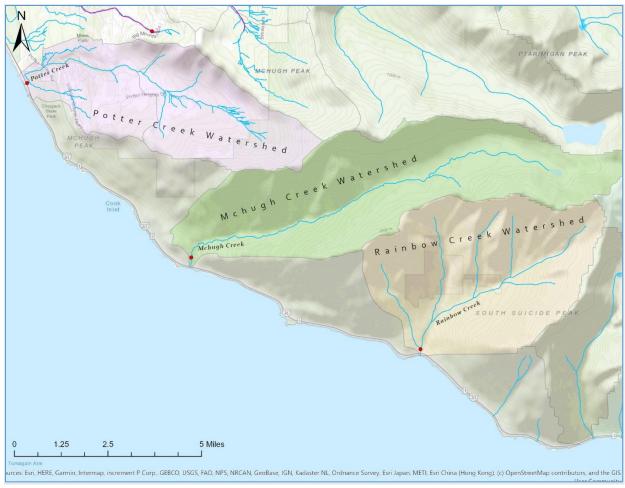
Figure 11. Map of monitoring locations in the Potter creek, McHugh Creek, and Rainbow Creek watersheds; impaired portions of streams are displayed in pink.

The Potter, McHugh, and Rainbow Creek watersheds are located south of Anchorage, head in Chugach State Park, and collectively drain approximately fifteen square miles before discharging into Turnagain Arm (Figure 11). Most of these watersheds are undeveloped and none of the creeks are currently listed as impaired. These creeks were tested for both fecal coliform and *E. coli*.
