Waterbody Assessment  
Alaska Department of Environmental Conservation

**VANDERBILT CREEK**

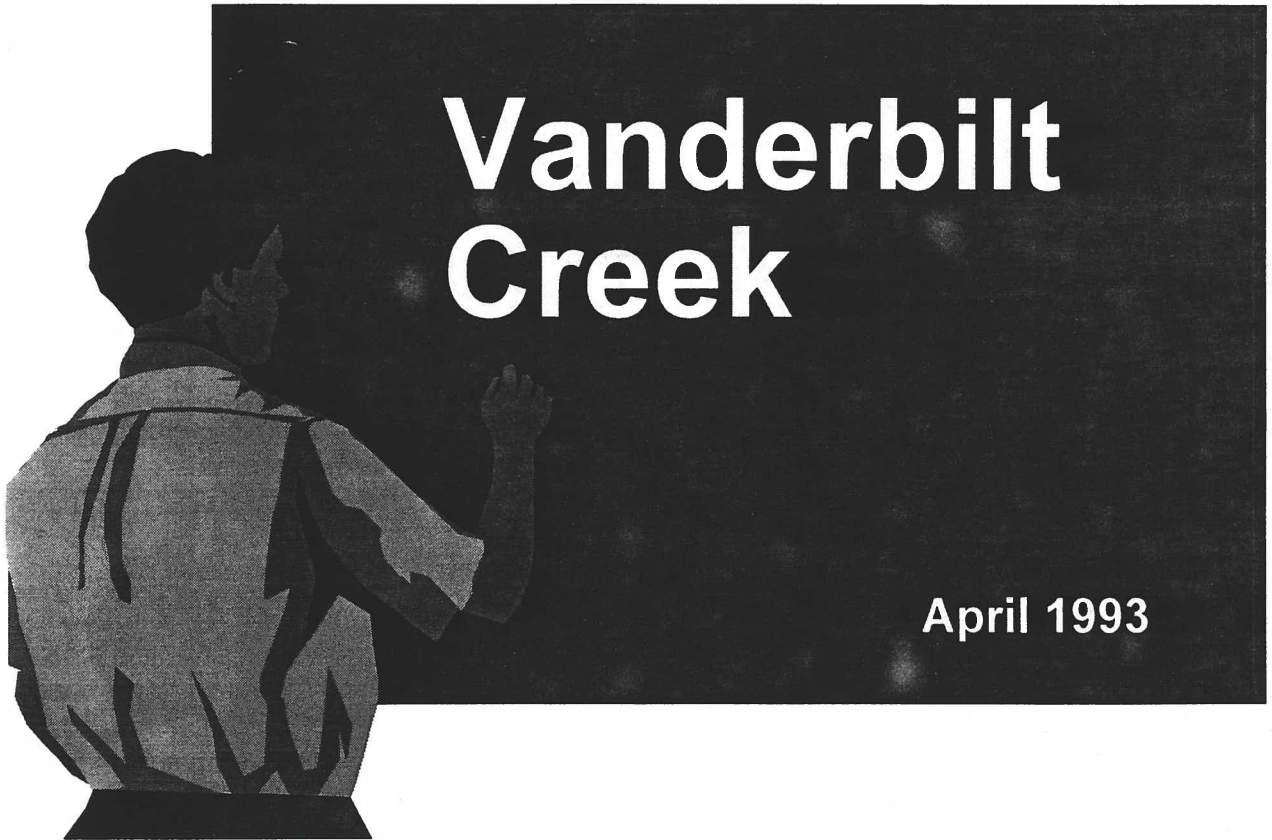
Figure 1 - Map of Lemon Creek Valley and Vanderbilt Creek

The area of concern is located in Lemon Creek Valley, about 5 miles northwest of downtown Juneau. The Lemon Creek Valley watershed is drained by three streams, Lemon Creek, Switzer Creek and Vanderbilt Creek. The drainage of Vanderbilt Creek includes the eastern side of Lemon Creek Valley and Blackerby Ridge. The study area comprises all of Vanderbilt Creek, from its headwaters to the east to the wetlands adjacent to Egan Expressway in the southwest. Located at the northern boundaries of the study area are the Channel Landfill and a residential and commercial area ending at Anka Street. The creek's southern boundaries are Glacier Highway and areas immediately adjacent to the highway. The north-eastern boundary includes the foot of Blackerby ridge and the city and commercial gravel pits. The geographical location of Lemon Creek Valley, Vanderbilt Creek and the boundaries of the study area are shown in Figure 1.

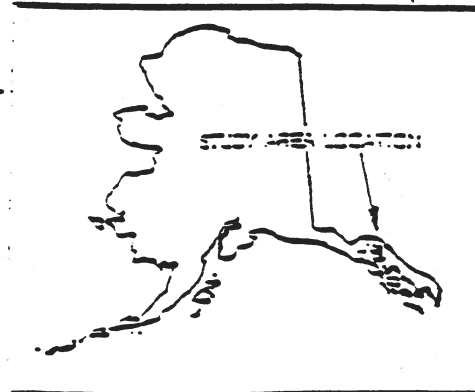
Figure 5: Chemical Sampling Sites - Vanderbilt Creek Figure 5 - Sampling Sites

- Station 11: Tributary to Vanderbilt Creek, East of East Pit
- Station 12: Vanderbilt Creek
- Station 13: Tidal Wetlands, SW of East Pond, near tide gate, outside dike
- Station 14: Tidal Wetlands Slough

In 1992, chemical data were collected by ADEC for the purpose of identifying impacts from landfill leachate to wetlands and the lower portions of Lemon and Vanderbilt Creek (ADEC Channel Landfill Study 1992). Four sampling sites relevant to Vanderbilt Creek were studied, these included one site in Vanderbilt Creek (Site 12), one from a ditch draining into Vanderbilt Creek (Site 11) and two sites in the estuary below the landfill (Sites 13 and 14). Figure 5 identifies the sampling sites. Site 12 is the same location as in the 1991 sampling effort.

Data include measurements for inorganic non-metals, physical measurements, metals and volatile organics. No turbidity and suspended solids data were collected in this study. The 1992 results are summarized in Table 4. Sites 11 and 13 show high conductivities, high dissolved solids and high magnesium concentrations which are possibly due to tidal saltwater influences. Coliform counts of 1600FC/100ml were obtained for sites 13 and 14. The source for these high levels has not been determined. Iron was found above drinking water standards at all four sampling sites. High iron in surface and groundwater is not uncommon in the Juneau area. Other metals were below freshwater criteria for aquatic life or below detectable levels. Copper, silver nickel and zinc detection limits were 100  $\mu\text{g/L}$ , corresponding freshwater criteria are 6.5 - 21  $\mu\text{g/L}$  (Cu), 0.12  $\mu\text{g/L}$  (Ag), 56 - 160  $\mu\text{g/L}$  (Ni), and 47  $\mu\text{g/L}$  (Zn).
