**ALASKA DEPARTMENT OF ENVIRONMENTAL CONSERVATION**  
**Division of Spill Prevention and Response**  
**Prevention Preparedness and Response Program**  
***SITUATION REPORT (SITREP)***

## **Kaktovik Tank KAK-70 ULSD Release**

**SITREP #:** 5 and Final

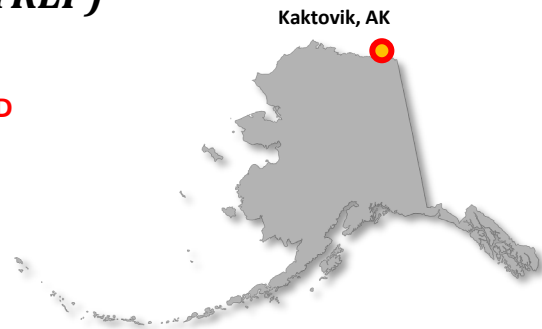
Following the winter weather event, street cleaning activities occurred prior to the discovery of the release and resulted in diesel-contaminated snow inadvertently being pushed through the northern portion of the community and stockpiled into 15 different snow push piles. Approximately 7,400 cy of impacted snow was transported to containment cells from locations within the community, including the source location. Snow melting, filtering, and snow-melt water treatment occurred from March through May 2017. The resulting melt

water was captured by mitigation measures, treated with granular activated carbon media (GAC), then discharged to nearby culverts along Kaktovik Avenue and Fourth Street, per ADEC authorization.

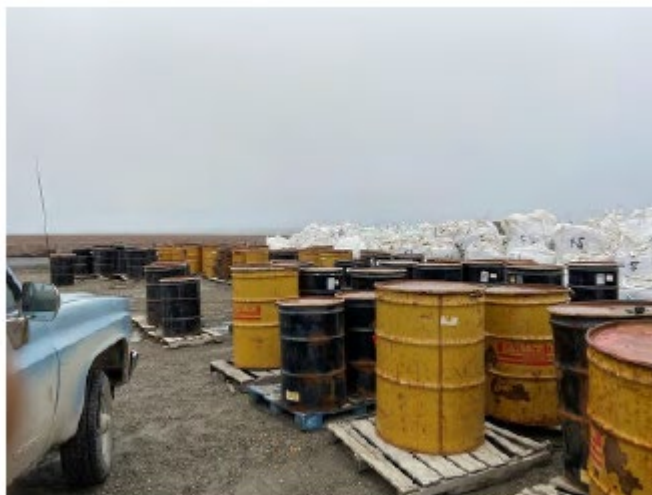
**Photo 1:** View of KAK-70 drum storage pad facing southeast (Jacobs, September 15, 2020)

**FUTURE PLANS AND RECOMMENDATIONS:** Future plans include the removal and transport of contaminated Super Sacks and drums from Kaktovik stockpiles for disposal.

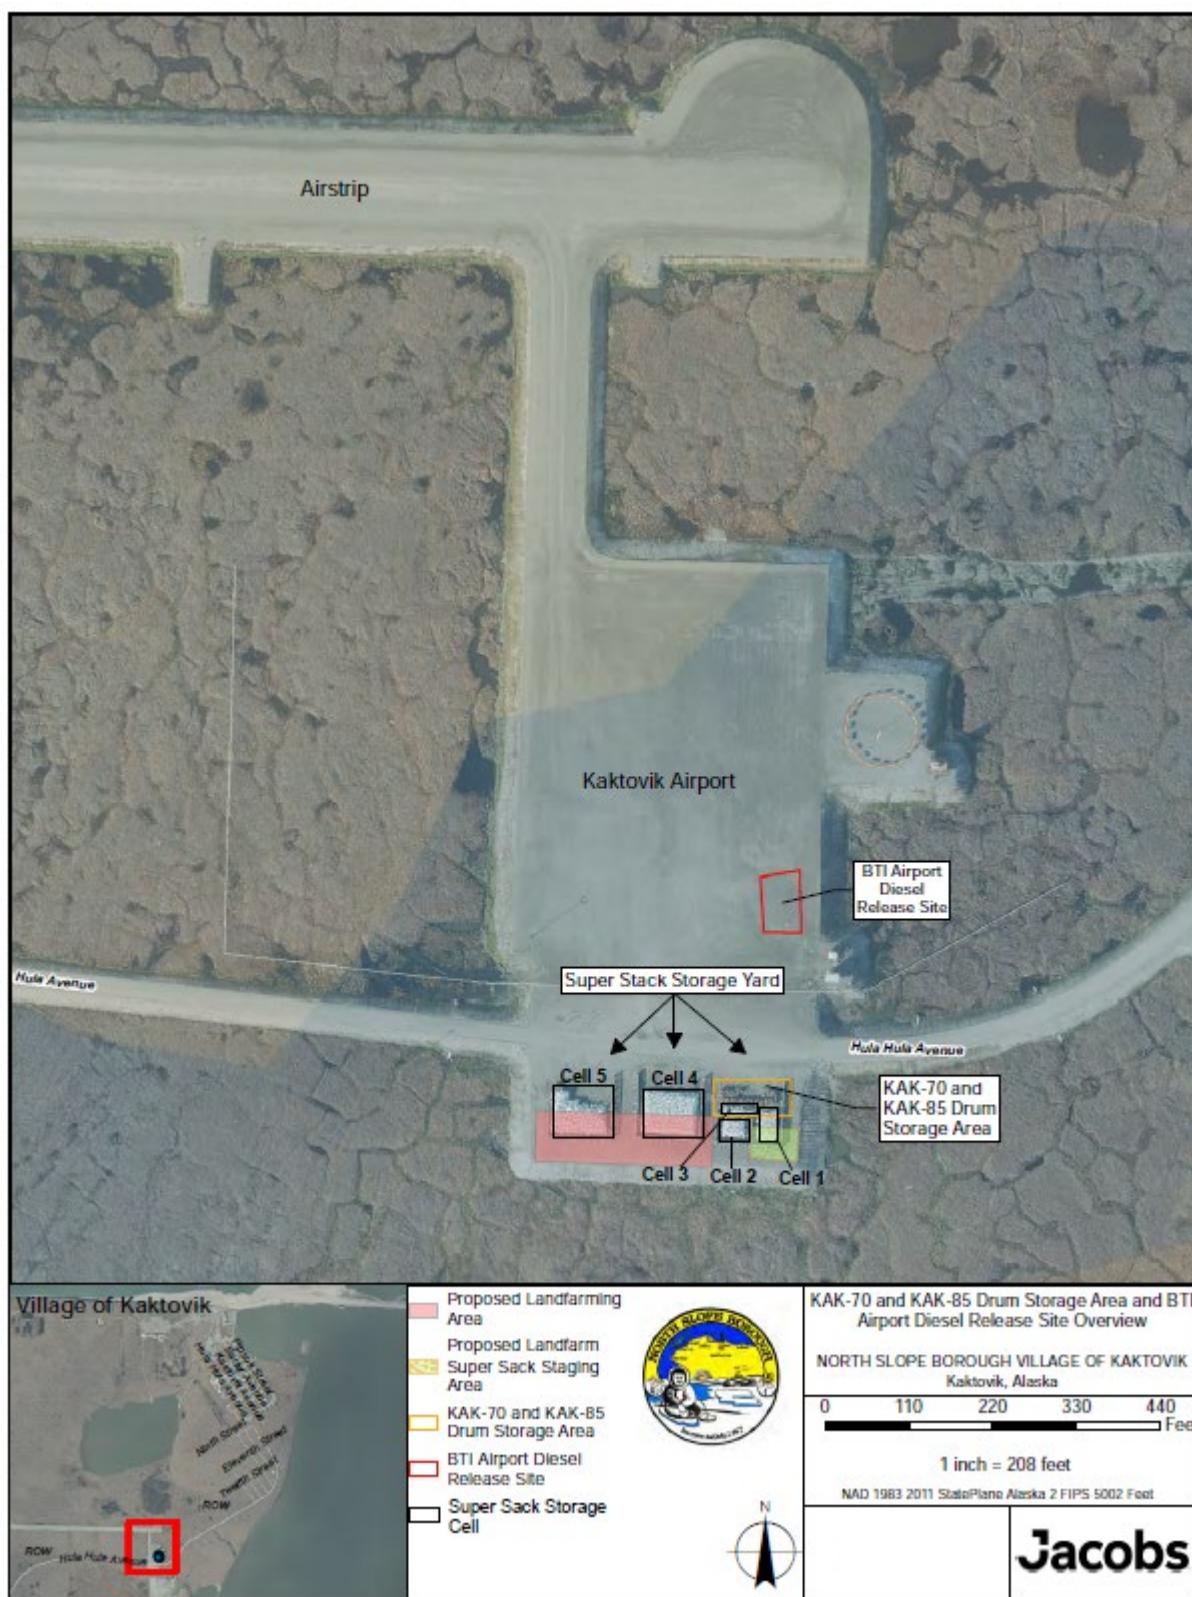
Figure 1: Contaminated Waste Storage Area at Kaktovik Airport (Jacobs, 2020)

Spill response and cleanup actions for this spill and another nearby spill generated 84 drums of various waste streams and five Super Sacks of oily waste. In September 2018, the Borough mobilized resources to Kaktovik to relocate the various Super Sack temporary storage areas into one consolidated location at the Kaktovik airport. In 2020, Jacobs Engineering Group Inc. (Jacobs) conducted waste characterization sampling and submitted a waste management plan in order to provide the characterization necessary for offsite transportation and disposal.
