Property Assessment and Cleanup Plan

Old City Shop

Elim, Alaska

By:
OASIS Environmental Inc.
December 8, 2010

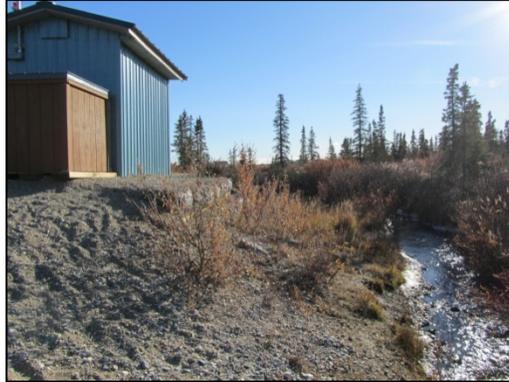
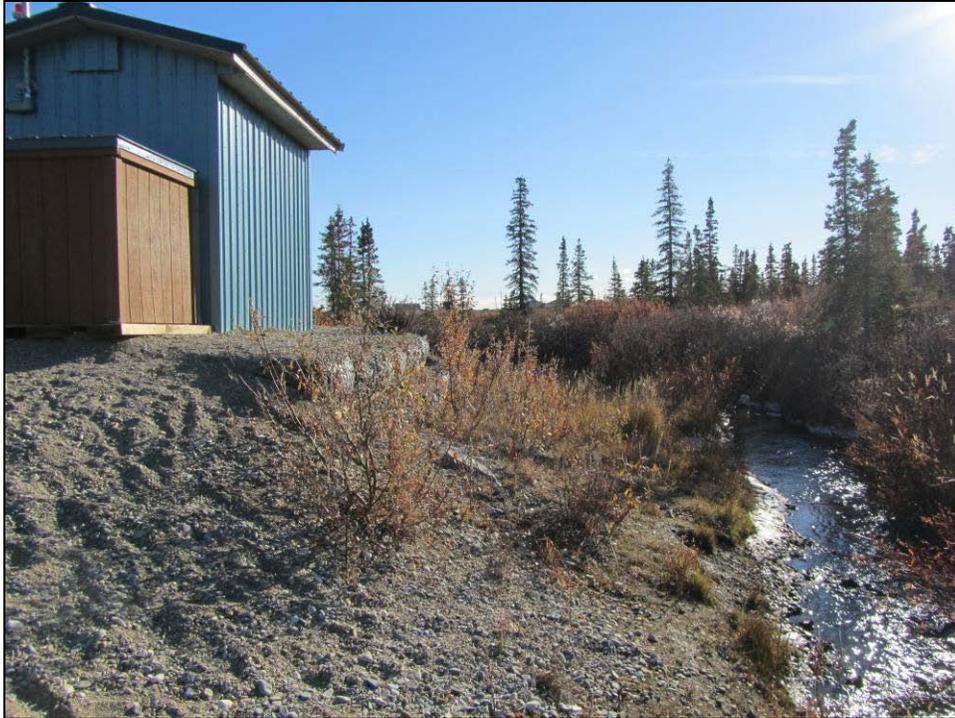
The water system is operated by the city. Water is derived from two sources, a stream (Elim Creek) which flows through an infiltration gallery northeast of the city, and a community spring located adjacent to Elim Creek (Figure 2, Photograph 1).

PHOTOGRAPH 1: DRINKING WATER SOURCE.

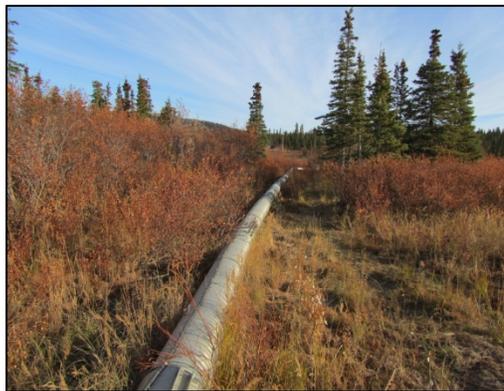
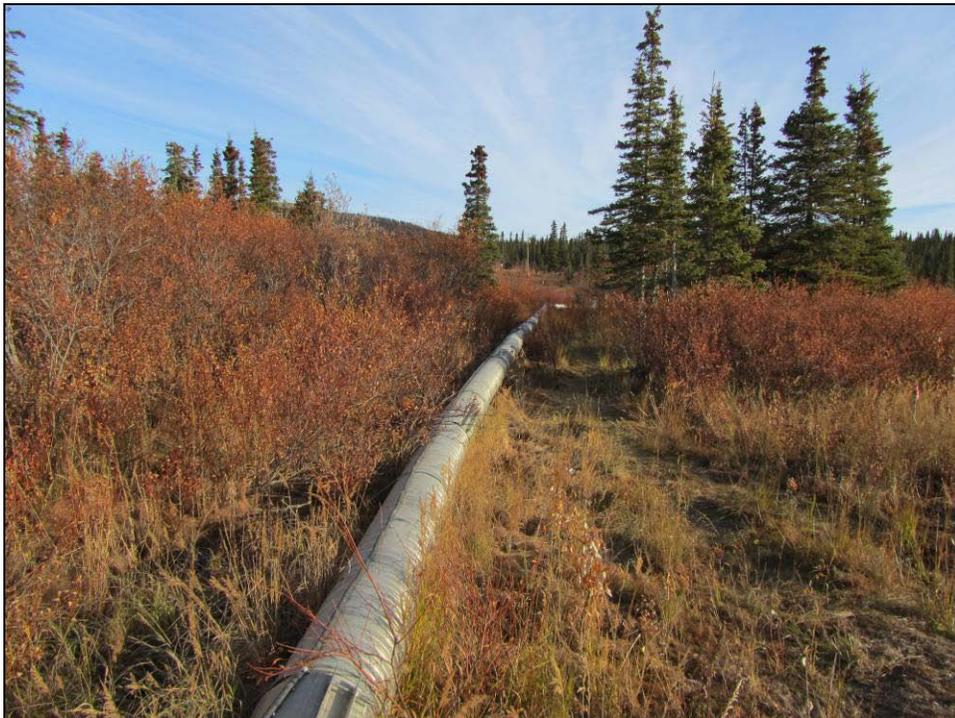
Water is stored in a 211,000-gallon community water storage tank, chlorinated, and piped to housing. There are no individual wells. Water lines are buried along the roads of the city with the exception of the 900 ft above ground raw water transmission line which connects the water source to the water treatment plant (Photograph 2).

PHOTOGRAPH 2: ABOVE GROUND RAW WATER TRANSMISSION LINE.

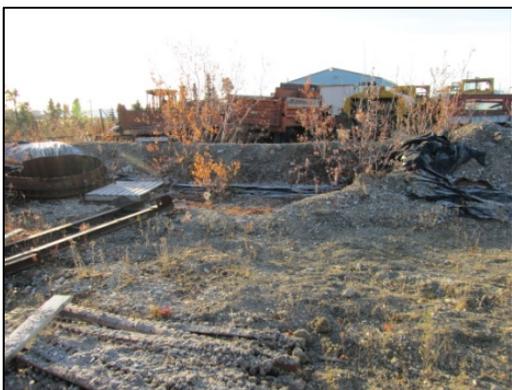
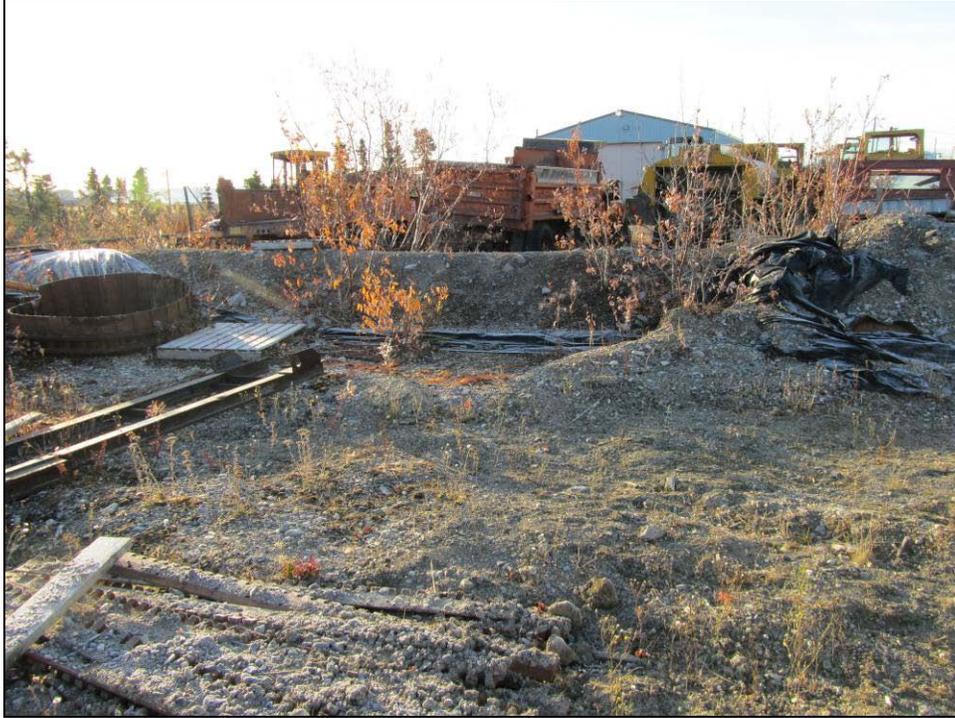
PHOTOGRAPH 9: ABANDONED TANK FARM FROM THE NORTHERN EDGE LOOKING SOUTH.

The abandoned tank farm area is the northern most part of the property where the remaining gravel berms are evidence of the abandoned tank farm (Figure 3). Photographs 7-10 show the area from the southern edge looking north, from the western edge looking east, from the northern edge looking south, and from the eastern edge looking west, respectively. Videos 1 and 2 begin with the area looking north and south respectively. The tank farm area has a liner beneath the surface soil and berms on three sides. The berm on the west side of the tank farm was apparently removed to provide traffic access into the tank farm area.

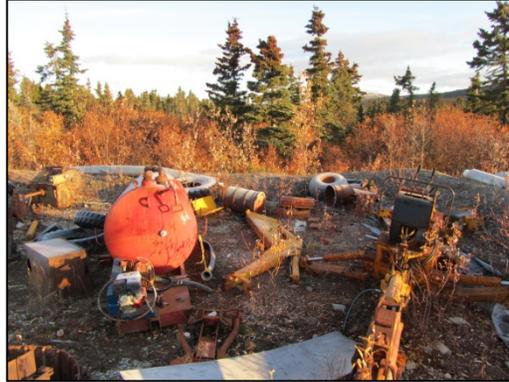
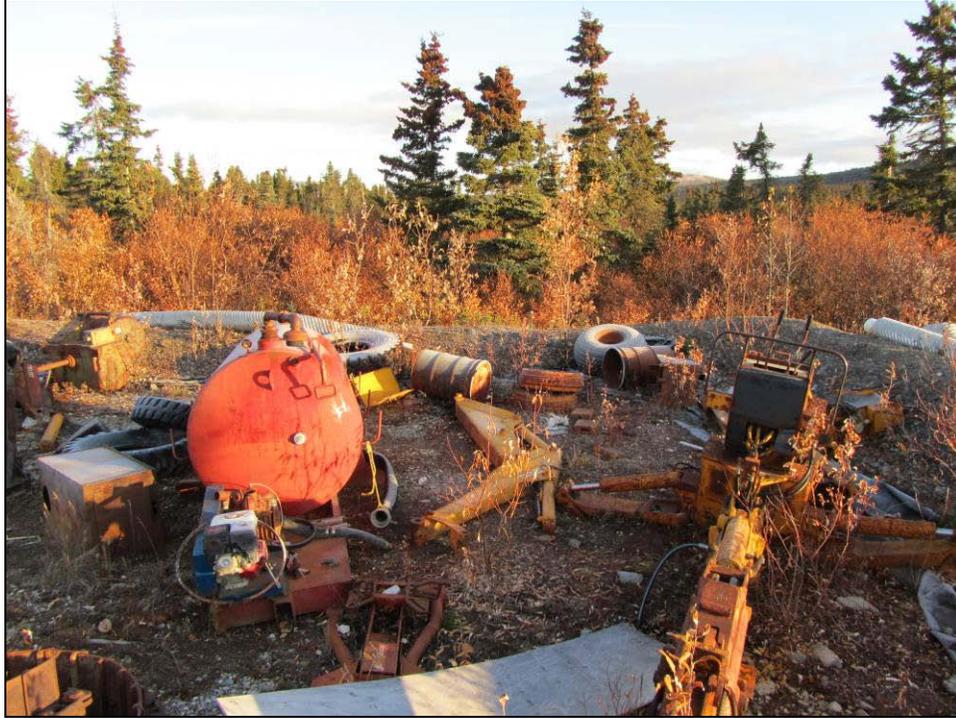
Various types of construction debris including corrugated metal pipe, drums and abandoned ASTs are stored on the east side of the tank farm in the narrow area between the tank farm and the down gradient forest, and in the center of the tank farm area (Photograph 7, Video 1, and Video 2).

PHOTOGRAPH 7: ABANDONED TANK FARM FROM THE SOUTHERN EDGE LOOKING NORTH.

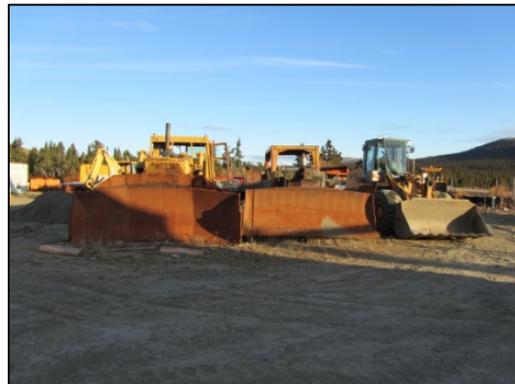
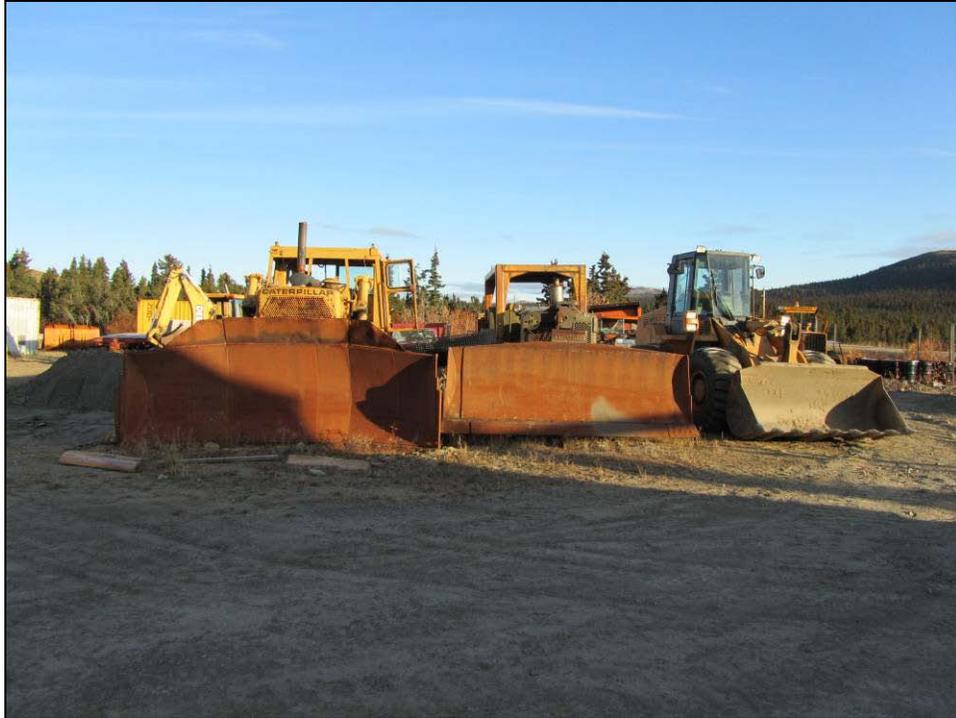
The equipment lay-down area is north of the shop building, but south of the abandoned tank farm area (Figure 3). Photographs 11-14 show the area from the southern edge looking north, from the western edge looking east, from the northern edge looking south, and from the eastern edge looking west, respectively. This portion of the site is a storage area for abandoned vehicles, broken equipment, drums, used batteries and miscellaneous construction debris. Several drums and construction debris stored in this area are reportedly leftover over from the

PHOTOGRAPH 11: THE EQUIPMENT LAY-DOWN AREA FROM THE SOUTHERN EDGE LOOKING NORTH.

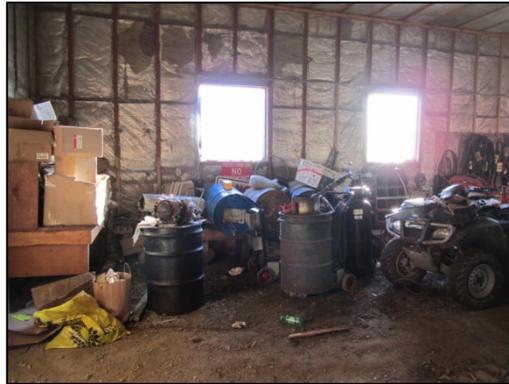
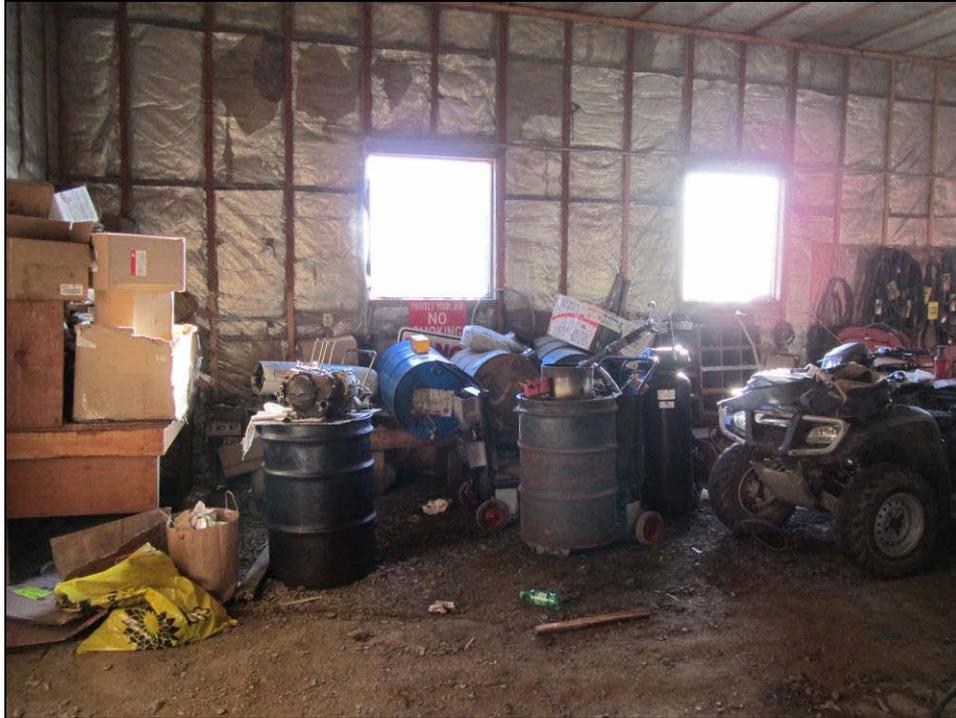
shop floor is made of dirt, considerable soil staining was observed inside the building (Photograph 17).

PHOTOGRAPH 17: INSIDE THE SHOP BUILDING FROM THE WESTERN END LOOKING EAST.

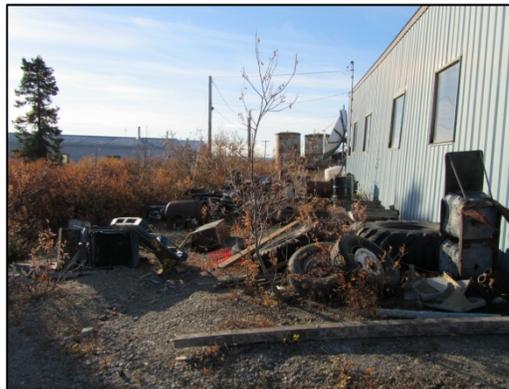
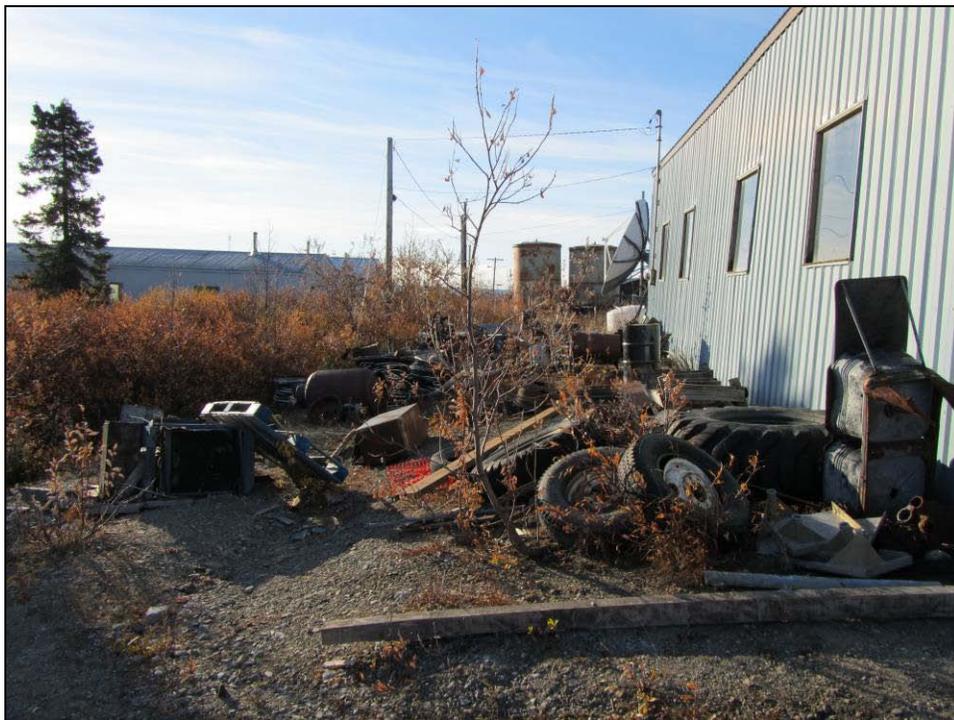
The yard on the east side of the building is a storage area for miscellaneous equipment and debris that is reportedly leftover from the school construction in the early 2000's. During that same time period, the Bureau of Land Management reportedly deposited construction debris from a nearby abandoned mine.

PHOTOGRAPH 20: OUTSIDE OF THE SHOP BUILDING ON THE BUILDING'S EASTERN SIDE LOOKING SOUTH.

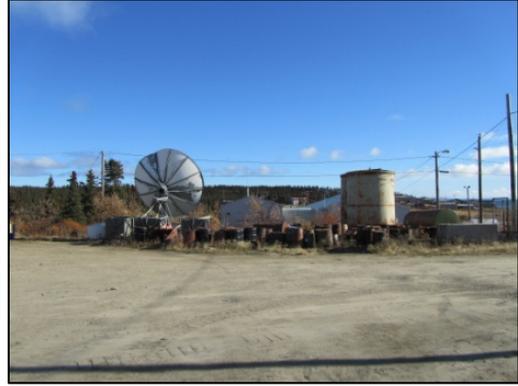
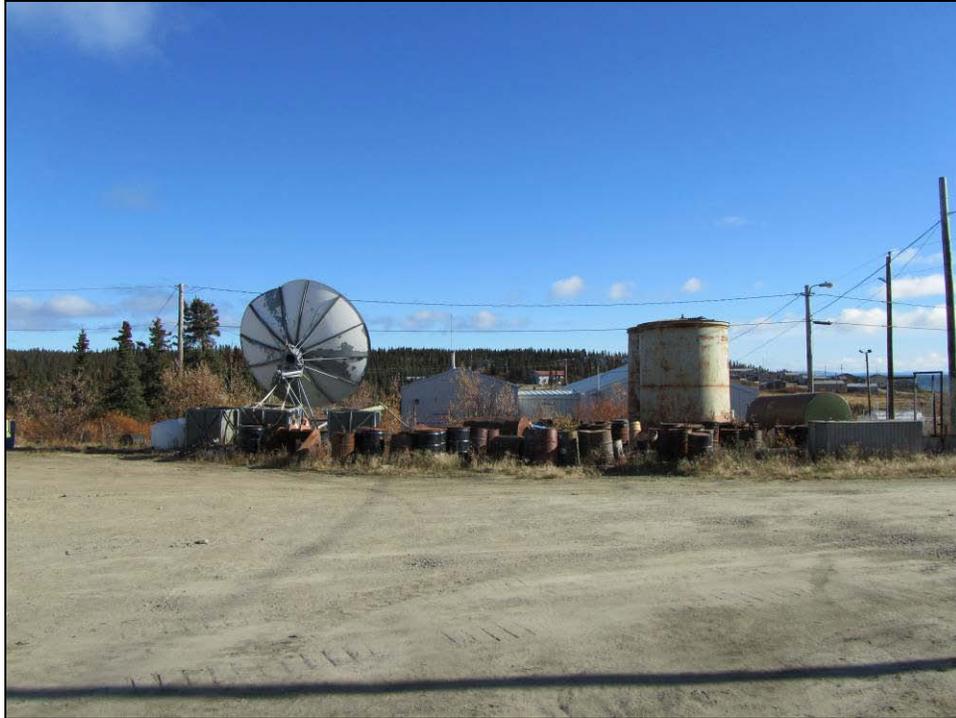
PHOTOGRAPH 21: THE SOUTH YARD AREA FROM THE WESTERN EDGE LOOKING EAST.

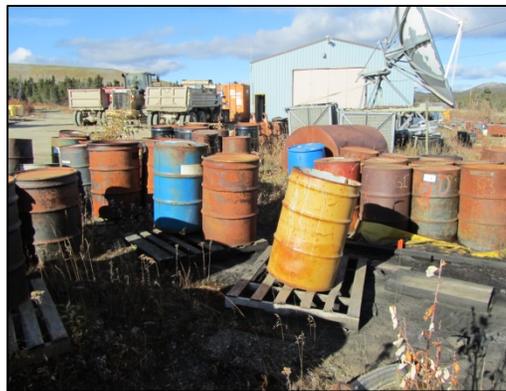
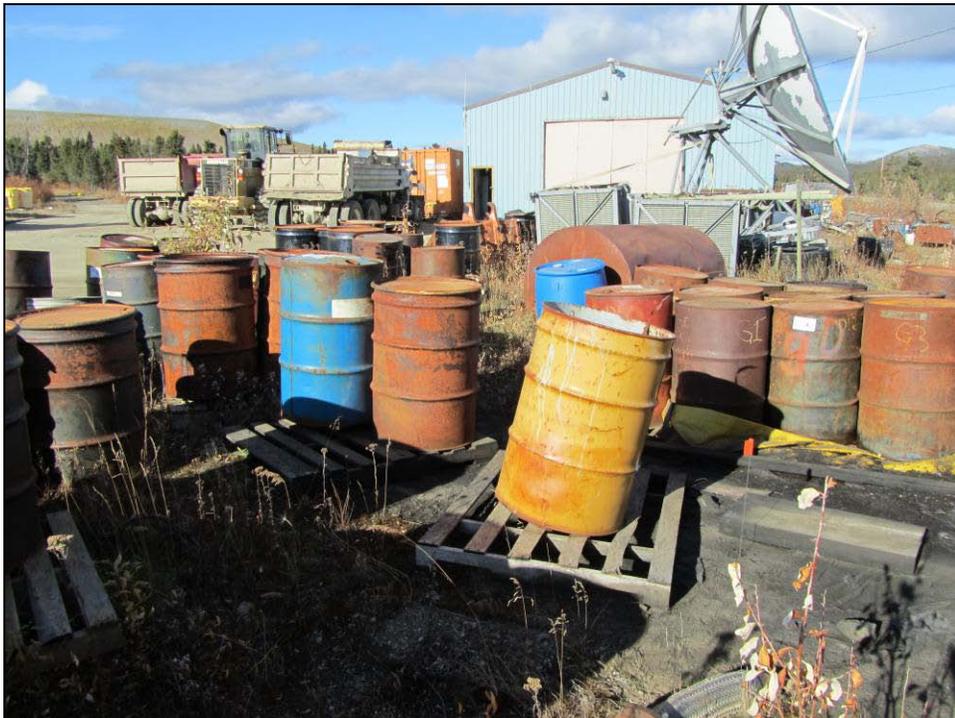
The 80 55-gallon drums stored in this area and noted in Table 1 were once located in the abandoned tank farm area and were reportedly full of heating fuel salvaged as part of the tank decommissioning. The fuel was being distributed to the community elders as they needed it and the drums are now assumed by Elim residents to be empty or may contain jet fuel (Photograph 24).

PHOTOGRAPH 24: 55-GALLON DRUMS FORMERLY USED FOR THE STORAGE OF HEATING FUEL.

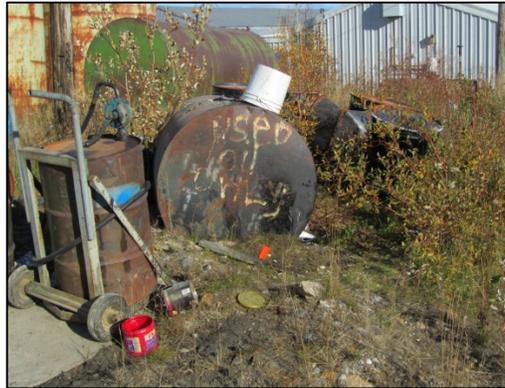
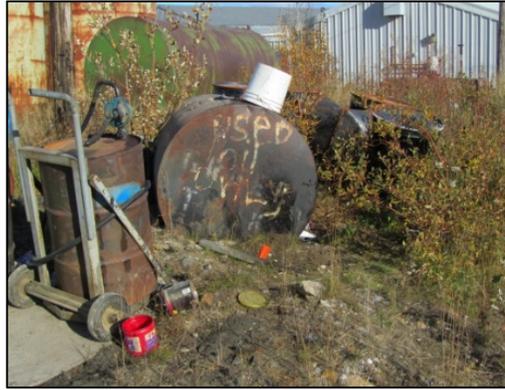
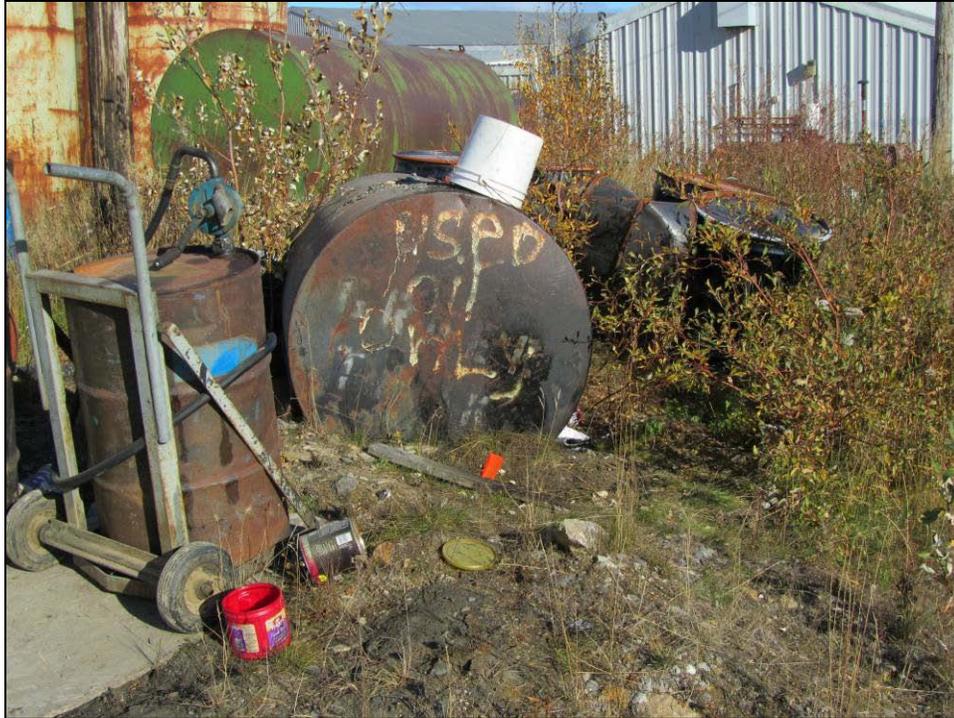
The used oil collection system consists of a 500 gallon AST which has been in place for storing used oil since the early 1990's (Photograph 25). The tank sits on the ground and is surrounded by stained soil. The mechanics working at the site dispose of the oil in a used oil burner when the tank reaches capacity.

**PHOTOGRAPH 25: USED OIL COLLECTION
AST.**

upgraded to include a double wall UL-142 listed tank and secondary containment. OASIS recommends reuse or recycling used oil and a departure from the current used oil disposal procedure when the tank reaches capacity. Potential reuse and energy recovery or recycling alternatives for the used oil include burning the used oil to heat the shop building or coordinating with the Kawerak Backhaul Project.

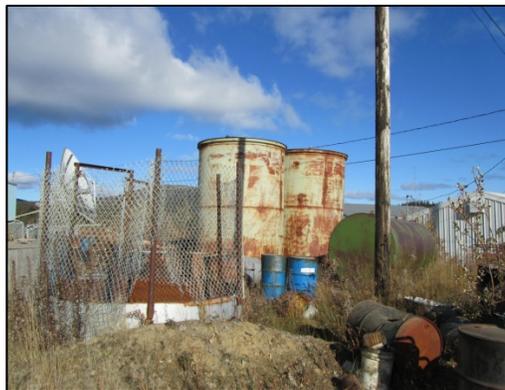
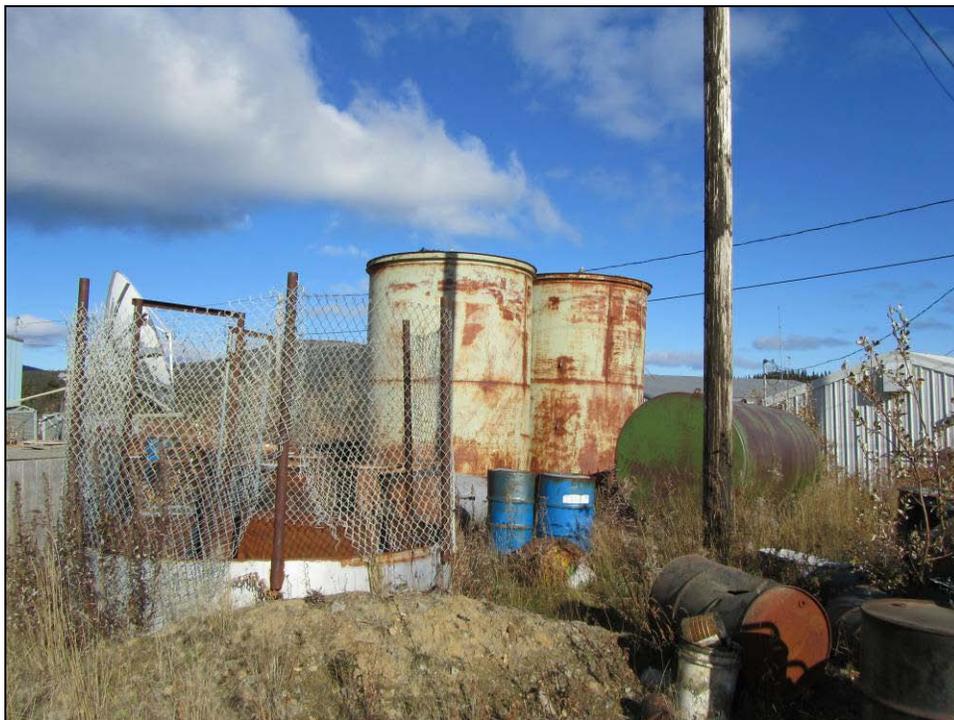
One unused horizontal AST and 2 abandoned 10,000-gallon vertical ASTs can be seen in the background of Photograph 25 and are also pictured in Photograph 26. The green AST was once used to store water. The 2 vertical ASTs were relocated to the Old City Shop from a former tank farm site. Their current contents are unknown.

**PHOTOGRAPH 26: 1 UNUSED AST (GREEN)
AND 2 ABANDONED VERTICAL ASTs.**

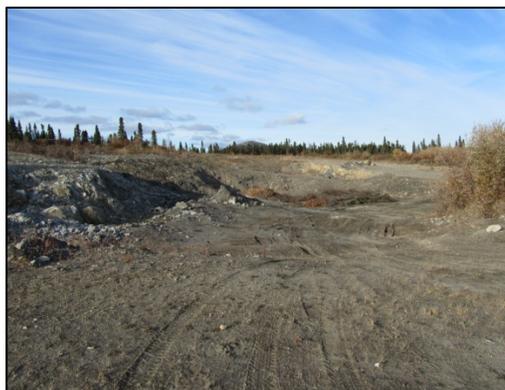
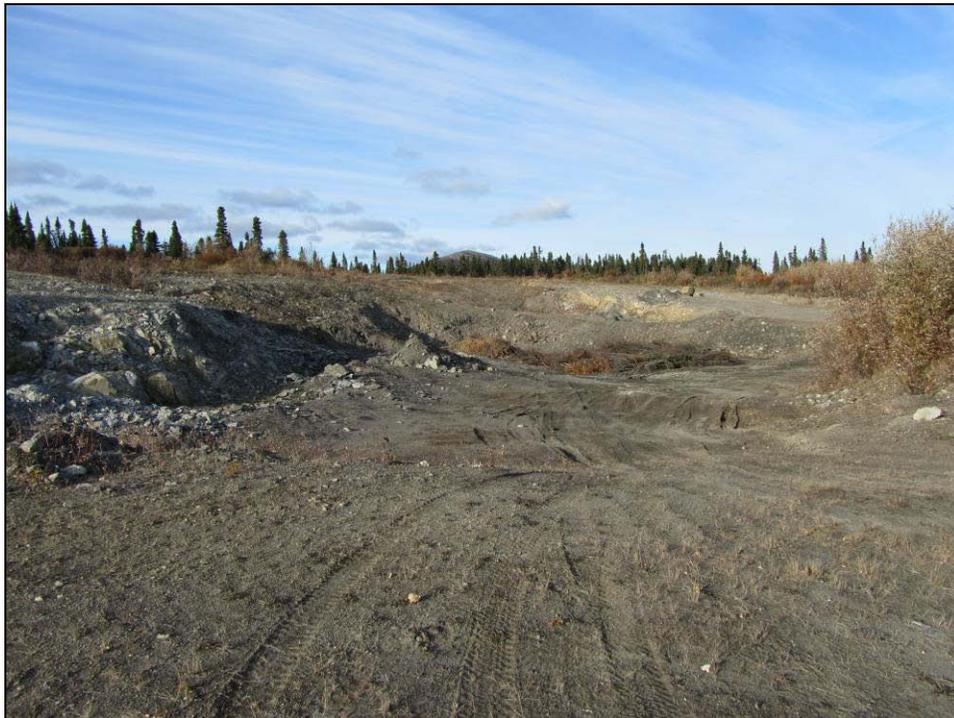
A clear, relatively flat area owned by the Elim Native Corporation is present beyond the current landfill approximately two miles east of the city along Moses Point Road (Photograph 34).

**PHOTOGRAPH 34: POTENTIAL SITE FOR
LANDFARMING.**

This area may be suitable for landfarming any petroleum-contaminated soil. The Elim Native Corporation requires a letter of request to use the land. Land use approval is likely given the objective to remediate contaminated soil. Surface hydrology in the vicinity of the proposed landfarming area is nominal. There are no obvious drainage channels

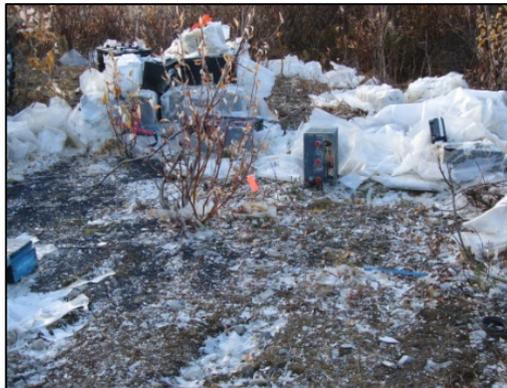
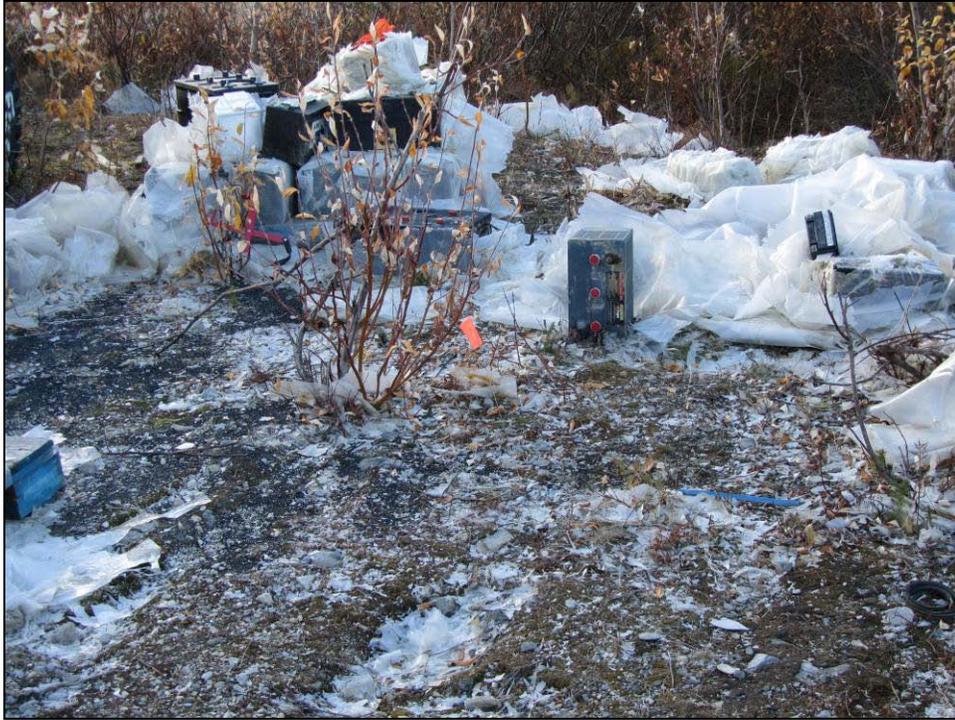
The Old City Shop site is currently a storage and disposal area for lead-acid batteries, used oil, broken vehicles and equipment, and construction debris. The city has shipped out two loads of lead-acid batteries through the Backhaul Project developed by Kawerak. The receipt for the last shipment is included in Appendix F. Several batteries still remain on the ground in the battery storage area within the equipment lay-down section of the

PHOTOGRAPH 15: CURRENT BATTERY STORAGE AREA.

property. Existing batteries should be bundled in overpacks and prepared for transport during the next backhaul shipment. A more robust battery storage area should be developed to store batteries deposited at the site in the future. The containment area should be easily accessible, enclosed, and impervious to battery acid.

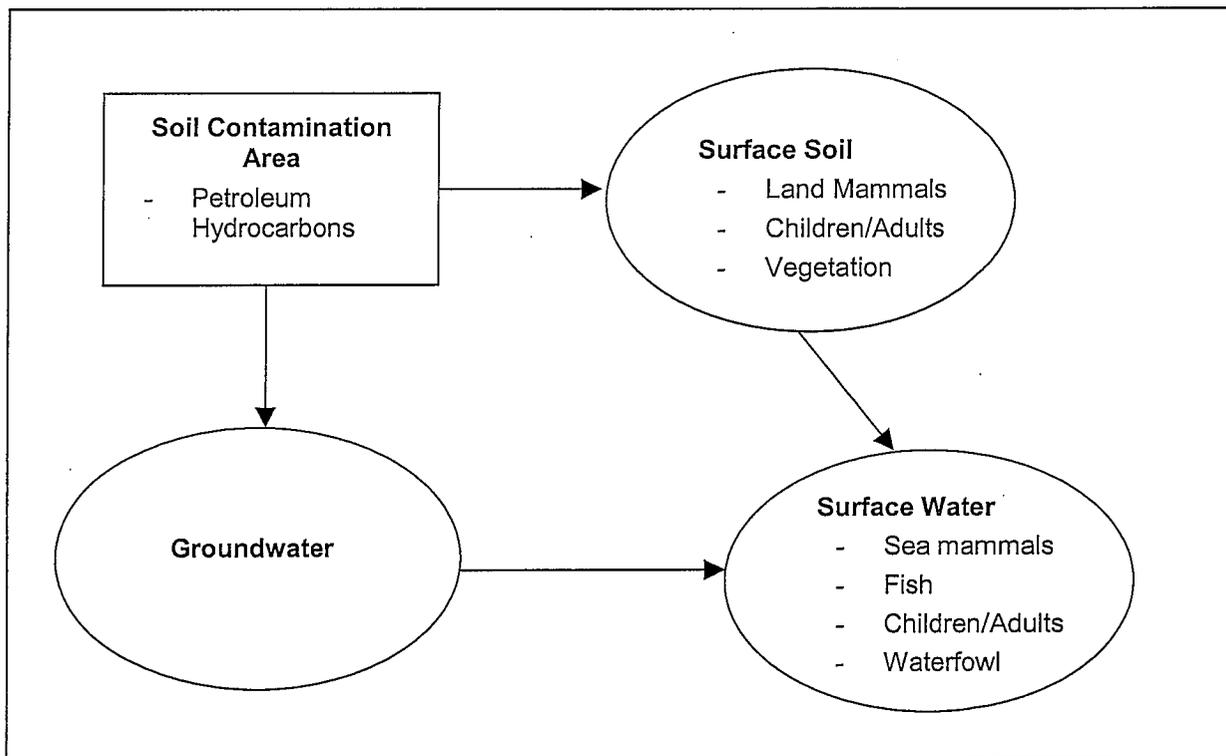
Figure 3-1 General Site Conceptual Model for the Elim Tank Farm Sites

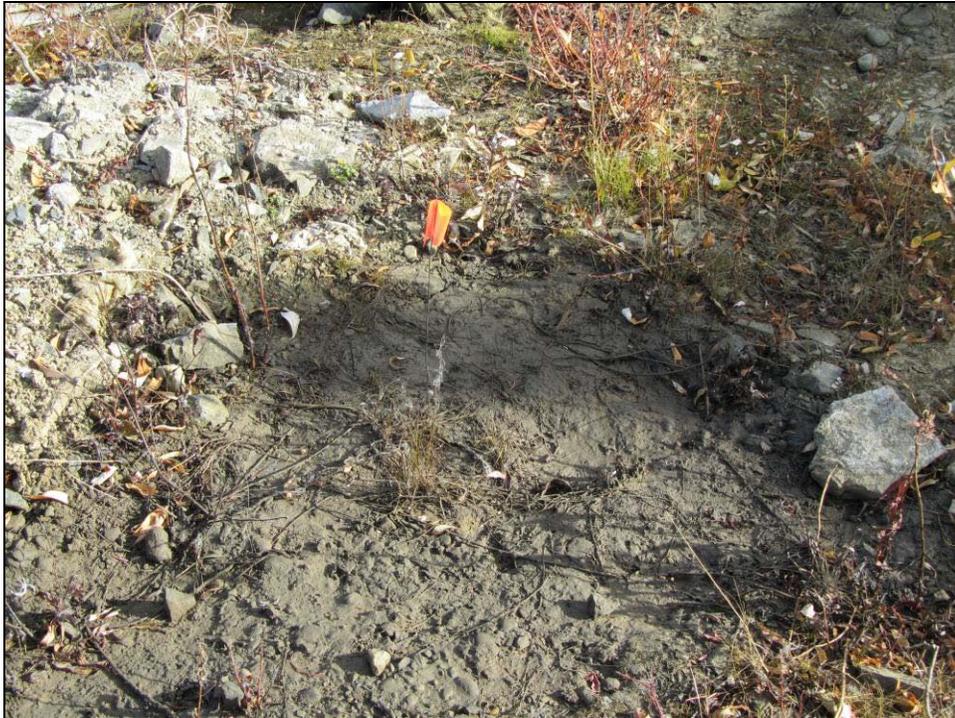
PHOTOGRAPH 30: SOIL STAINING NEAR DRUMS (SE CORNER OF THE EQUIPMENT LAYDOWN AREA), FLAG MARKS HS4.

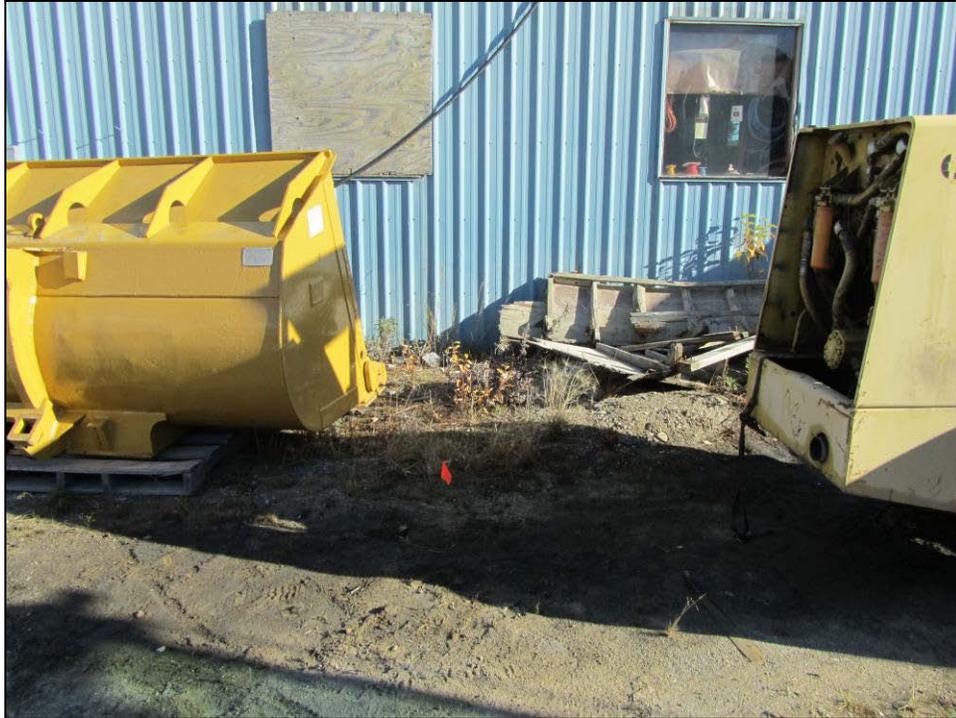
PHOTOGRAPH 31: SOIL STAINING OUTSIDE THE SHOP BUILDING (WEST SIDE), FLAG MARKS HS6.

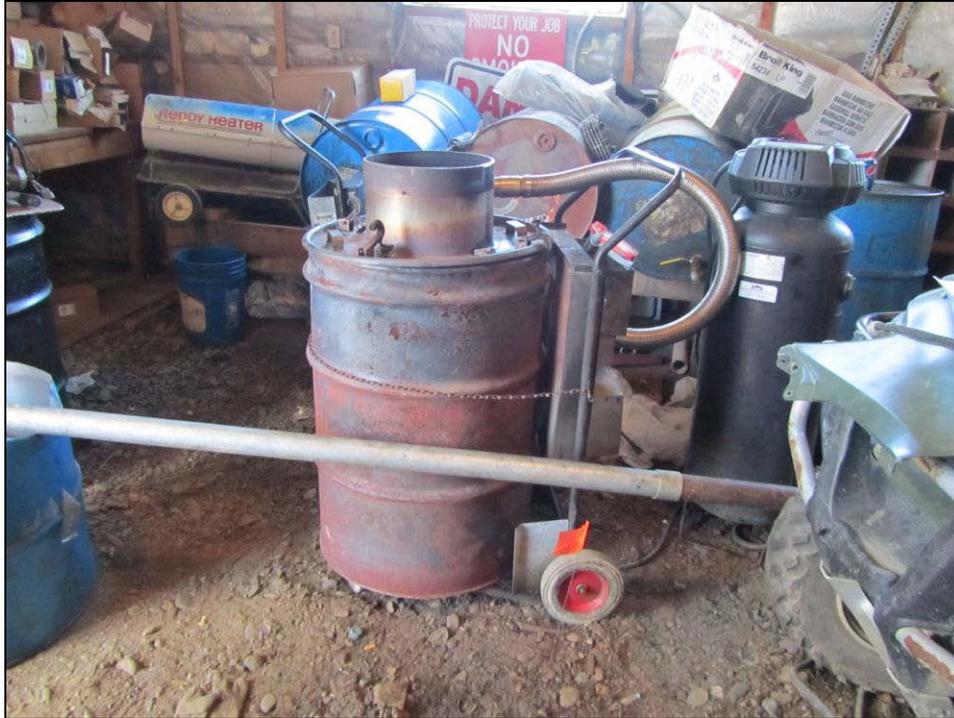
PHOTOGRAPH 33: INSIDE THE SHOP BUILDING (NE CORNER), FLAG MARKS HS10.
