Attachment A
DSWD Test Pit Presentation Materials

DSWD TP001 – Slit Trench

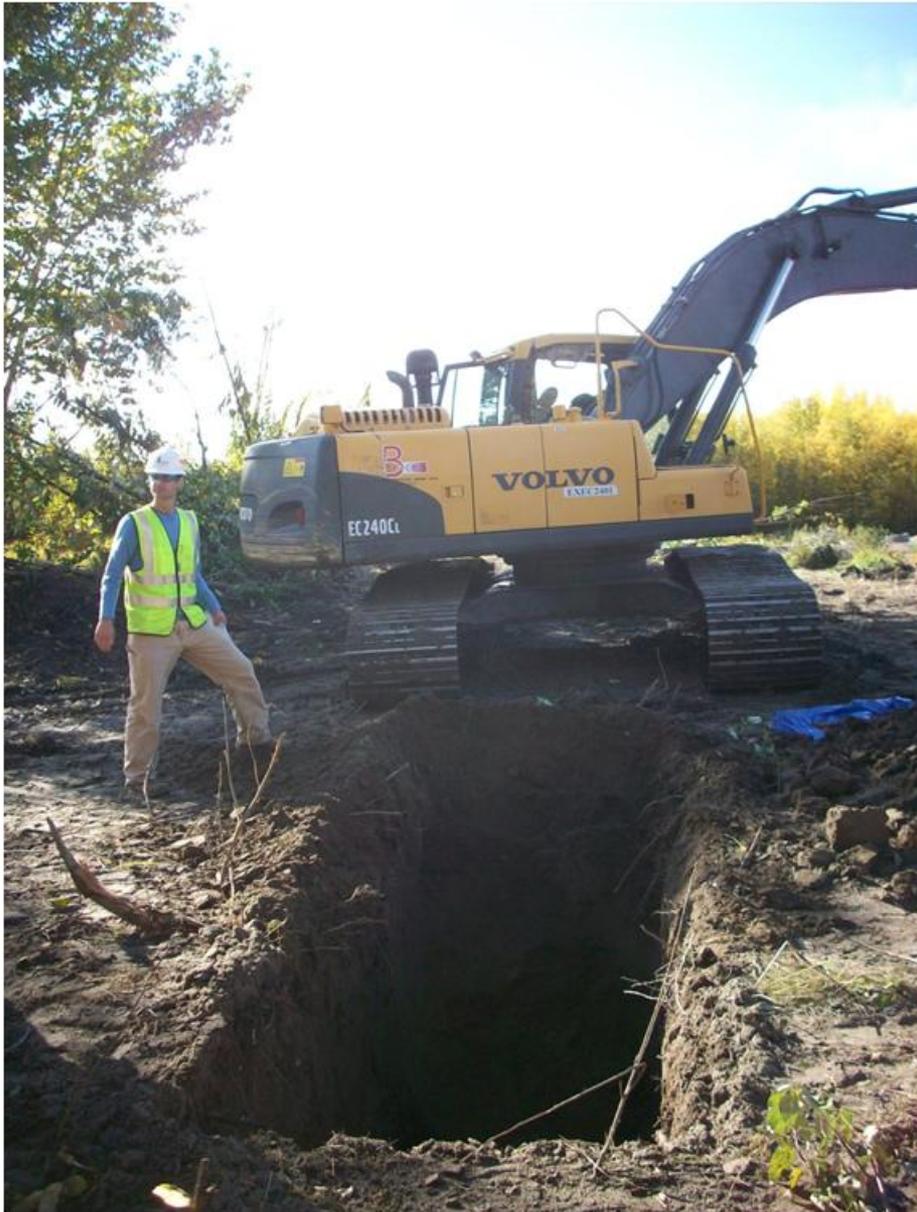
TP001 was located within the northern portion of the DSWD Slit Trench. The test pit excavation was approximately 15 feet long by 4 feet wide by 8 feet deep.

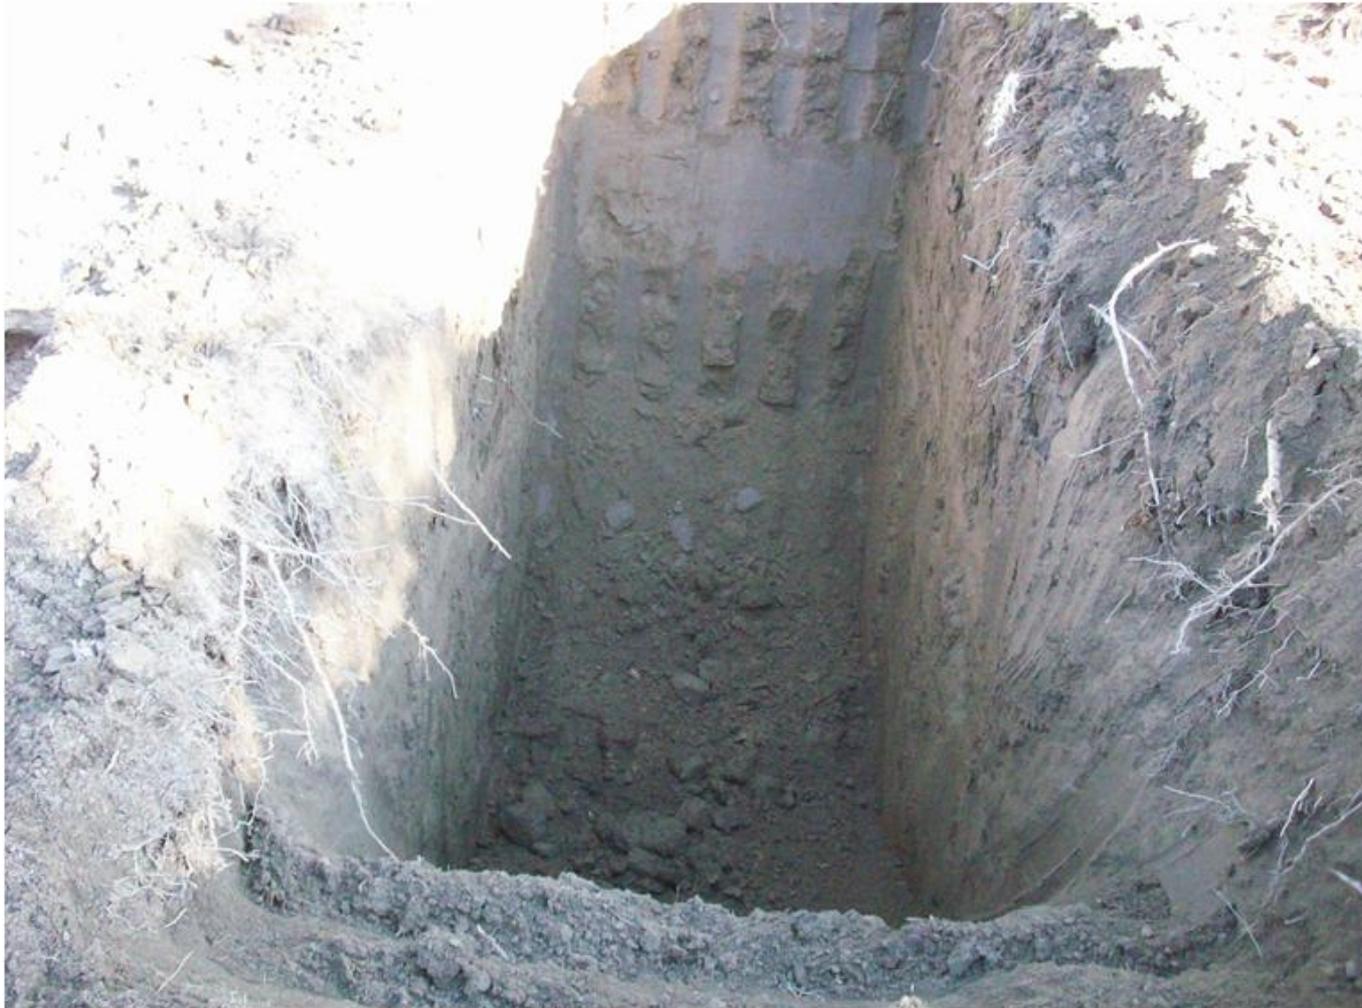
DSWD TP001 Slit Trench

View of final TP001 test pit excavation. Brown silt and fine sand was observed to a depth of approximately 3 feet. A 2-inch layer of brick material and wood debris was observed at 3 feet, with brown silt and sand to base of the trench. No metal debris was observed.

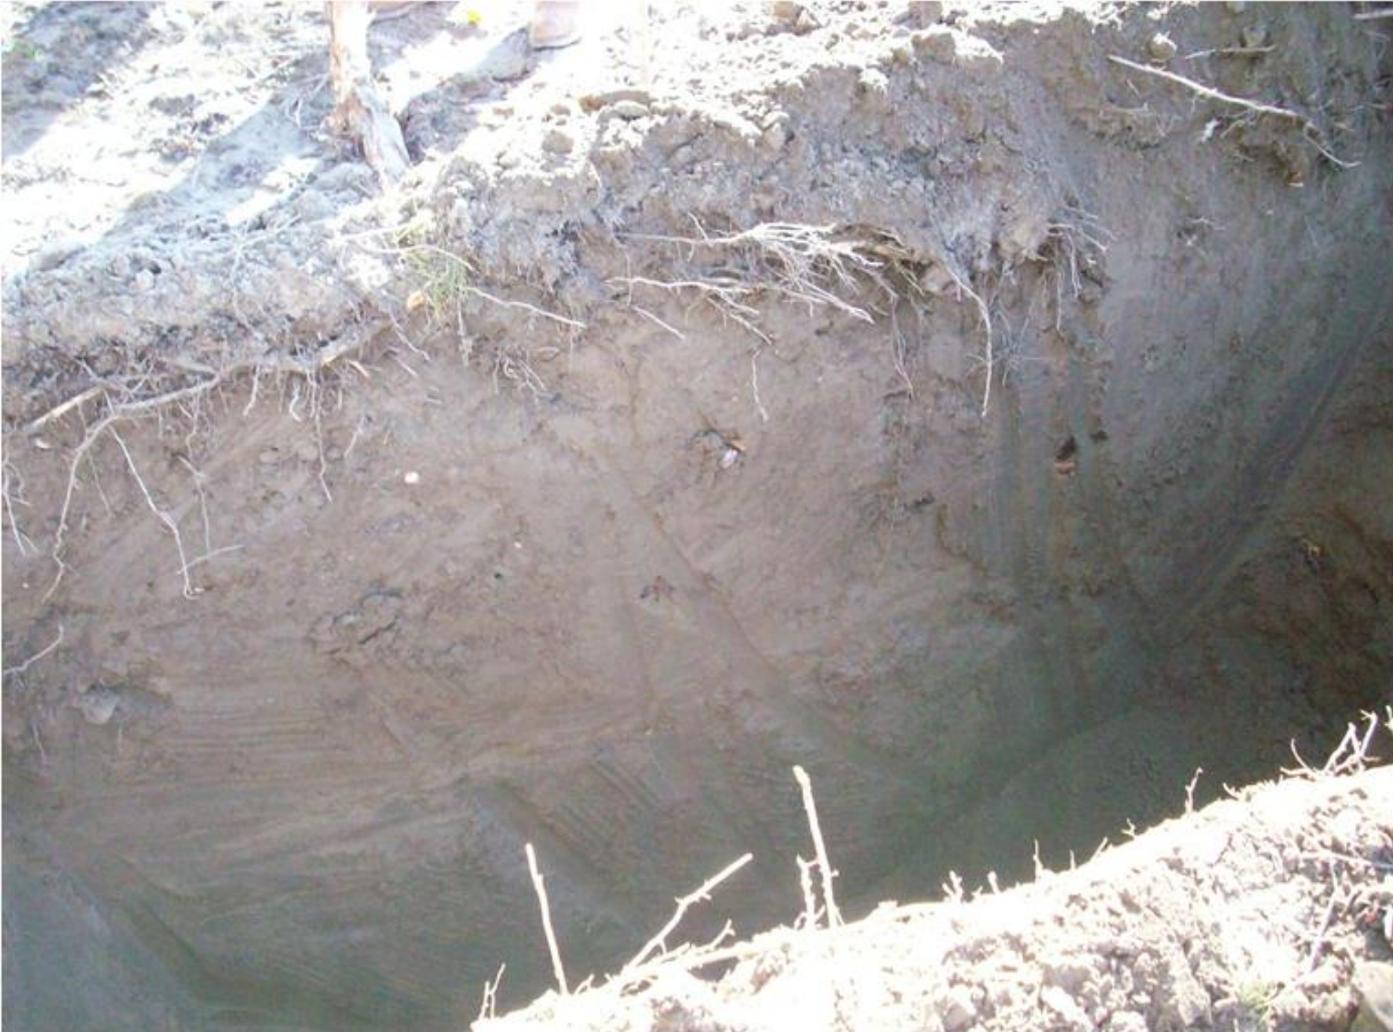
DSWD TP001 Slit Trench

View of TP001 side wall showing discolored soil from debris layer at 3 feet. Three soil samples were collected from the base of the test pit, and two sidewall samples were collected at a depth of approximately 3 feet (debris layer).

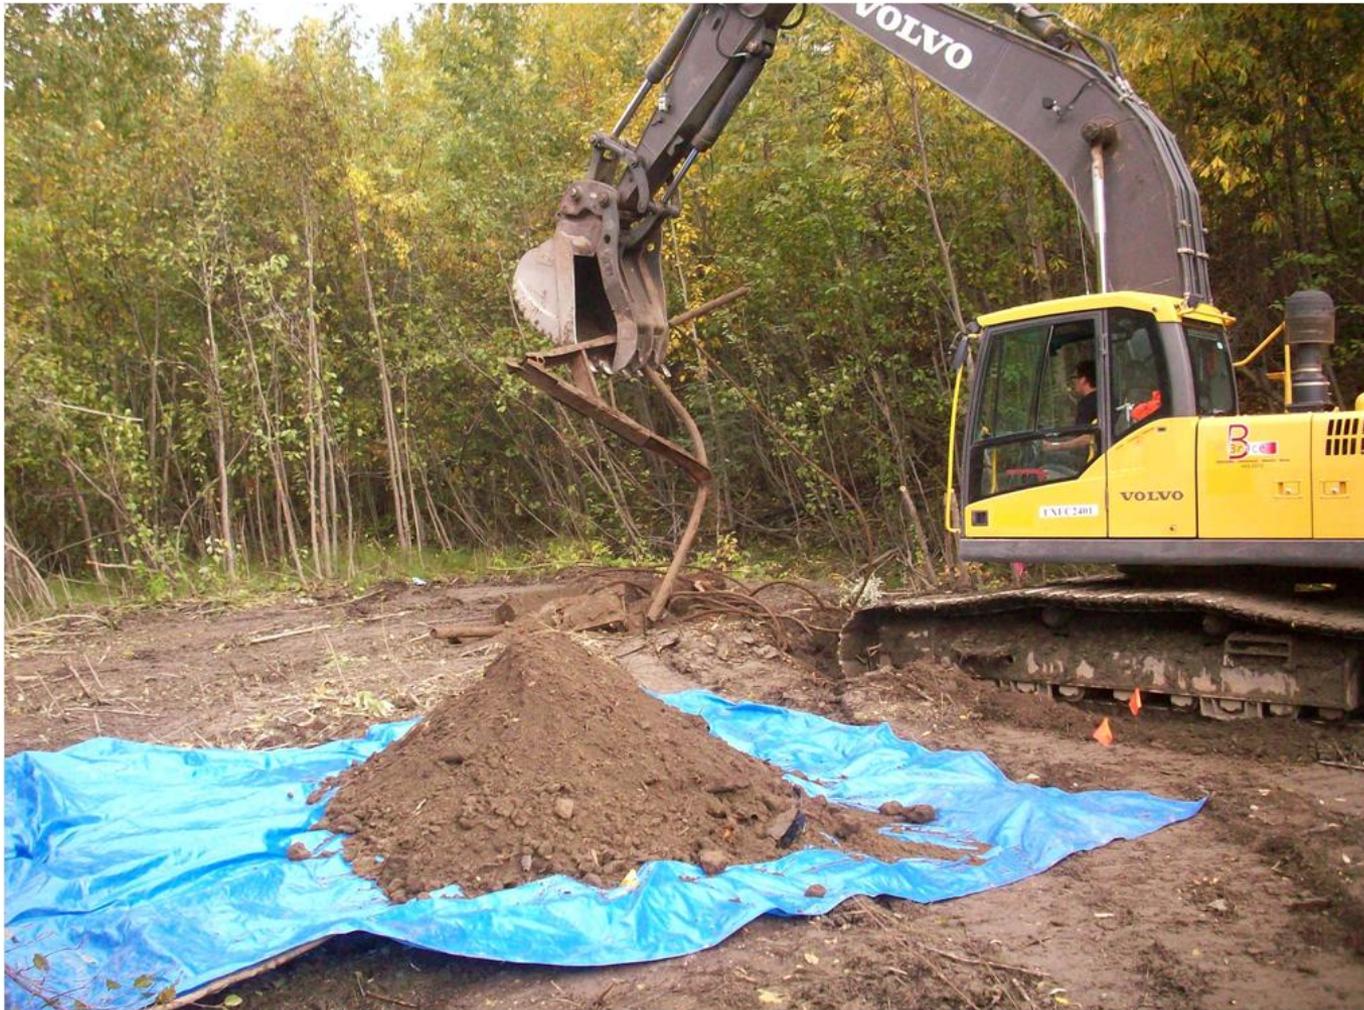
DSWD TP002

Test Pit TP002 was located within the geophysical anomaly on the west side of the DSWD site. Debris from the excavation included abundant metal cable, pipes, hoses, and what appeared to be parts of a demolished truck frame.

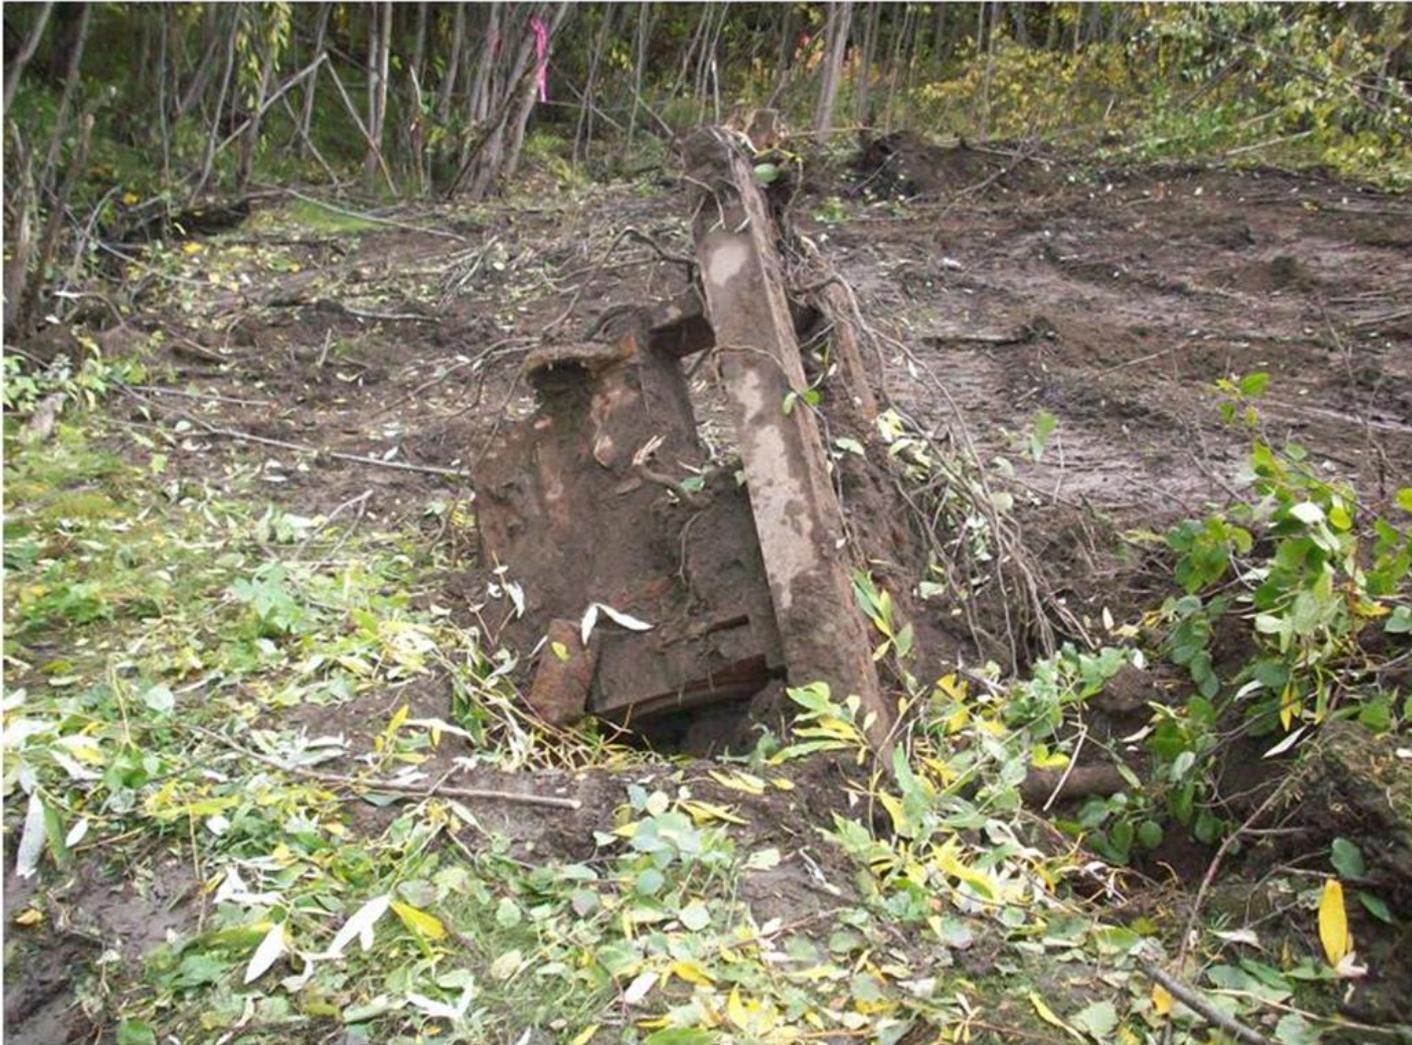
DSWD TP002

An old engine block attached to a piece of chassis frame was encountered in shallow soil at TP002

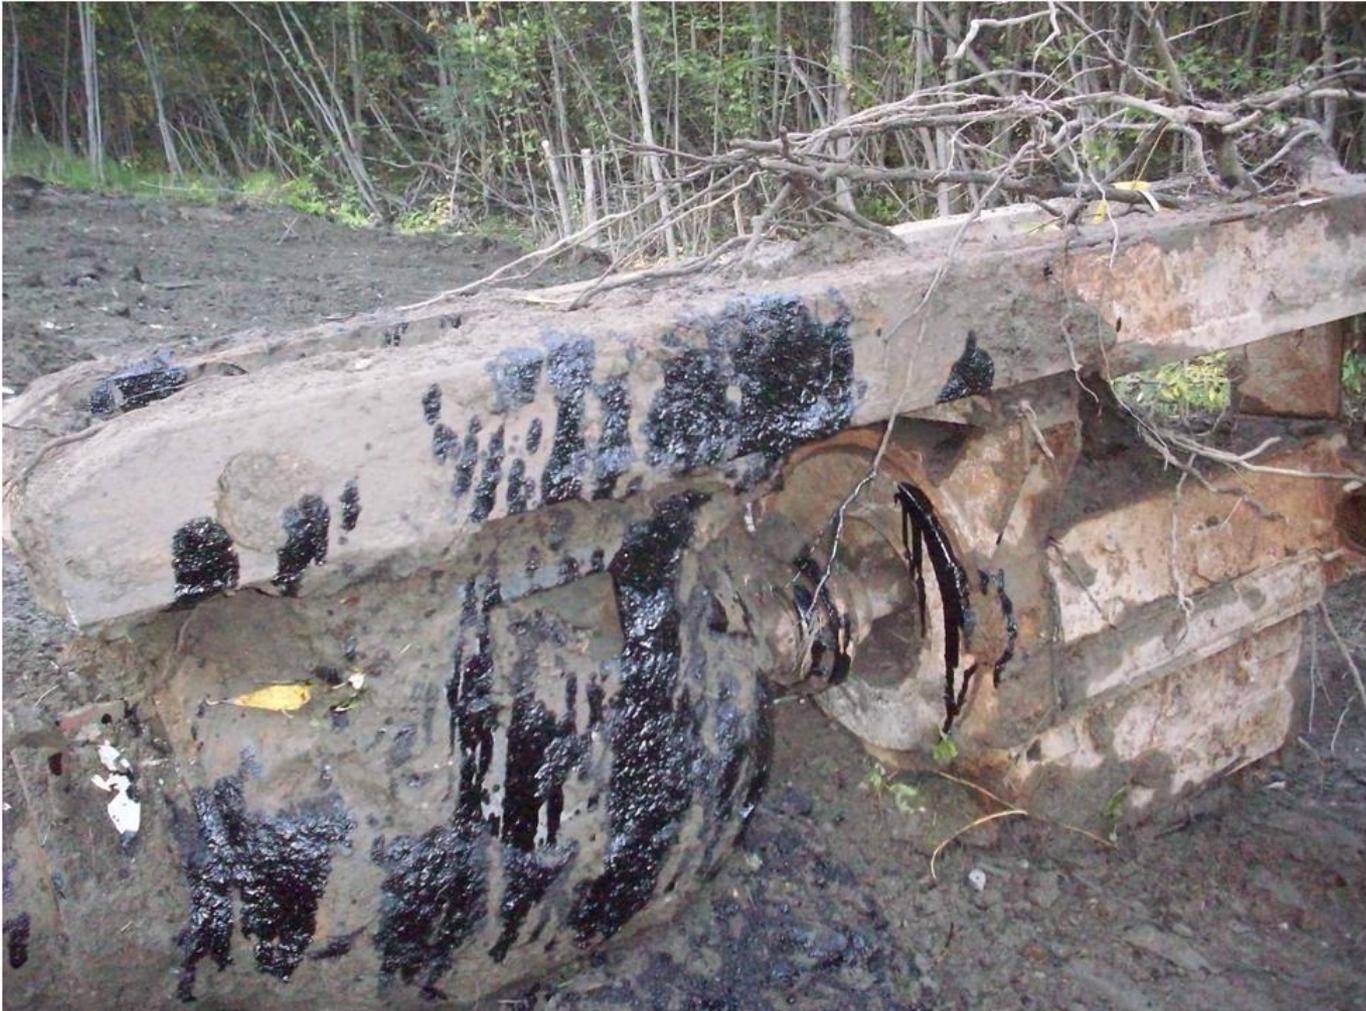
DSWD TP002

Upon excavation, the engine block in TP002 was attached to a transmission, and was partially covered with what appeared to be transmission fluid or engine oil.

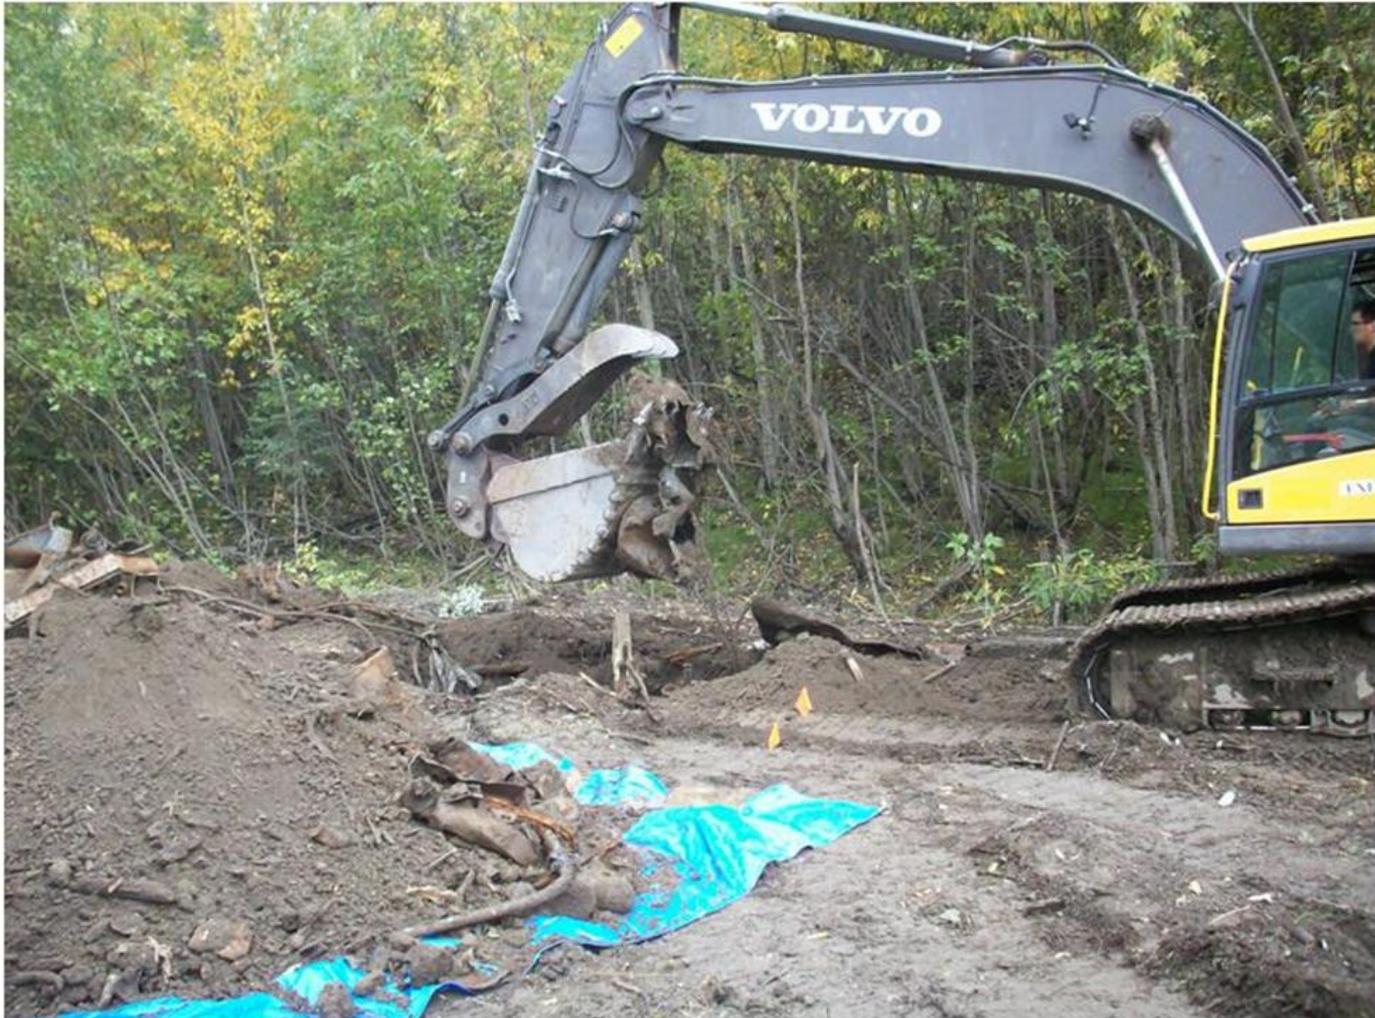
DSWD TP002

Three crushed empty drums were also pulled from TP002. Groundwater was encountered at a depth 8 feet (bottom of excavation). Three soil samples were collected from the base of the excavation and two soil samples were collected from the side walls of the excavation at a depth of approximately 6 feet, corresponding to soil with elevated PID readings.

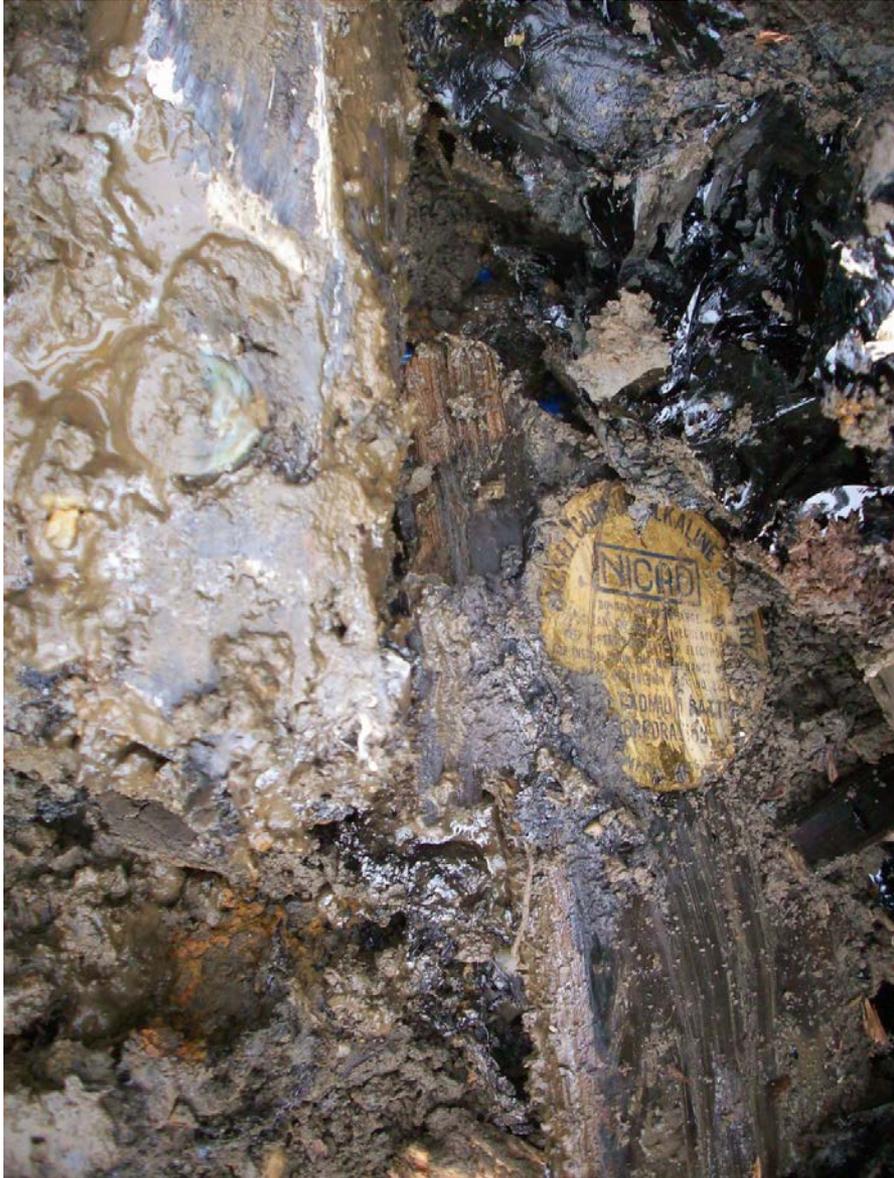
DSWD TP002

A nickel-cadmium (NiCad) alkaline battery label was exposed in the TP002 excavation along with wooden debris and stained soil.

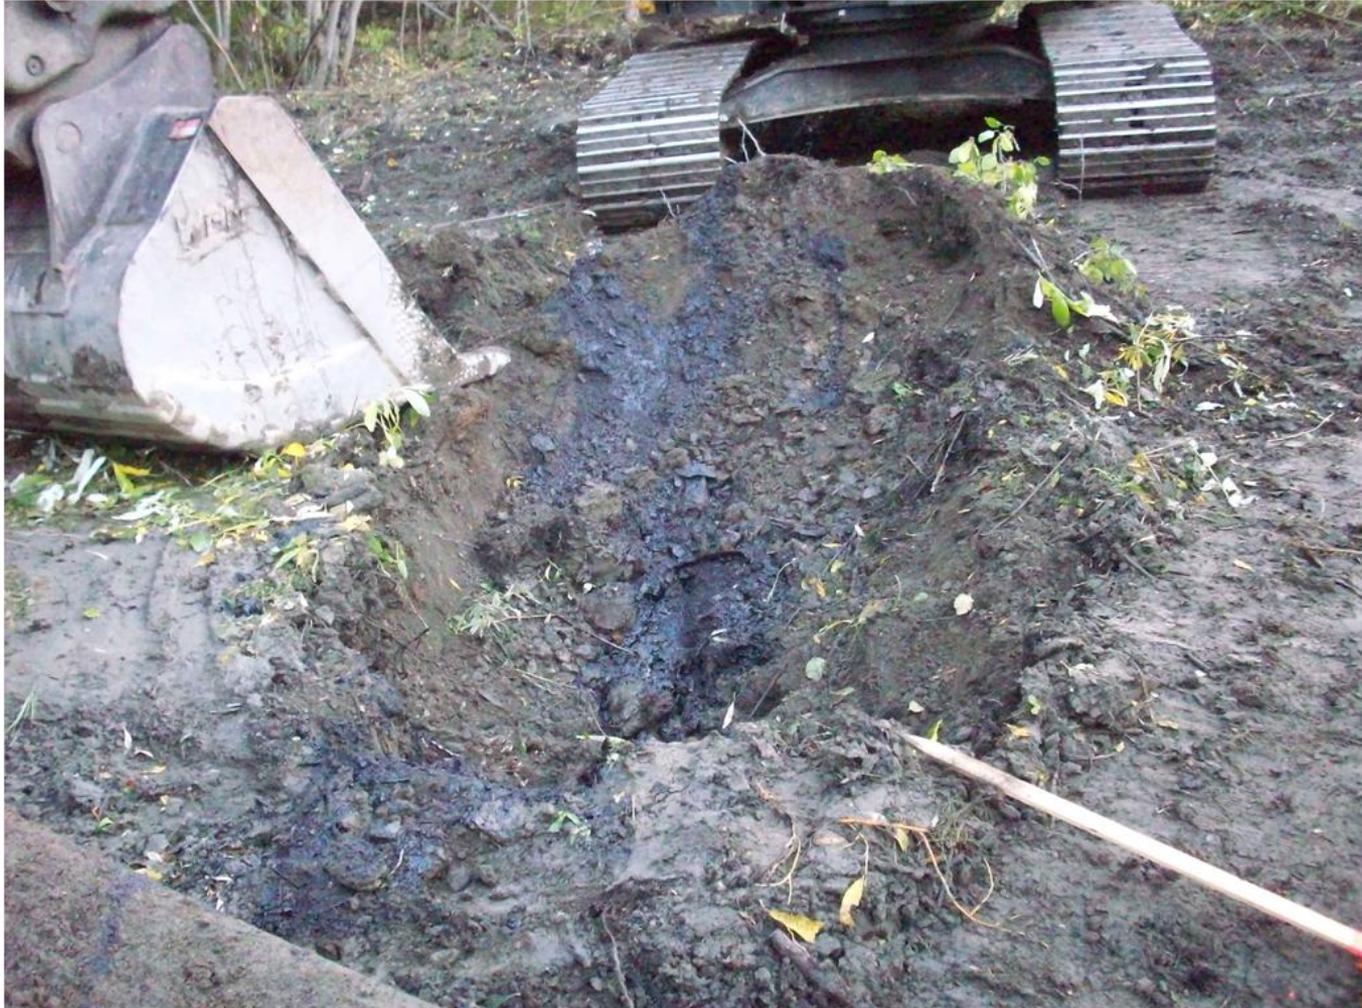
DSWD TP003

TP003 was also located within the geophysical anomaly on the west side of the DSWD site. This photo shows the excavation after the initial scoop with the excavator bucket. A drum containing oil was removed from the test pit, with oil stained soil present in the excavation. Oil stained soil was removed to the extent practical and containerized in 55-gallon drums.

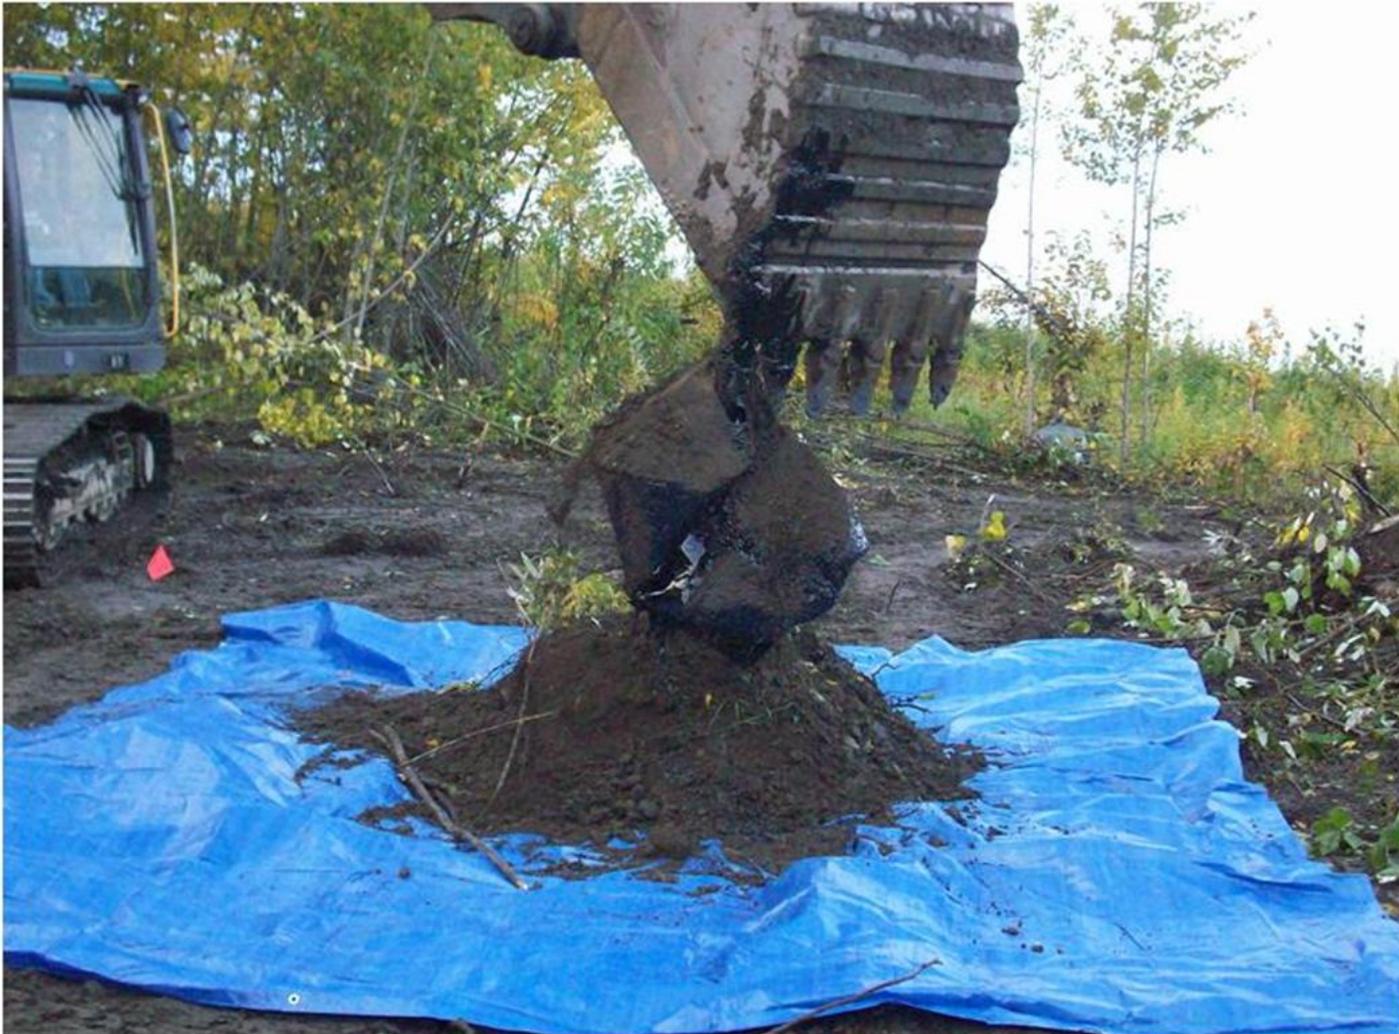
DSWD TP003

The drum was filled with what appeared to be waste oil was immediately placed on a tarp to contain oil and oil-stained soil. Oil can be seen leaking from the middle of the drum.

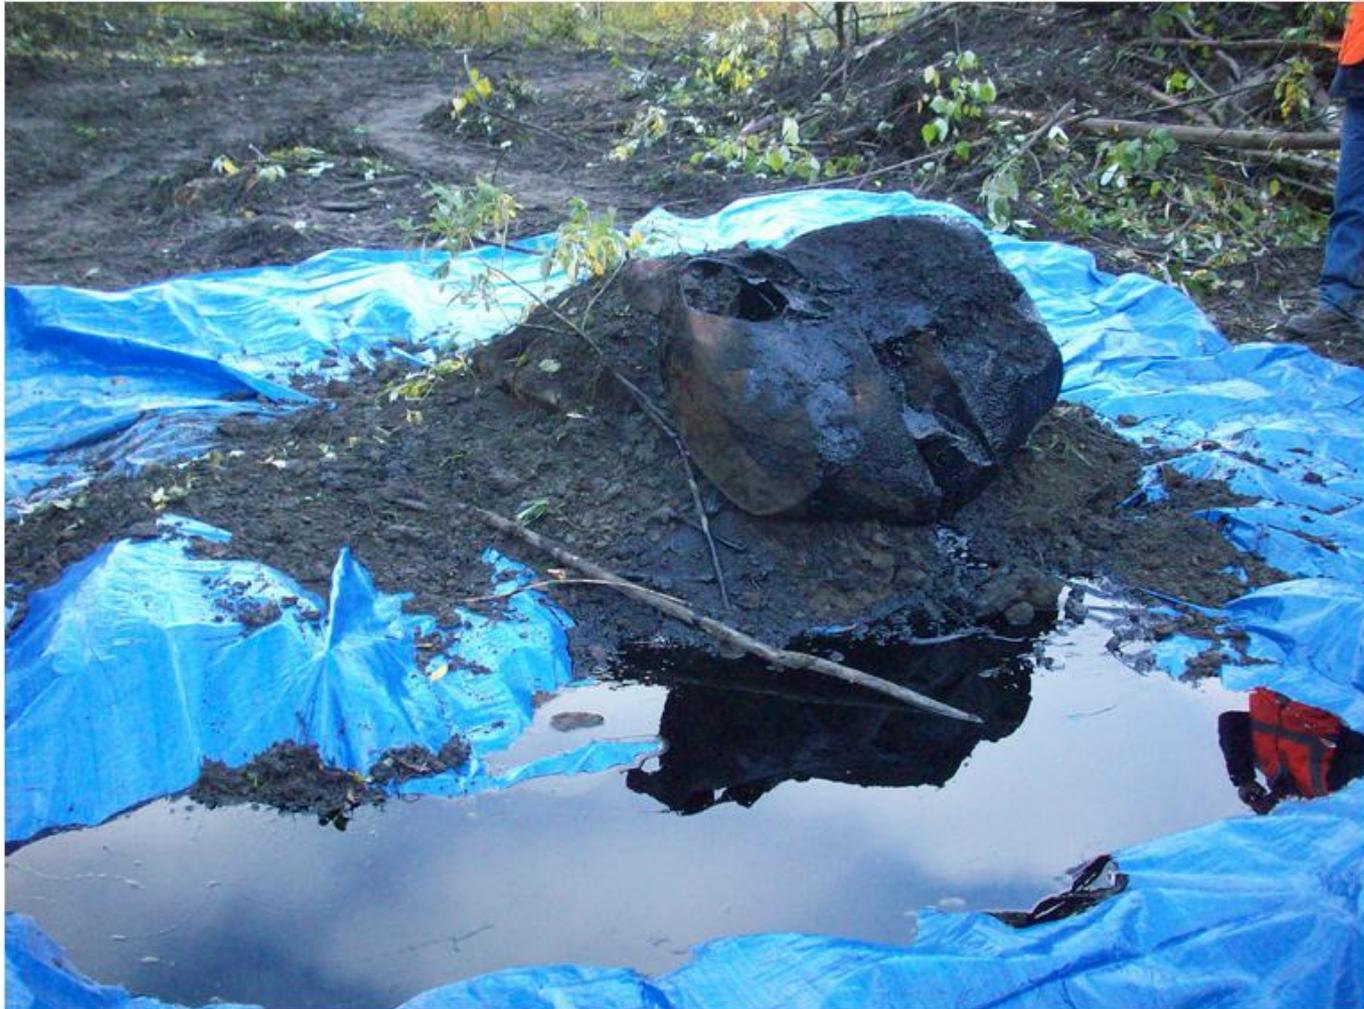
DSWD TP003

Approximately 35 gallons of oil leaked from the drum and was contained and placed in a 55-gallon drum for characterization and disposal. Excavated soil was also drummed for characterization and disposal. Two soil samples were collected from the oily soil on the tarp.
