Annual Report to Alaska Department of Environmental Conservation

Commitment to Corrosion Monitoring Year 2008

Prepared by
Corrosion, Inspection and Chemicals (CIC) Group
BP Exploration (Alaska), Inc.

March 2009

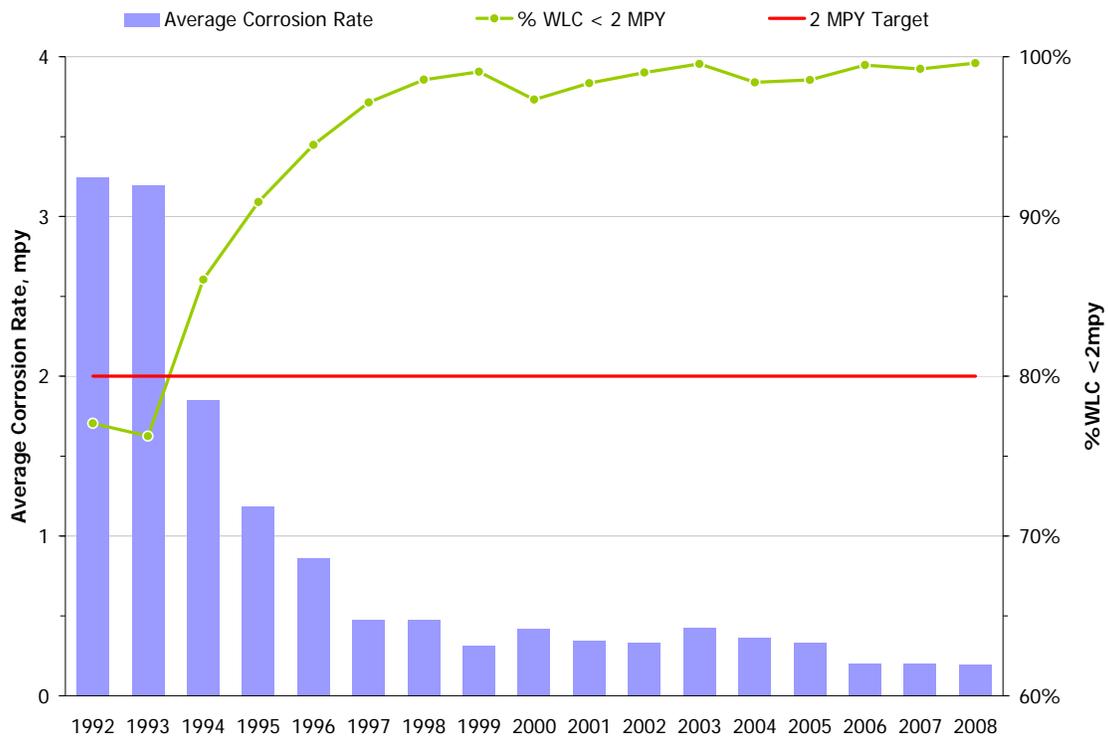
GPB Figure A.2 Flow Line Oil Service Corrosion Rate Trend

GPB Figure A.2 shows the average corrosion rate and percentage of coupons meeting the performance standard target since 1992. The results show that the percentage of conformant flow line coupons has continued to improve since 1992. In fact, the average WLC corrosion rate has been <0.5 mpy since 1997 and <0.25 since 2006. While the data clearly point to the success of mitigation efforts, such consistently low corrosion rate values approach the limit of practical and statistical significance for this monitoring method.

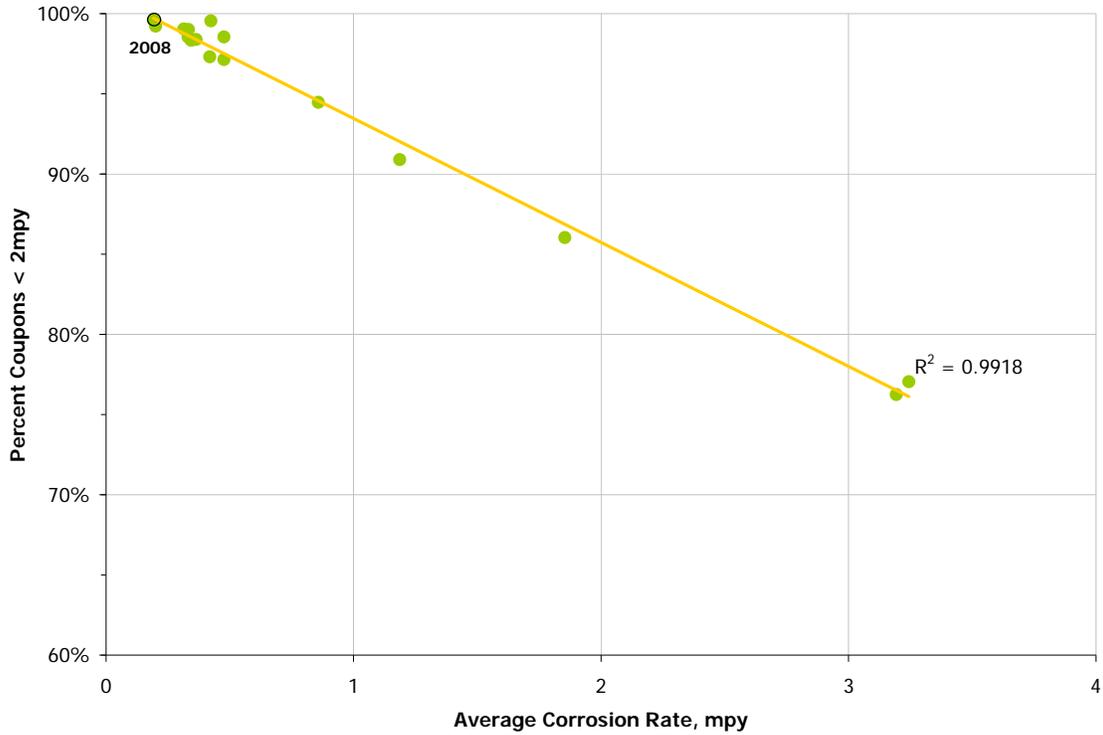
GPB Figure A.3 Correlation between Flow Line Corrosion Rate and Percentage Conformance

GPB Figure A.3 shows the correlation between average corrosion rate and the percentage of weight loss coupons meeting the 2 mpy target. As might be expected, there is a strong correlation between these two metrics. The average corrosion rate metric has the advantage of showing the overall performance trend for the system that would otherwise be lost when only looking at the exceptions >2 mpy. The value of exceptions is certainly not overlooked however, and all WLC corrosion rate exceptions are validated and addressed as needed.

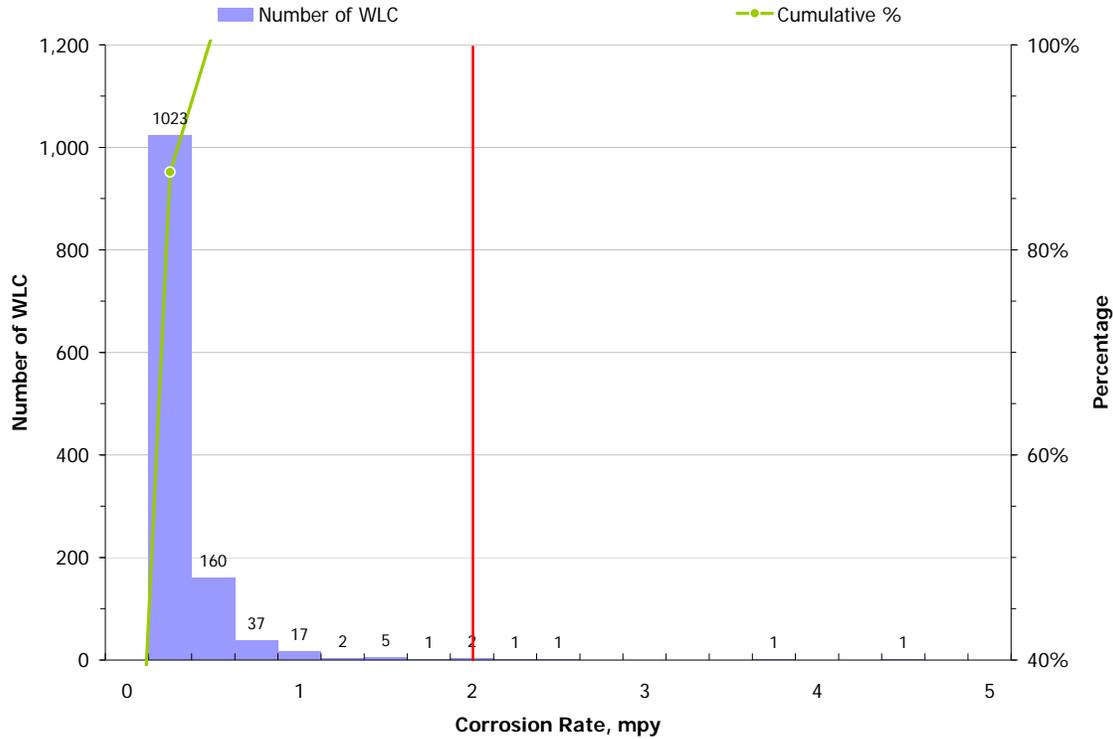
GPB Figure A.4 Flow Line Oil Service WLC Histogram

GPB Figure A.4 shows the distribution of corrosion rates for WLC in flow line oil service. Only four WLC in flow line oil service exhibited general corrosion rates above the 2 mpy target; the highest being 4.4 mpy. None of the coupons in flow line oil service exceeded the pitting rate target of 20 mpy. Results from coupon analysis are reviewed on a regular basis as new data is received. Corrosion rate exceptions are investigated and inhibitor increases or other mitigation steps may be implemented according to established protocols. Two corrosion inhibitor increases were performed based on flow line WLC exceptions. Refer to Section D.1.5 for details and corrective actions for WLC exceptions.

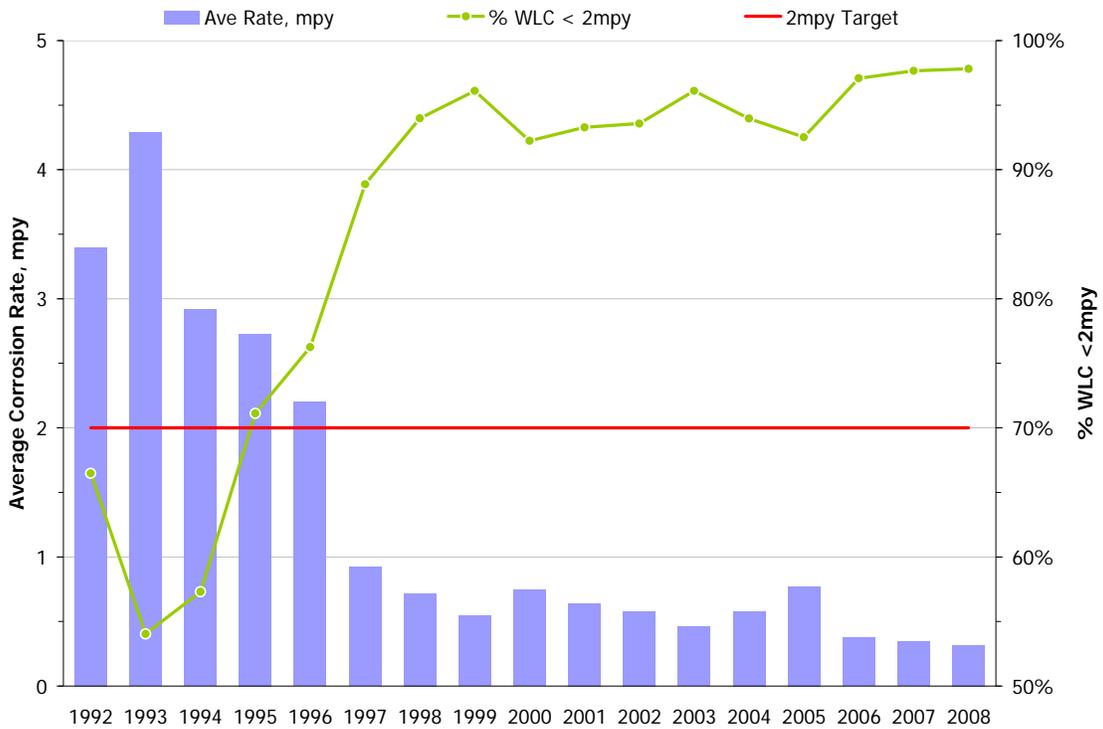
GPB Figure A.5 Well Line Oil Service Corrosion Rate Trend

GPB Figure A.5 shows the average corrosion rate and percentage of WLC ≤2 mpy for well line WLC since 1992.

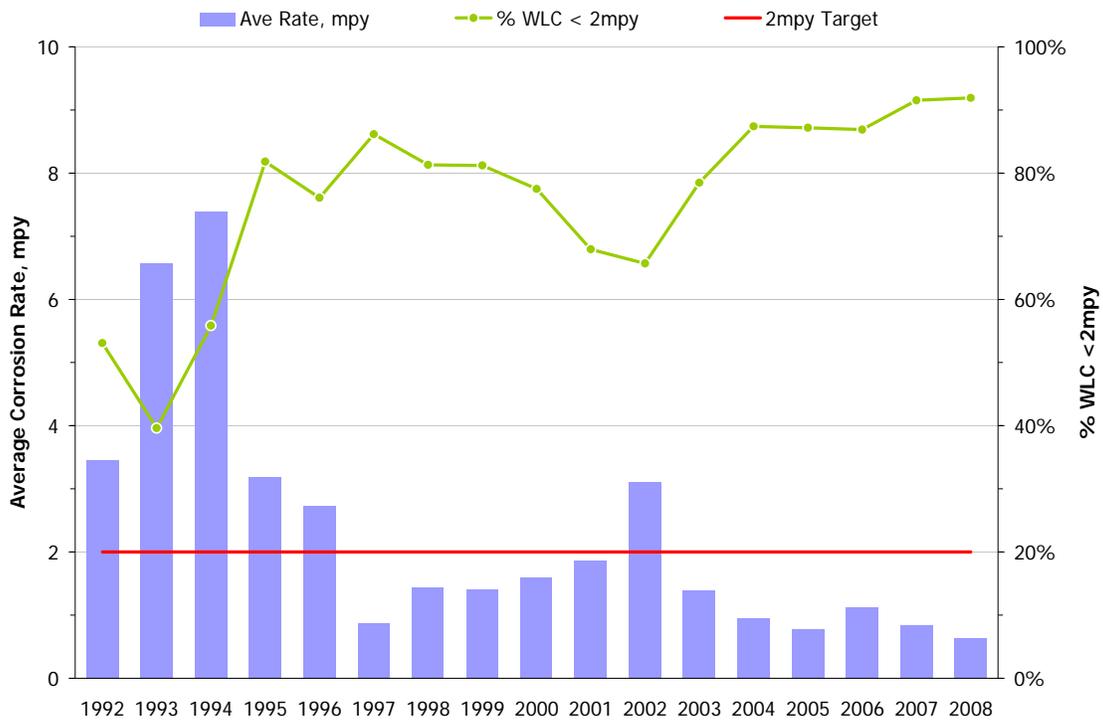
GPB Figure A.6 Flow Line PW/SW Service Corrosion Rate Trend

GPB Figure A.6 is a summary of aggregate data for produced water and seawater flow lines. The WLC corrosion rate data show an improvement in performance over last year and comparable performance as in recent years. The average corrosion rate of WLC in produced water and seawater flow lines was 0.63 mpy and 92% of the coupons were below the 2 mpy general corrosion rate target. The average pitting corrosion rate for WLC in the same PW and SW flow lines was 1.3 mpy and 97% of the coupons were below the 20 mpy target pitting rate.

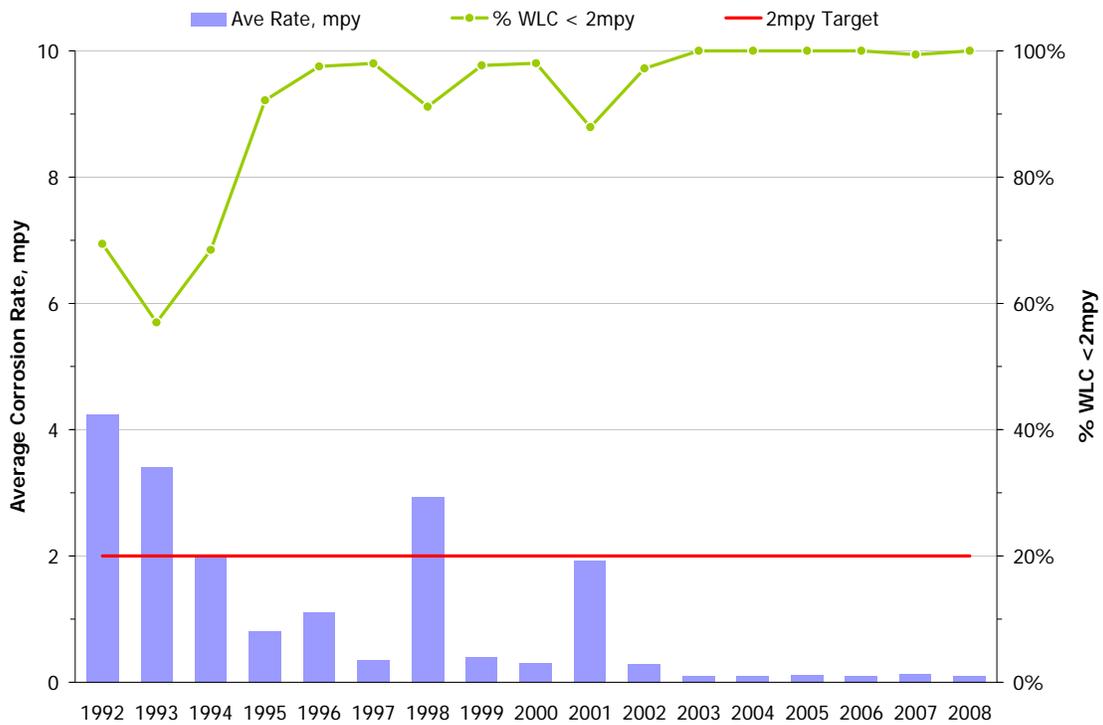
GPB Figure A.7 Corrosion Rate Trend for 100% PW System

GPB Figure A.7 and GPB Figure A.8 summarize the historical corrosion rate data for produced water well lines. The data show general corrosion rates in the produced water system have fallen as the level of inhibition in the 3-phase system was increased and after supplemental produced water corrosion inhibitor injection was initiated.

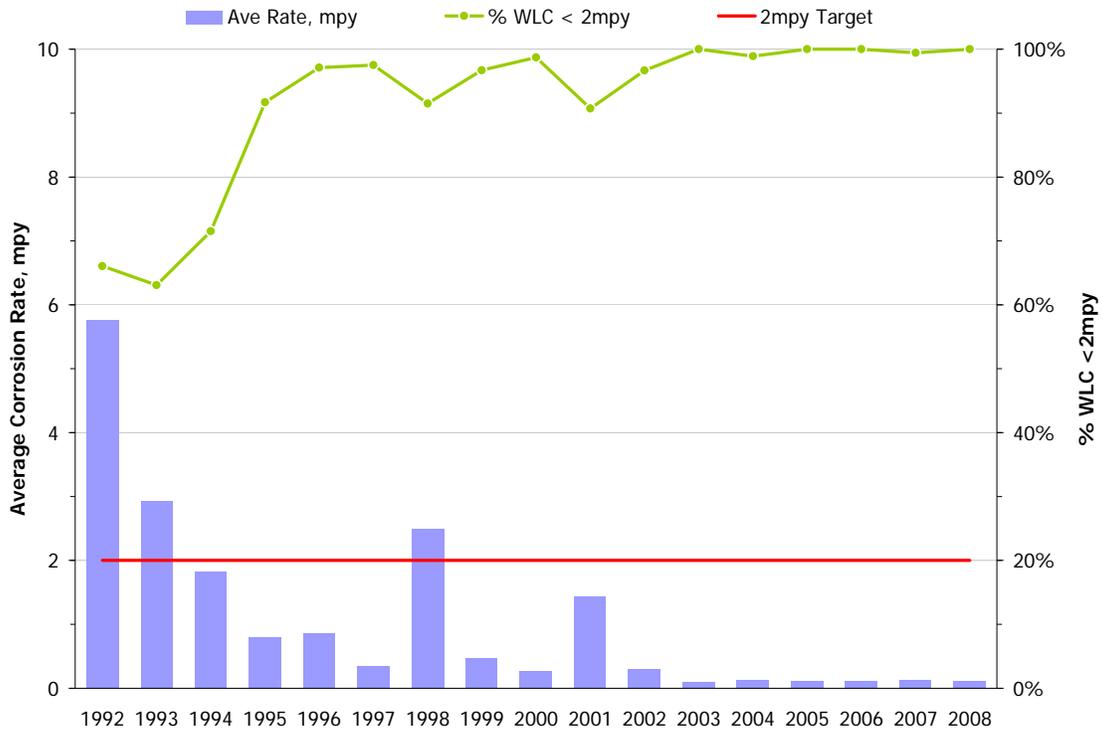
GPB Figure A.8 Corrosion Rate Trend for Majority PW System

The overall improvement in the PW monitoring data since 2001 to date can be attributed to three primary factors. First, a change in the continuous corrosion inhibitor in the 3-phase system in 2002 provided more favorable partitioning characteristics to the water phase than the prior product. This change had the effect of increasing the levels of corrosion inhibitor carried from the upstream 3-phase system into the produced water distribution network. The second contributor is the increase in field-wide average concentration of corrosion inhibitor over time. The third contribution is the continuation of corrosion mitigation programs specific to the PW system that started in 2002. The programs include supplemental continuous inhibitor injection in the PW system at all GPB production facilities except Lisburne.

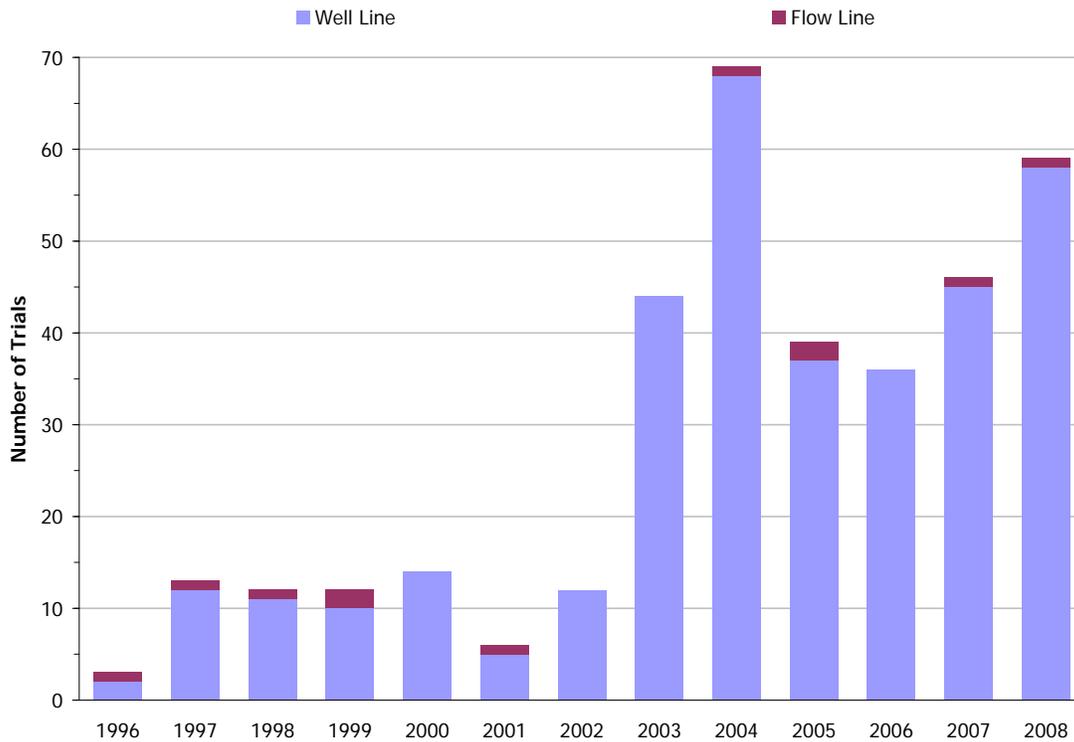
GPB Figure A.20 Number of Well Line and Flow line Tests

GPB Figure A.20 summarizes the number of well line and flow line tests that have been completed since 1996. The level of well line test activity increased beginning in 2003 due to a change in the screening protocol, which reduced the time required per test. The combined number of well line and flow line tests have increased from 10-14 per year⁷ to more than 59 during 2008; a 28% increase in the number of tests as compared to 2007. This level of activity represents a substantial investment of resources towards the development of new and more effective corrosion inhibitors.

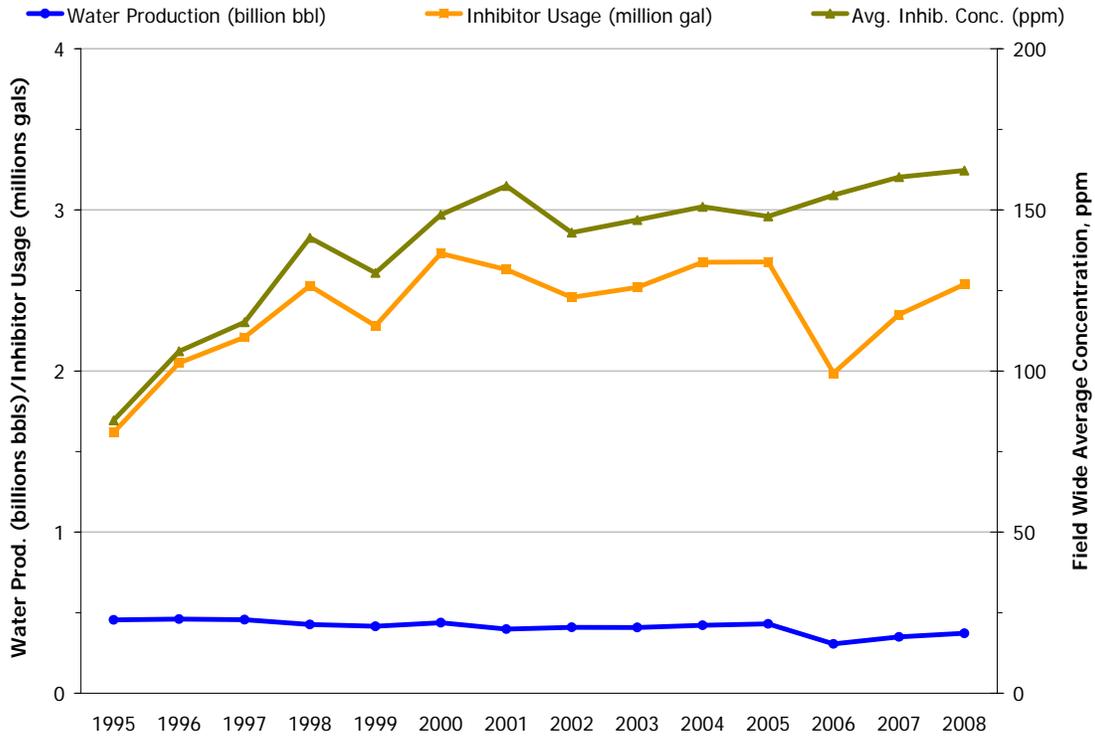
GPB Figure A.21 Field Wide Chemical Usage

While the metrics in GPB Figure A.21 deal with chemical delivery at the overall field level, chemical optimization activity primarily focuses on injecting the correct amount of corrosion inhibitor to each piece of equipment. On a local level, the inhibitor requirement is driven by factors such as water cut, water volume, flow regime, velocity and condition of the equipment. Corrosion inhibitor rates for specific equipment vary over a wide range, from a few parts per million (ppm) to several hundred ppm. For 2008 the field-wide target chemical usage was 2.52 million gallons as compared to actual field-wide usage of 2.54 million gallons.

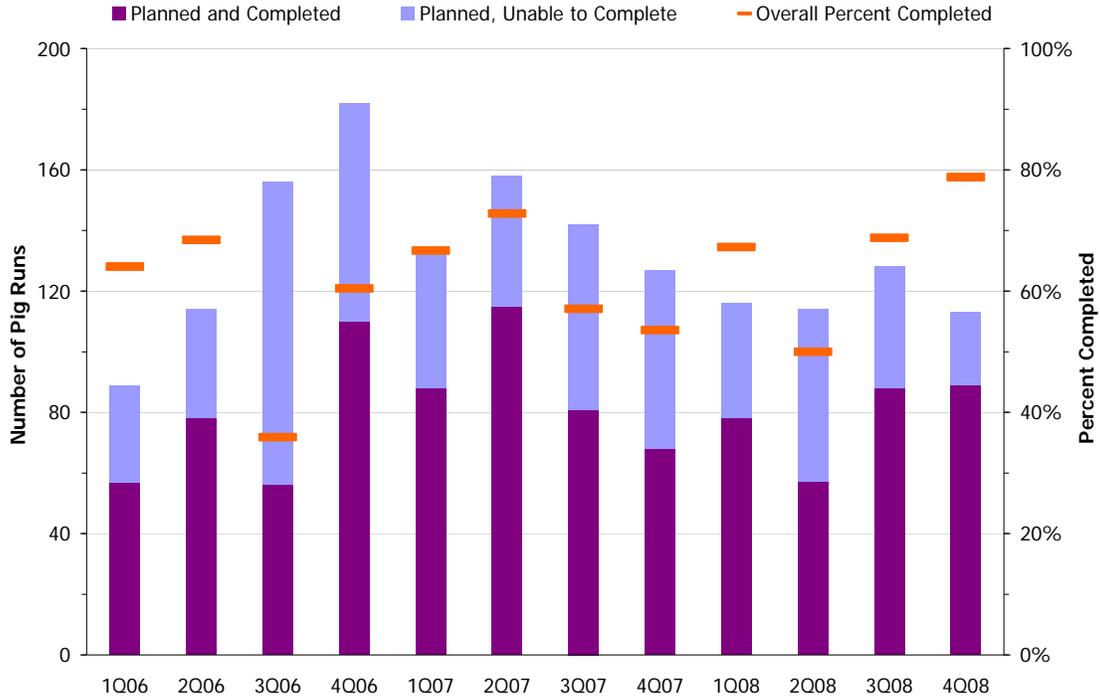
GPB Figure A.24 Maintenance Pig Runs Scheduled and Completed, All Service Types

and the percent of scheduled runs completed, by year. GPB Figure A.24 shows the overall performance of the program since 2006 for scheduled pig runs on all service types. The average percentage of scheduled pig runs that were completed each year has increased for each of the last three years ($^{2006}56\% < ^{2007}63\% < ^{2008}66\%$), illustrating continuous improvement in the maintenance pigging program for GPB.

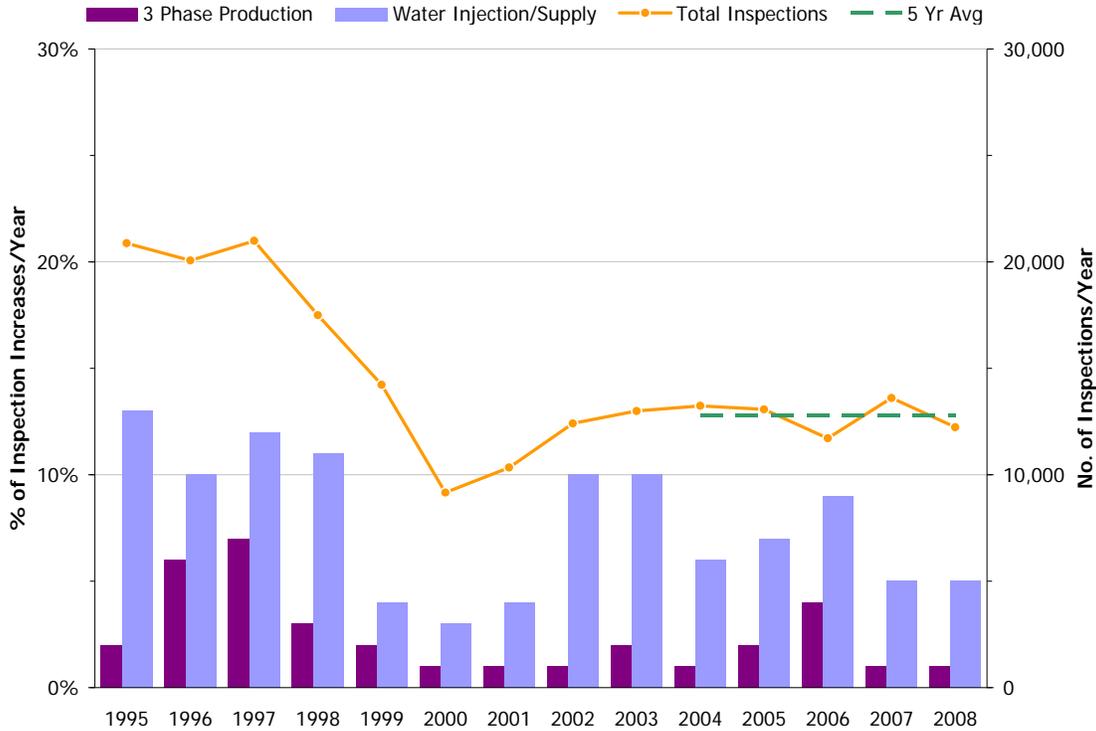
GPB Figure B.2 Flow Line Internal Inspection Increase by Service

GPB Figure B.2 shows the percentage of inspection increases and the number of inspections per year for the flow lines segregated by 3-phase production and water injection (seawater and produced water) service. In 2008 the number of flow line inspections (12,229) was within 4% of the five year average.

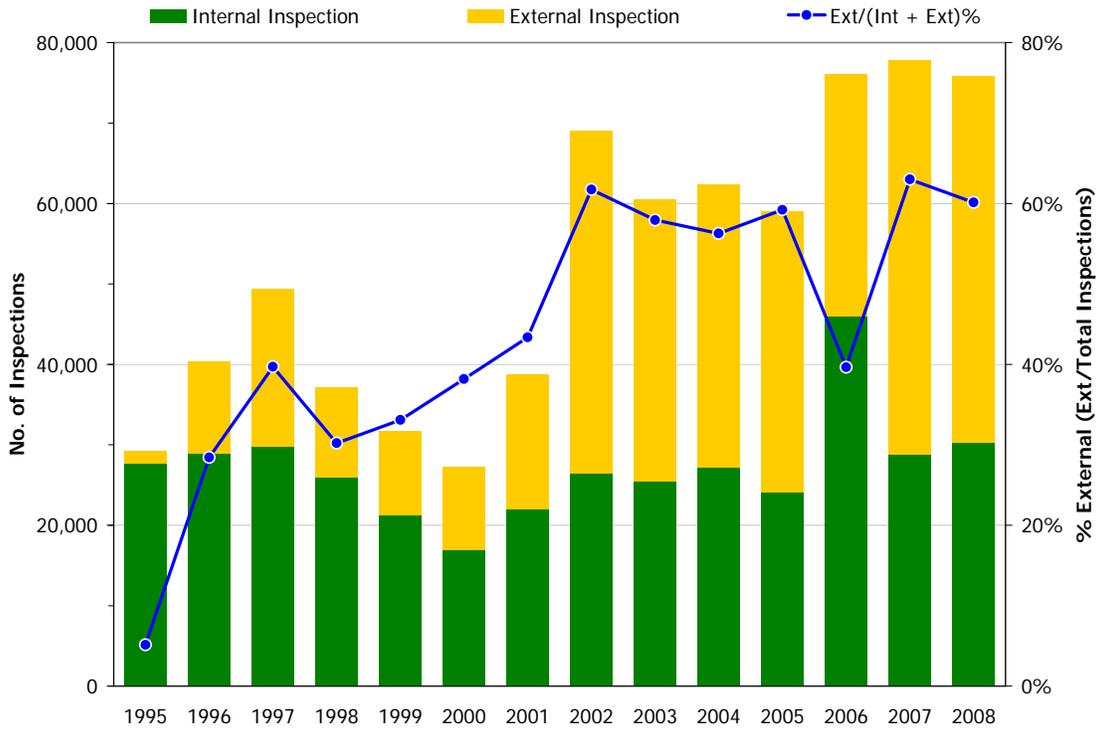
GPB Figure B.5 Internal and External Inspection Activity for Transit, Flow and Well Lines

GPB Figure B.5 and GPB Table B.5 summarize the level of internal and external inspection activity across GPB since 1995. Due to the events involving processed oil transit lines, the level of internal corrosion inspection during 2006 increased significantly when compared to other years. The number of inspections in 2007 returned to a more typical level, balanced with activity in other areas of the system.

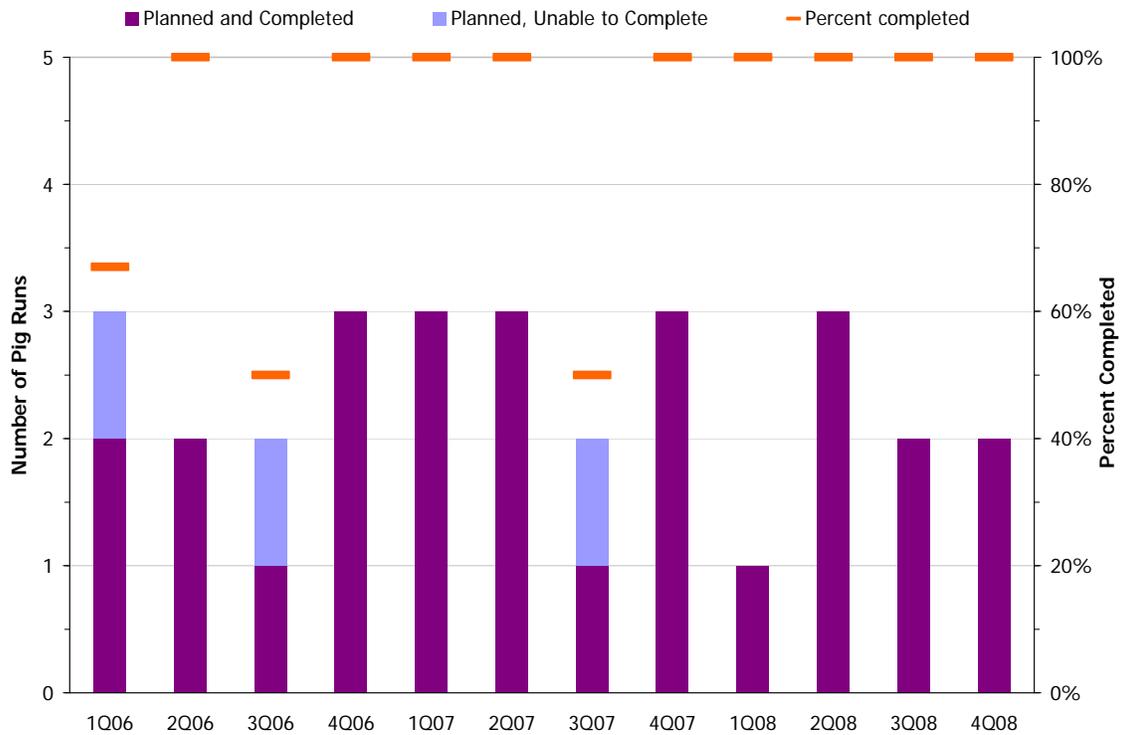
ACT Figure A.2 Endicott IIWL Maintenance Pigging Performance

Maintenance pigging of the Endicott IIWL is scheduled on a five-week interval. ACT Figure A.2 shows the delivery performance for the IIWL pigging by quarter beginning in 2006. In 2008, 100% of the maintenance pig runs were completed as scheduled. In addition, improvements in the maintenance pigging program were made to increase the effectiveness of cleaning during the pig run.

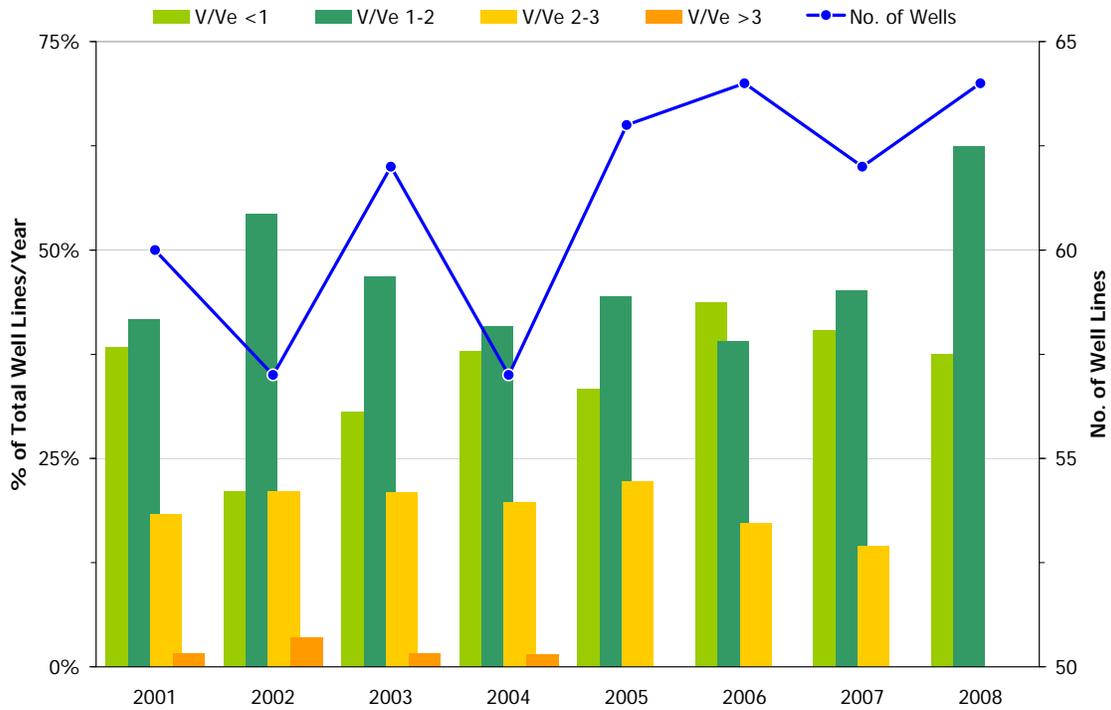
ACT Figure A.3 Endicott Velocity Monitoring

In the production system, the primary damage mechanism is erosion in the duplex stainless steel sections and corrosion in the carbon steel C-Spool sections. The erosion rate is monitored through inspection and mitigated through velocity management. Wells are risk-ranked monthly based on mixture velocity and the velocity information is used to adjust the inspection frequency and fluid velocity. ACT Figure A.3 is an overview of the average velocity data since 2001. Shown are the percent of wells within V/V_e ratio ranges, where V is the actual mixture velocity, V_e is the velocity at which erosion becomes a concern as defined by API-RP-14E⁹, and V/V_e is the erosion velocity ratio.

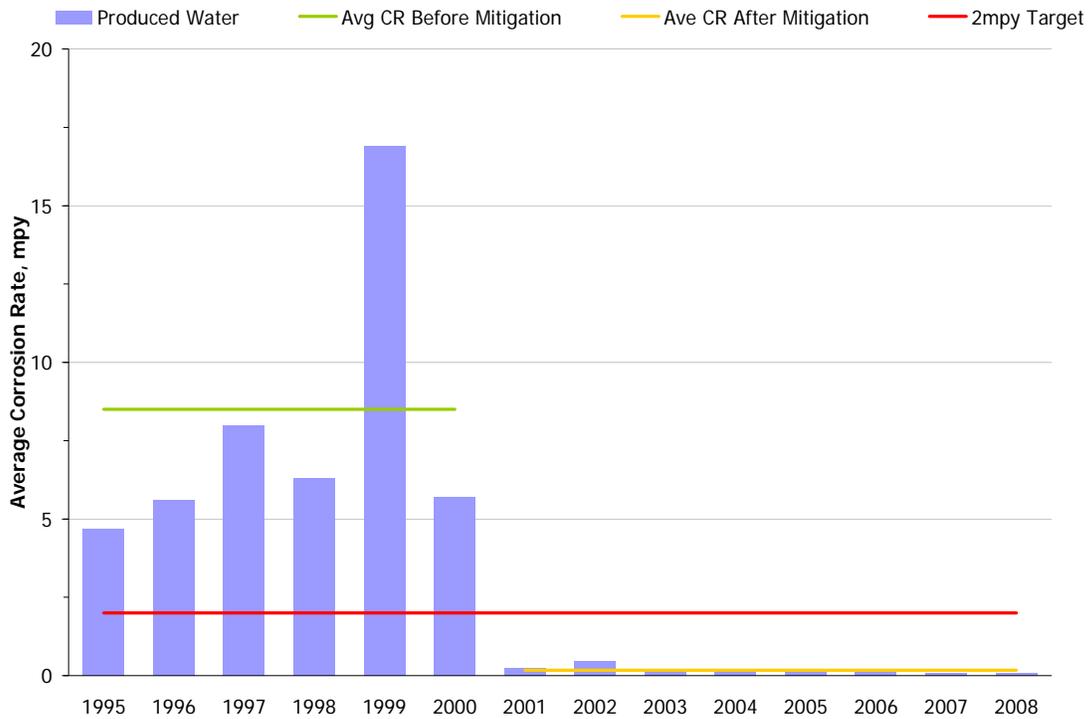
ACT Figure A.5 Milne Point Produced Water Corrosion Rate Trend

The annual corrosion inhibitor target volume for produced water was 71,998 gallons and the actual volume of CI used was 75,160 gallons. The annual average CI target concentration for produced water was 55 ppm; the annual average delivered concentration was 57 ppm.

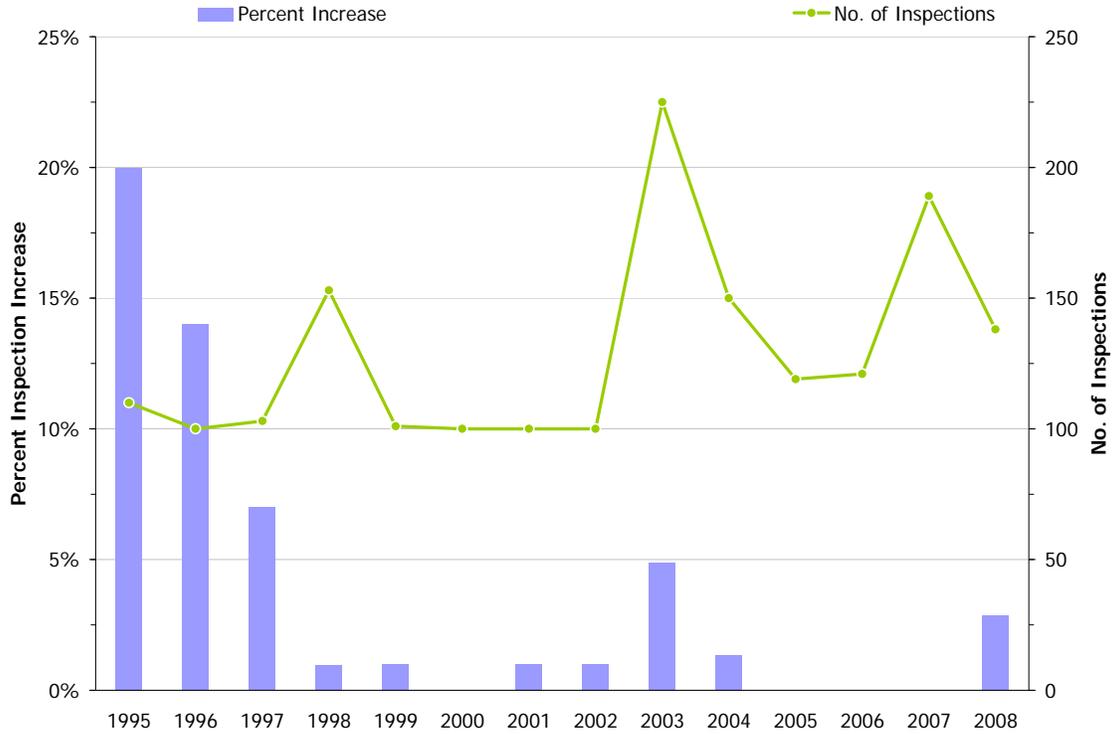
ACT Figure B.3 Endicott IWL Frequent Inspection Results

A more accurate representation of corrosion activity through time is shown in ACT Figure B.3 which includes only data from inspections performed on a frequent basis since 1995. The frequently monitored locations show a decrease in corrosion activity during 2004, and no increases during 2005-2007. In 2008, three frequently inspected locations showed inspection increases; 3% of all frequent inspections. The average long term corrosion rate was 2.7 mpy for the three inspection increases that were identified in January 2008. In response to the inspection increases the continuous corrosion inhibitor rate was increased from 30 to 40 ppm. None of the frequent internal corrosion inspections performed after January 2008 showed inspection increases.

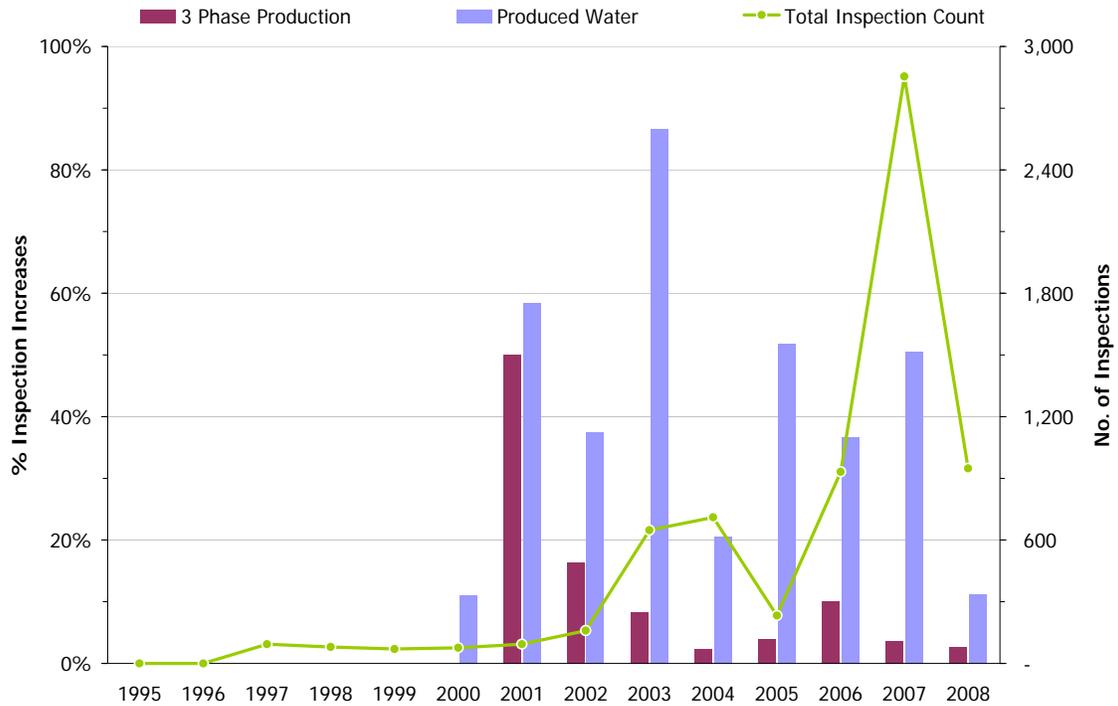
ACT Figure B.4 MPU Flow Line Internal Inspection Increases

The results of the internal inspection program are shown in ACT Figure B.4. Overall the 3-phase flow lines are continuing to show a decreasing trend of locations with corrosion activity as additional inhibition locations are established. In 2007, the Tract 14 main trunk line was placed on continuous inhibition.

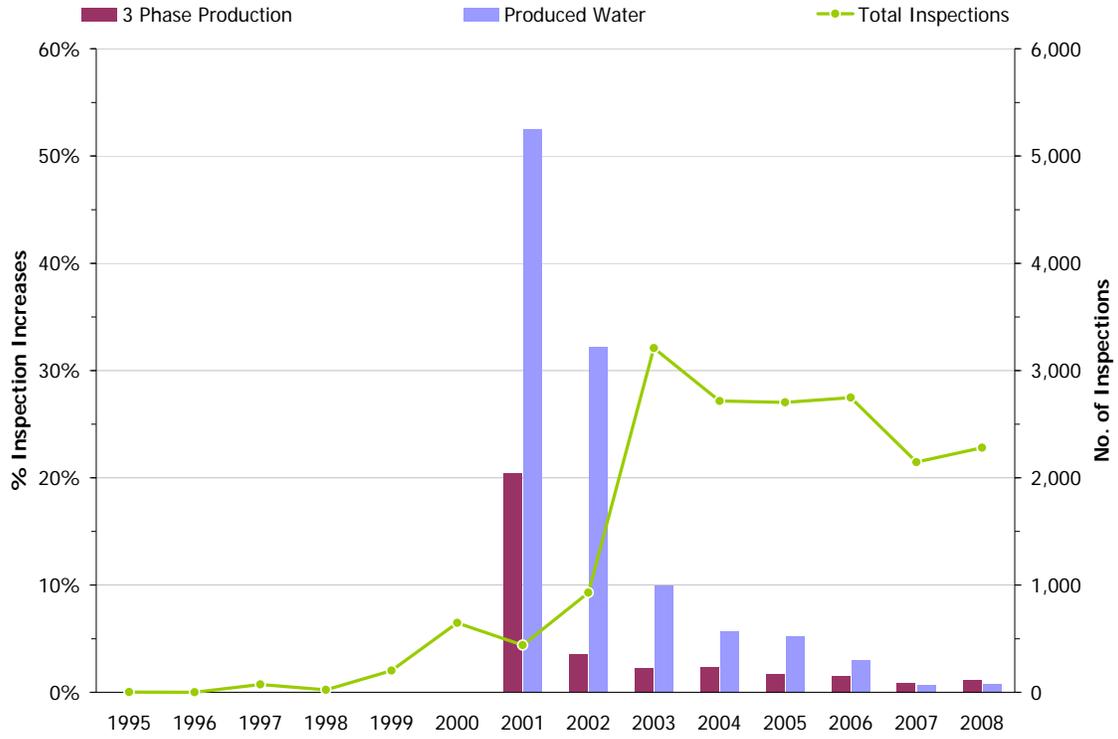
ACT Figure B.5 MPU Well Line Internal Inspection Increases

The 3-phase well line damage rate has remained essentially level over the past several years, with <2% of the repeat locations showing an increase in corrosion activity.

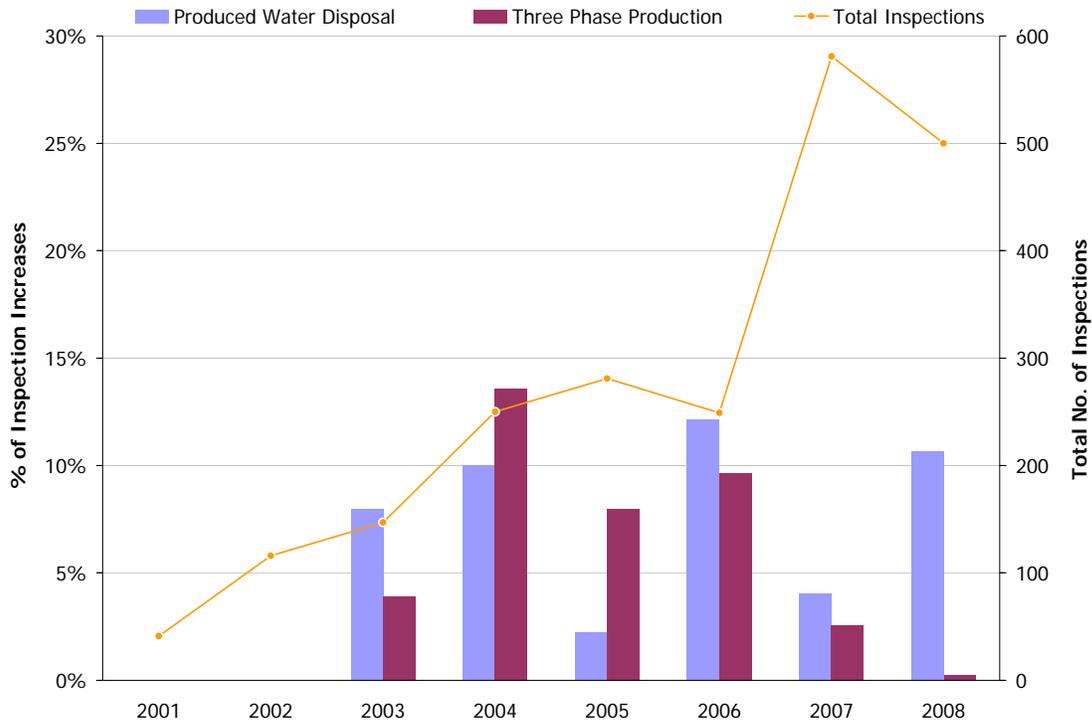
ACT Figure B.6 Northstar Well Line Internal Inspection Increases

Both the 3-phase and produced water systems continue to show decreasing trends in inspection increases for 2008 (refer to ACT Figure B.6). By the end of 2007, all 3-phase well lines had the corrosion inhibitor injection locations moved further upstream to the well head, assuring the entire well line was inhibited. Inspection increases in the disposal well are believed to be associated with oxygenated fluids from the drilling mud plant and also oxygenated fluids introduced from the effluent system. The disposal system is inspected on a quarterly basis.

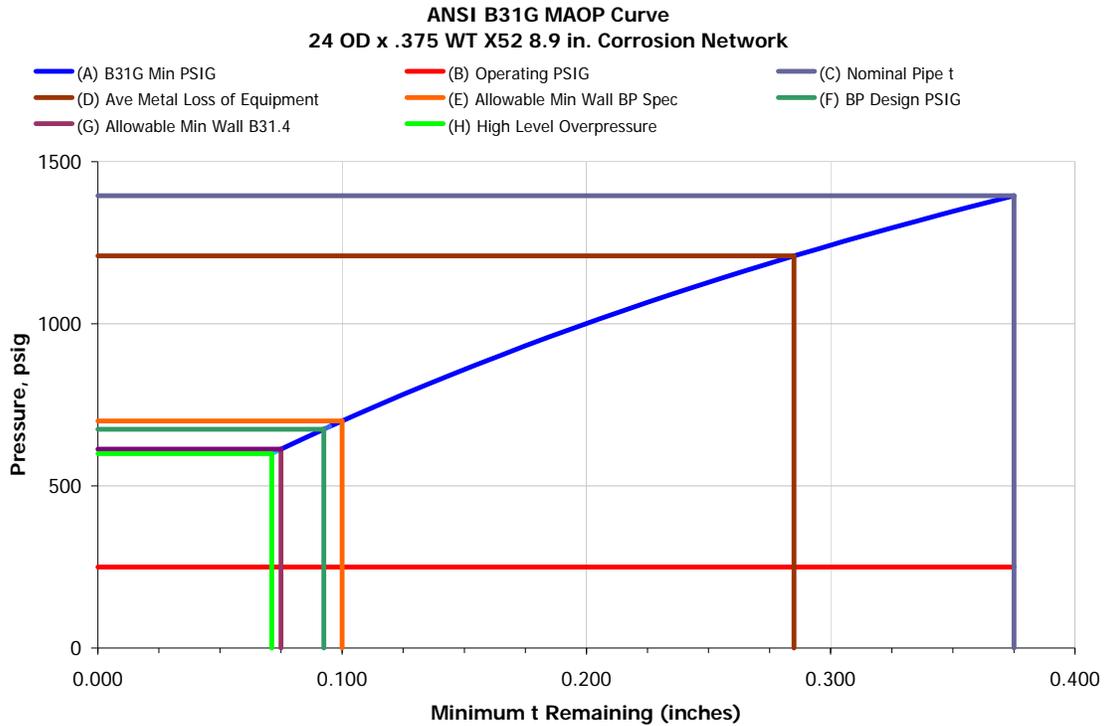
Legend	Description/Comments
(A) B31G Min PSIG	The relationship between maximum allowable operating pressure, MAOP, as given by B31G and the remaining wall thickness
