ANALYSIS OF BROWNFIELD CLEANUP ALTERNATIVES
Former Joseph Guy Community Center
Kwethluk, Alaska
August 11, 2011

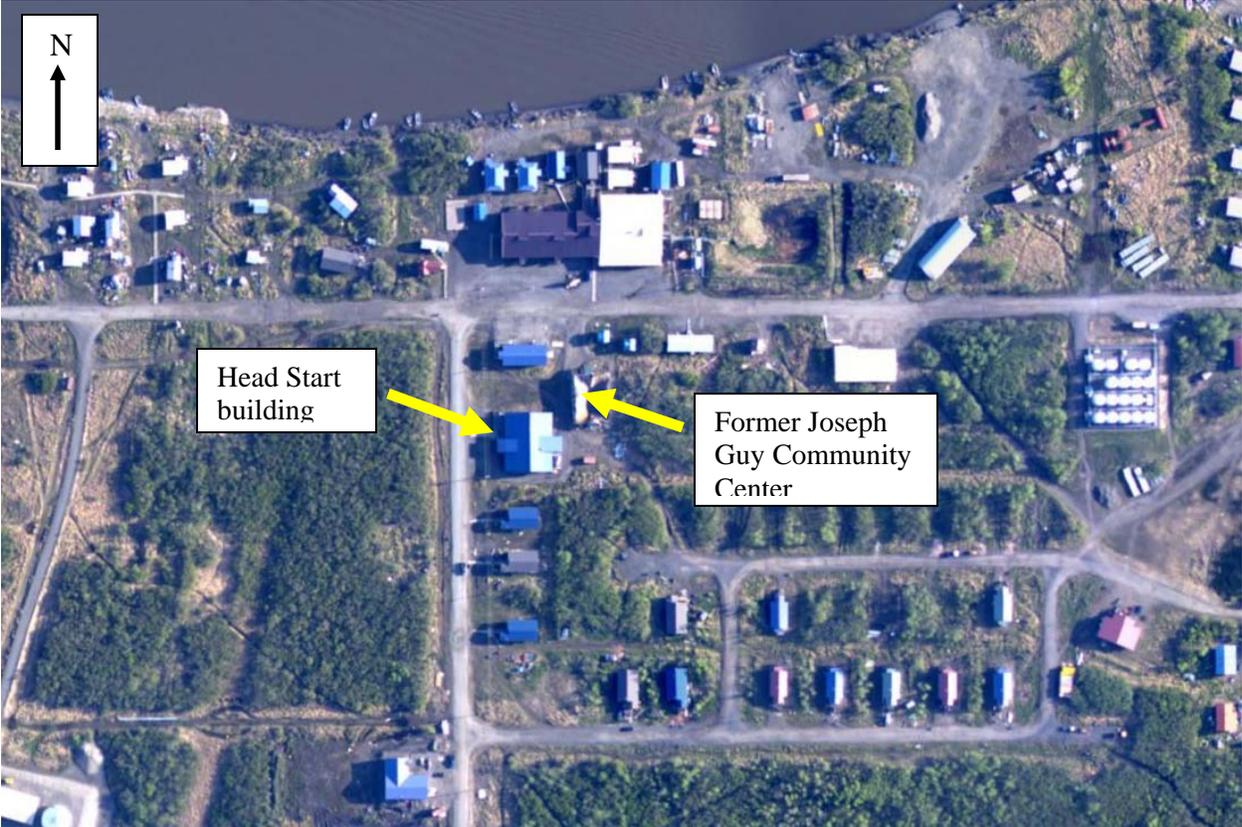
Photo 1: Aerial view of project site in Kwethluk, Alaska.

The 0.5-acre site is located in Section 5, Township 8 North, Range 69 West, Seward Meridian at 60.810278N, -166.423945W. The project location is shown in Photo 2.

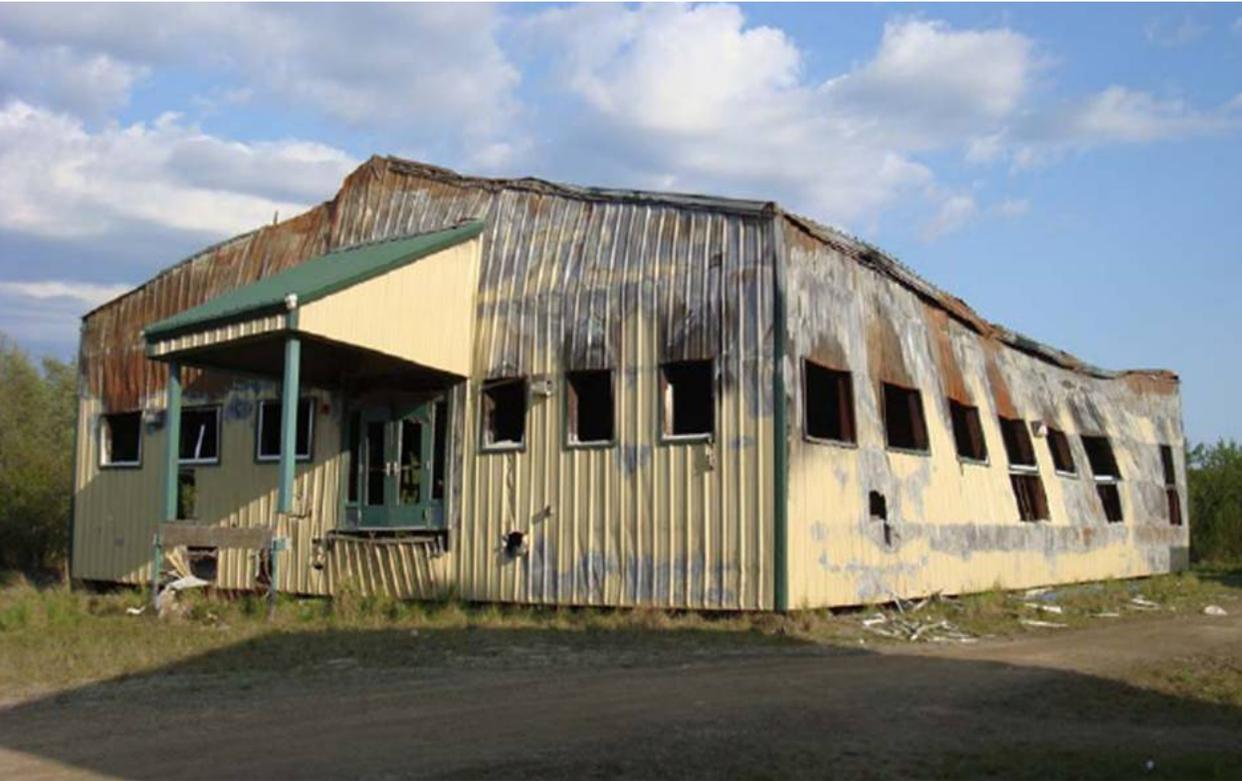
Photo 2: Former Joseph Guy Community Center in Kwethluk, Alaska.

The Former Joseph Guy Community Center (Center) is located at the intersection of Jay Hammond Way and Airport Road in Kwethluk, Alaska. The building was destroyed by fire in April 2006 (see Photo 1). The Center was built with a combination of federal, state, and private funds between 1998 and 2002. The burned-out structure is adjacent to both the post office and Head Start buildings, and is across the street from the Lower Kuskokwim School District school. The Organized Village of Kwethluk (OVK) owns the site.
