Former Tok Fuel Terminal, Alaska

Project Update

Tok Public Meeting
December 9, 2013

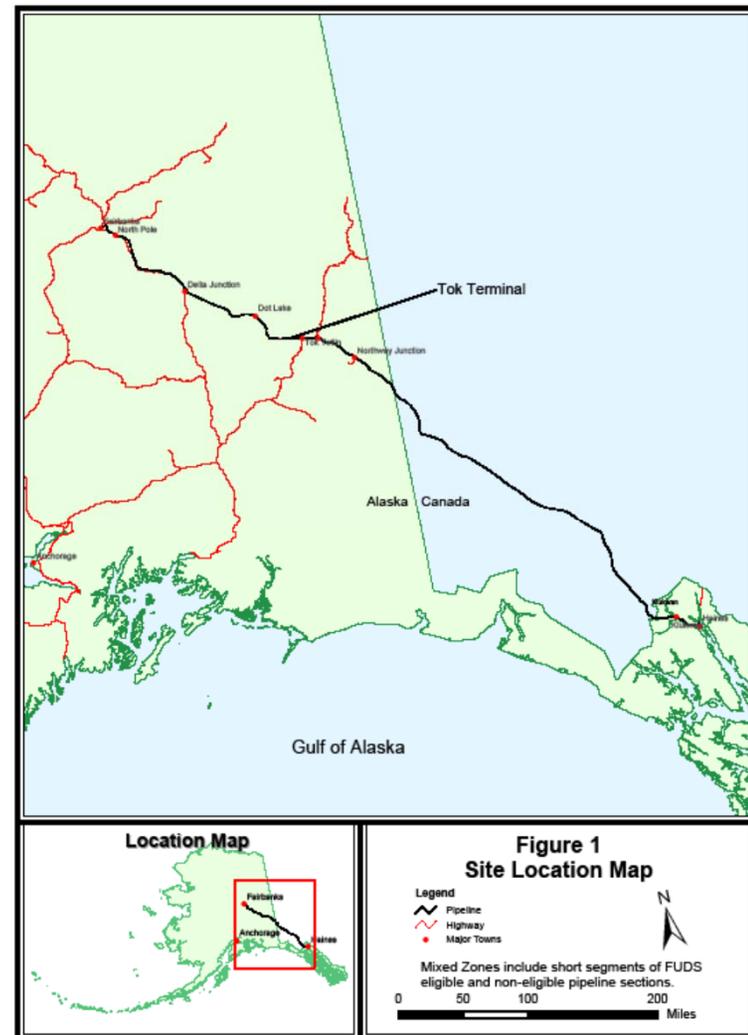
- Located 7 miles west of Tok Junction at Mile Post 1321 along the Alaska Highway.
- Former pump station and bulk fuel storage facility supporting former Haines to Fairbanks Pipeline.
- Operated from mid-1950s to 1979.
- Consisted of ASTs, USTs, piping, support buildings, residential buildings and landfills.

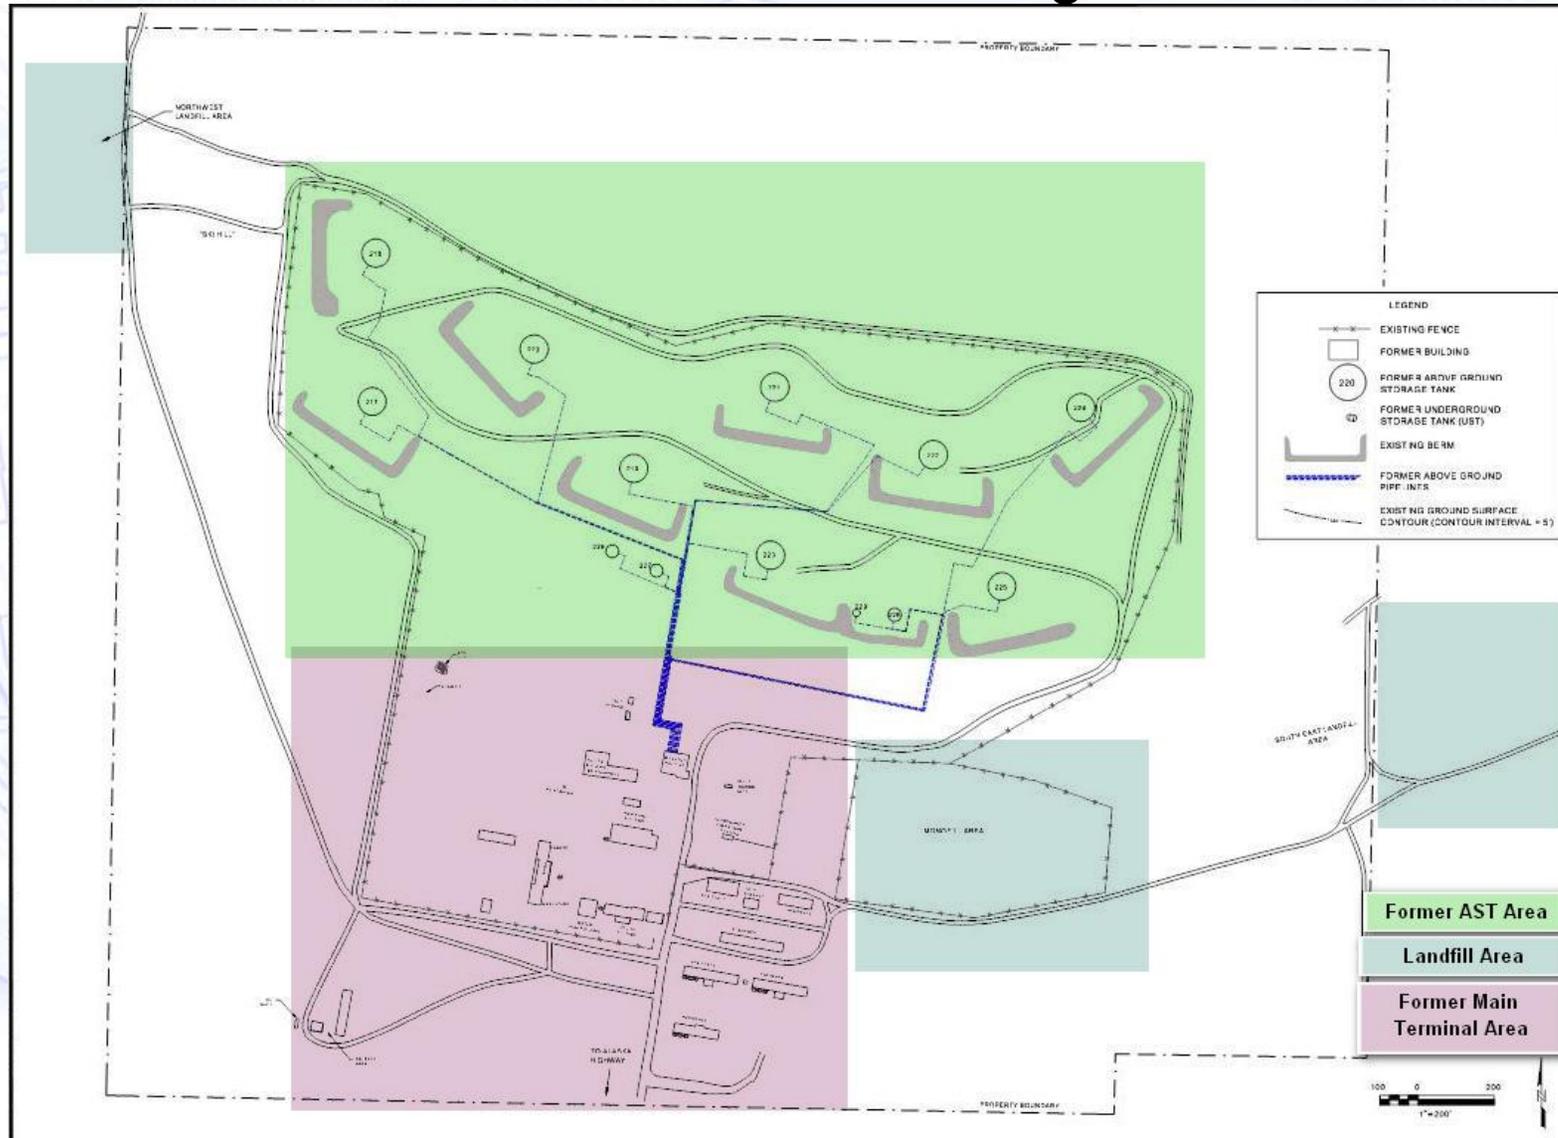
TFT - Site Layout

- Main Terminal Area
 - Former Butler Building (Maintenance Building)
 - Former Manifold Building
 - Former Truck Loading Rack
 - Former Main Pump Building
 - Former Building 9-104 (Garage, Shop, Warehouse)
 - Former Burn Pit
 - Former Oil Rack Area
- Aboveground Storage Tanks Area (AST) (all Former)
 - 9 x 30,000 barrel ASTs
 - 2 x 5,000 barrel ASTs
 - 1 x 1,000 barrel AST
- Landfills
 - Northwest Landfill
 - Southeast Landfill
 - Monofill Landfill

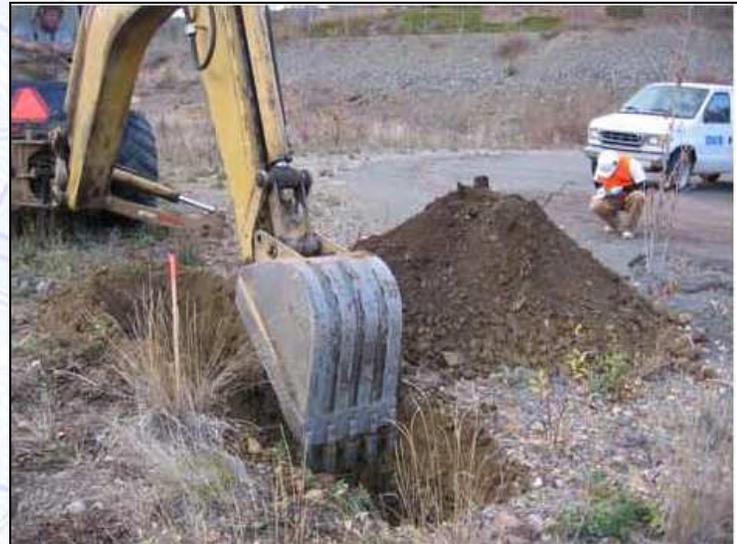
- Test pitting adjacent to former AST locations identified 3 areas where DRO-impacted soil exceeded ADEC CLs.
- Test pitting confirmed the absence of USTs at 5 locations where geophysics detected magnetic anomalies.
- 14 groundwater monitoring wells were installed across the site, developed and sampled. DRO, RRO, SVOCs and a chlorinated solvent were detected above cleanup levels.

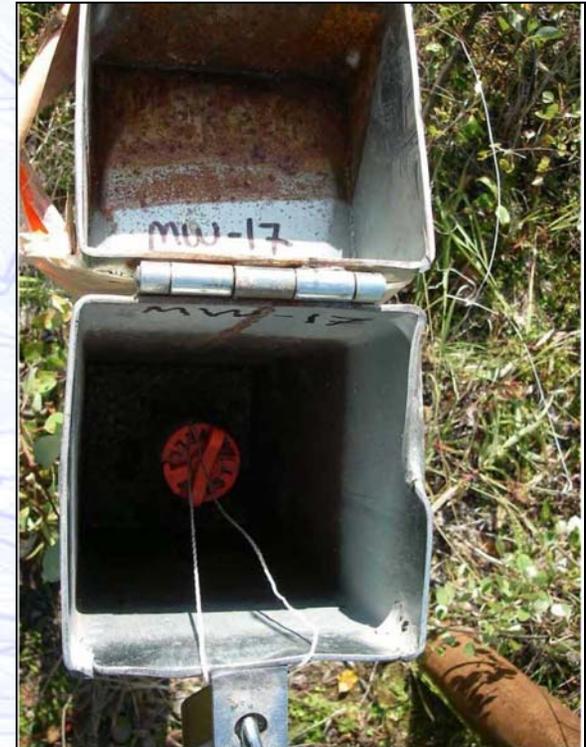
All 24 groundwater monitoring wells were sampled in August 2012.

- No exceedance in 5 monitoring wells associated with the Monofill Landfill.
- DRO and RRO exceeded CLs in monitoring well downgradient of former AST 219.
- Bis-(2)-ethylhexylphthalate exceeded CL in monitoring well downgradient of former AST 218
- 7 monitoring well associated with the Main Terminal Area has exceedances for 1 or more of the following: DRO, PCE, bis-(2)-ethylhexylphthalate.

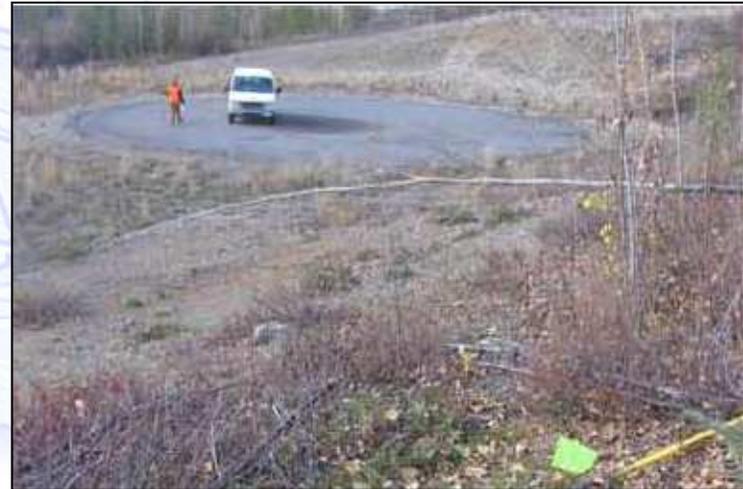
- Soil:
 - *Metals*: Lead was detected above CL near AST 222
 - *POL*: DRO detected above CL near AST 221
 - *VOCs*: Not detected above the most stringent CL
 - *PAH*: Not detected above the most stringent CL
 - *Pesticides*: Not detected above the most stringent CL.
- Groundwater:
 - *Metals*: Not detected above the most stringent CLs
 - *POL*: GRO was detected above CL. DRO was detected below the CL.
 - *VOCs*: Not detected above the CL.

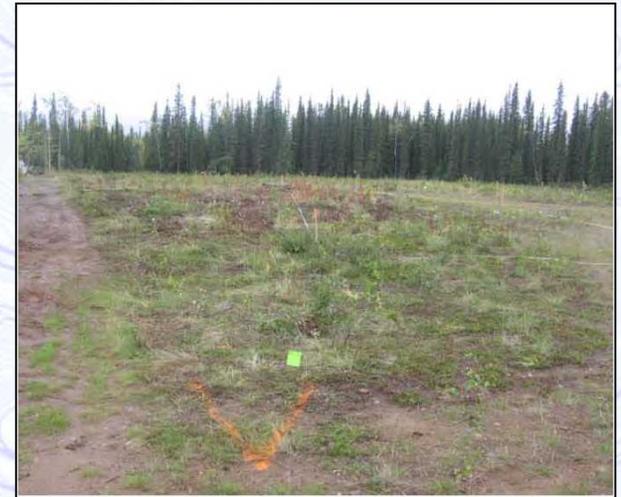
1. Northwest Landfill - Located on the NW side of, and slightly outside of, the property boundary. Reportedly used for construction debris and household waste during mid-1950s.
2. Southeast Landfill - Located on the SE side of, and slightly outside of, the property boundary. Reportedly used for construction debris and household waste until facility was closed in 1979.
 - *TCE was detected above CL in a soil sample collected from the Southeast Landfill.*
3. Monofill Landfill - located on the northeast side of the Main Terminal and within TFT property boundary. Used for disposal of demolition debris, piping, building, and AST demo debris. Operated 2002-2003. Permitted by ADEC.
