**PCB Cleanup
Aniak Middle School
Aniak, Alaska**

December 2001

32-1-16491-002

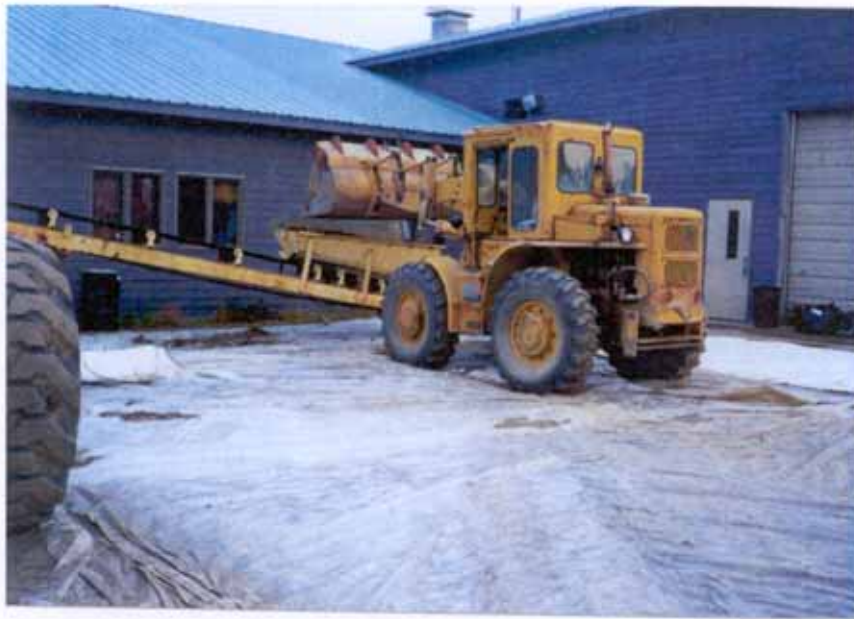
Photo 1: The front end loader is shown placing soil onto the conveyor belt. The work area was covered with a plastic liner. After the supersacks were loaded, the soil collected on the plastic liner was placed in supersacks for disposal.

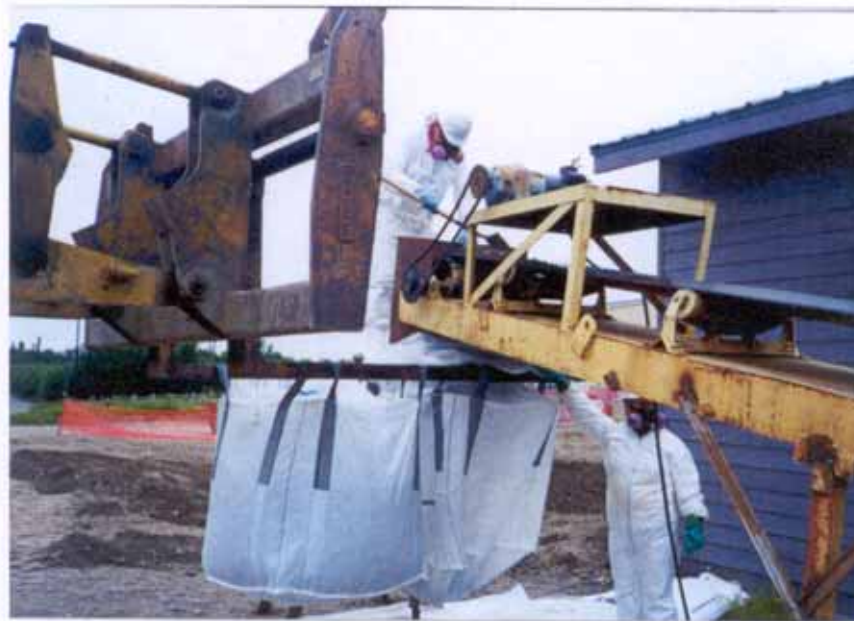
Photo 2: A forklift was used to support the supersacks while they were being filled with PCB impacted soil.

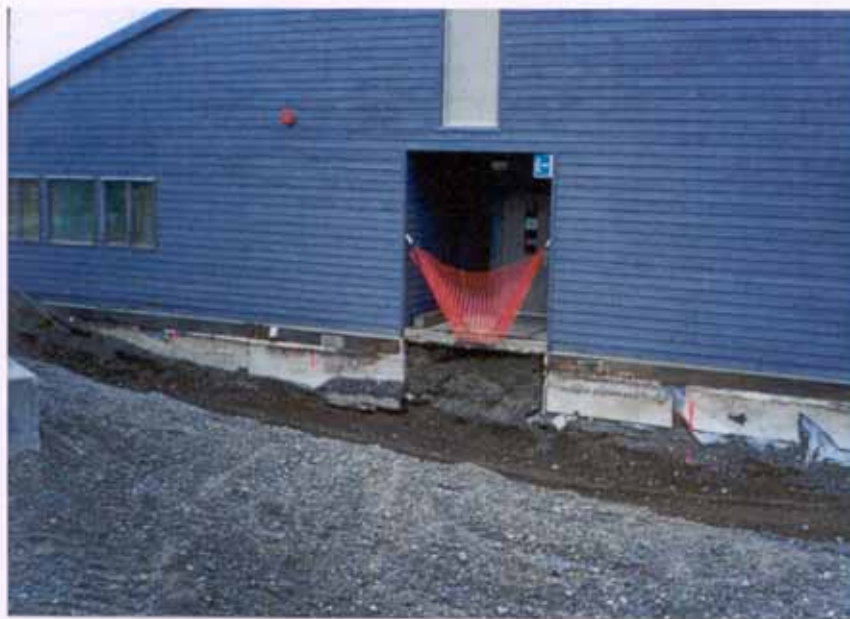
Photo 4: This is a photo of the same area shown in Photo 3 after removing several feet of PCB impacted soil. The doorway shown above is the south entrance to the Aniak Middle School.

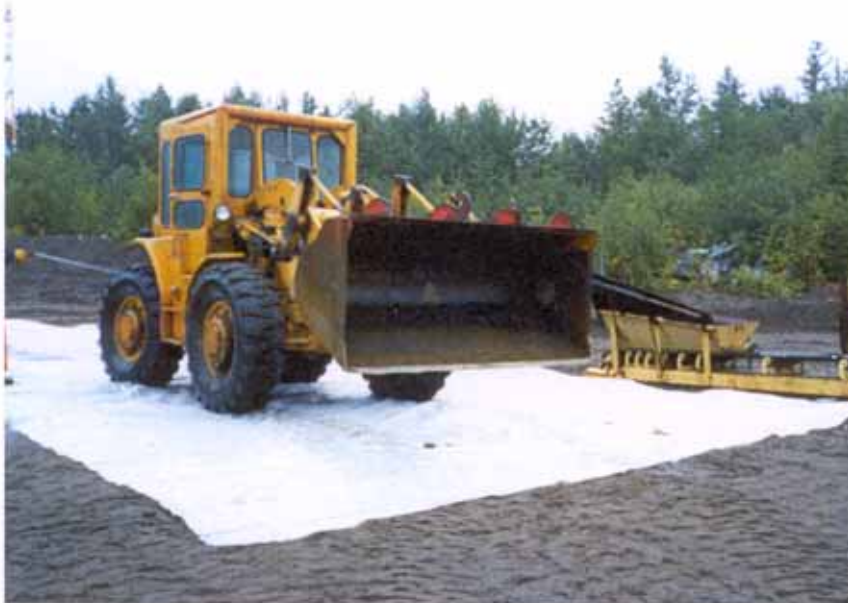
Photo 4: At the conclusion of the excavation activities, a decontamination station was set up using a plastic liner. Gravel berms were constructed on the downslope edges of the plastic liner shown above, and the rinsate from washing the equipment was collected and transferred to a 55-gallon drum.

At the completion of the excavation activities, the project equipment was cleaned of loose soil using stiff brushes. The soil removed from the hard surfaces of the equipment was added to the soil supersacks. Following the removal of the loose soil, the equipment and rubber surface of the conveyer belt was washed with water and brushes. Final decontamination of the tools and equipment used for this project was accomplished by wiping the surfaces with hexane using disposable towels. The decontamination water was placed in a 55-gallon drum for disposal. The hand towels and plastic liners used for the decontamination station were placed in supersacks for disposal with the other PCB-impacted material. The front-end loader used for this project is shown at the decontamination station in Photograph 5.

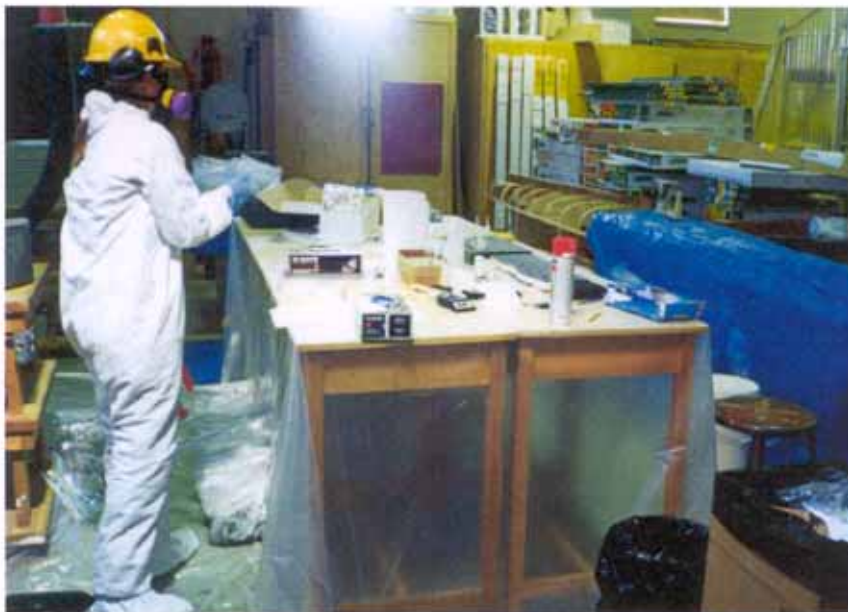
Photo 6: The Aniak Middle School wood shop was used to perform the PCB soil screening tests. The work area surfaces within the wood shop were covered with plastic liners and tarps.
