**NORTH RIVER
RADIO RELAY STATION**

SITE INSPECTION REPORT

FINAL

MARCH 2005

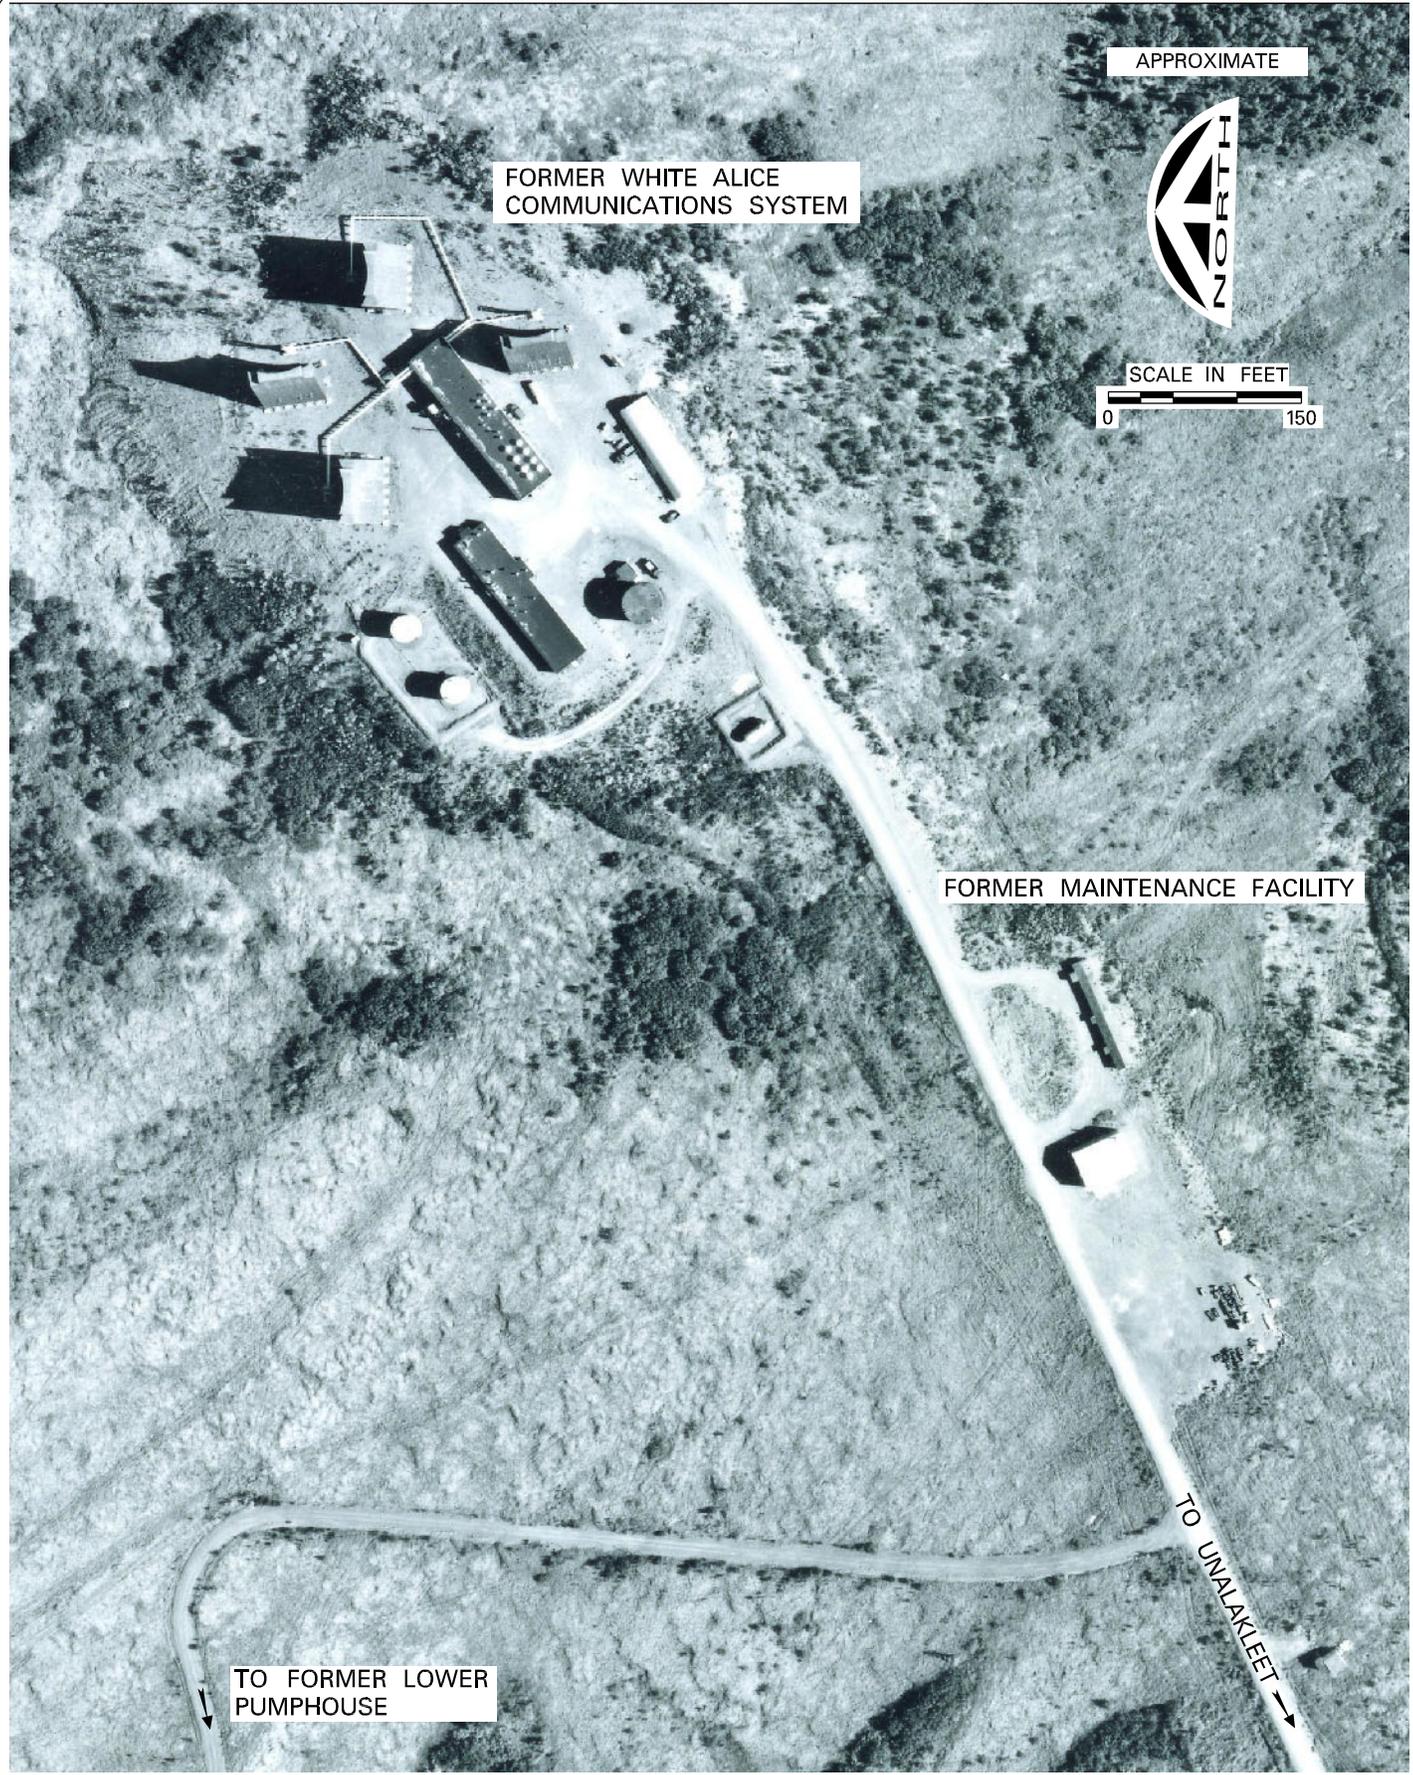
FIGURE 1-2
U. S. AIR FORCE
NORTH RIVER RADIO RELAY STATION – SITE INVESTIGATION REPORT
SITE MAP

North River RRS sits on top of a bluff on the north side of the Unalakleet River, approximately 12 road miles from the City of Unalakleet (Figure 1-1). Site OT01 is the designation for the entire installation, which consisted of two main areas: a former WACS and former Maintenance Facility (Figure 1-2).

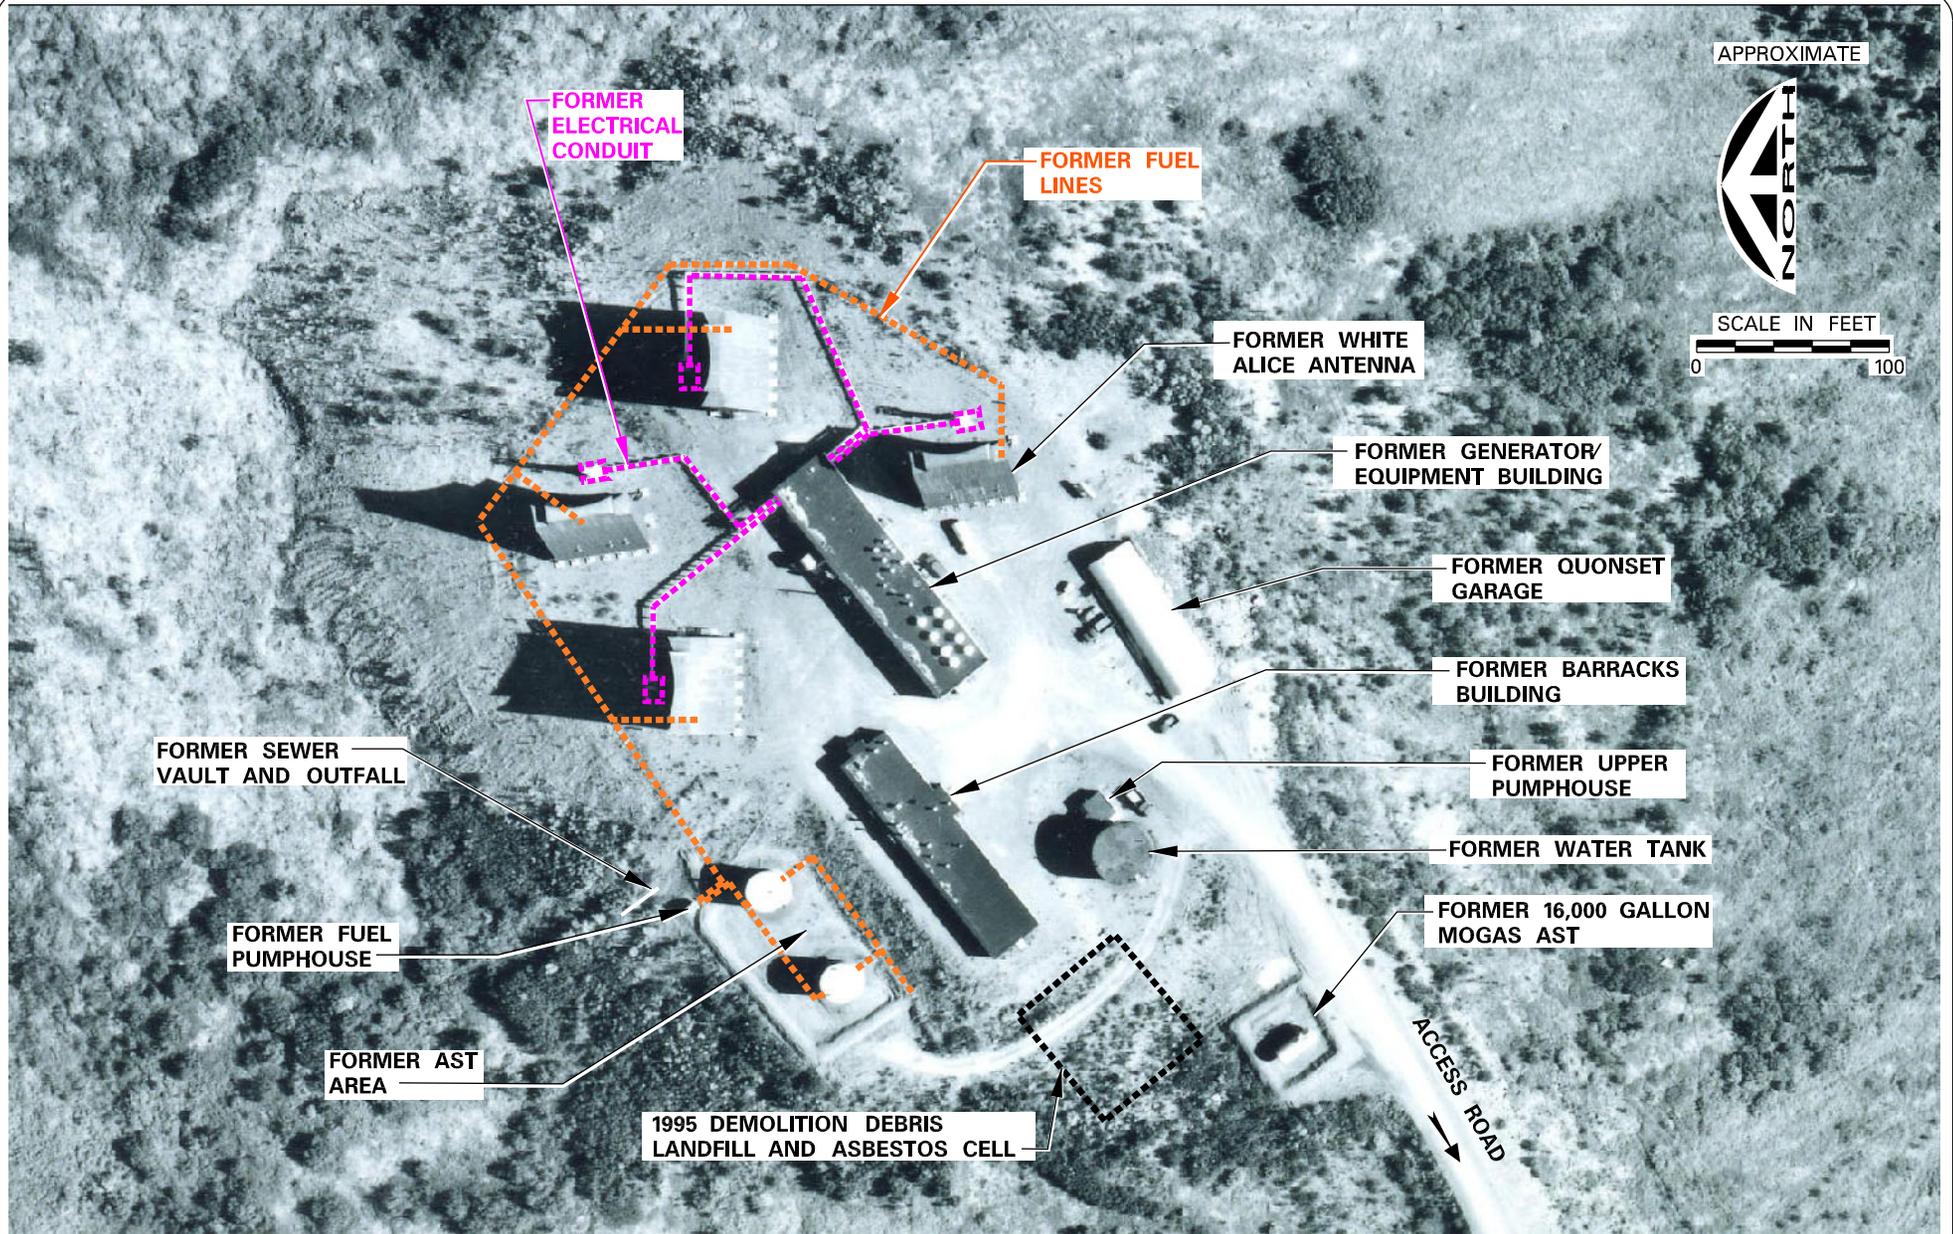
FIGURE 2-1
U. S. AIR FORCE
NORTH RIVER RADIO RELAY STATION – SITE INVESTIGATION REPORT
FORMER WACS

Former WACS. These facilities are shown on Figure 2-1 and consisted of:

- A Barracks
- A Generator/Equipment Building
- A Quonset garage
- A water tank with pumphouse
- Four WACS antennae
- Two 2,000-barrel ASTs
- A fuel pumphouse with piping that connected the ASTs to each antennae
- A sewer vault and outfall

The only things remaining at the WACS are the landfill, which is covered by soil, and a mounded area suggesting a buried concrete pad at the former Generator/Equipment Building.

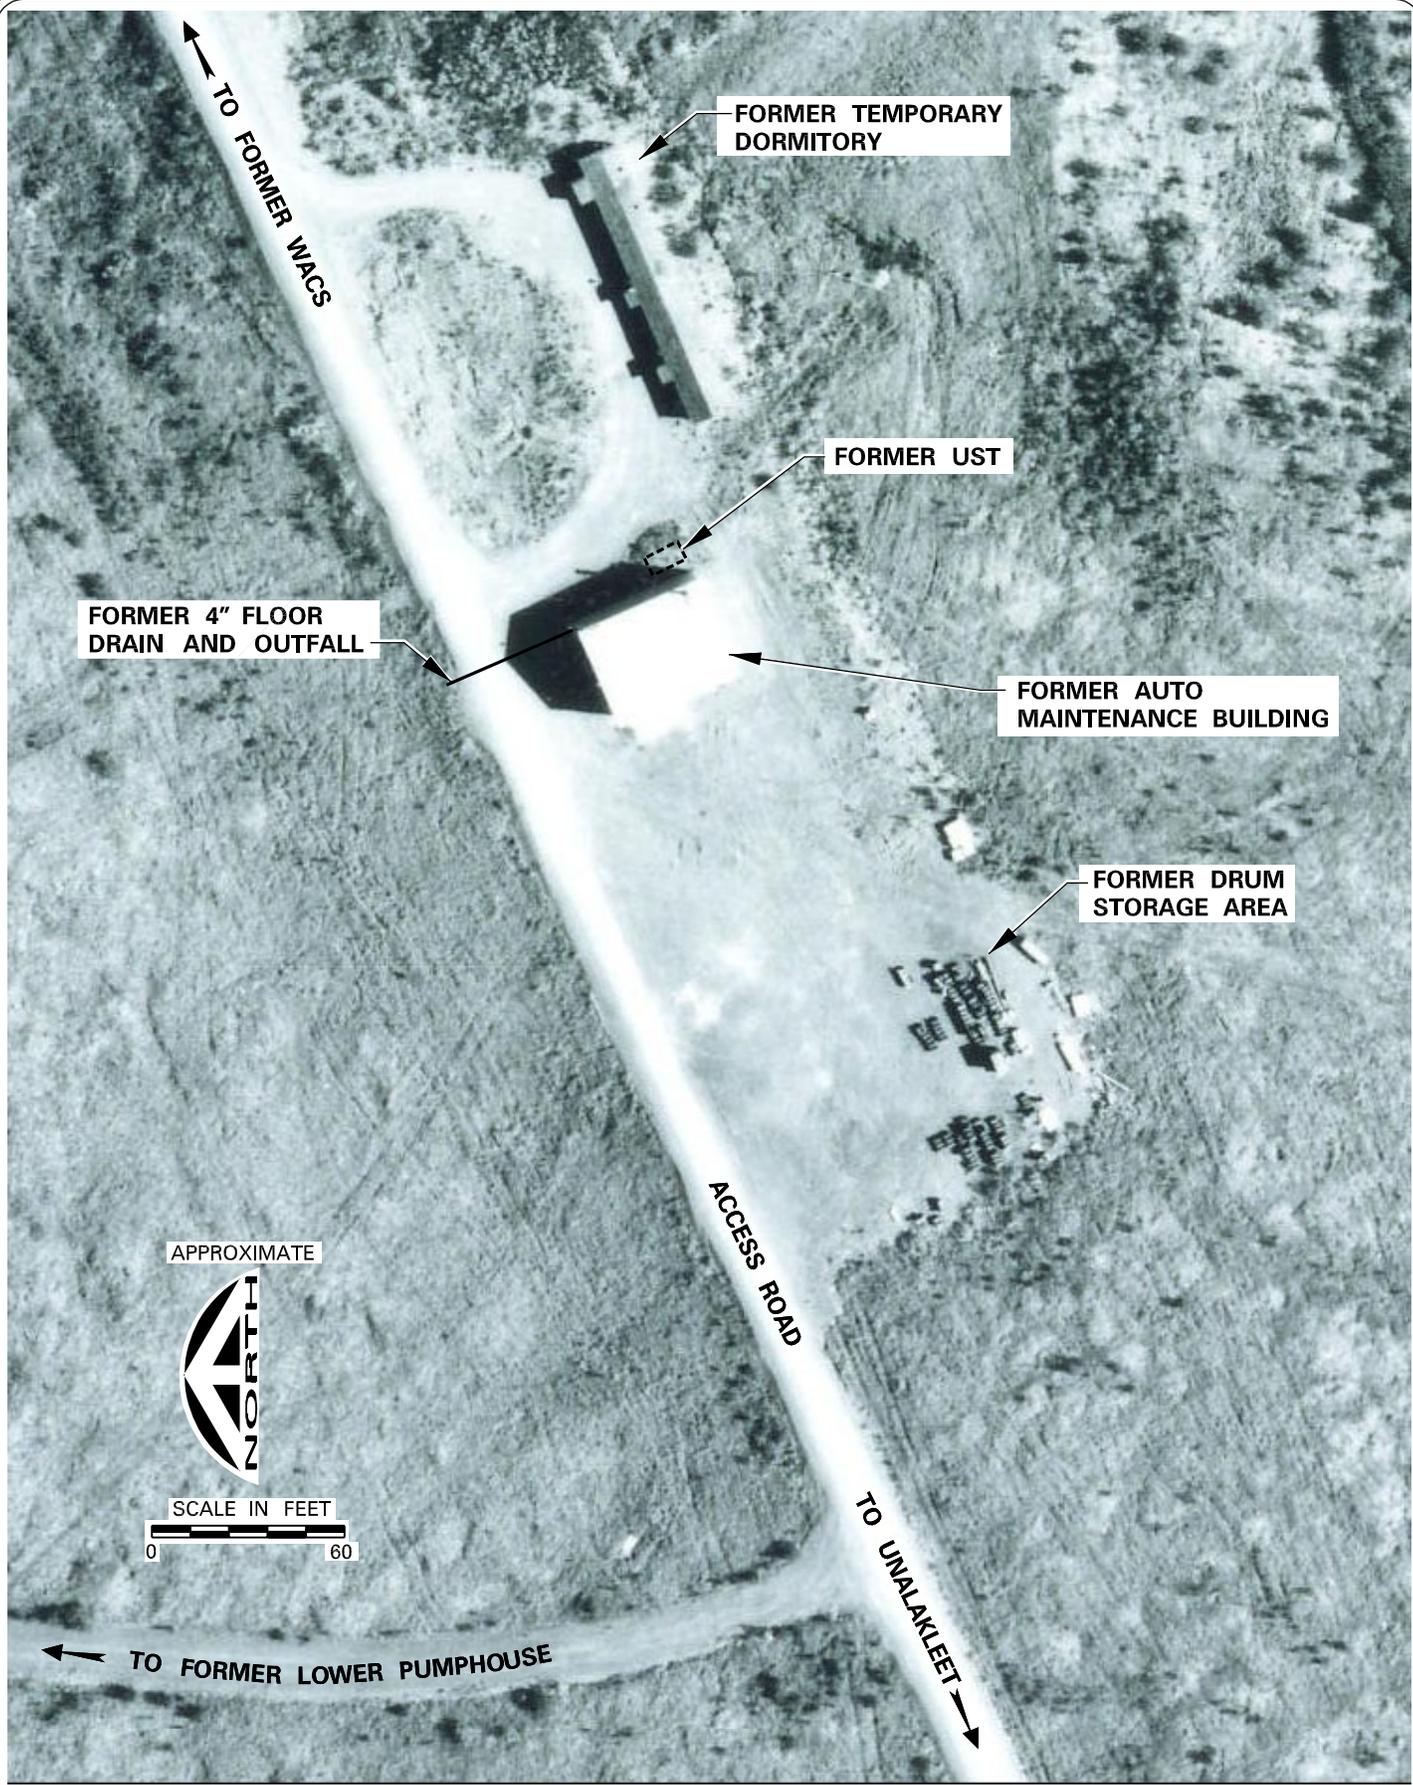
FIGURE 2-2
U. S. AIR FORCE
NORTH RIVER RADIO RELAY STATION – SITE INVESTIGATION REPORT
FORMER MAINTENANCE FACILITY

Former Maintenance Facility. This site is located approximately ¼ mile west of the WACS. This was the location of the Auto Maintenance Building (removed from the site in 1995) and a 500-gallon UST used to supply fuel to heat the building (also removed in 1995). These facilities are shown on Figure 2-2. A mounded area remains at the location of the former Auto Maintenance Building, suggesting a buried concrete pad.

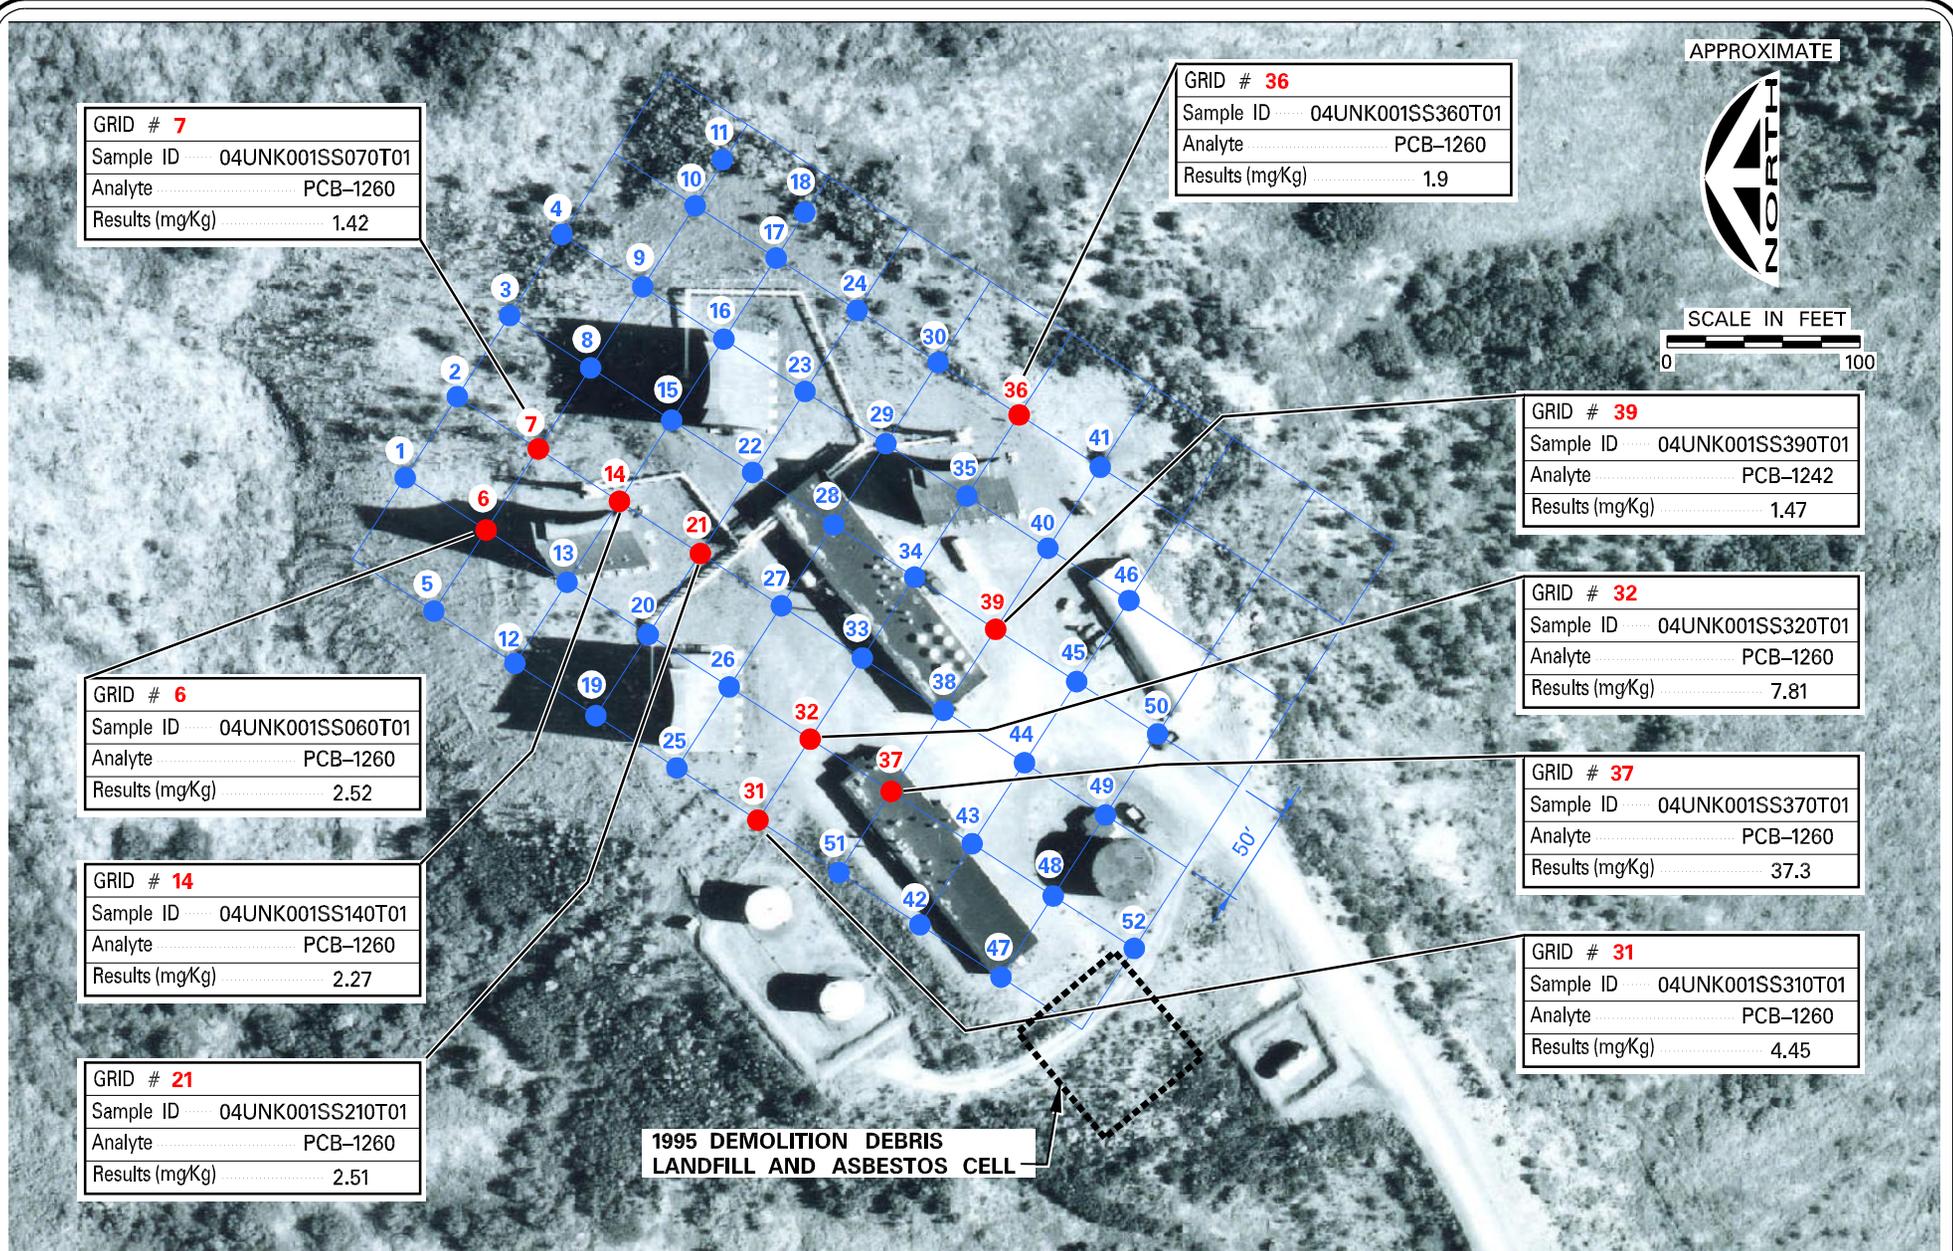
FIGURE 3-1
 U. S. AIR FORCE
 NORTH RIVER RADIO RELAY STATION – SITE INVESTIGATION REPORT
FORMER WACS – PCB SAMPLING GRID LOCATIONS WITH RESULTS ABOVE 1.0 mg/Kg

Surface soil samples collected from the grid at the WACS contained PCBs ranging from 0.027 mg/Kg to 37.3 mg/Kg, with 9 of 52 samples containing PCBs above the ADEC Method Two cleanup level of 1 mg/Kg (Figure 3-1, Table 3-1). PCBs above 1 mg/Kg were concentrated in two areas as shown on Figure 3-1. Other discreet areas were also identified, while the eastern section of the pad did not contain any PCBs above 1 mg/Kg. Areas with PCBs above 1 mg/Kg do not appear associated with former structures at the site and were likely the result of post-demolition soil grading activities.

- Soil with PCB concentrations exceeding the ADEC Method Two soil cleanup level was found in nine of the 52 soil sample locations at the former WACS. The vertical and horizontal extent of PCB contaminated soil at these locations is unknown at this time. The 611th CES/CEVO completed additional surface soil sampling in the vicinity of the former WACS Grid Sample ID #37; these additional sample locations and results are presented in Appendix F.

Based on the findings of the 2004 SI, further investigation is recommended at the former WACS and Maintenance Facility.

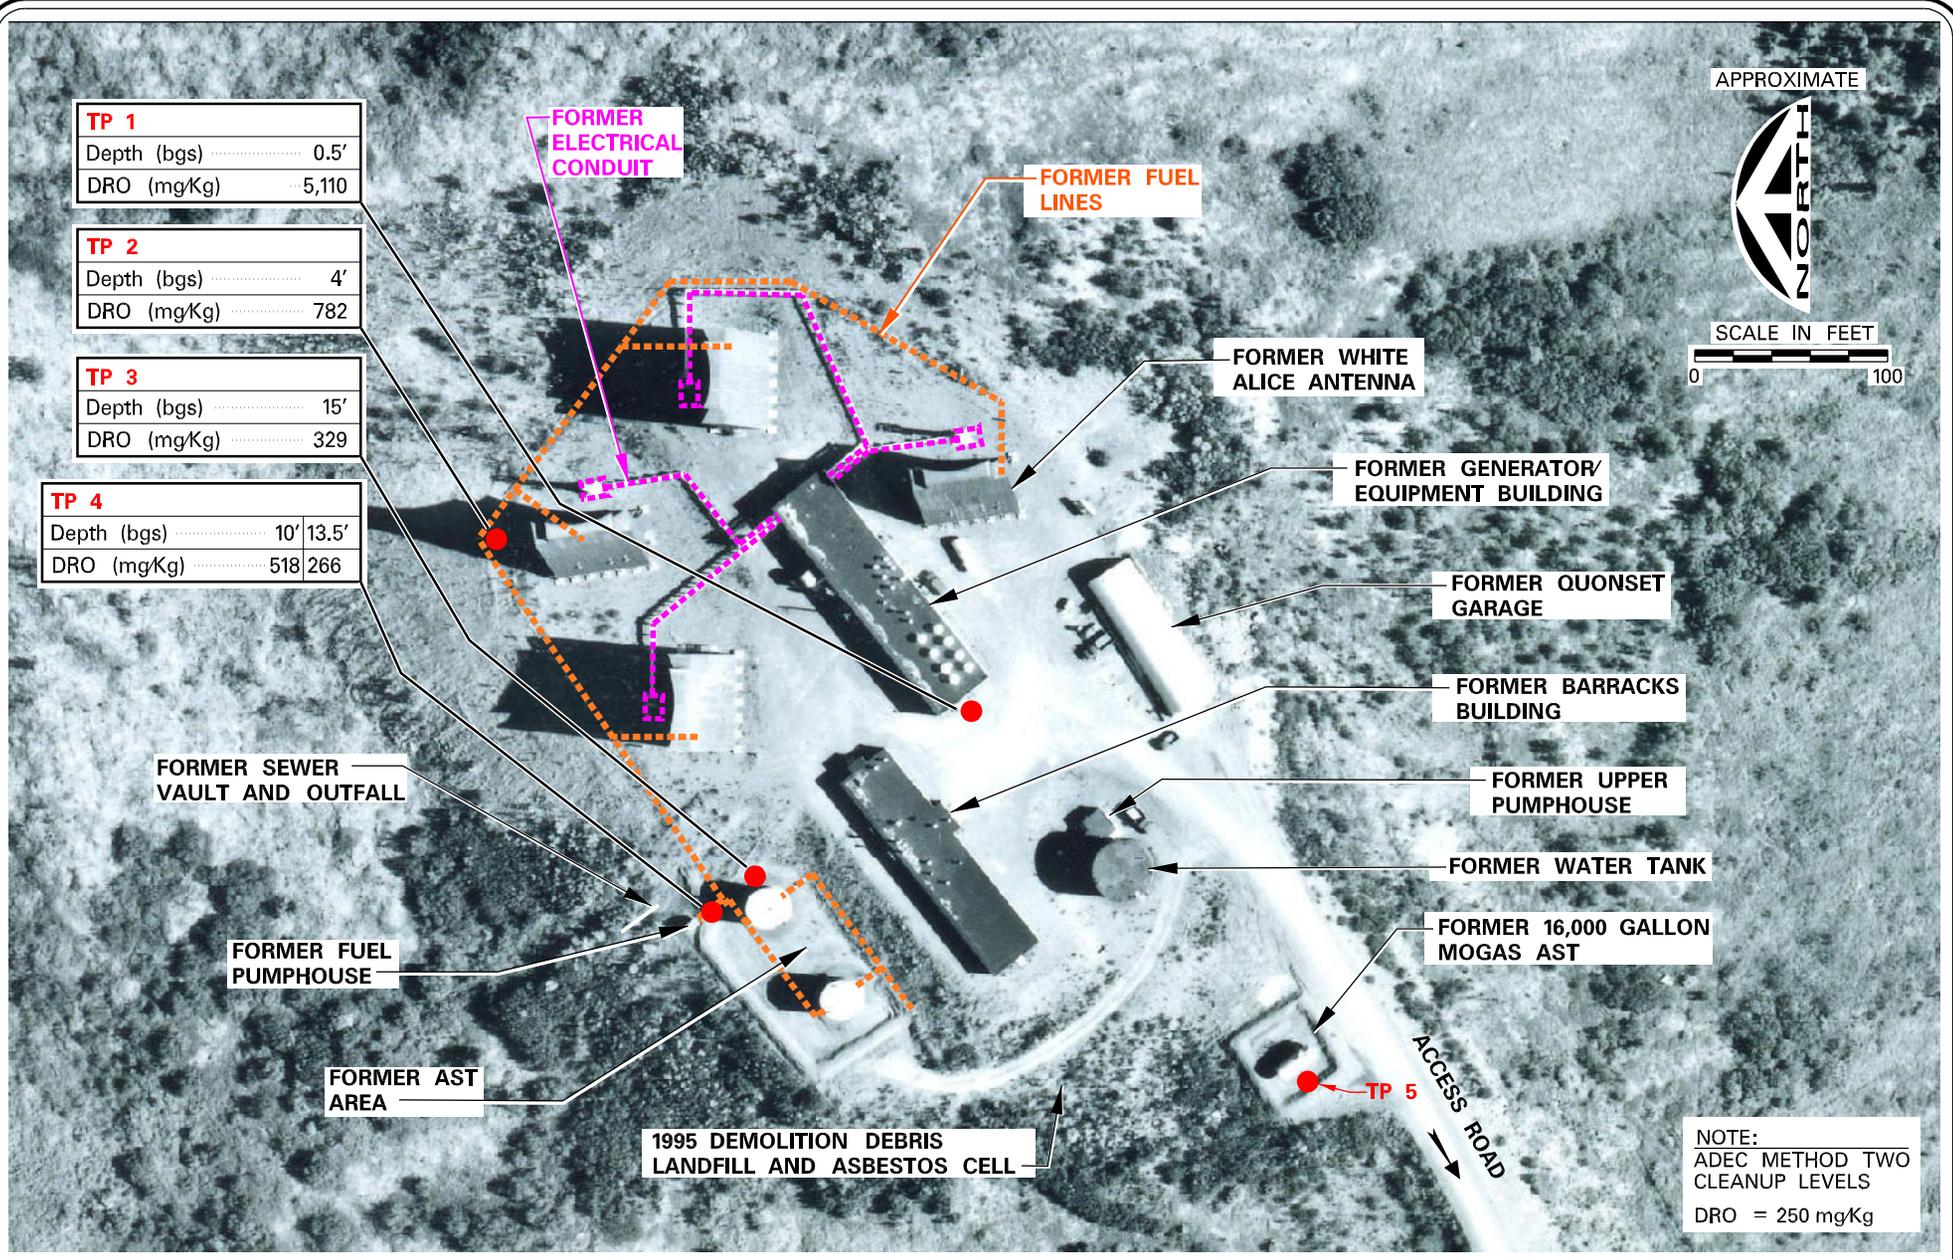
FORMER WACS TEST PIT LOCATIONS

One surface soil sample collected from a test pit at the former WACS contained DRO above the ADEC Method Two cleanup level of 250 mg/Kg (Figure 3-2 and Table 3-2). Surface soil in Test Pit 1 had 5,110 mg/Kg DRO at approximately 0.5 feet bgs. The test pit was excavated near the former Generator/Equipment Building and reached refusal at approximately 2 feet bgs.

Subsurface soil samples contained DRO above the ADEC Method Two cleanup level of 250 mg/Kg in four samples collected from three test pits at the WACS (Figure 3-2, Table 3-2). DRO concentrations above the cleanup level ranged from 266 mg/Kg to 782 mg/Kg at depths ranging from 4 feet bgs in Test Pit 2 to 15 feet bgs in Test Pit 3. Residual POL appears concentrated near the location of the former ASTs (Test Pits 3 and 4) and at the location of Test Pit 2 along the fuel pipeline that delivered fuel to heat the former antennae.

- Soil with DRO concentrations exceeding the ADEC Method Two soil cleanup level was found at the former WACS in four of the five test pits. The soil locations correspond with known locations of the former fuel system tanks and piping, with the exception of Test Pit 1.

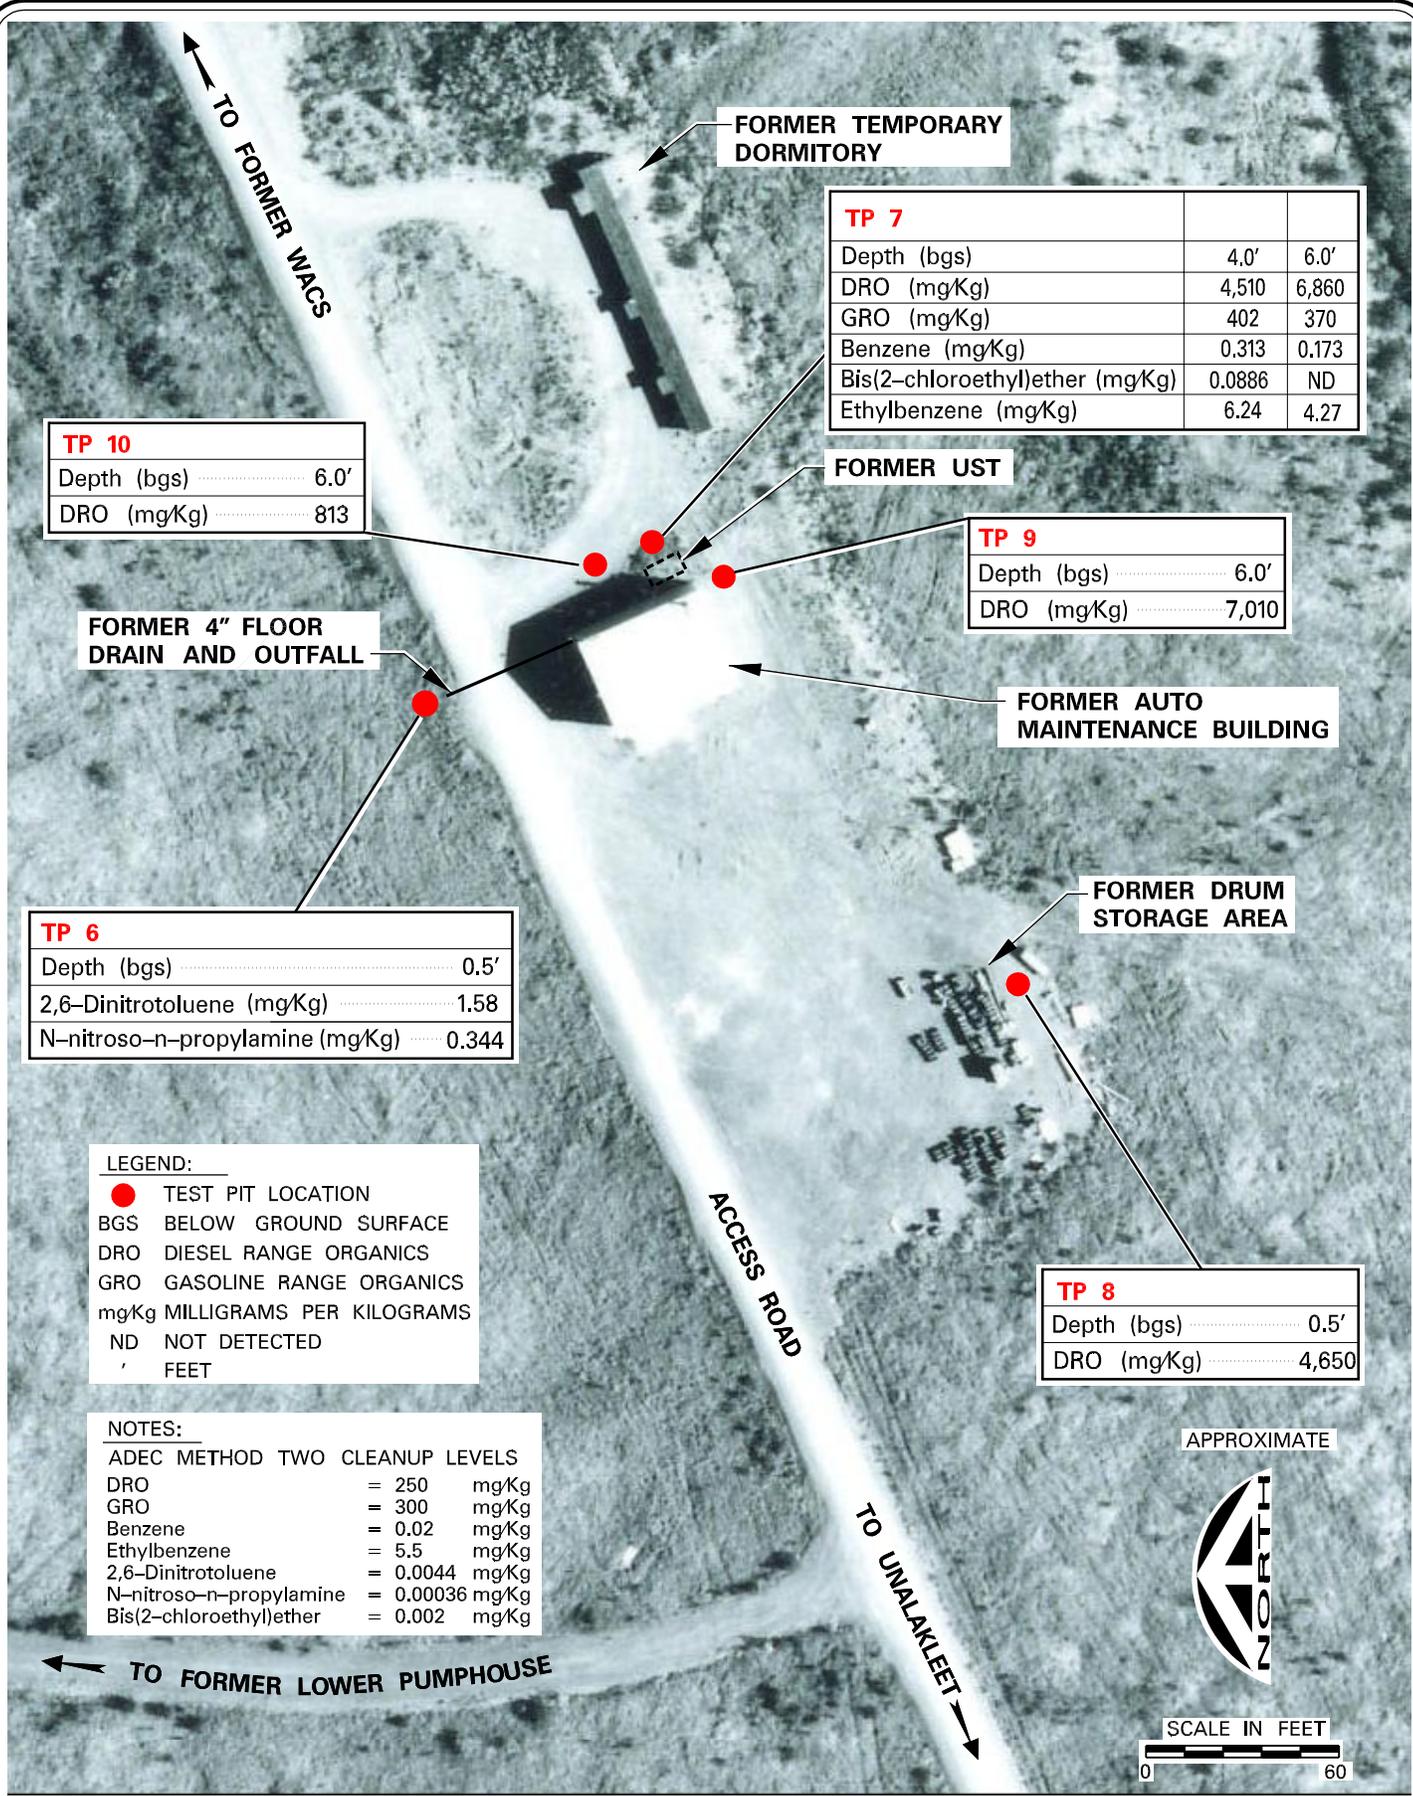
TP 10

Depth (bgs)	6.0'
DRO (mg/Kg)	813

- Soil with DRO concentrations exceeding the ADEC Method Two soil cleanup level was found in Test Pits 7, 8, 9, and 10 at the former Maintenance Facility.
