FINAL
ENVIRONMENTAL BASELINE SURVEY

AIR FORCE PROPERTY AT GALENA AIRPORT, ALASKA

February 2010

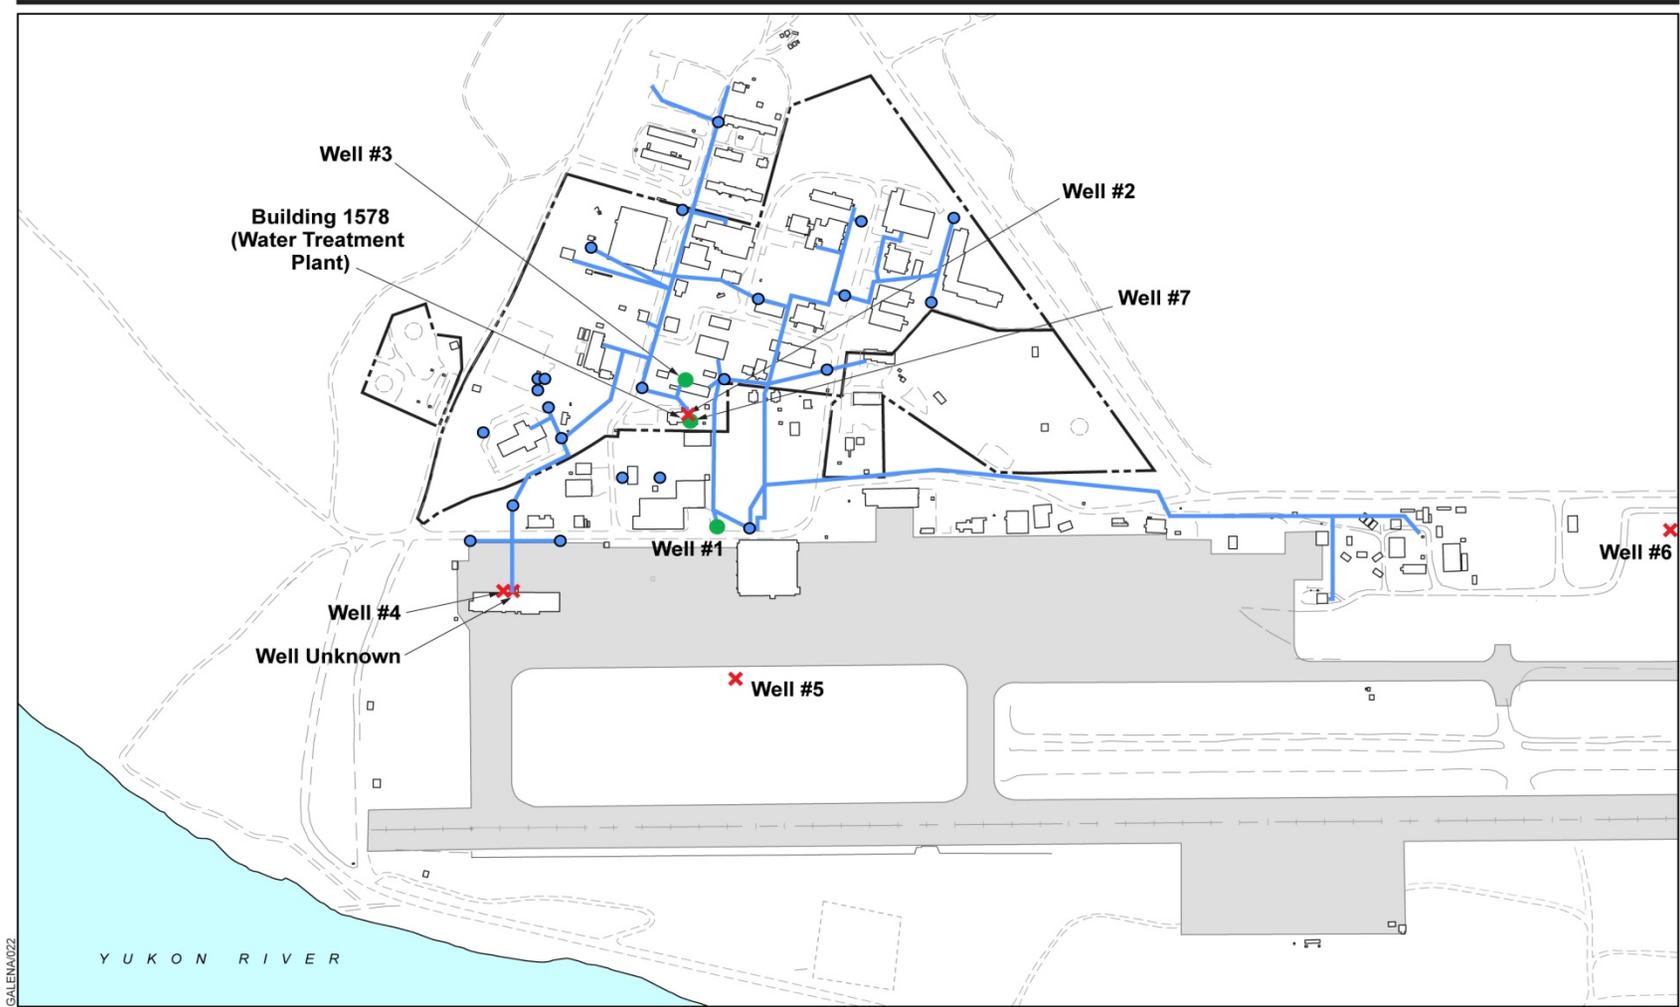
The water distribution system consists of steel, copper, and cast iron lines ranging from 4 to 8 inches. These lines radiate away from the treatment plant and are carried in wooden aboveground utilidor, concrete below-ground utilidor, or direct-buy insulated "Arctic Pipe." This system serves the airport cantonment, including the Alert Hangar (Building 1428), apron area, fire station, 25 fire hydrants, and the BLM headquarters. Civilian air carriers are not served

- Water Line
- Active Well
- ✕ Inactive/Abandoned/Unknown Well
- Hydrant

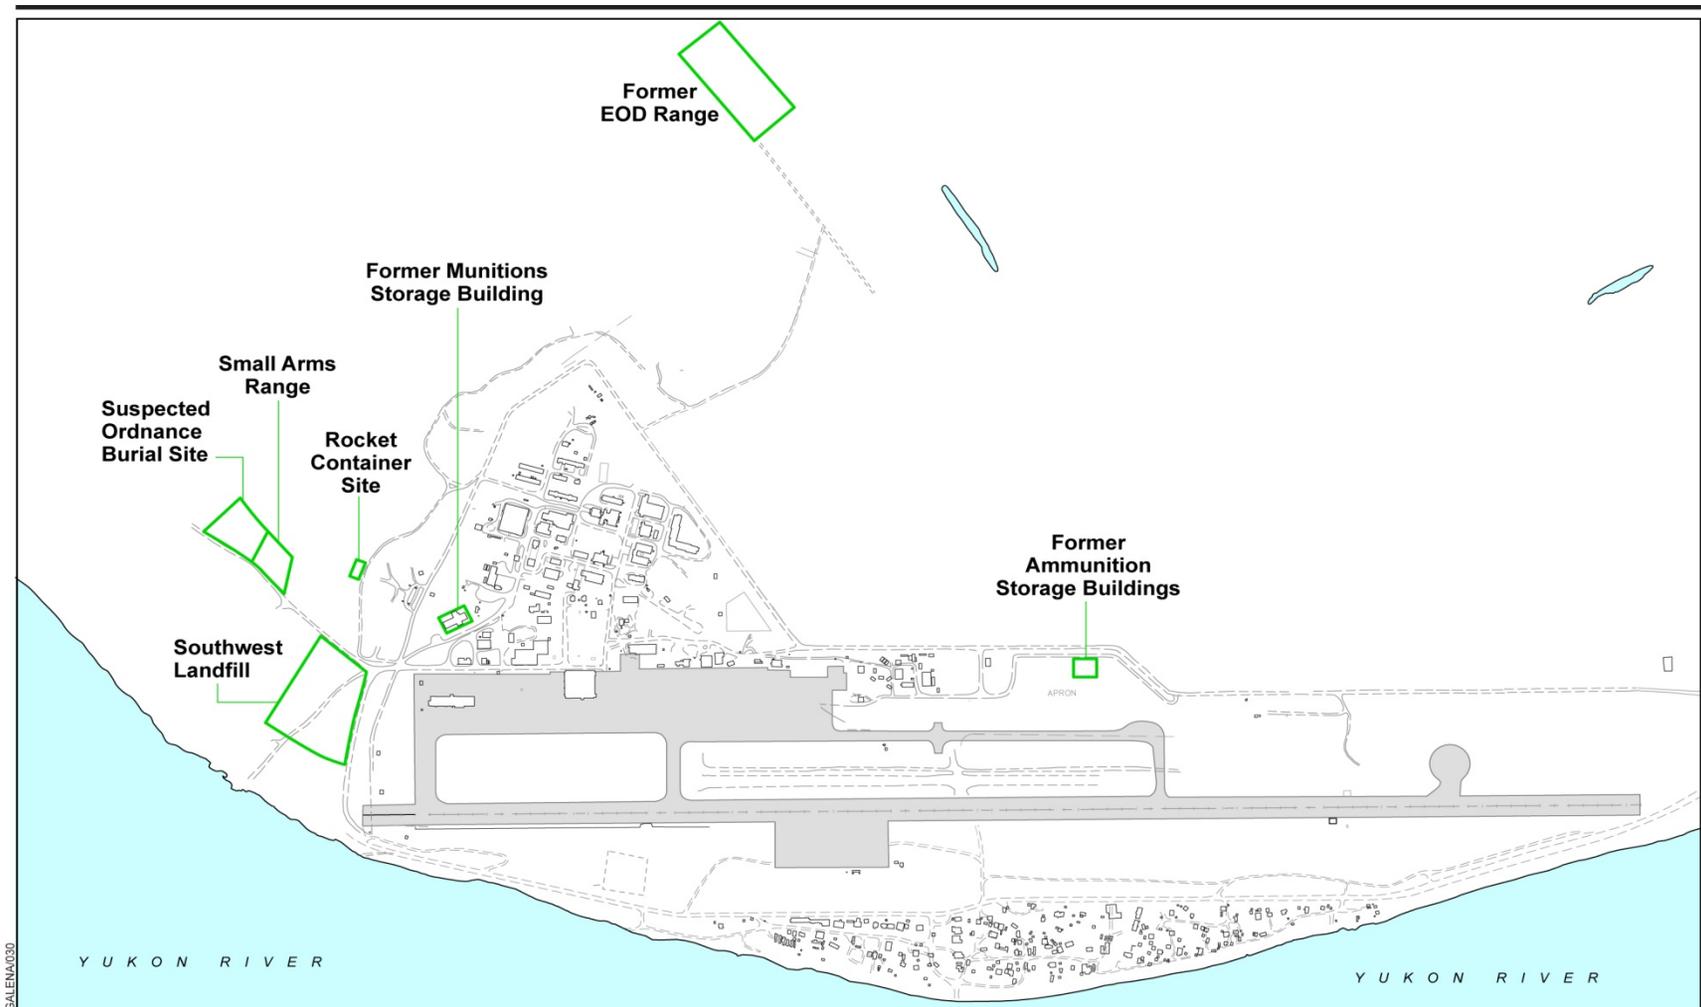
Suspected Ordnance Burial Site. The Suspected Ordnance Burial Site was identified in 1993. An aerial photo from 1963 shows a small disturbed area on the west side of the Small Arms Range within the boundaries of the suspected burial site. This area is also within the boundaries of the Southwest Landfill. The site encompasses approximately 3.5 acres and appears on aerial photos from 1963 as a small disturbed area possibly used as a burial site for non-munitions debris. This site is now covered by thick brush. A visual survey of the site identified numerous partially buried and exposed non-munitions-related metal debris. There was no evidence of MEC observed. In addition, there was no evidence of munitions burial found in historical records. No future response actions were recommended at this site.

Ordnance Investigation Locations

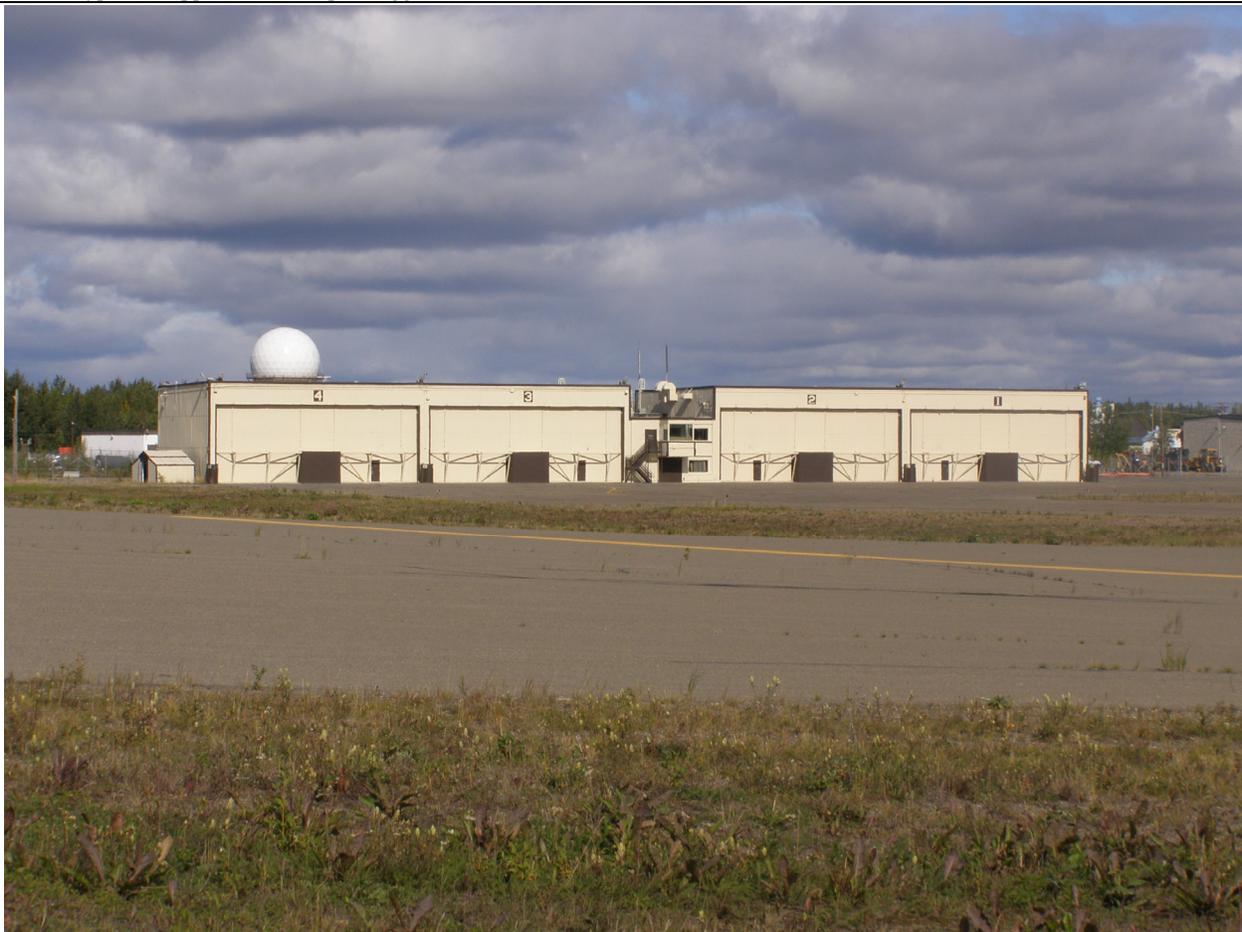
Description of Facility: This former alert hangar is currently vacant. The hangar was used to house alert fighter aircraft of various types in support of intercept of aggressor nation aircraft.

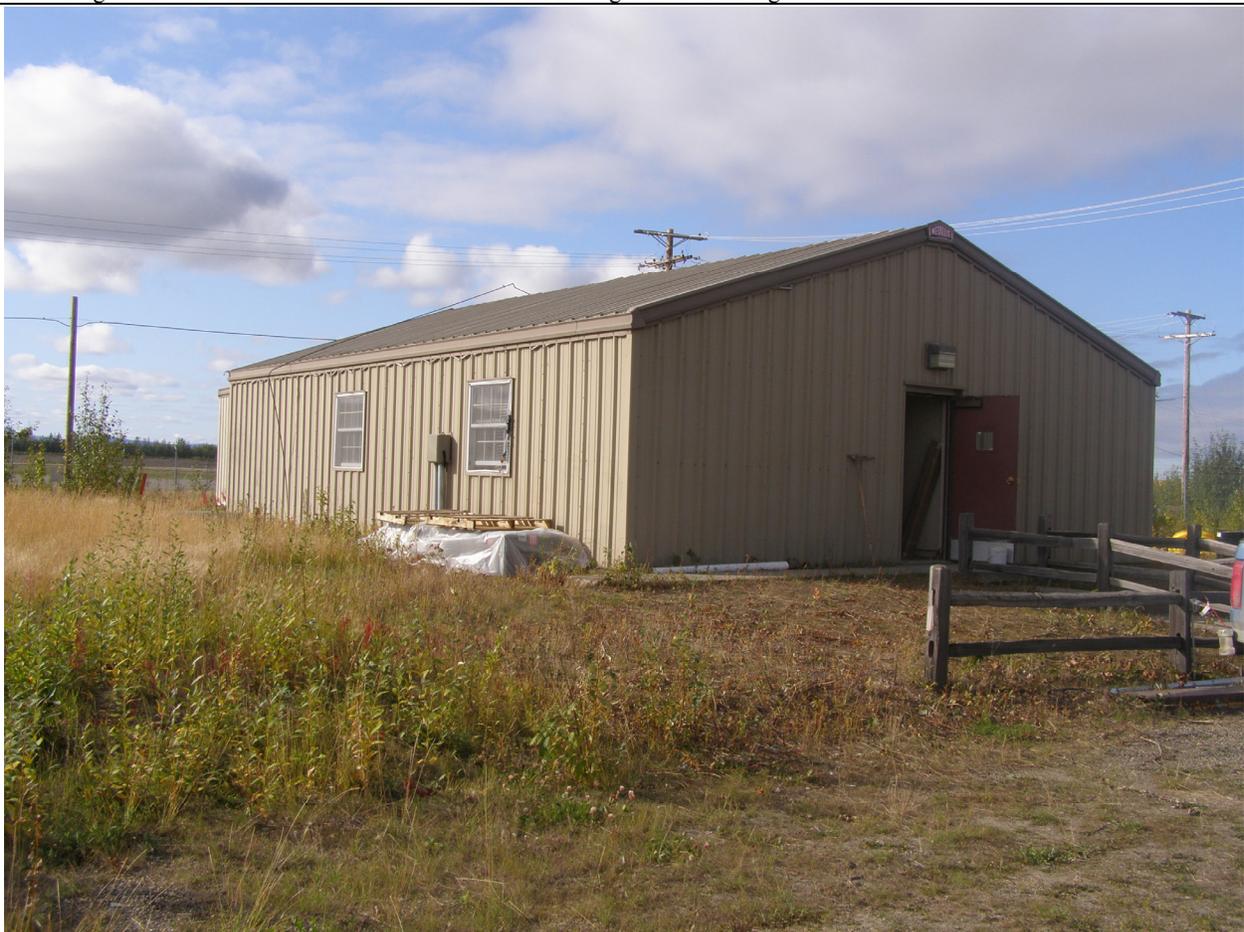
Description of Facility: This former RAPCON building has been used for storage and administrative space supporting continuing remedial efforts at former Galena AFS. The building is vacant during the winter months.
