# Division of Spill Prevention and Response Contaminated Sites Program

## ADOT&PF PEGER ROAD MAINTENANCE STATION

Summary updated: March. 14, 2014

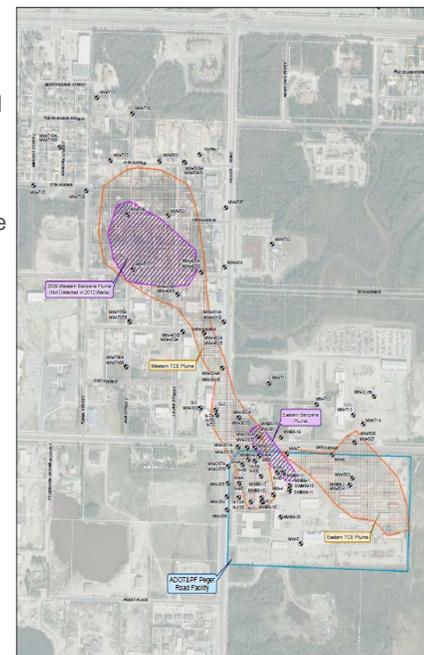
The map (above) shows the rough boundaries of the two TCE plumes and two benzene plumes. Three of the four plumes were drawn based on the results of 2012 well sampling. The fourth plume, the Western Benzene Plume, is based on the 2009 sampling results; in the 2012 sampling, the levels were below DEC’s cleanup level of 5 parts per billion.

The areas inside all four plumes have samples from wells that came in above DEC’s cleanup level; the areas outside the

plume boundaries had levels that were less than 5 parts per billion. (Map from Shannon & Wilson, Inc.)

Here is a rundown of the plumes, which is based on 2012 sampling data with one exception:

1. The Western TCE Plume – This is the major plume at the site. It overlaps with the Western Benzene Plume and extends off the Department of Transportation property to the northwest into commercial and residential neighborhoods.
2. The Eastern TCE Plume – This plume appears to extend off the Department of Transportation property in both a northerly and easterly direction.
3. The Western Benzene Plume – This plume, as shown on the map of the plumes (right), is the only plume of the four based on 2009 sampling results. When the same wells were sampled in 2012, benzene was still in the wells, but the amount of benzene was below DEC's 5 parts per billion groundwater cleanup level.
4. The Eastern Benzene Plume – This plume also appears to be diminishing in size, similar to the Western Benzene Plume.

1. The extent the Western TCE Plume, again, the major plume, has been identified, and it overlaps – or commingles – with the Western Benzene Plume. The Western TCE Plume extends from the Department of Transportation complex northerly to 17th Avenue and westerly toward Kiana Street. It appears to be stable and decreasing in concentration.

2. The Western Benzene Plume is north of 20th Avenue.
3. The Eastern Benzene Plume, which also commingles with the Western TCE Plume, spans across Davis Road.

4. Additional sources of TCE were discovered during the 2010-2012 period at the eastern property boundary of the Department of Transportation complex, and that contamination is labeled as the Eastern TCE Plume. Groundwater contamination was also identified near the cat house, and may extend offsite in a northerly direction. Additional information on all the plumes will be collected during future investigations to refine the extent of those plumes.

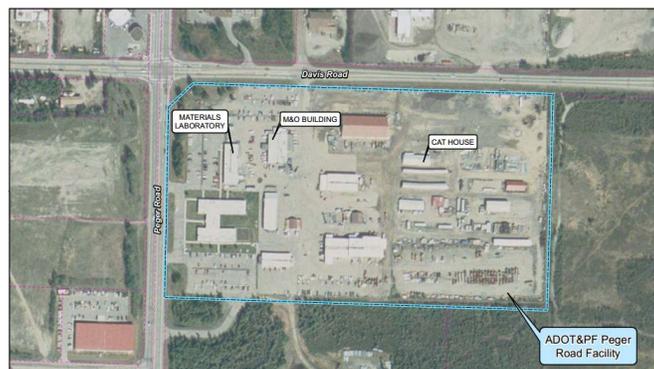
The above overhead view shows the Alaska Department of Transportation and Public Facilities complex, which is at the southeast corner of Peger and Davis roads in Fairbanks. (Map from Shannon & Wilson, Inc.)

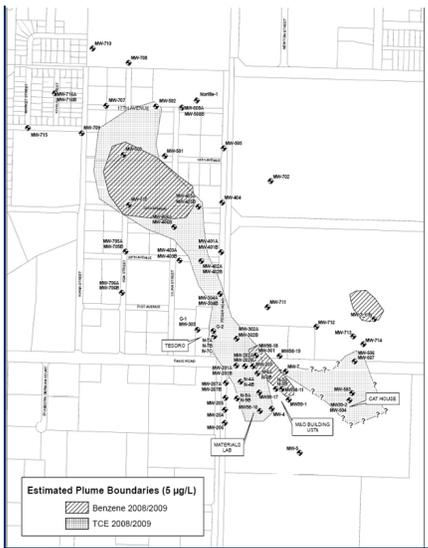
The estimated boundaries of the plumes are shown (above) as they were in June 2009. (Map from Shannon & Wilson)
