**Annual Report to Alaska Department of Environmental Conservation**

# **Commitment to Corrosion Monitoring Year 2007**

Corrosion, Inspection and Chemicals (CIC) Group  
BP Exploration (Alaska), Inc.

March 2008

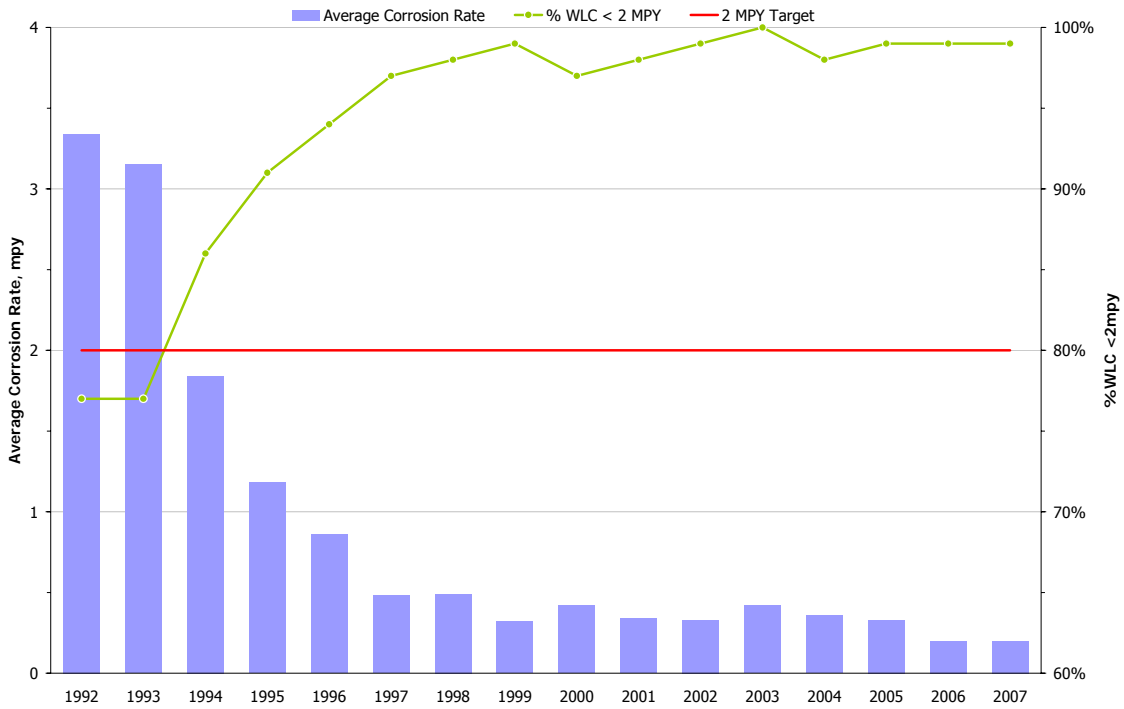
GPB Figure A.2 Flow Line Oil Service Corrosion Rate Trend

GPB Figure A.2 shows the average corrosion rate and percentage of coupons meeting the performance standard target since 1992. The results show that the percentage of conformant flow lines has improved consistently over the last decade.

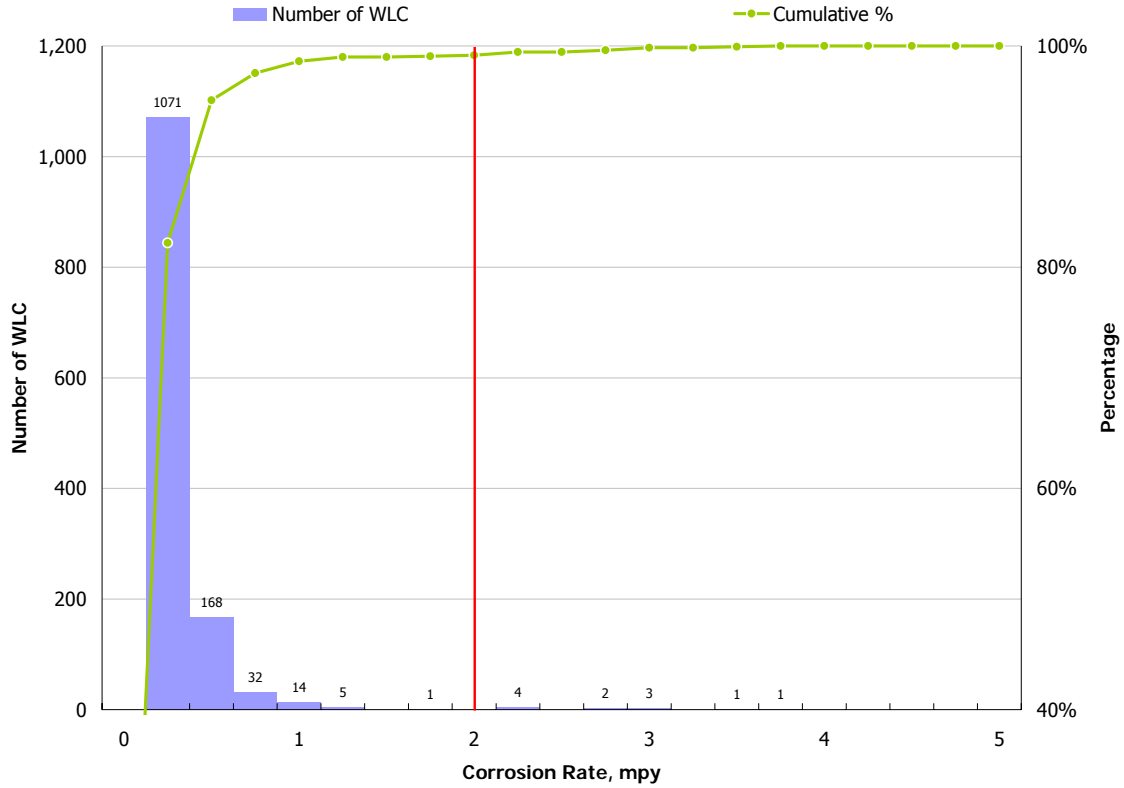
GPB Figure A.4 Flow Line Oil Service WLC Histogram

GPB Figure A.4 shows the distribution of corrosion rates for WLC in flow line oil service. In 2007, eleven WLCs exhibited general corrosion rates above the 2 mpy target; however the highest rate observed was only 3.75 mpy. None of the coupons in flow line oil service exceeded the pitting rate target of 20 mpy. Refer to Section D.1.5 for details and corrective actions for WLC exceptions.

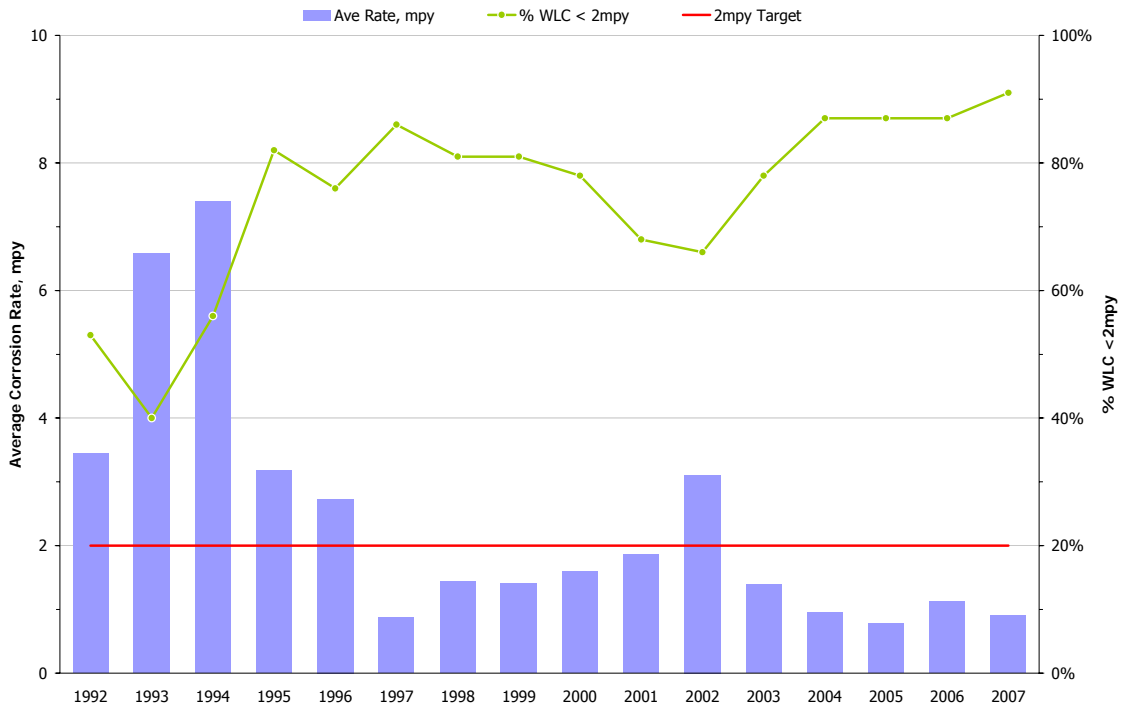
GPB Figure A.6 Flow Line PW/SW Service Corrosion Rate Trend

GPB Figure A.6 is a summary of aggregate data for produced water and seawater flow lines. The 2007 WLC corrosion rate data show an improvement in performance over last year and comparable performance as in the last four years.

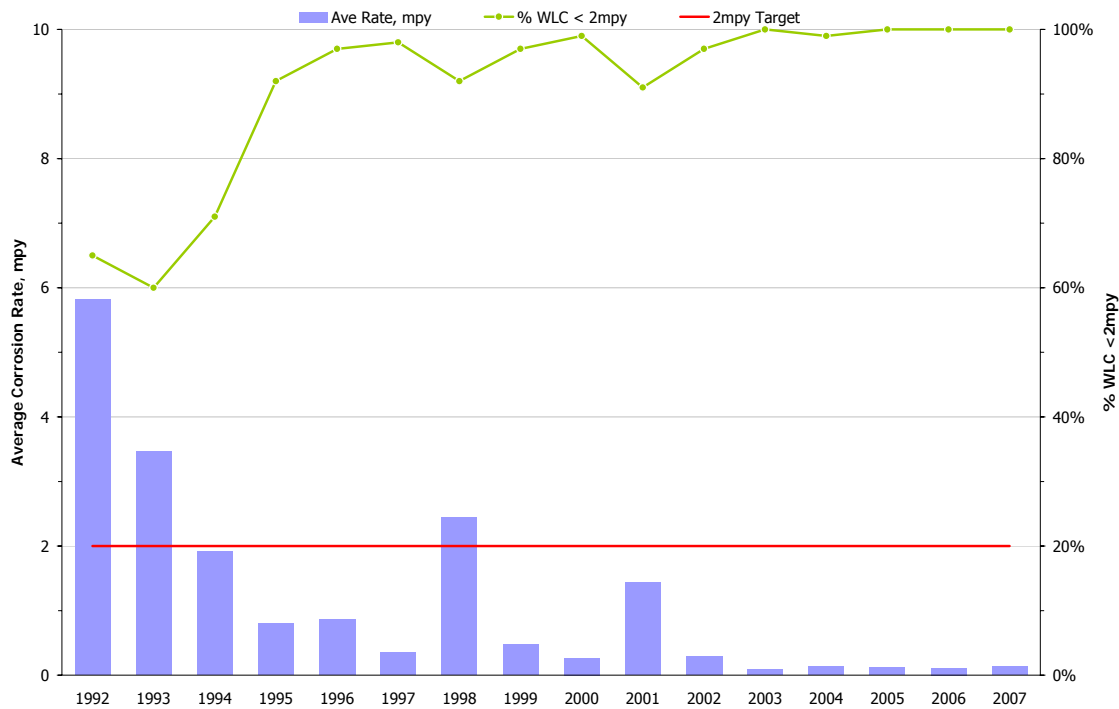
GPB Figure A.8 Corrosion Rates for Majority PW System

The overall improvement in the PW monitoring data since 2001 to date can be attributed to three primary factors. First, a change in the continuous corrosion inhibitor in the 3-phase system in 2002 provided more favorable partitioning characteristics to the water phase than the prior product. This had the effect of increasing the levels of corrosion inhibitor carried from the upstream system into the produced water distribution network. The second contributor is the increase in field-wide average concentration of corrosion inhibitor over time. The third contribution is the continuation of corrosion mitigation programs specific to the PW system that started in 2002. The programs include continuous inhibitor injection in the PW system at all production facilities except LPC.

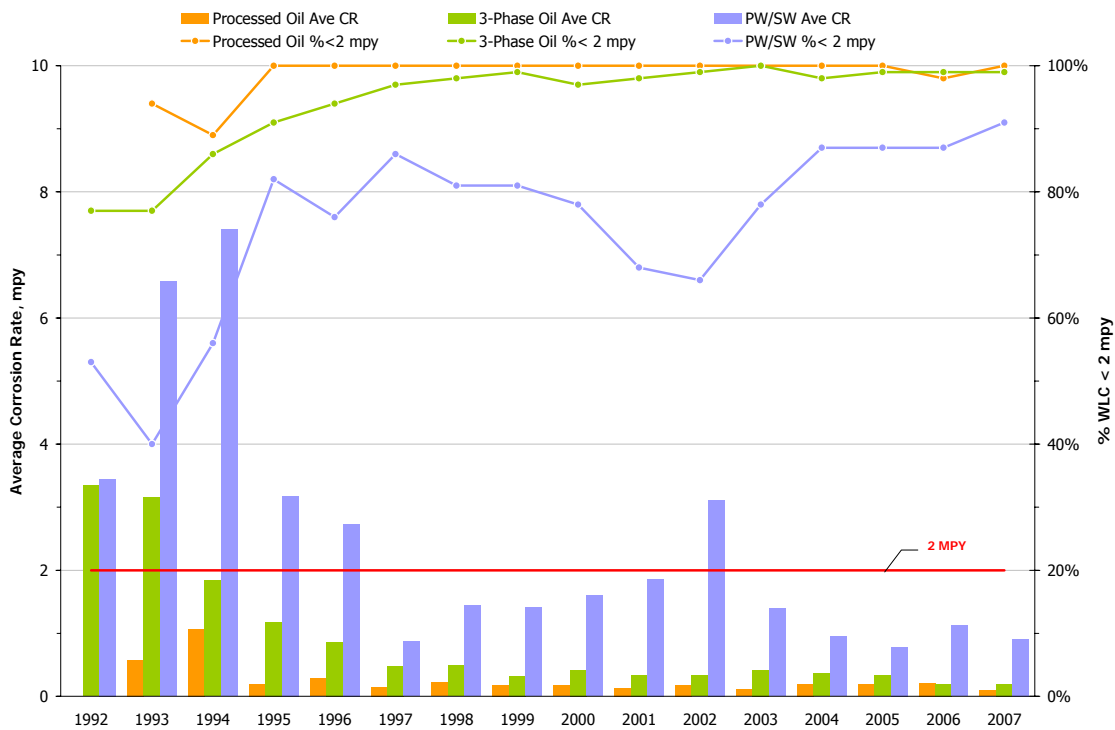
GPB Figure A.11 Flow Line Corrosion Coupon Summary by Equipment and Service

This section provides a comparative summary of WLC data collected since 1992 for the major systems at GPB. GPB Figure A.11 shows the WLC corrosion rate and corrosion target conformance since 1992. The average corrosion rate in the 3-phase production system has remained low since 2002 and illustrates a high level of corrosion control. The reasons for improvement in the water injection system performance were provided in Section A.1.2.

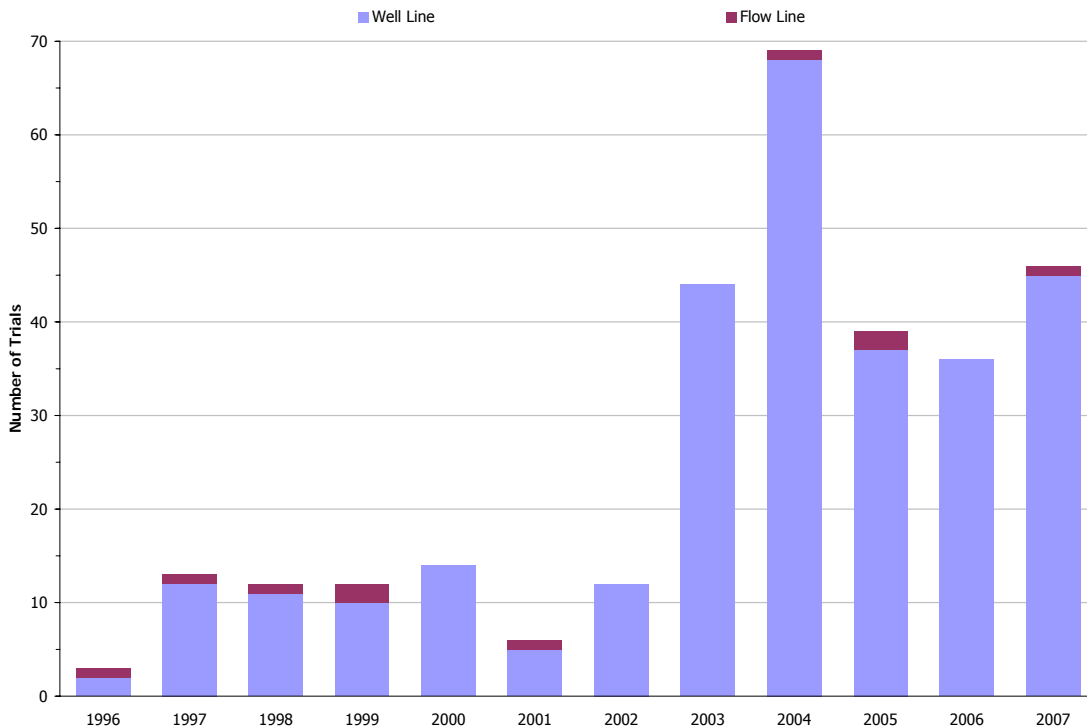
GPB Figure A.20 Number of Well Line and Flow line Tests

GPB Figure A.20 summarizes the number of well line and flow line tests which have been completed since 1996. The level of well line test activity increased beginning in 2003 due to a change in the screening protocol, which reduced the time required per test. The combined number of well line and flow line tests has increased from ~10-14 per year<sup>8</sup> to more than 45 during 2007. This level of activity represents a substantial investment of resources towards the development of new and more effective corrosion inhibitors.

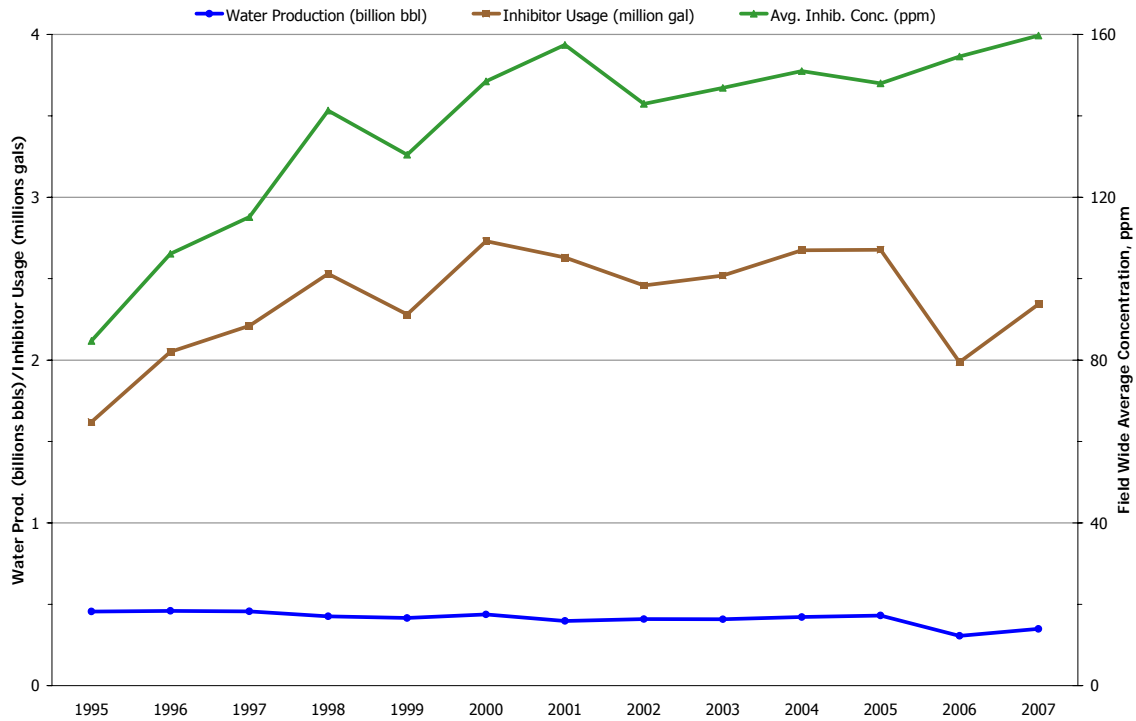
GPB Figure A.21 Field Wide Chemical Usage

The metrics in GPB Figure A.21 deal with chemical usage at the field level but much of the chemical optimization activity focuses on injecting the correct amount of corrosion inhibitor to each piece of equipment. The inhibitor requirement is driven by factors such as water cut, water volume, flow regime, and condition of the equipment and varies over a wide range, from a few parts per million (ppm) to several hundred ppm. For 2007 the target chemical usage was 2.31 million gallons as compared to actual usage of 2.34 million gallons; or just over 100% of the target volume.

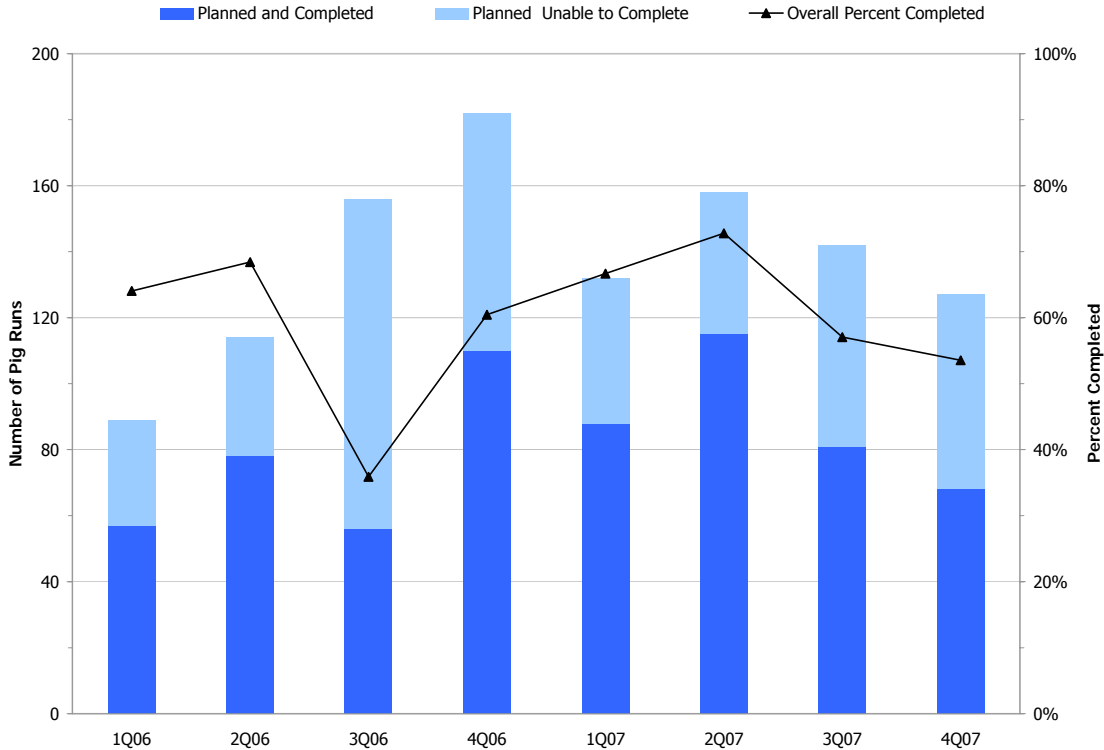
**GPB Figure A.24 Maintenance Pig Runs Scheduled and Completed, All Service Types**

and the percent of scheduled runs completed, by year. GPB Figure A.24 shows the overall performance of the program for all scheduled pig runs in 2006 and 2007, for all service types. The average percent of scheduled pig runs completed was 56% in 2006 and 63% in 2007.

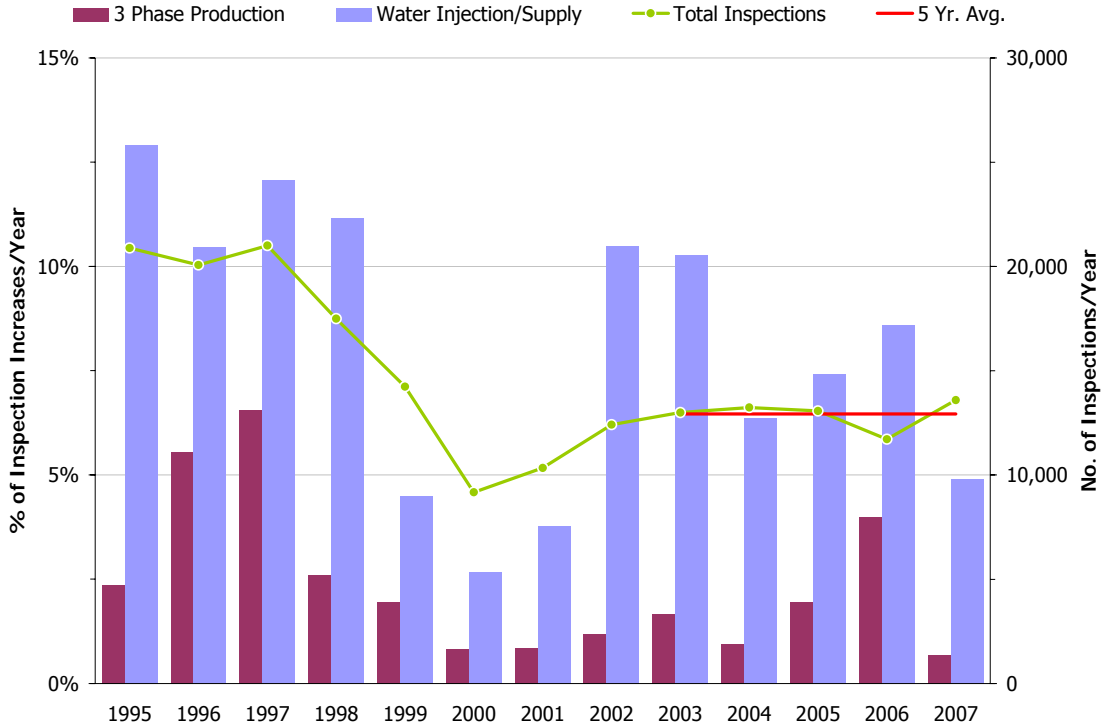
GPB Figure B.2 Flow Line Internal Inspection Increase by Service

GPB Figure B.2 shows the percentage of inspection increases and the number of inspections per year for the flow lines segregated by 3-phase production and water injection (seawater and produced water) service. The number of flow line inspections increased by 14% over the number of inspections last year; higher than the five year average.

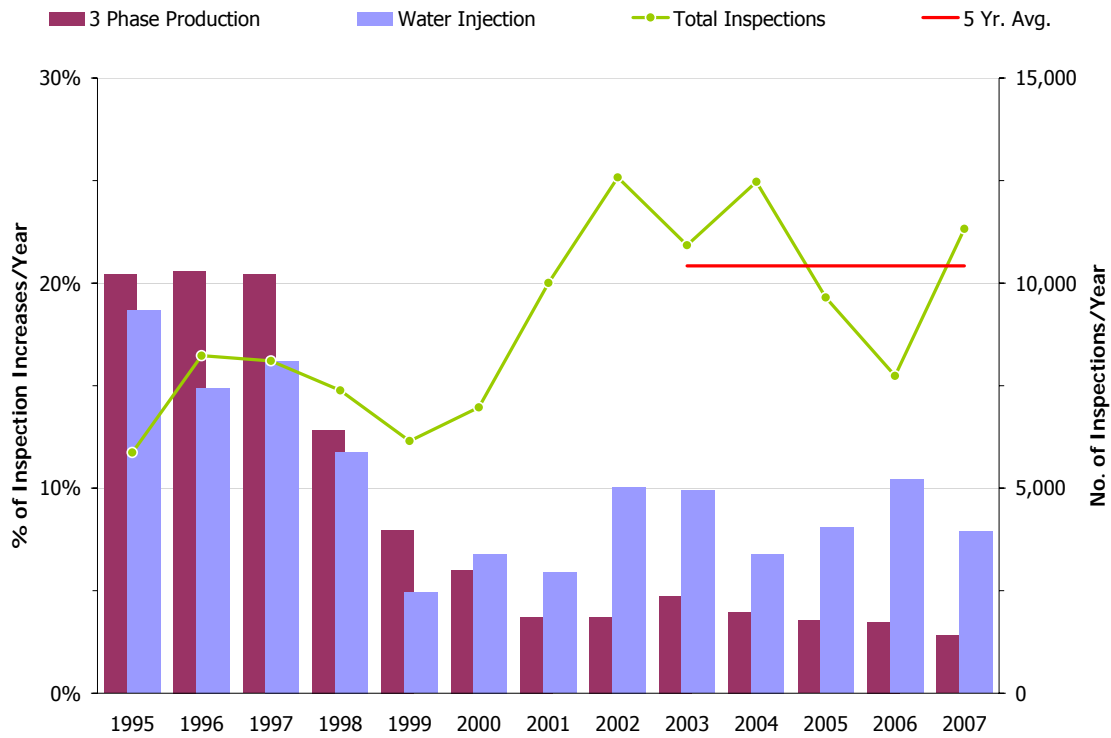
GPB Figure B.3 Well Line Internal Inspection Increase by Service

For the water system, the trends for well lines are similar to flow lines; declining for the first time in four years. As with the flow lines, improvements in the chemical mitigation program are expected to continue, adding to the level of corrosion control.

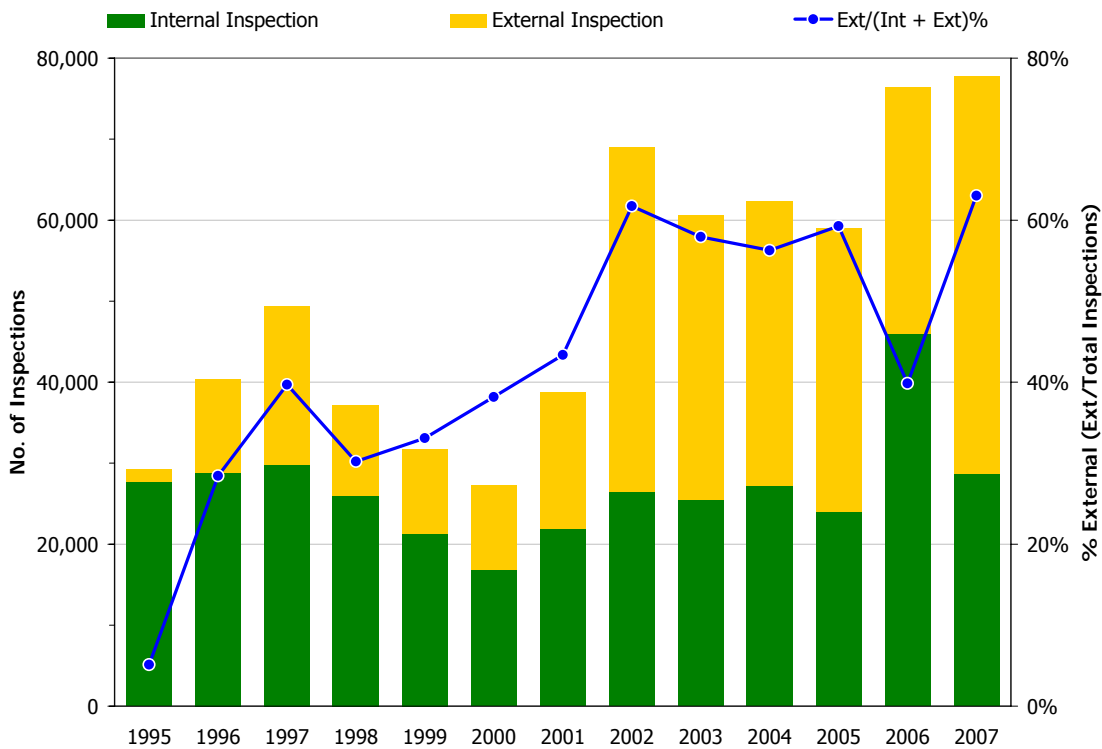
GPB Figure B.5 Internal and External Inspection Activity for Transit, Flow and Well Lines

GPB Figure B.5 and GPB Table B.5 summarize the level of internal and external inspection activity across GPB since 1995. Due to the events involving processed oil transit lines, the level of internal corrosion inspection during 2006 increased significantly when compared to other years. The number of inspections in 2007 returned to a more typical level, balanced with activity in other areas of the system.

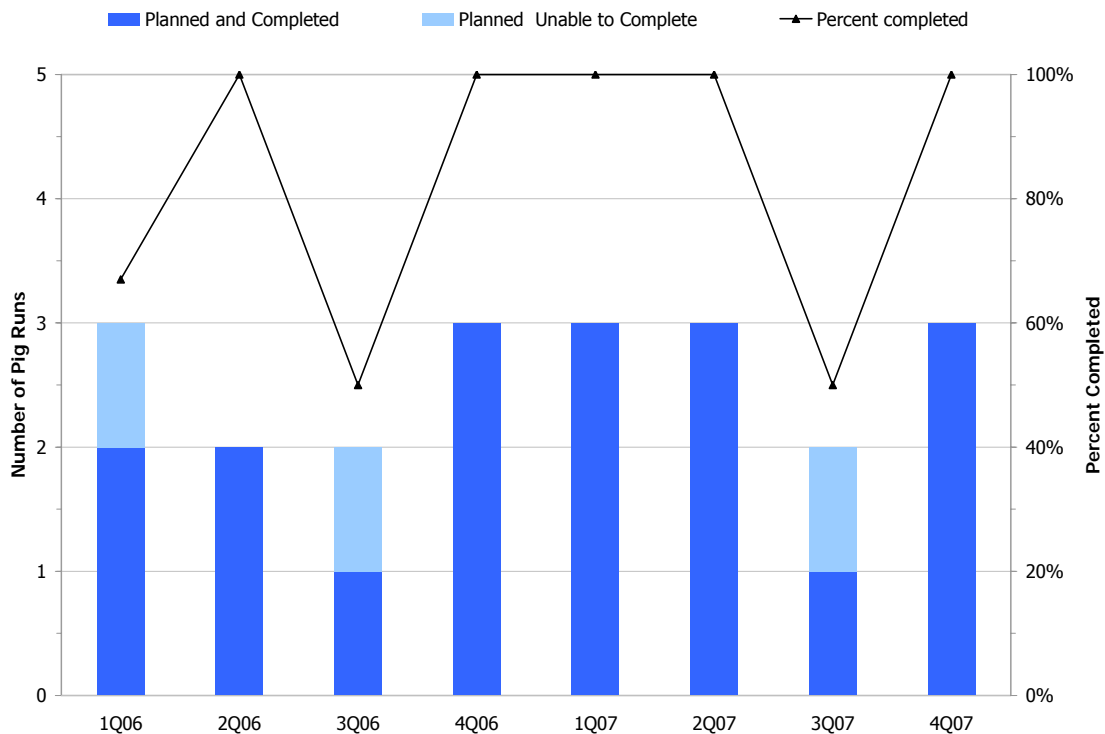
ACT Figure A.2 Endicott IIWL Maintenance Pigging Performance

Maintenance pigging of the Endicott IIWL is scheduled on a five-week interval. ACT Figure A.2 shows performance for the IIWL pigging by quarter for the years 2006-2007. The missed cycle in the third quarter of 2007 is due to the plant just coming back on line after a planned shutdown. Prior to the shutdown, the line was cleaned multiple times for evacuation and replacement of the below grade section at the "Y" intersection.

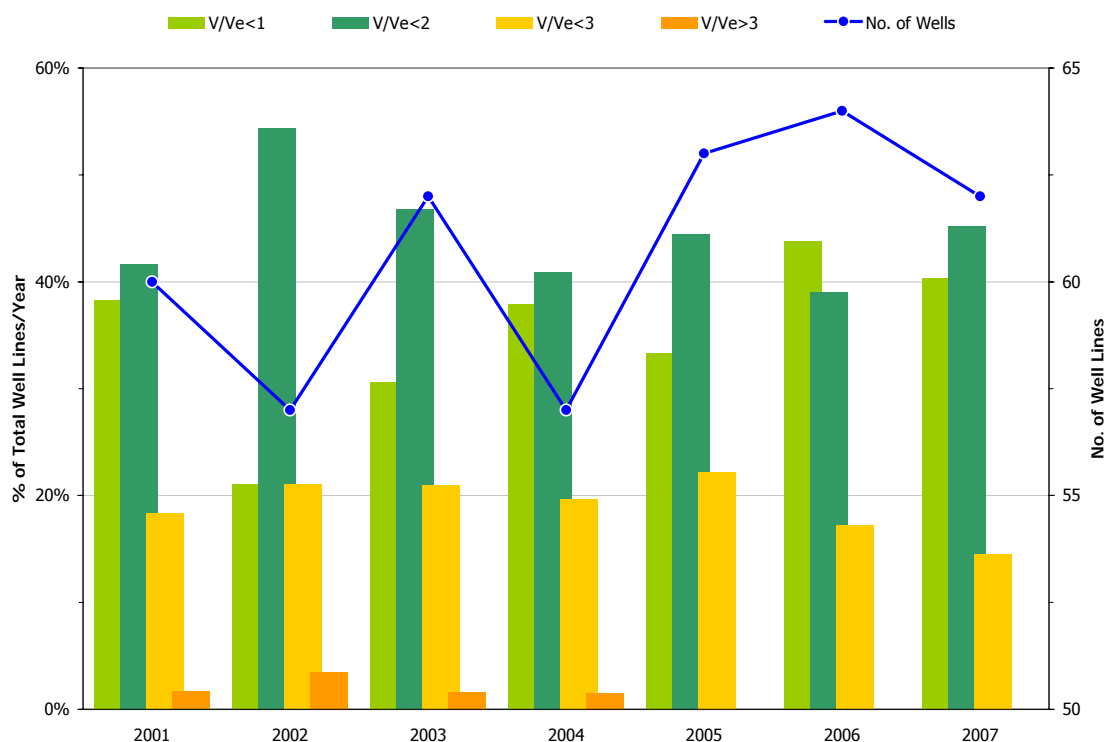
ACT Table A.2 Endicott Velocity Monitoring

are risk ranked by mixture velocity once per month and the information is used to adjust the inspection frequency and fluid velocity. ACT Table A.2 is an overview of the average velocity data since 2001. Shown are the percent of wells within  $V/V_e$  ratio ranges, where  $V$  is the actual mixture velocity,  $V_e$  is the velocity at which erosion becomes a concern and  $V/V_e$  is the allowable erosion velocity ratio as defined by API-RP-14E<sup>10</sup>.

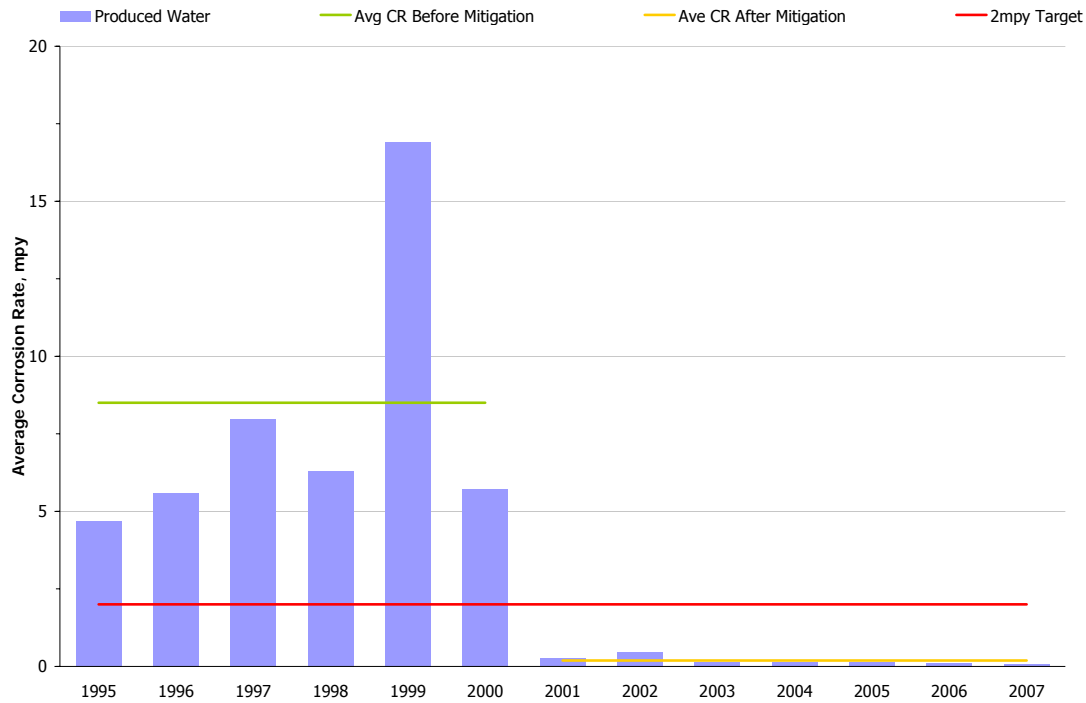
ACT Figure A.4 Milne Point Produced Water Corrosion Rate Trend

Corrosion inhibition of the water injection system began in mid-2000. In addition, a more rigorous maintenance pigging program was implemented. Weight loss coupon data indicate the system is under control as the WLC corrosion rates have averaged less than 2 mpy since mid-2000. This represents a significant reduction from previous years as can be seen in ACT Figure A.4. For the period 1996-2000, the average corrosion rate was approximately 7 mpy. Since the enhancement of the corrosion management program in 2000, the average WLC corrosion rate for the PW system has been reduced to less than 1 mpy. Although the corrosion rate monitoring data indicates good performance, the inspection data are indicating better control is needed in the PW service lines. As a result of a trial of a new corrosion inhibitor, the inhibitor concentration was increased from 40 ppm to 55 ppm as well as eliminating the biocide regime. This trial is still under investigation awaiting follow up inspection to confirm the effectiveness.

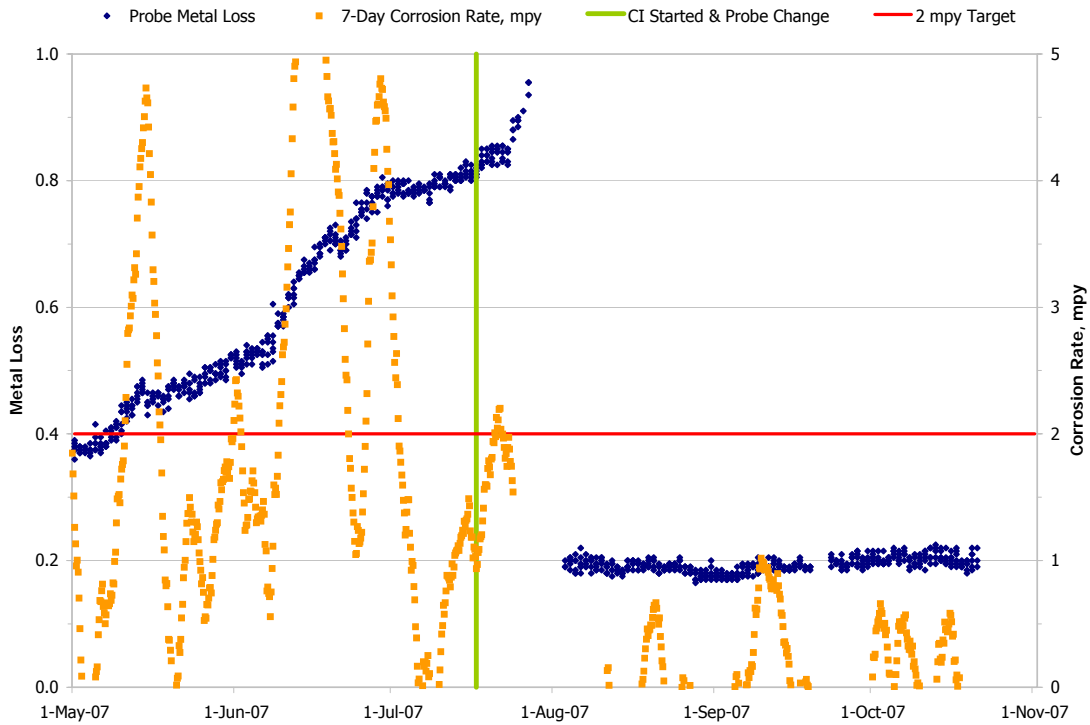
ACT Figure A.5 ER Probe Response, MPU Flow Line, CI Injection

The Tract 14 production flow lines at I-Pad and J-Pad were fitted with continuous corrosion inhibition facilities. Continuous inhibition in these lines began in July, 2007. Initial results from corrosion monitoring indicate a significant reduction in corrosion rate as shown in ACT Figure A.5.

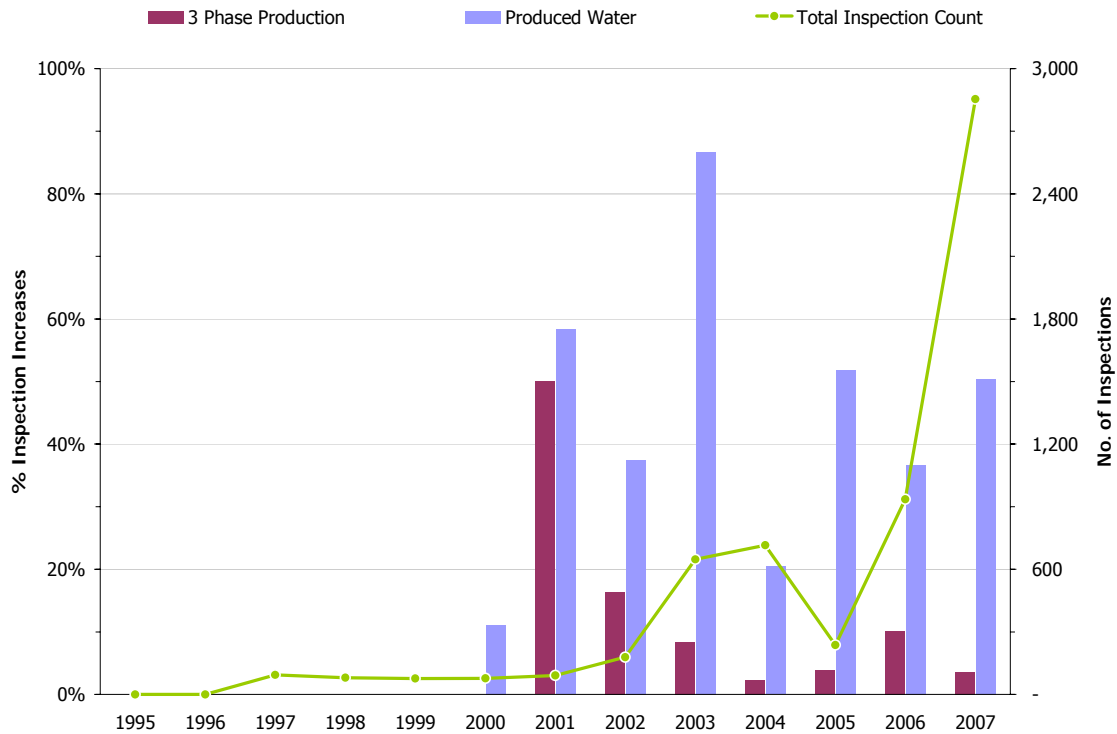
ACT Figure B.4 MPU Flow Line Internal Inspection Increases

The results of internal inspection program can be seen in ACT Figure B.4. The figure shows the total number of flow line inspection items has been, in general, increasing since 2001.

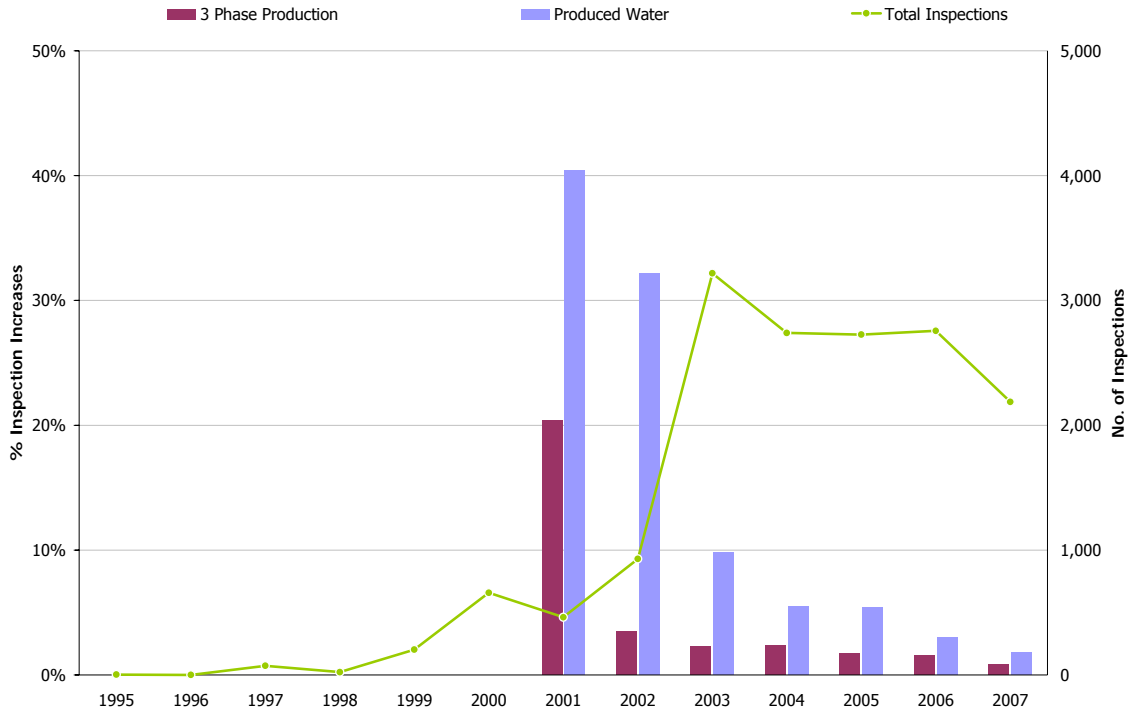
ACT Figure B.5 MPU Well Line Internal Inspection Increases

The 3-phase well line damage rate has remained essentially level over the past several years, at about 2% of the repeat locations showing an increase in corrosion activity. There is currently no corrosion inhibition program for the production well lines.

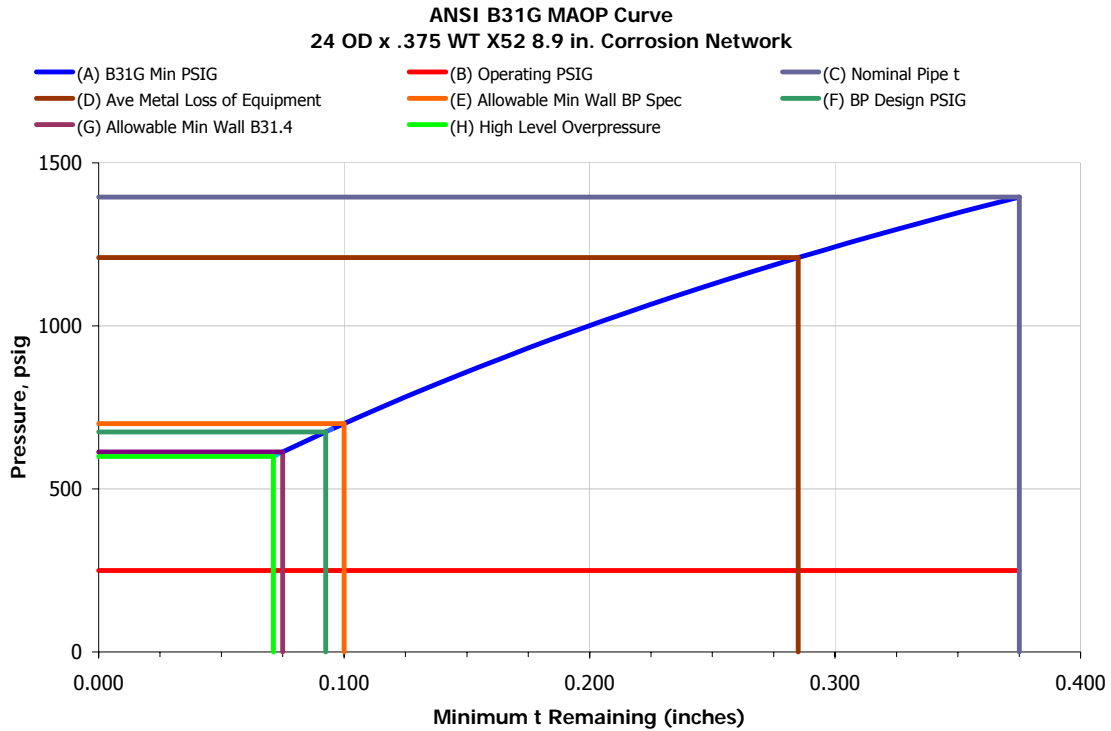
Legend	Description/Comments
(A) B31G Min PSIG	The relationship between maximum allowable operating pressure, MAOP, as given by B31G and the remaining wall thickness
