Tundra Treatment Guidelines

A Manual for Treating Oil and Hazardous Substance Spills to Tundra

Third Edition

Alaska Department of Environmental Conservation

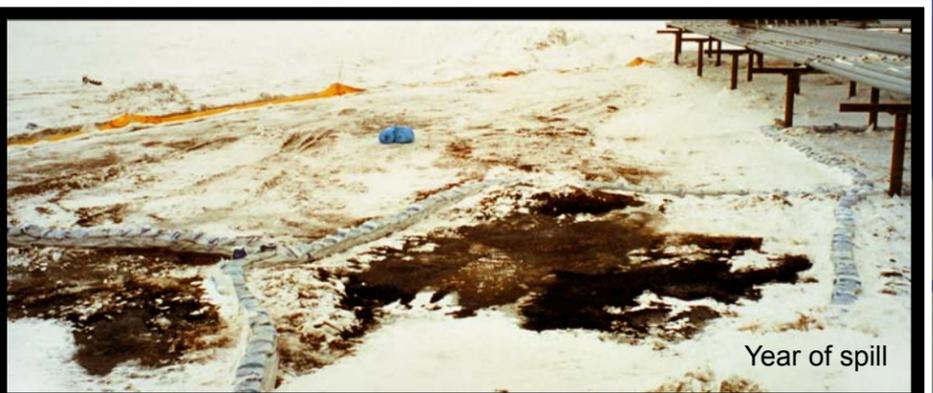
Year of spill

1. March 1997: A mixture of crude oil, methanol, and water affected 0.5 acre of tundra. Snow was used as an adsorbent, and the tundra surface was flooded and flushed with hot and warm water to melt contaminated ice and snow, and to recover contaminants.
2. June 1997: After the snow melted and the site was dewatered, propane torches were used to burn small areas of residual oil remaining on plants and on the soil surface. Fertilizer was applied to promote biodegradation and plant growth.
3. August 2009: After 13 growing seasons, indigenous plants have revegetated the affected area, giving it an appearance similar to the surrounding tundra. These plants originated from rootstock that survived the spill and cleanup operation.
