ALASKA DEPARTMENT OF ENVIRONMENTAL CONSERVATION
Division of Spill Prevention and Response
Prevention and Emergency Response Program
SITUATION REPORT (*sitrep*)

BPXA H Pad Well 8 Three-Phase Flowline Spill

SITREP #: 6

SPILL #: 14399911801

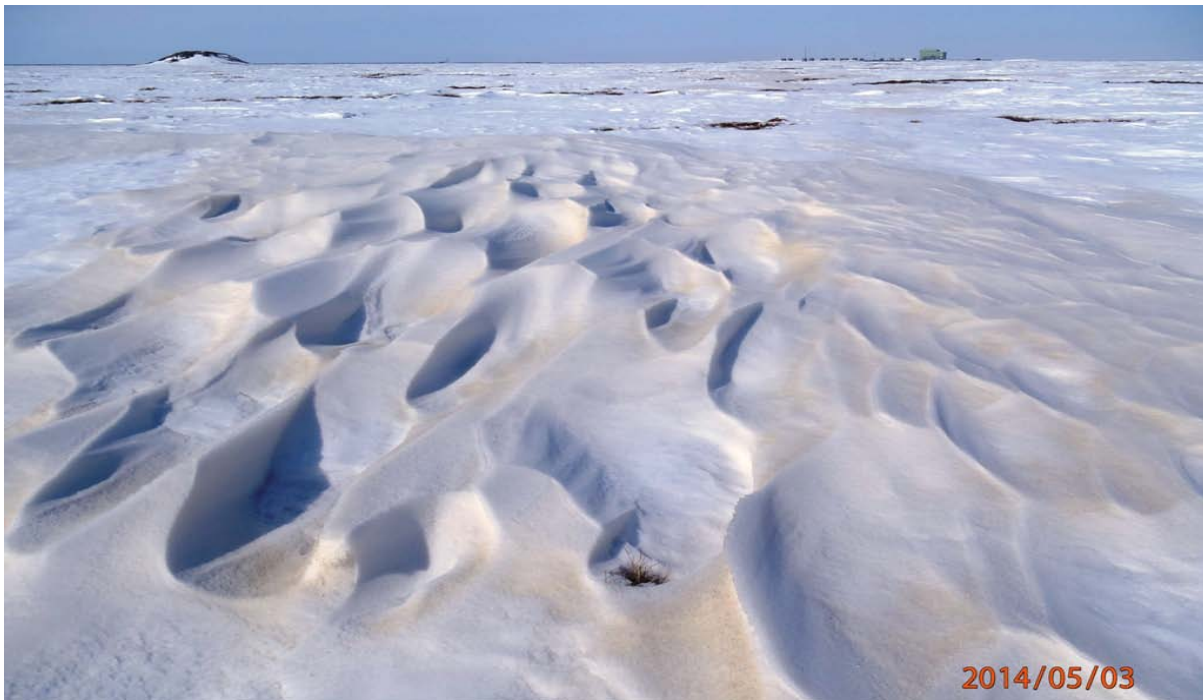
An area of wind-driven oiled snow identified for removal. May 3, 2014 (photo: Fritz, ADEC)

Colder temperatures late on May 4 made access to areas of snow-covered tundra more practicable. The 22 cleanup personnel of the night crew on May 4, supplemented with 27 members of the day crew who agreed to work an extra half-shift, focused on removing isolated areas of oil-contaminated snow. Workers removed 102 cubic yards of snow from the tundra during the 6:00 p.m. to 6:00 a.m. night shift.

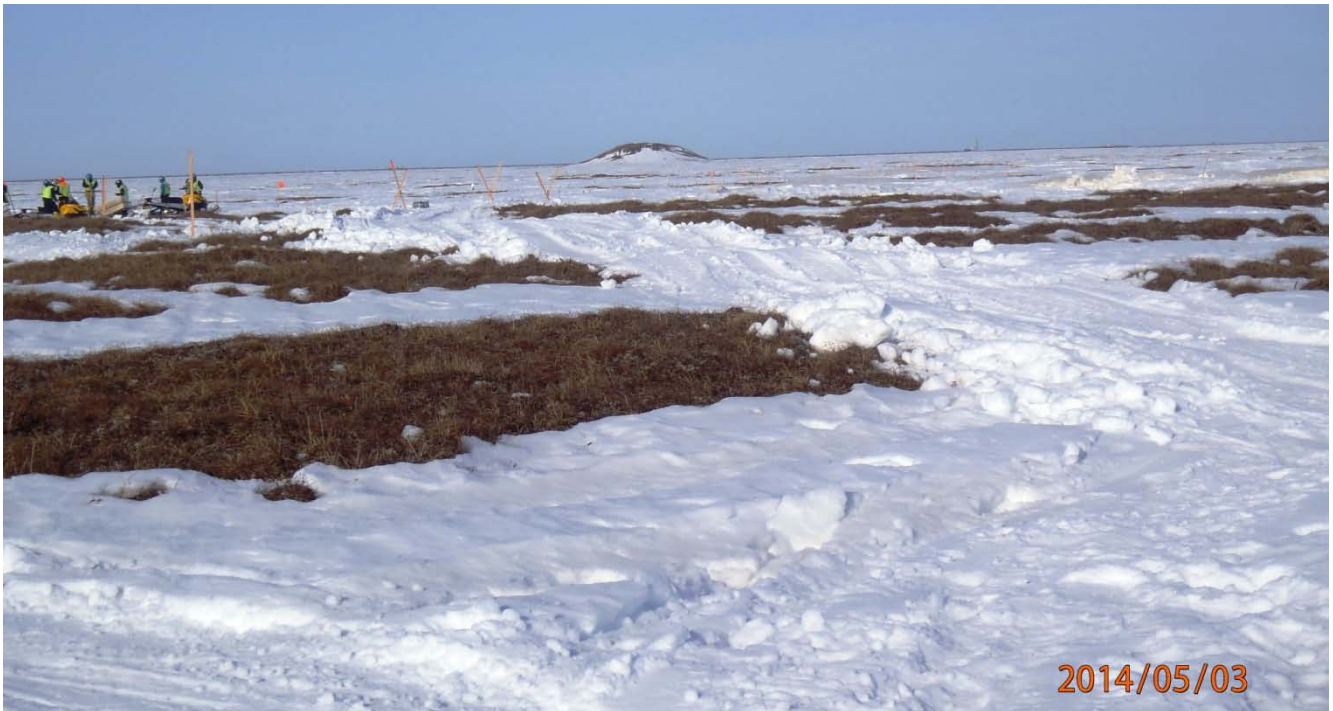
Snow “roads” have been built to protect the tundra from damage and assist cleanup personnel in their effort to remove isolated pockets of contaminated snow. May 3, 2014 (photo: Fritz, ADEC)

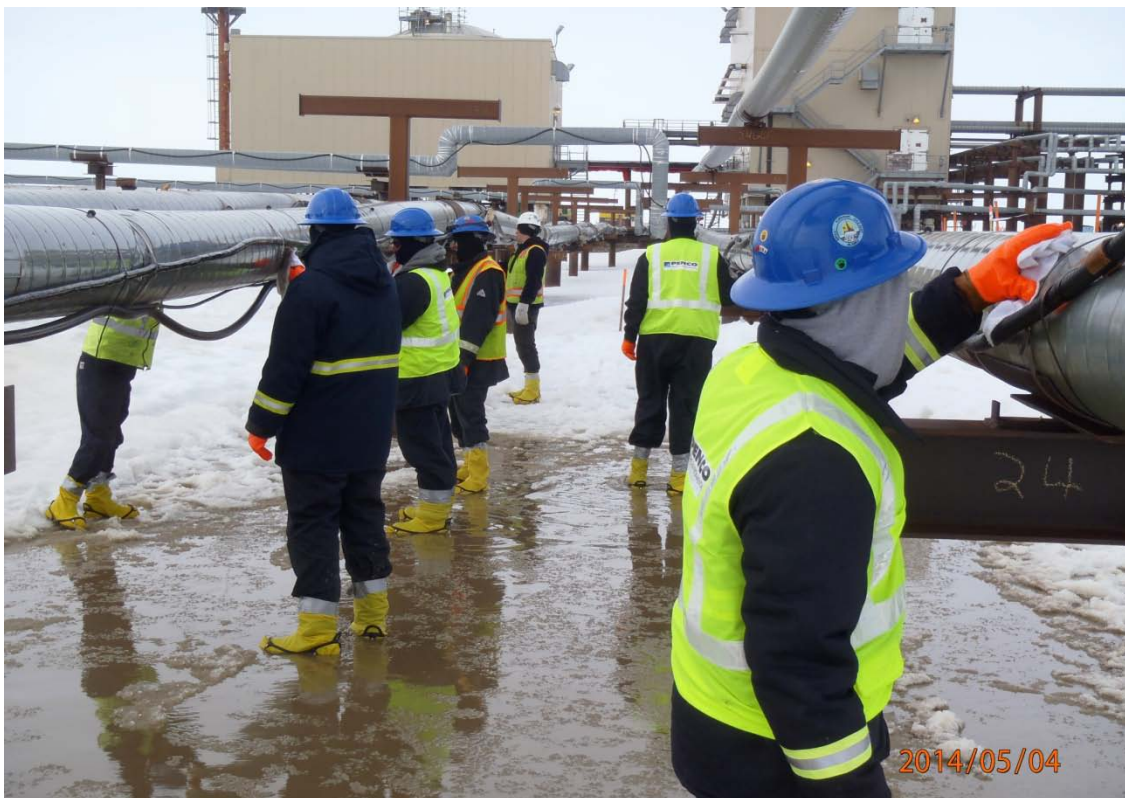
Cleanup personnel remove oil sprayed onto well piping during the April 28 H Pad Well 8 flowline rupture. May 3, 2014 (photo: Fritz, ADEC)

The wipe-down of oiled piping and well-housing at H Pad is approximately 80% complete, and this will be the focus for cleanup personnel today. A three-member team consisting of representatives from the State, the North Slope Borough and BPXA will inspect the spill area that covered the tundra to see if any remaining patches of oil-contaminated snow warrant removal.
