ALASKA DEPARTMENT OF ENVIRONMENTAL CONSERVATION
Division of Spill Prevention and Response
Prevention, Preparedness and Response Program
SITUATION REPORT

Kiana Water Treatment Plant Diesel Release

SITREP #: 3 and Final

SPILL #: 15389933501

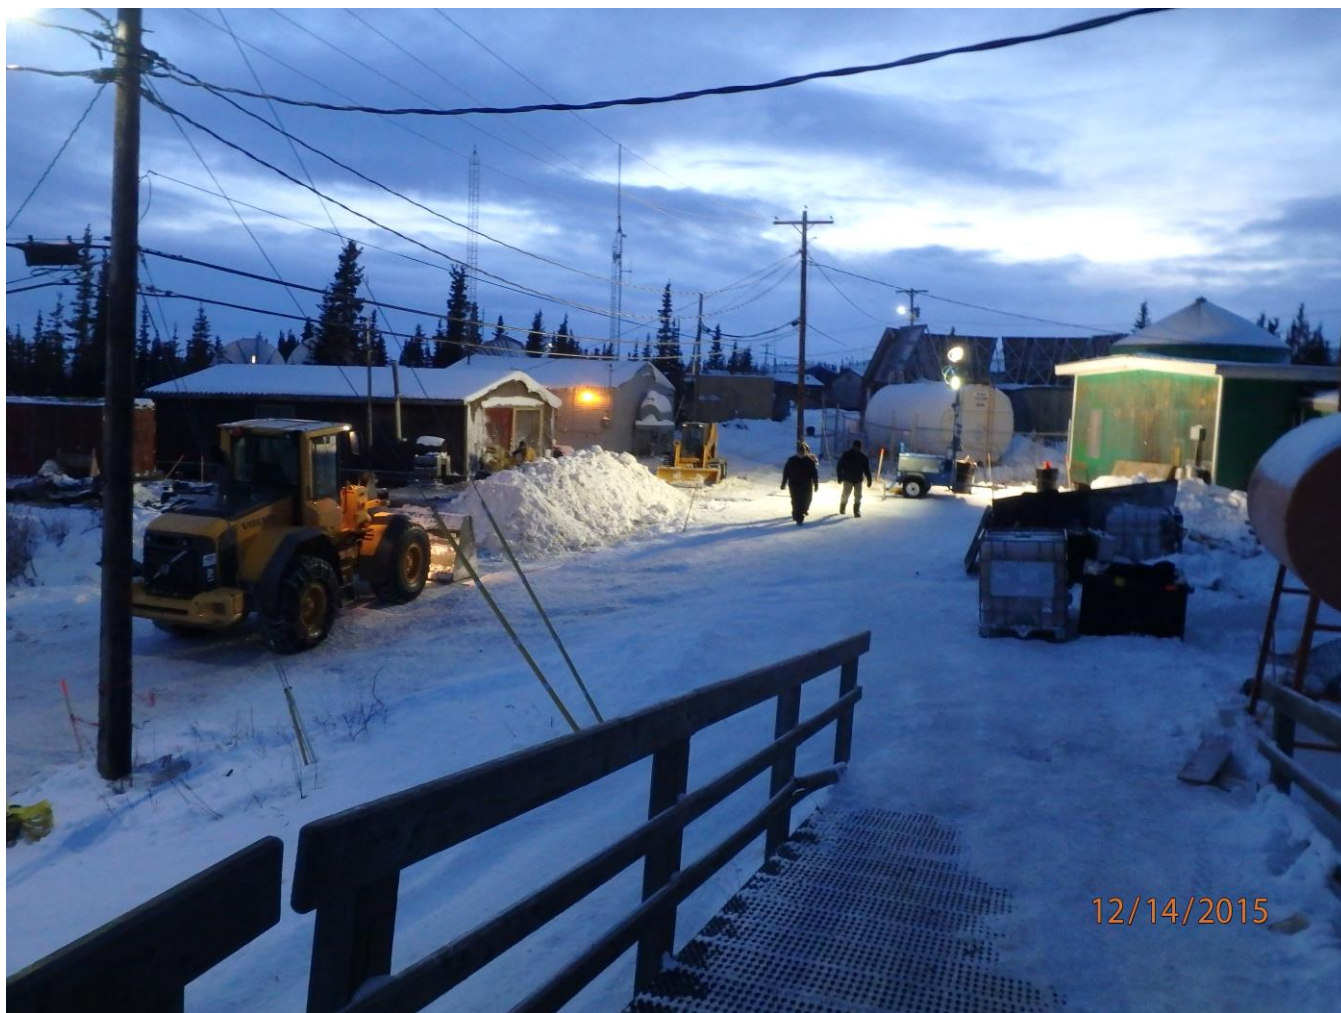
Figure 1. City tank is on right behind light plant; and the loader is moving contaminated snow from the “hot zone” to the vertical tank melting area. [Photo: ADEC/John Ebel]

Contaminated snow was hand shoveled near the building and moved to a common pile in the "hot zone" with tub sleds. Responders used a skid steer in the hot zone to load contaminated snow into the bucket of a front end loader, which was transported about 100 yards into the lined and bermed secondary containment area of

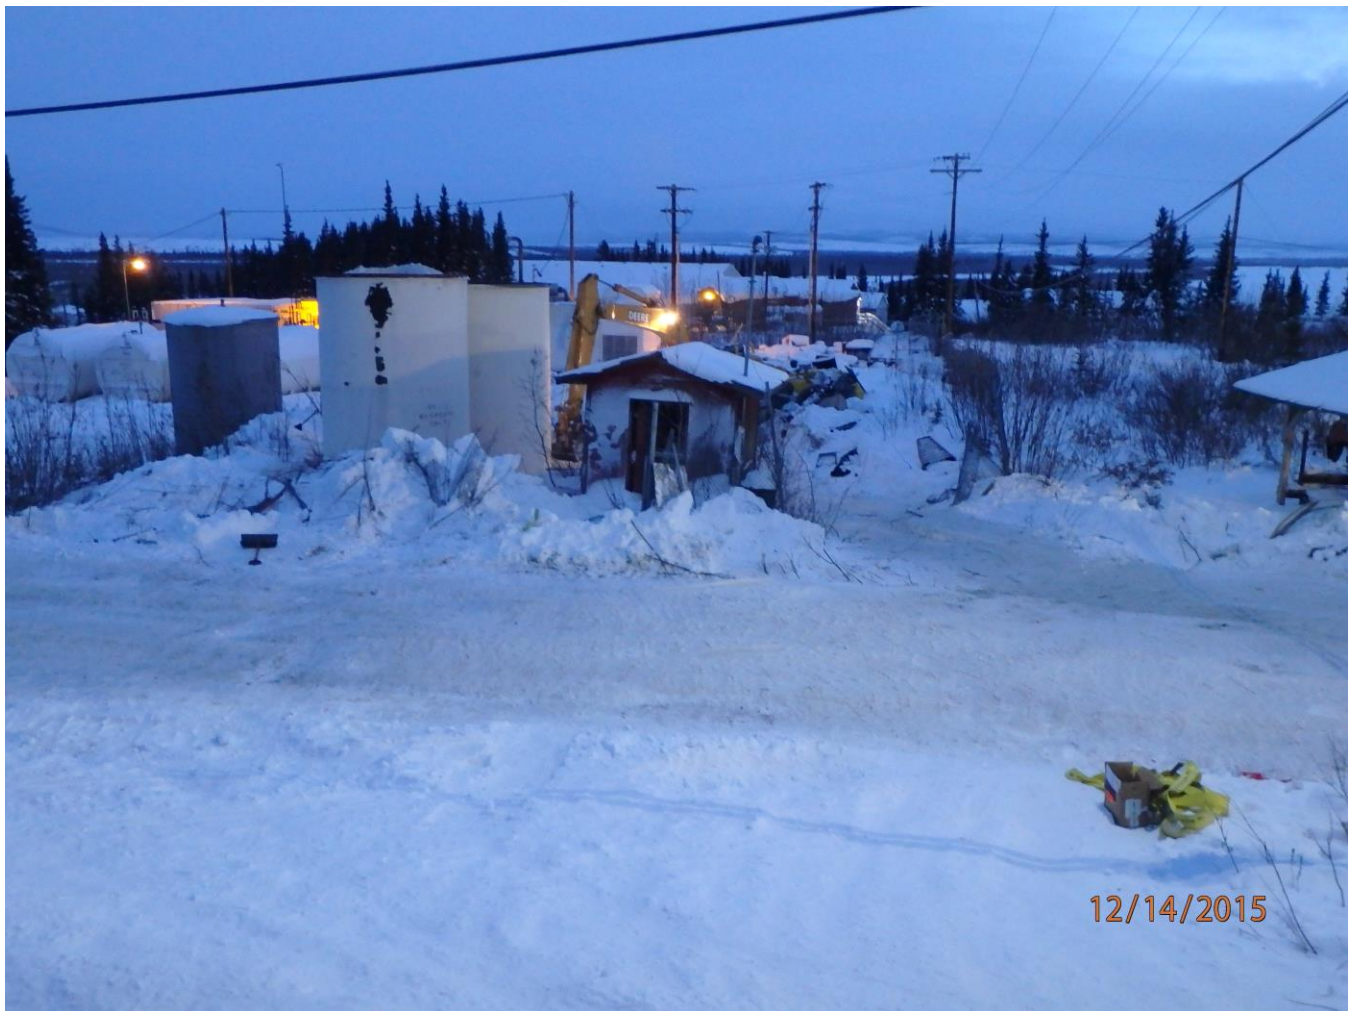
Figure 2. Backhoe moving contaminated snow into two vertical storage tanks for melting. [Photo: ADEC/John Ebel]

the city's old tank farm. Snow was dumped on a common pile where it was picked up by an excavator and loaded into two out-of-service fuel storage tanks for contaminated snow melting during the thaw season. Valves were added to the lower bung openings of the tanks for water treatment and fuel recovery after the snow melts. Two fish totes were also used to store the contaminated snow for melting. The resultant fuel/water mixture will be managed according to a waste management plan.
