Clearwater Creek

Water

Quality

Monitoring

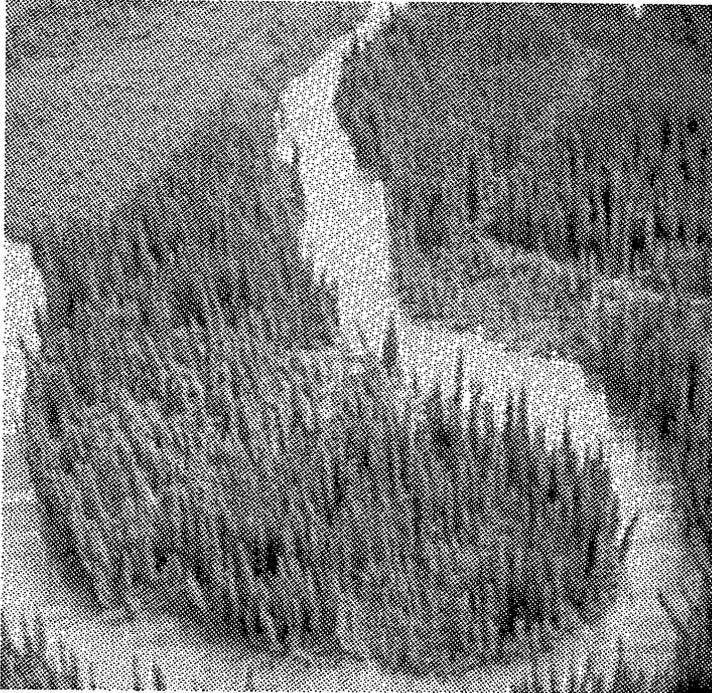
Sediment from flood event, turns naturally clear DCR brown.
