Underwater Bark Debris Survey  
Permit Monitoring Services - Twelve Sites

USDA Forest Service - Tongass N.F.  
Federal Building  
Ketchikan, AK 99901

**Subject: Marguerite Bay dive survey.**

<u>Site:</u> Traitors Cove 8, NPDES No. AK-004559-4, (Marguerite Bay)	
<u>Date Surveyed:</u> 5/22/97	<u>Total # of Sample Points:</u> 42
<u>Time of Sampling:</u> 1813	<u>Average Bark Depth:</u> 11.9 cm
<u>Sampler:</u> C. Sempert	<u>Calculated Survey Area:</u> 0.47 acres

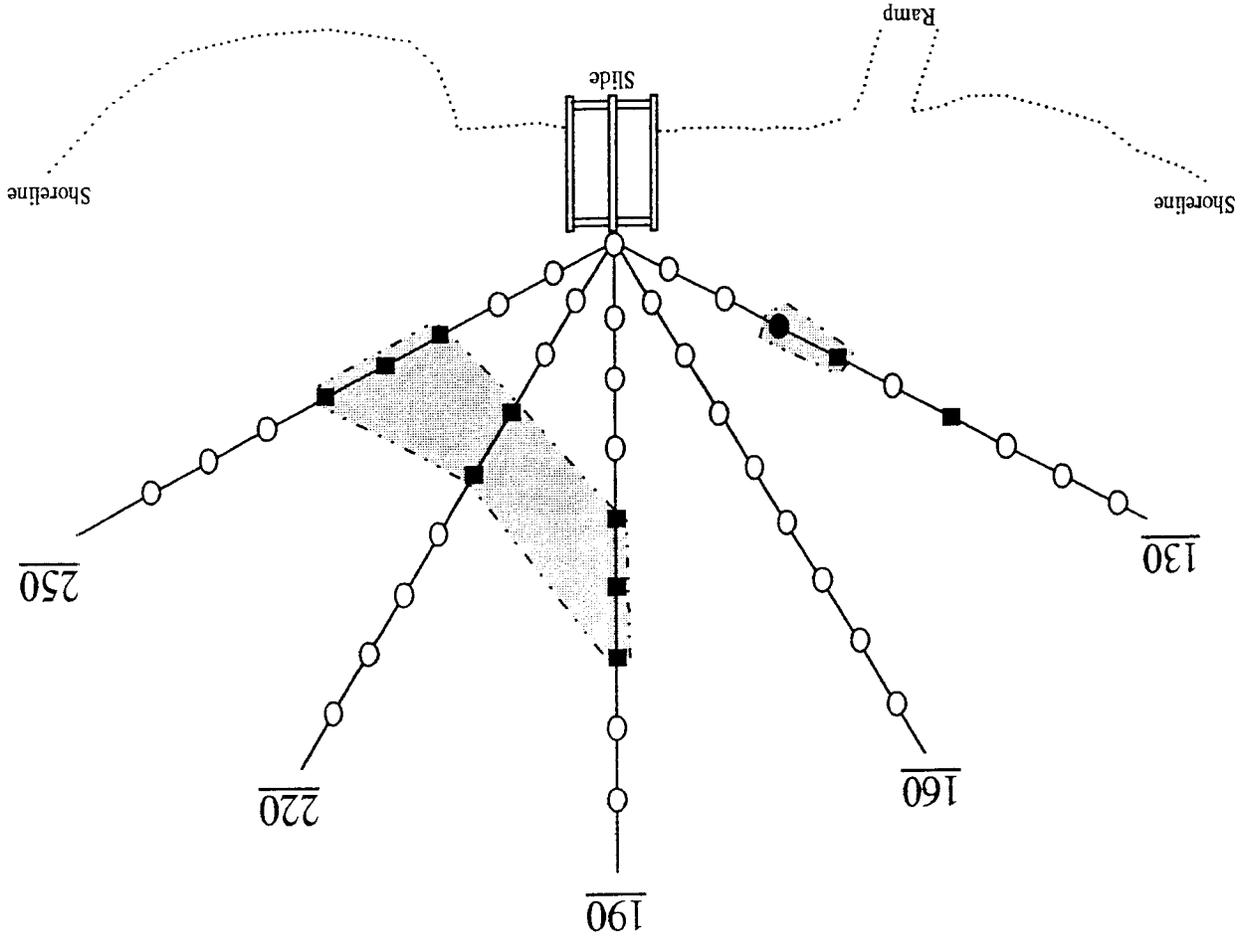
# 5/22/97 Traitors Cv. Bark Debris Survey

Not to Scale  
 Sample Point Interval = 5 m  
 Area of 100 % Cover

- Sample point - No debris
- Sample point - Debris present
- Sample point - Debris with 100 % coverage
- Sample point - Debris depth ≥ 10 cm, 100 % coverage

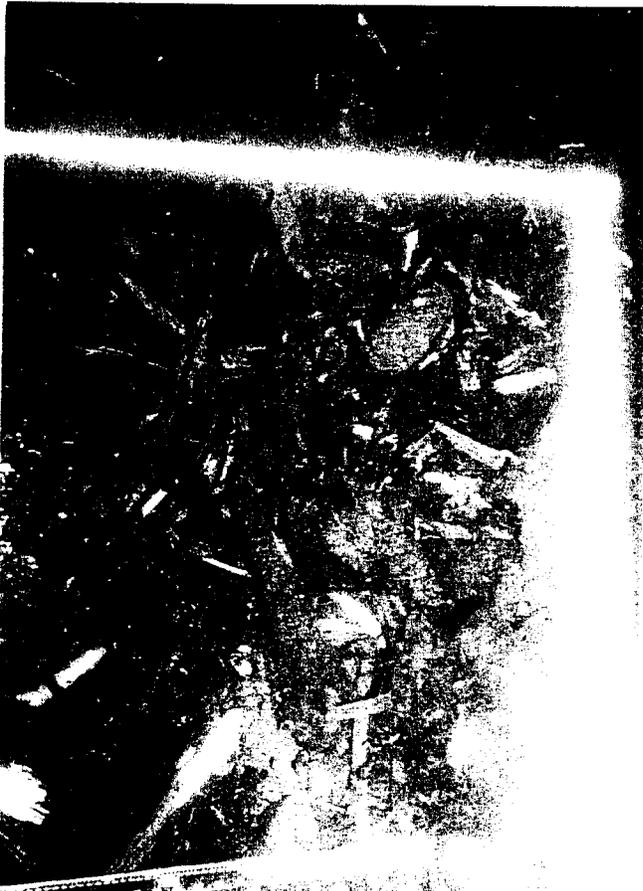
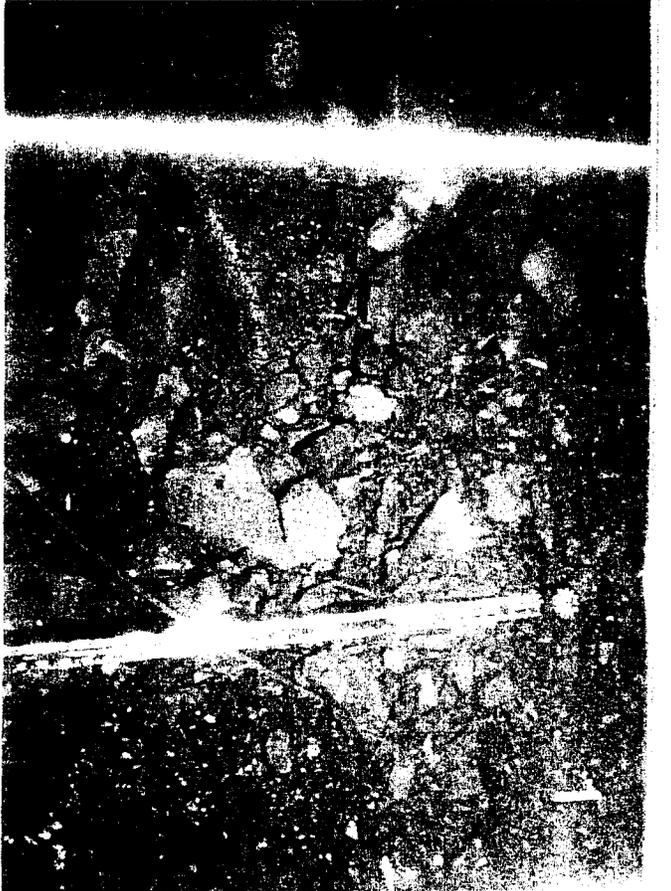
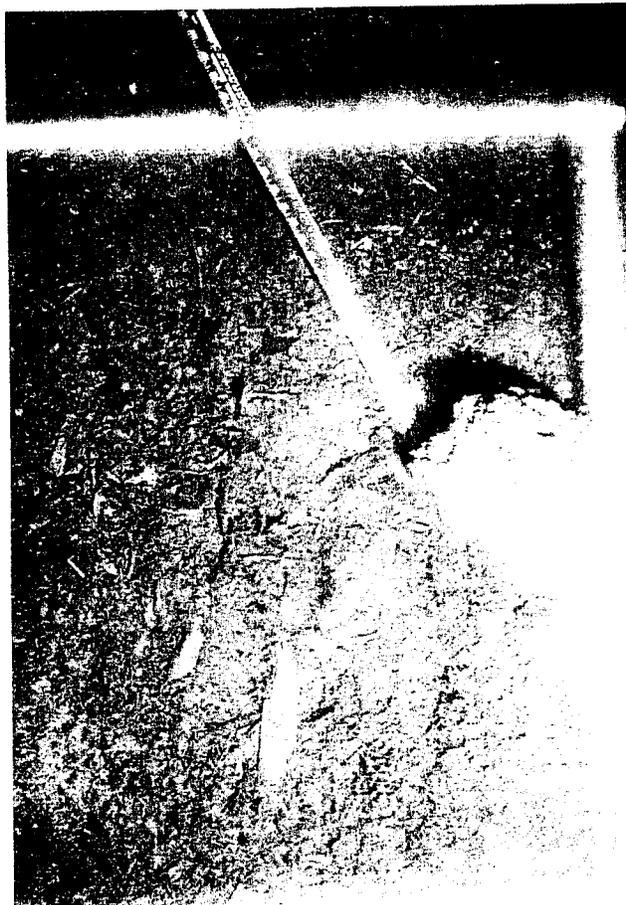
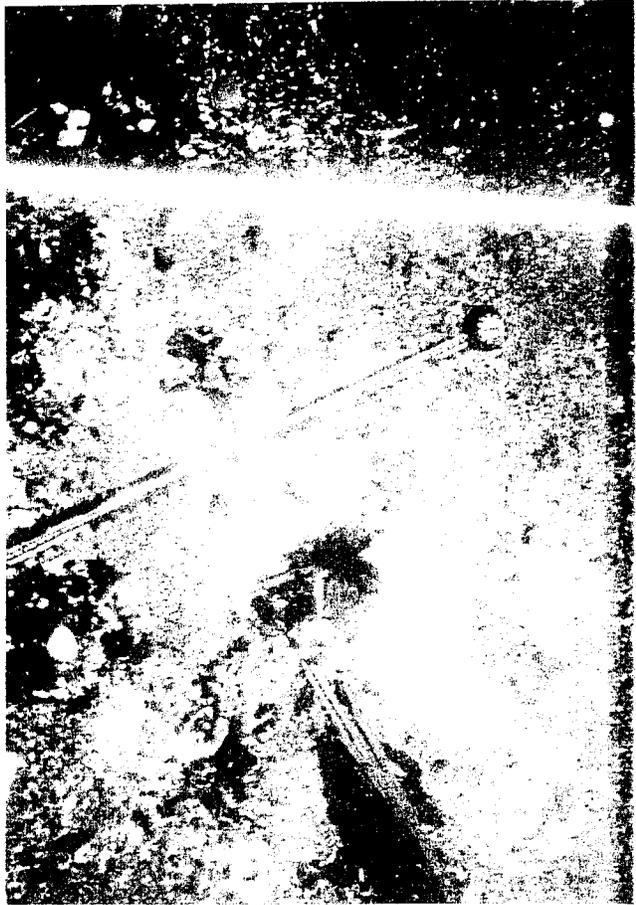
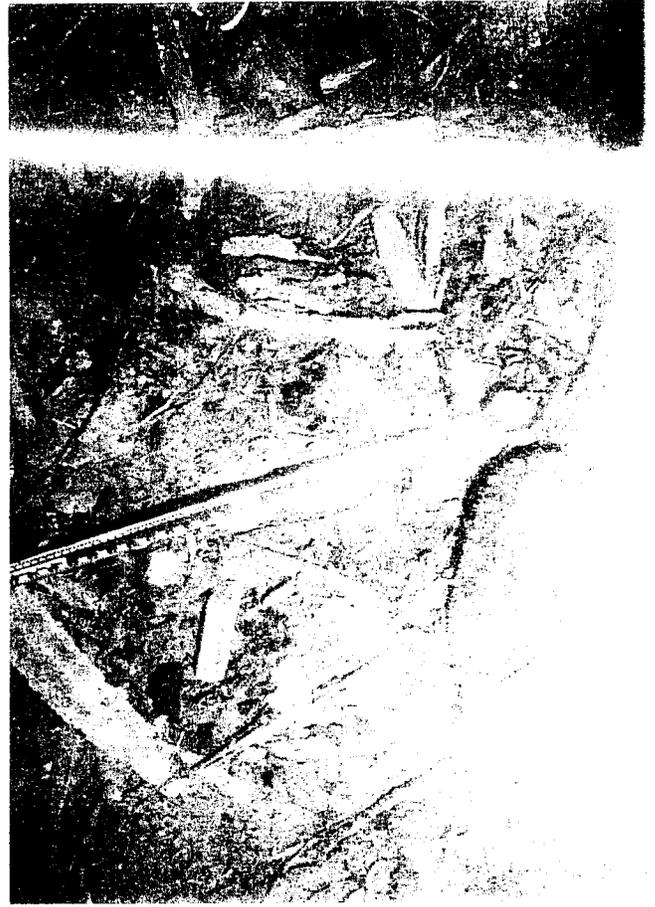
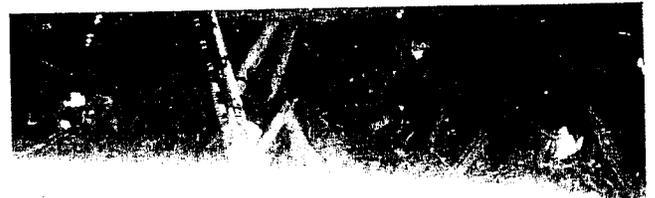
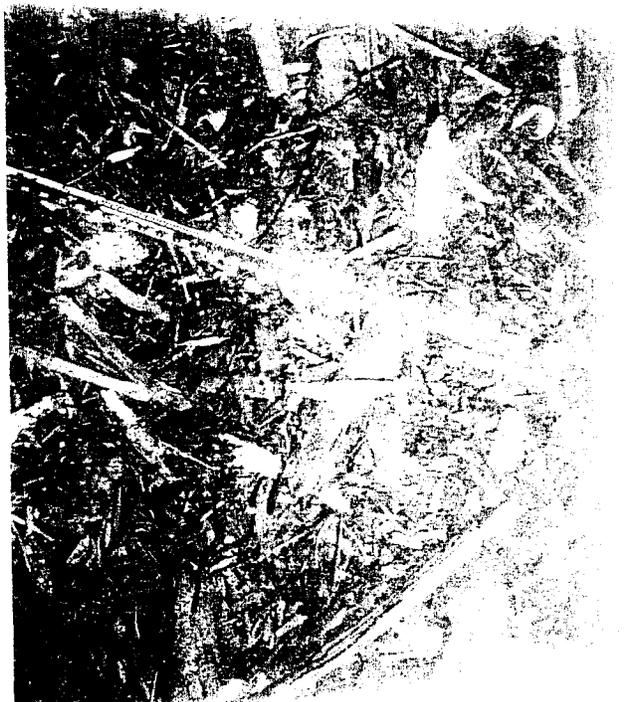
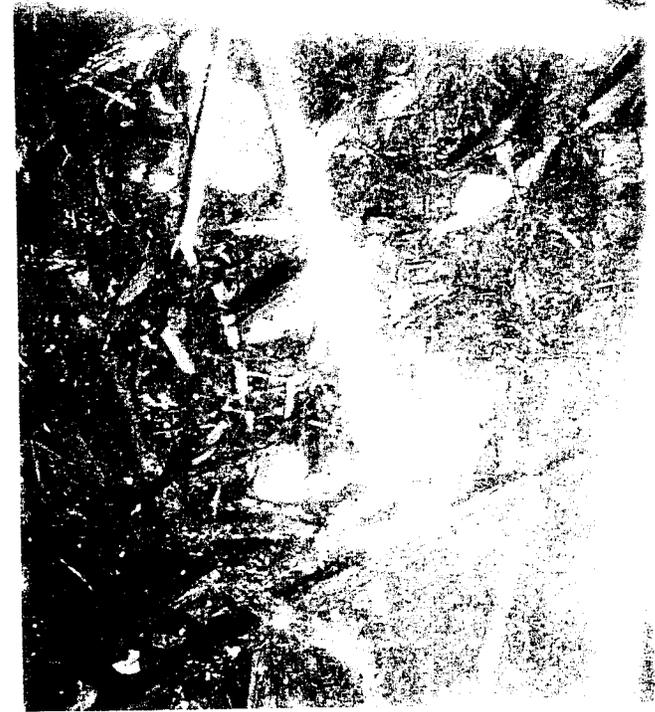
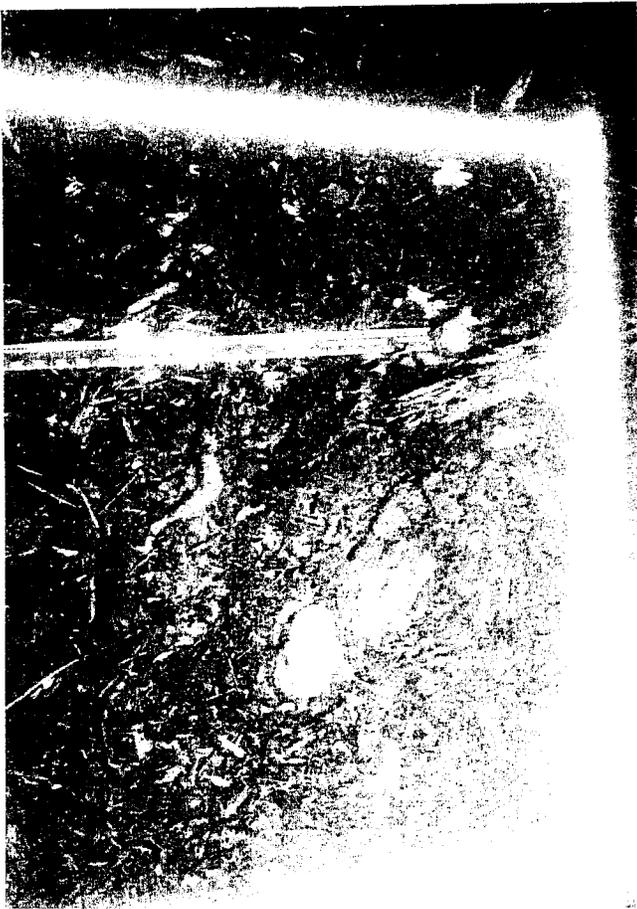
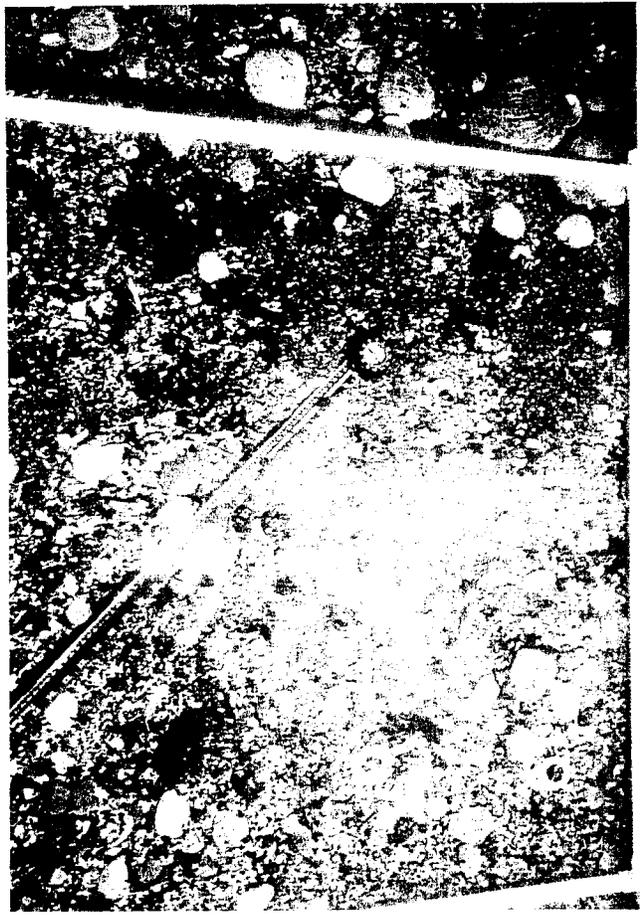
Photograph Key

Photo #	Transect/ Sample Pt.	Description
1	Ref. Pt.	Fill gravel and rocks
2	250/1	Bark debris with a little substrate showing
3	250/2	Smaller debris sizes
4	250/3	100% cover of homogeneous debris sizes
5	250/4	Slightly larger debris sizes
6	250/5	End of old log
7	250/6	Increased silt/mud mixed with debris
8	250/7	2" pipe; small branch
9	250/8	Large <i>Metridium anemone</i>
10	190/1	Sand/gravel at edge of bundle drop zone
11	190/2	Still in the high energy area
12	190/3	Near edge of shelf drop-off
13	190/4	Variety of wood debris on slope
14	190/5	Debris at base of slope
15	190/6	Sea cucumber; silt on debris surface
16	190/7	Concrete anchor; much less debris
17	190/8	Sea cucumber; scattered wood pieces
18	130/1	Bark debris filling in small trough
19	130/2	High shell component to substrate
20	130/3	Female <i>Dungess</i> crab buried in debris
21	130/4	Natural detritus mixed in with bark debris
22	130/5	Sand visible through debris

23	130/6	Sea star on 100% debris cover
24	130/7	Thin, patchy debris area
