**Log Transfer Facility
Permit Monitoring Services -
Eight Sites**

USDA Forest Service Order # 43-0116-8-0043

Underwater Bark Debris Survey
Permit Monitoring Services - Eight Sites

Subject: Marguerite Bay dive survey.

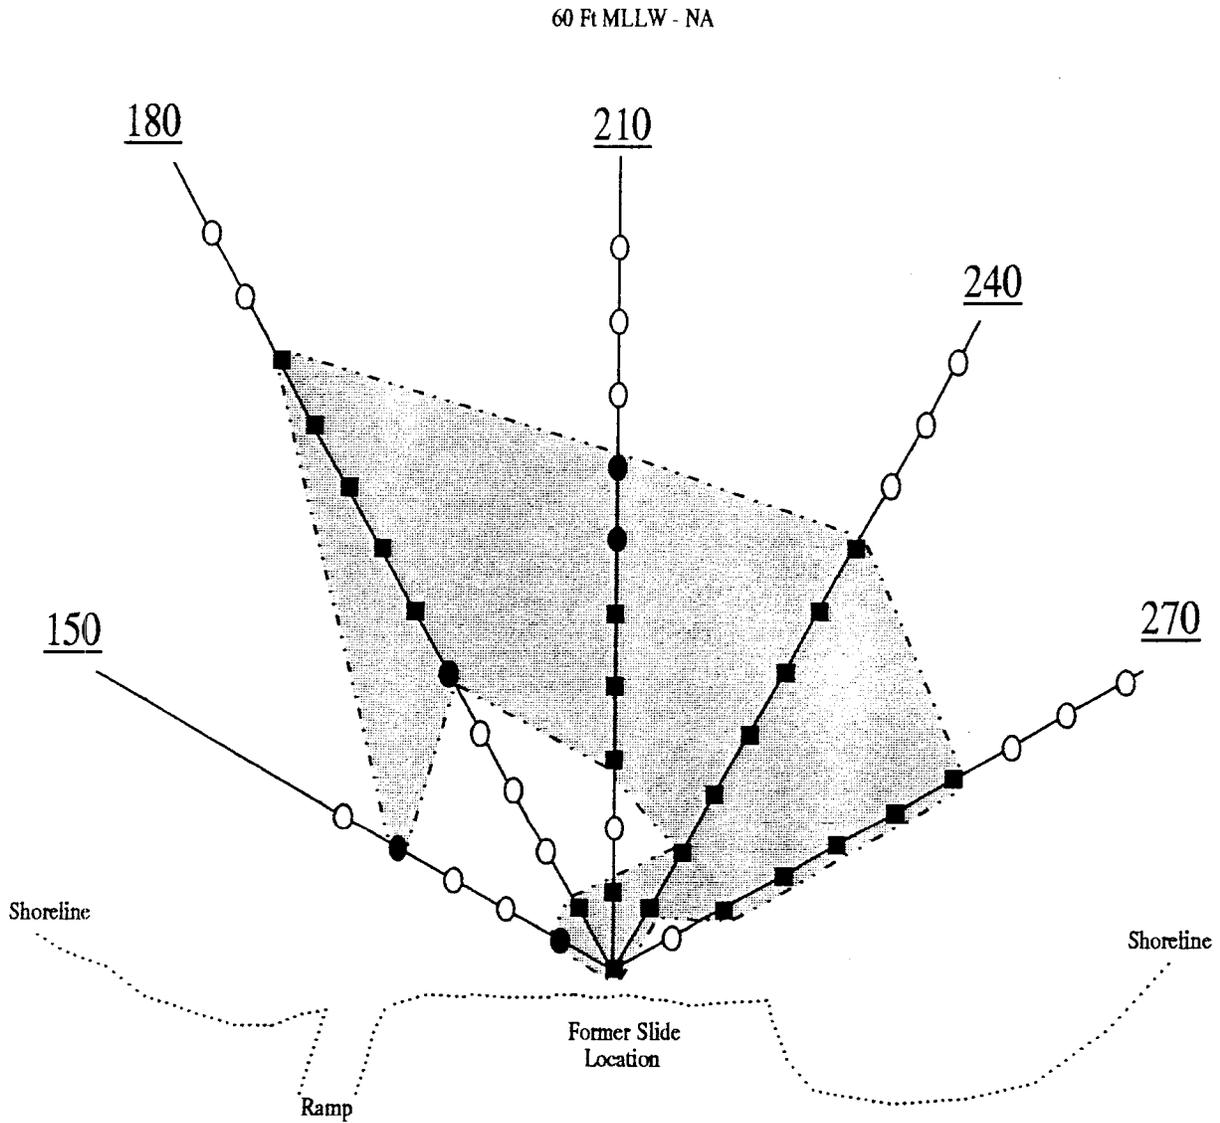
8/30/98 Marguerite Bark Debris Survey

- Sample point - No debris
- Sample point - Debris present
- Sample point - Debris with 100 % coverage
- Sample point - Debris depth \geq 10 cm, 100 % coverage

Not to Scale
 Sample Point Interval = 5 m

Area of 100 % Cover

The permanent reference point was positioned in the approximate rail slide area at a depth estimated to be close to zero feet MLLW. Actual corrected depth of the reference point was 5 feet MLLW. A total of 47 sample points were taken on the five transects and all sample points had at least a trace of debris present. Of these, 23 had a measured debris depth of 10 centimeters or greater and 100% cover. A total of 28 sample points had an estimated 100% coverage. Surface area covered by bark debris in the survey, using transects 150 and 270 as boundaries, totals to 0.88 acres.

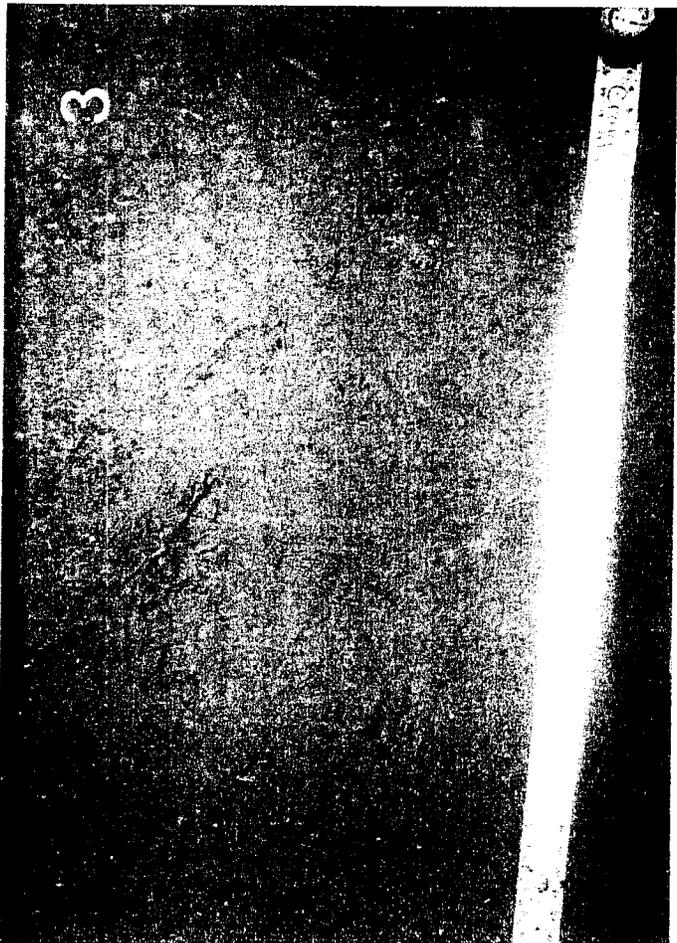
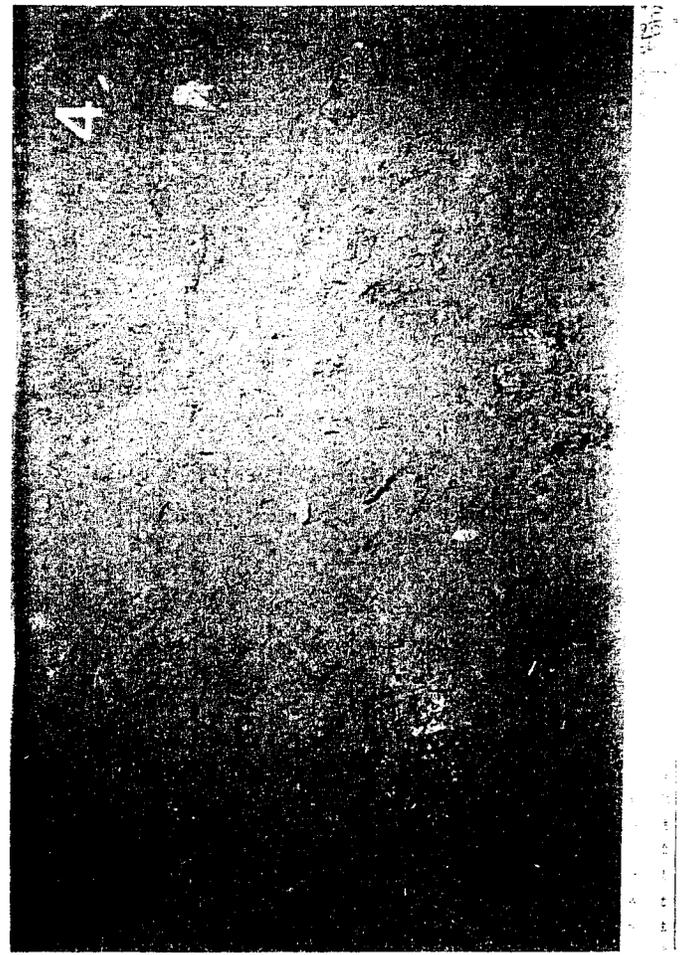
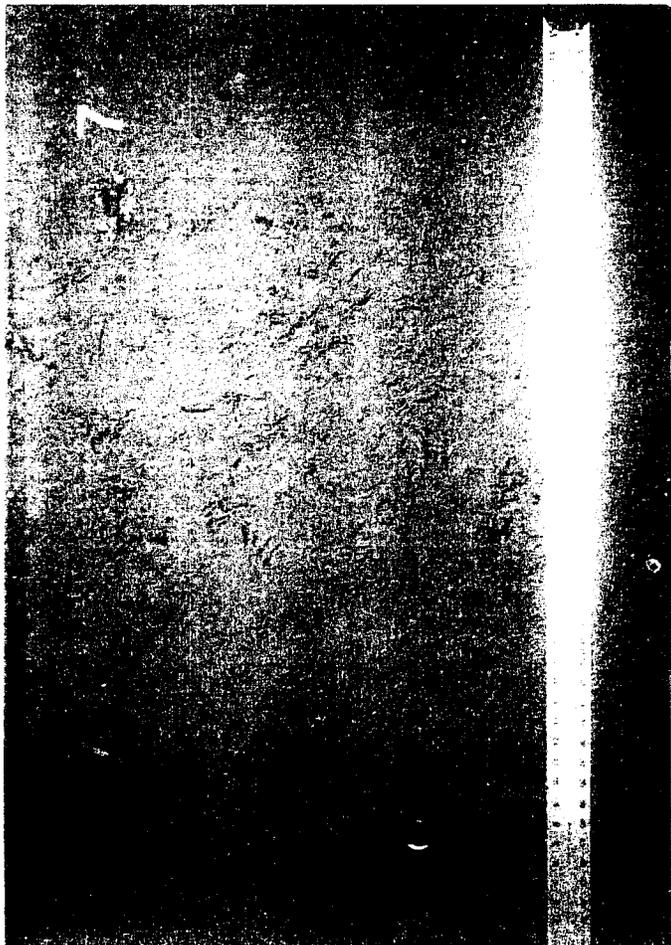
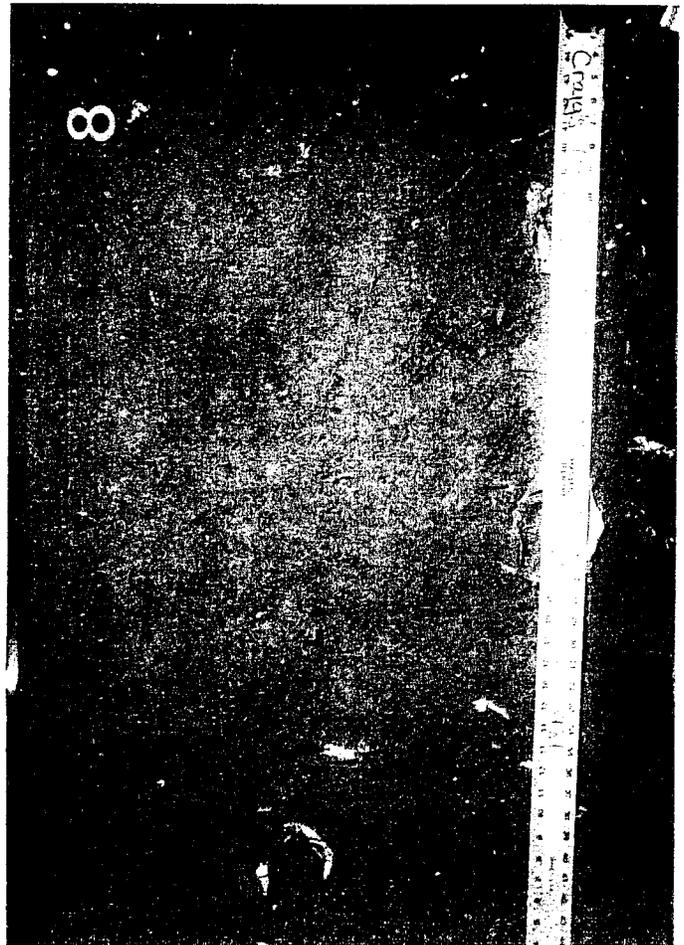
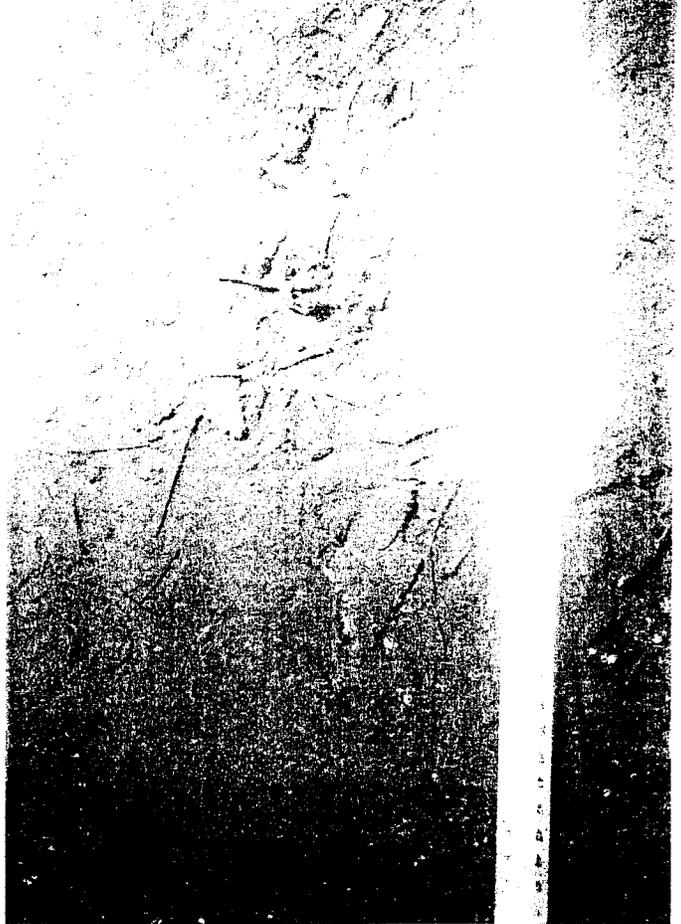
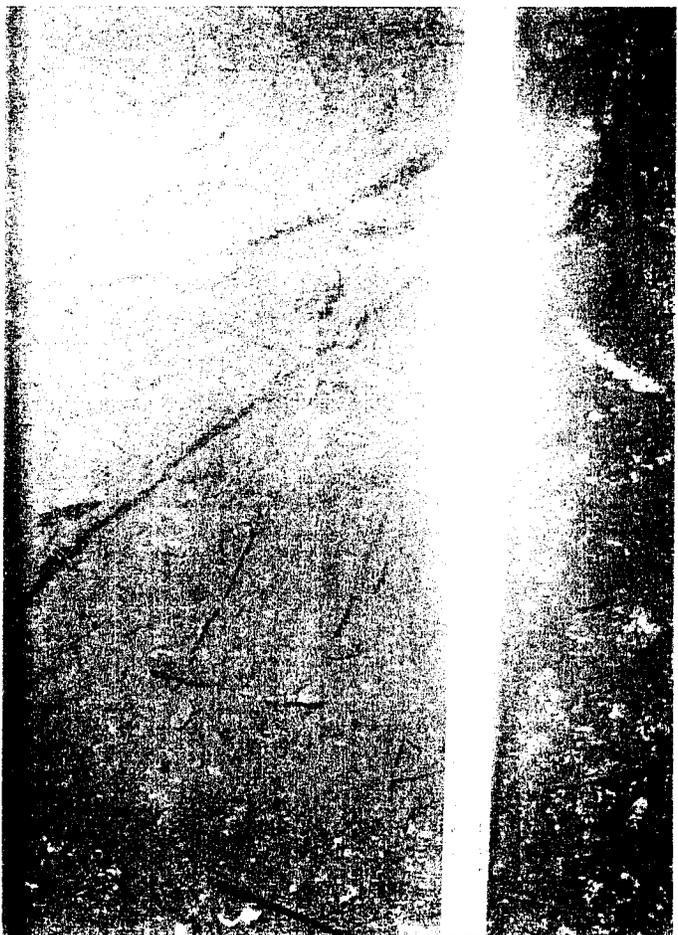
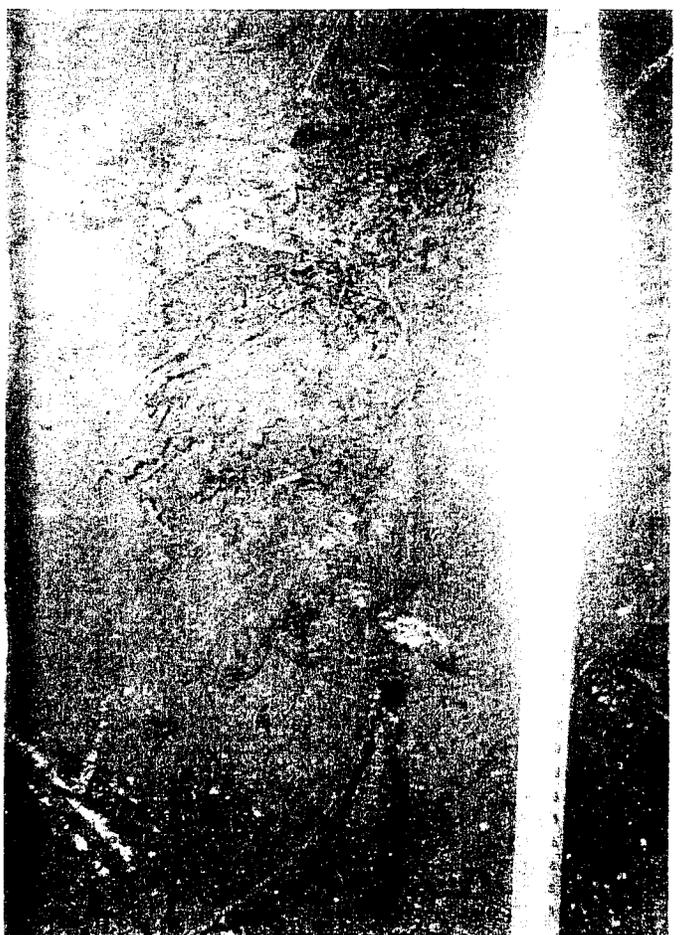
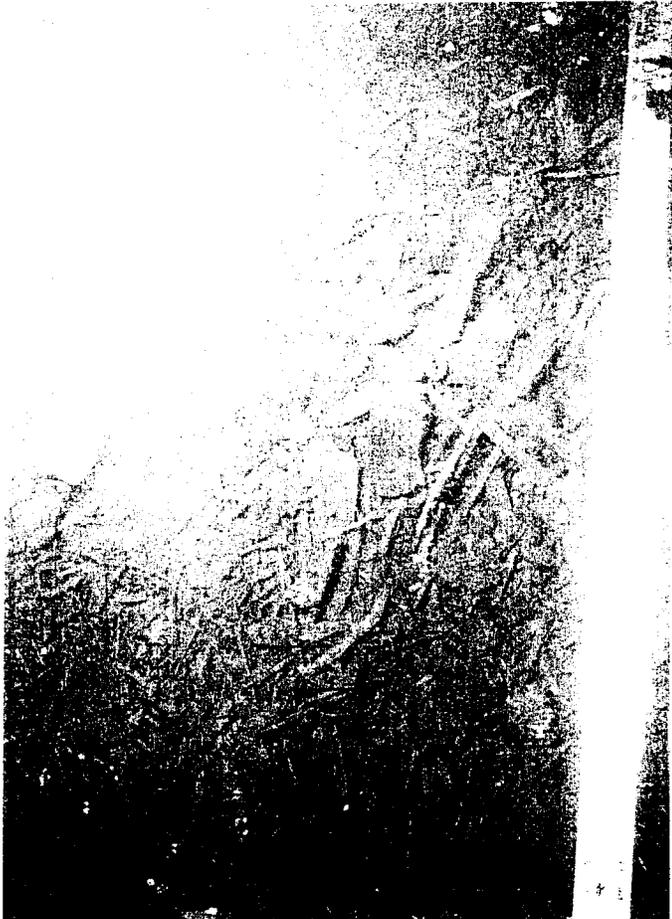
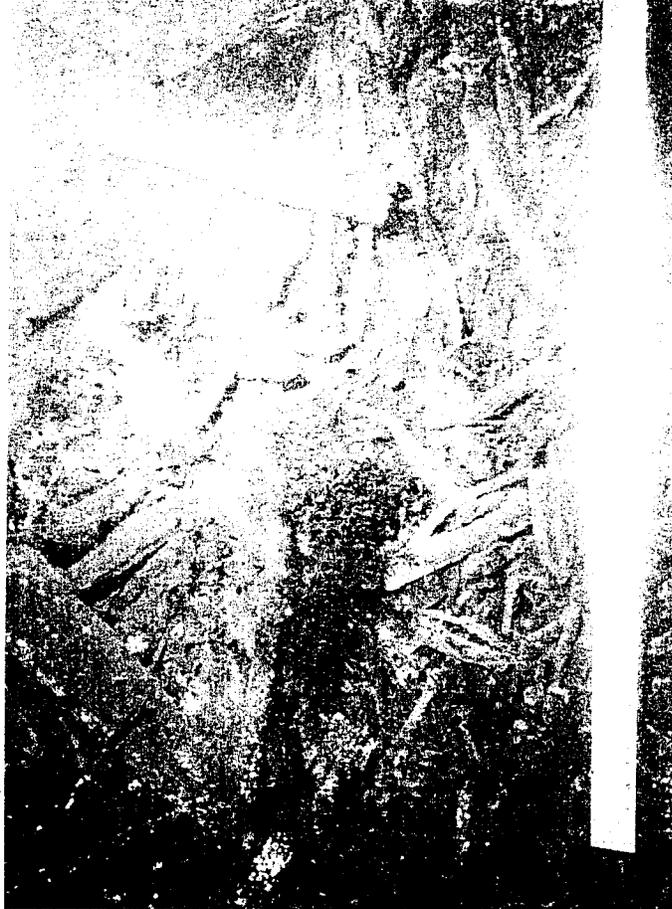
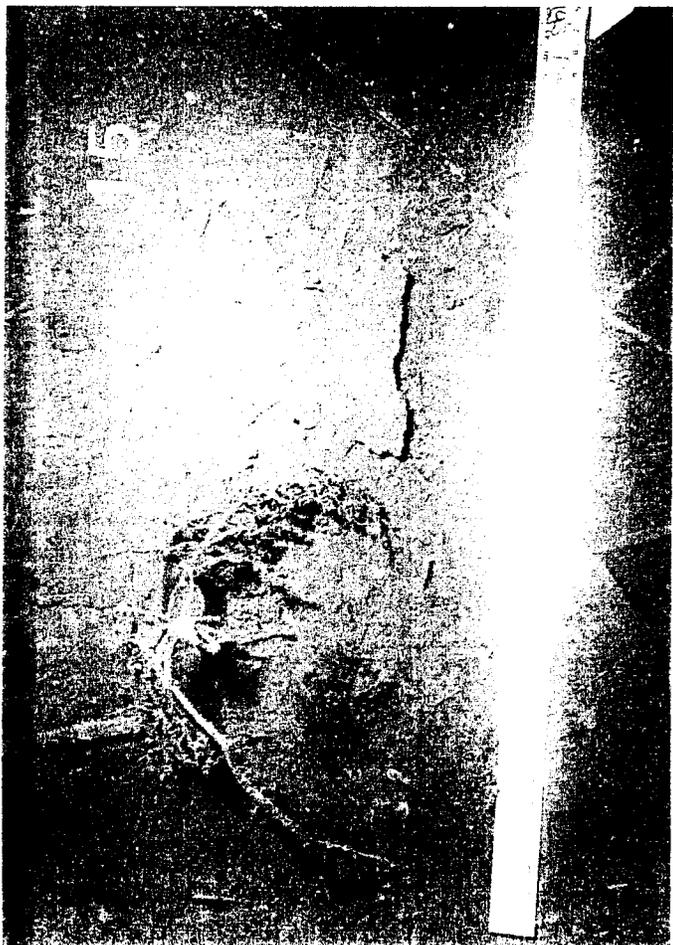
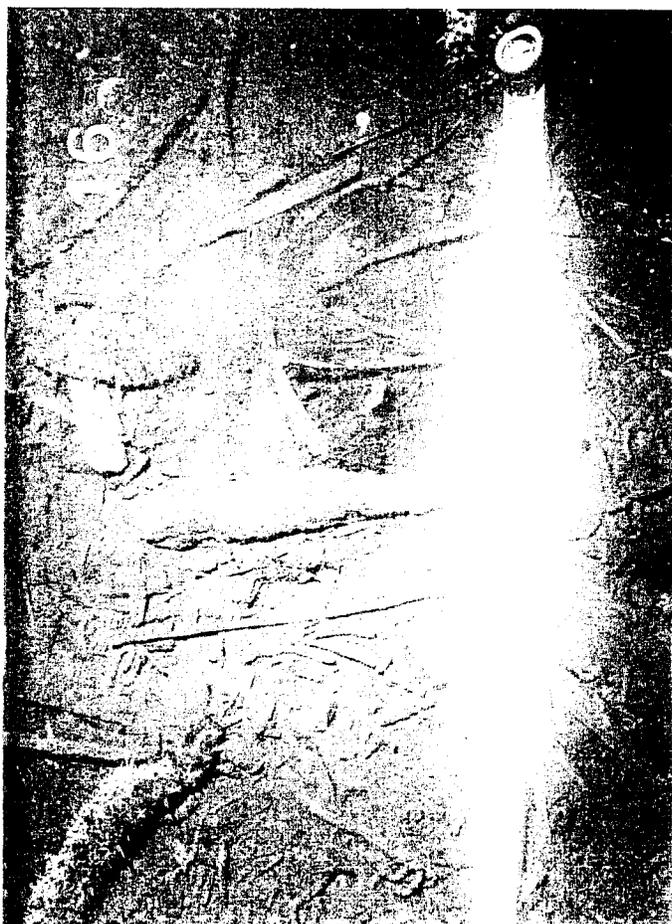
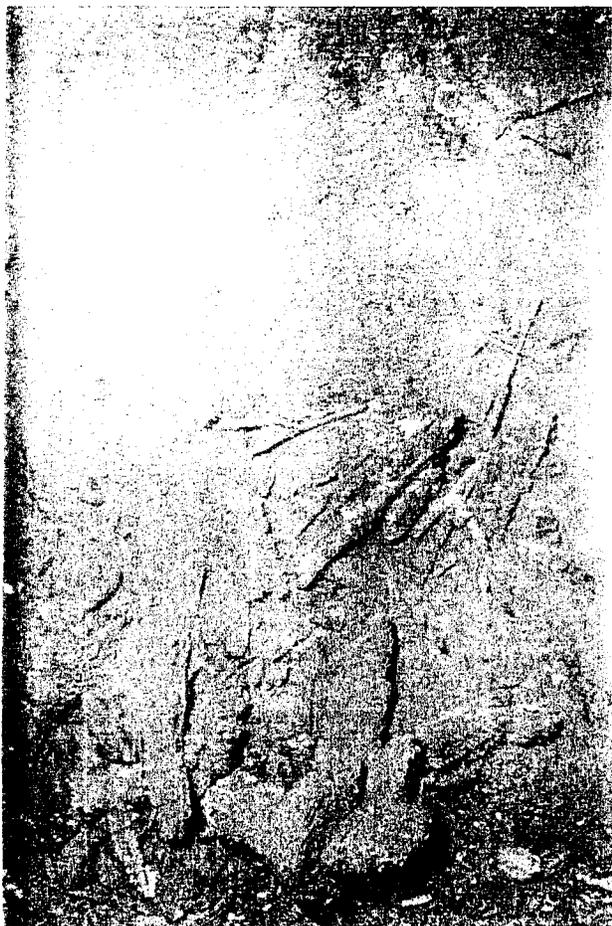
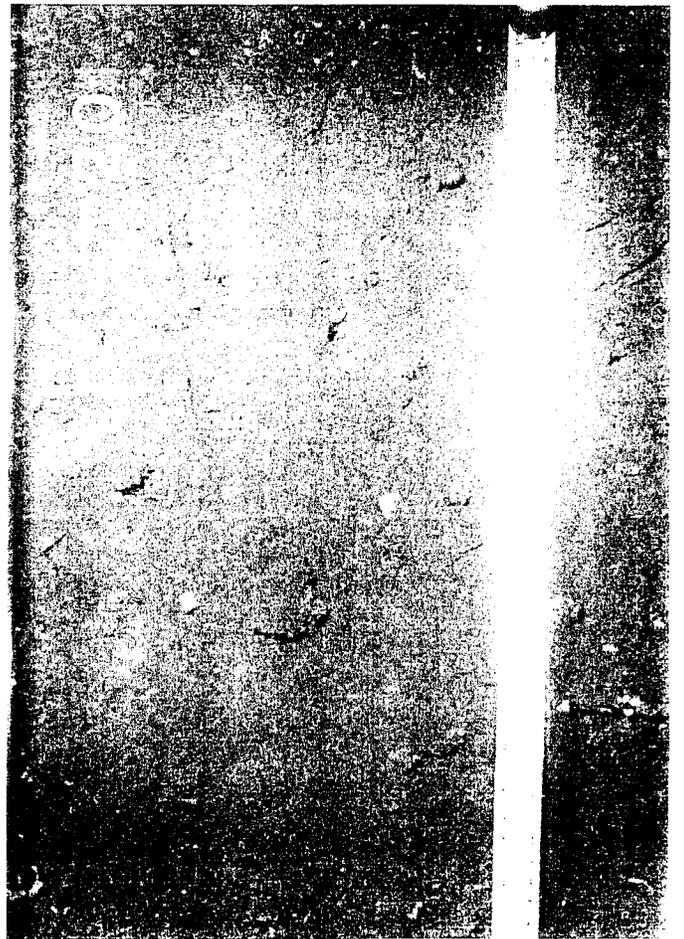
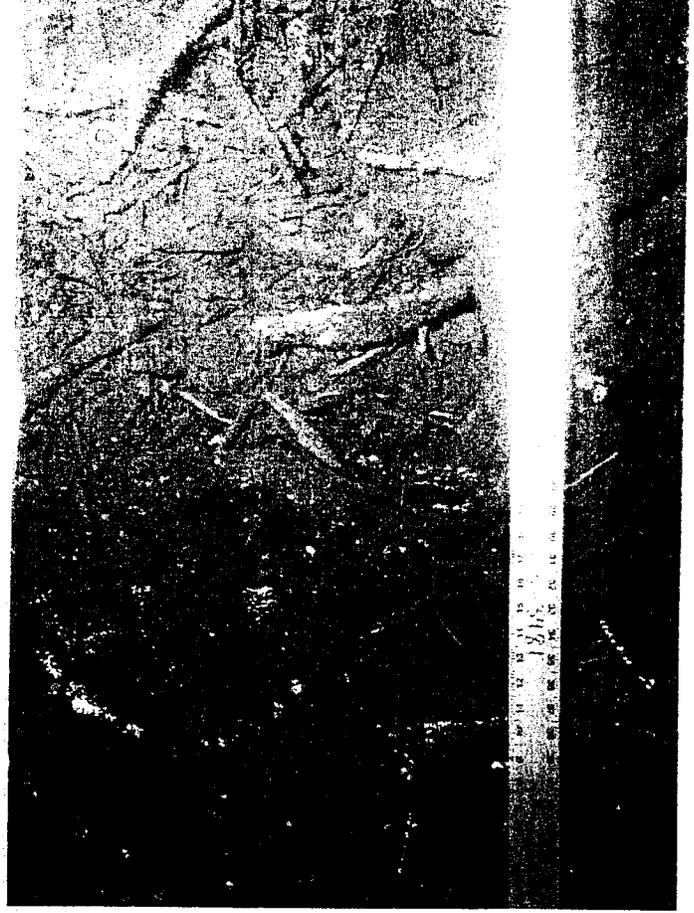
Table 2
Photograph Key

Photo #	Transect/ Sample Pt.	Description
1	Ref. Pt.	Sea star on fill rock, gravel; few bark chips
2	270/1	Small bark sizes filling in trough
3	270/2	Silt layer on surface of fine debris zone
4	270/3	Silt layer on surface of fine debris zone
5	270/4	Continued homogeneous fine debris zone
6	270/5	Silt layer on debris again
7	270/6	Silt layer on debris, some detrital algae
8	270/7	Crab shell parts on surface, more silt
9	270/8	Silt now more extensive
10	210/1	Variety of debris sizes
11	210/2	Dungeness crabs, bark chips and natural
12	210/3	Wire, silt on total bark cover
13	210/4	Some natural debris mixed in
14	210/5	Crab, detrital algae and natural debris
15	210/6	Crab on branch, silt now covering debris
16	210/7	Buried Dungeness crab, sea cucumbers
17	210/8	Crab on silt/bark mix
18	210/9	Some detrital algae, more silt
19	150/1	Patch of LTF and stream woody debris
20	150/2	Silt and little bark on sand, gravel & shell

21	150/3	Silt and little bark on sand, gravel & shell
22	150/4	Patch of LTF and stream woody debris
23	150/5	Silt and little bark on sand, gravel & shell

The marine life community has not changed noticeably from previous surveys. However, few horse neck clam siphons were observed (see photograph # 21) compared with the many noted during the last survey. Possible explanations include lowered salinity (especially on the shallow flats of transect 150) due to the recent heavy rainfall, decreasing plankton density and the start of seasonal hibernation given the time of year. Dungeness crabs were numerous on the substrate/debris moving about and also buried in both debris (see photographs # 11, 16 & 17) and substrate. They were observed on all transects and at all depths. Other typical crab species and shrimp also were observed (see photographs # 14 & 15).
