Underwater Bark Debris Survey
Shoal Cove Log Transfer Facility
Revillagigedo Island, Alaska

Submitted to: USDA Forest Service, Region 10
Ketchikan Area, Tongass National Forest
Federal Building, 648 Mission Street
Ketchikan, AK 99901

Prepared by: Craig's Dive Center
P.O. Box 796
107 Main Street
Craig, AK 99921

September 12, 2000

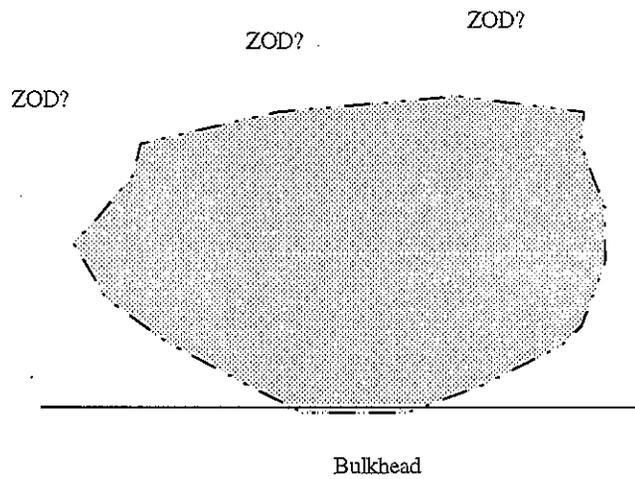
60 feet MLLW

The zone of deposit covers the entire dive survey area. The zone of 100 % coverage by bark encompasses the slopes and bottom of the semi-circular bowl of the bight shape out to the maximum survey depths, except on transect 005 and 245, where the bark debris became discontinuous five sample points before the transect ends. The depth of bark accumulation was decreasing rapidly on the three transects that ended with 100% coverage. In the areas of deepest bark accumulation, the bark layer exhibited a "jiggling" movement when the measuring stick was inserted into the layer. Overall, the size of the bark debris tended to be small, with patches of larger bark chips and chunks on the surface in some areas. Few sunken logs were observed, and they were in various stages of considerable decay.
