Facility: Tolstoi Bay Log Transfer Facility

Underwater Bark Monitoring Survey Date: February 22, 2002

**Bark Debris Survey**  
**TOLSTOI LOG TRANSFER FACILITY**

Tolstoi LTF Surve  
February 22, 2002

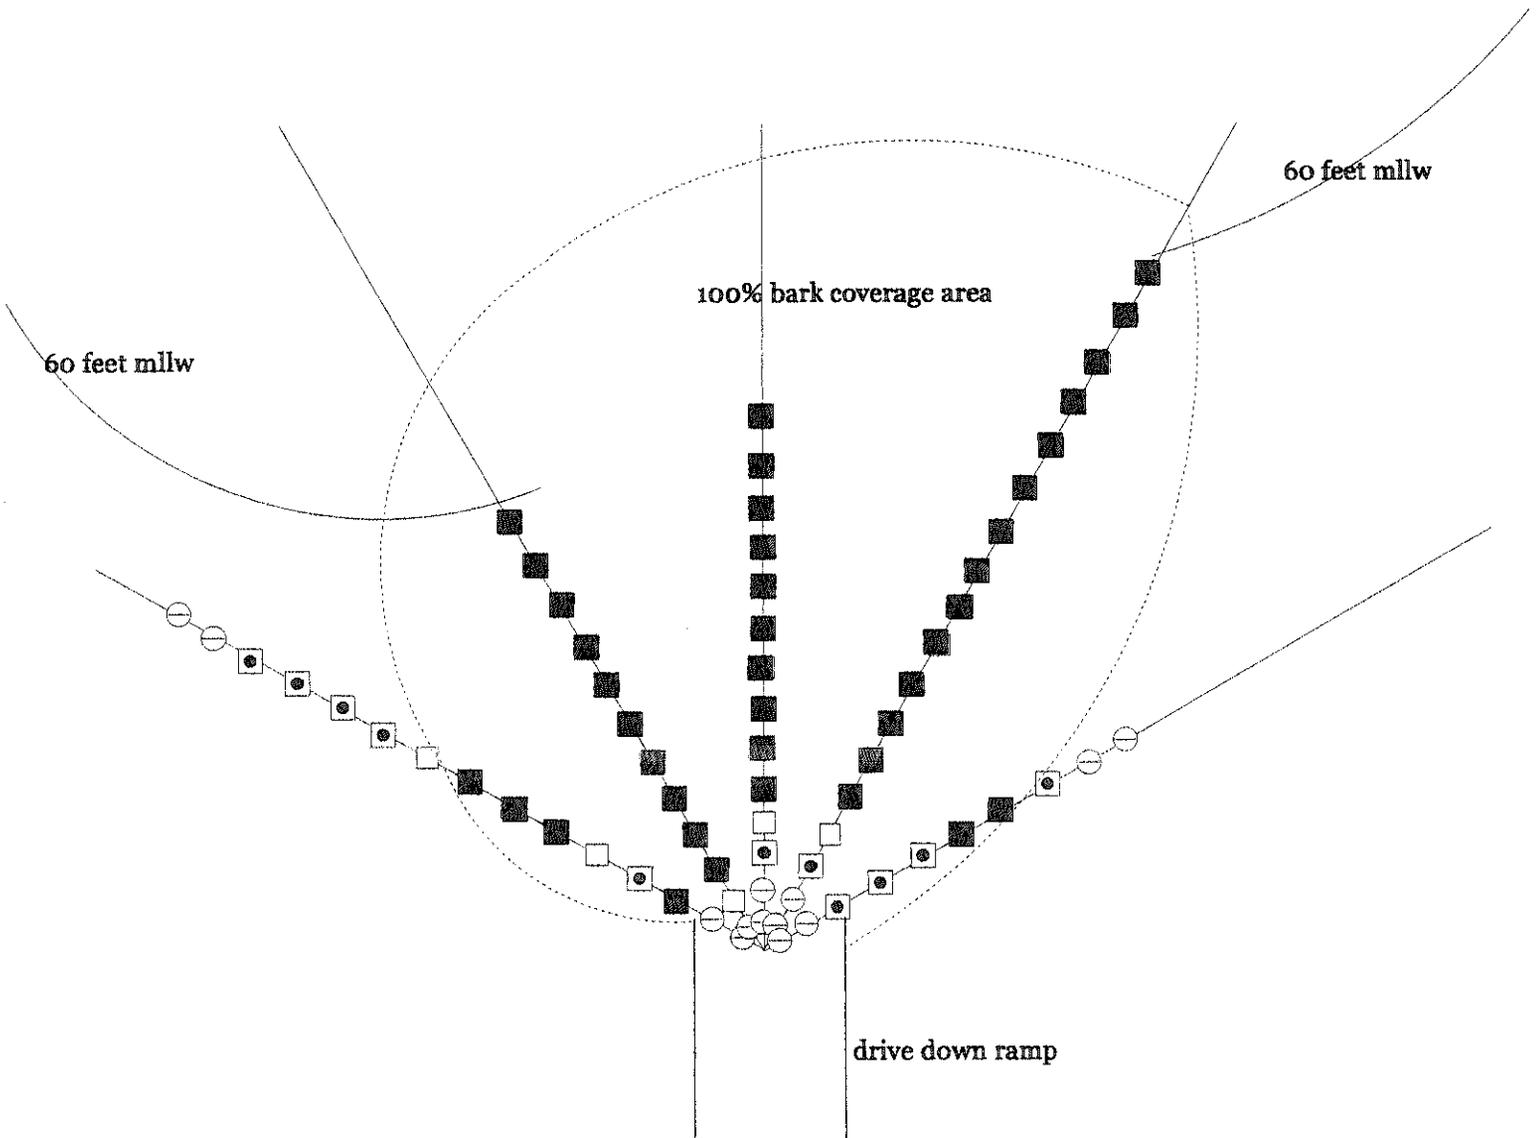
Bark Deposition Summary		
Total survey area	Area with continuous bark coverage.	Area with discontinuous bark coverage.
.86	.712	.15

- sample point w/ no bark
- ◐ sample point w/ minimal bark
- sample point w/ 100% coverage
- sample point w/ 100% coverage *over 4 inches*
