Underwater Bark Debris Survey
Tolstoi Log Transfer Facility
Prince of Wales Island, Alaska

Prepared by: Craig's Dive Center
P.O. Box 796
107 Main Street
Craig, AK 99921

May 15, 2000

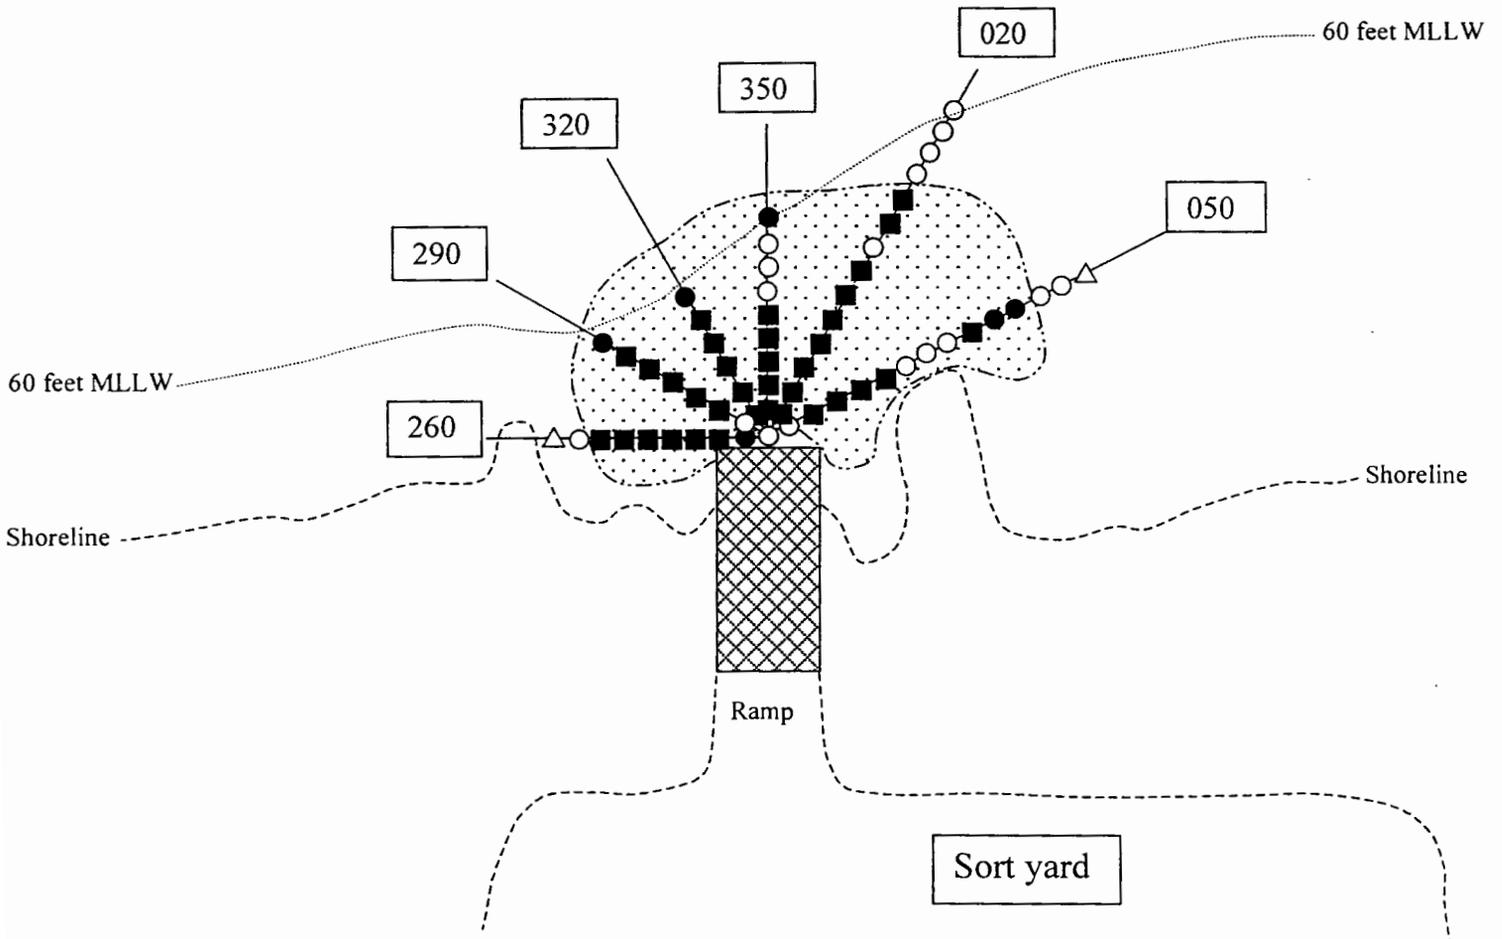
Diagram Not To Scale

A total of 60 sample points were taken on the six transects, and all sample points had some bark debris. A new transect, transect 260, was added to better define the bark deposit shoreward from transect 290. Of these, 41 (68 %) had 100 % bark cover. Thirty-five sample points (58 %) had 100 % cover and a bark depth of ten centimeters or greater. The total area covered by the dive survey was 1.07 acres. The area covered by 100 % bark cover was 0.73 acres. The area covered by 100 % bark cover and a bark depth of at least 10 centimeters was 0.62 acres.

The reference point was moved a little deeper, to the end edge of the ramp surface, in order to clear most of the dense algal cover on top of the ramp. The zone of deposit covers the entire dive survey area, though it is broken up by the reef system. The bark depth measurement data show a decreasing trend towards the ends of the transects, with the majority of bark accumulation on and surrounding the fill rock structure of the ramp. Character and size of the observed bark debris varied, depending on where it was located within the survey area. In the valley between the drive-down ramp and the bedrock reef, debris along transects 020 and 050 tended to be very small in size, characterized as bark dust, with few to no bark chips. Beyond the reef on these transects the bark debris was the more typical chips and chunks. The area of transects 260 to 350 was dominated by larger debris sizes, predominantly as bark chips and bark chunks to small wood pieces. A few, scattered sunken logs were noted during the dive. Where the bark depth was greater than approximately 25 centimeters, the bark mass exhibited a "jiggling" when the measuring ruler was inserted into the debris.

- △ Sample Point with Insignificant Bark Debris
- Sample Point with No Debris
- Sample Point with Debris Present
- Sample Point with 100% Bark Debris Cover
- Sample Point with 100% Cover & Debris Depth > 10 cm
- ⊙ Area of 100% Bark Cover
